# **Long-Term In-Service Evaluation of Two Bridges Designed with Fiber-Reinforced Polymer Girders**

Thesis submitted to the Faculty of the  
Virginia Polytechnic Institute and State University  
in partial fulfillment of the requirements for the degree of

Master of Science  
In  
Civil Engineering

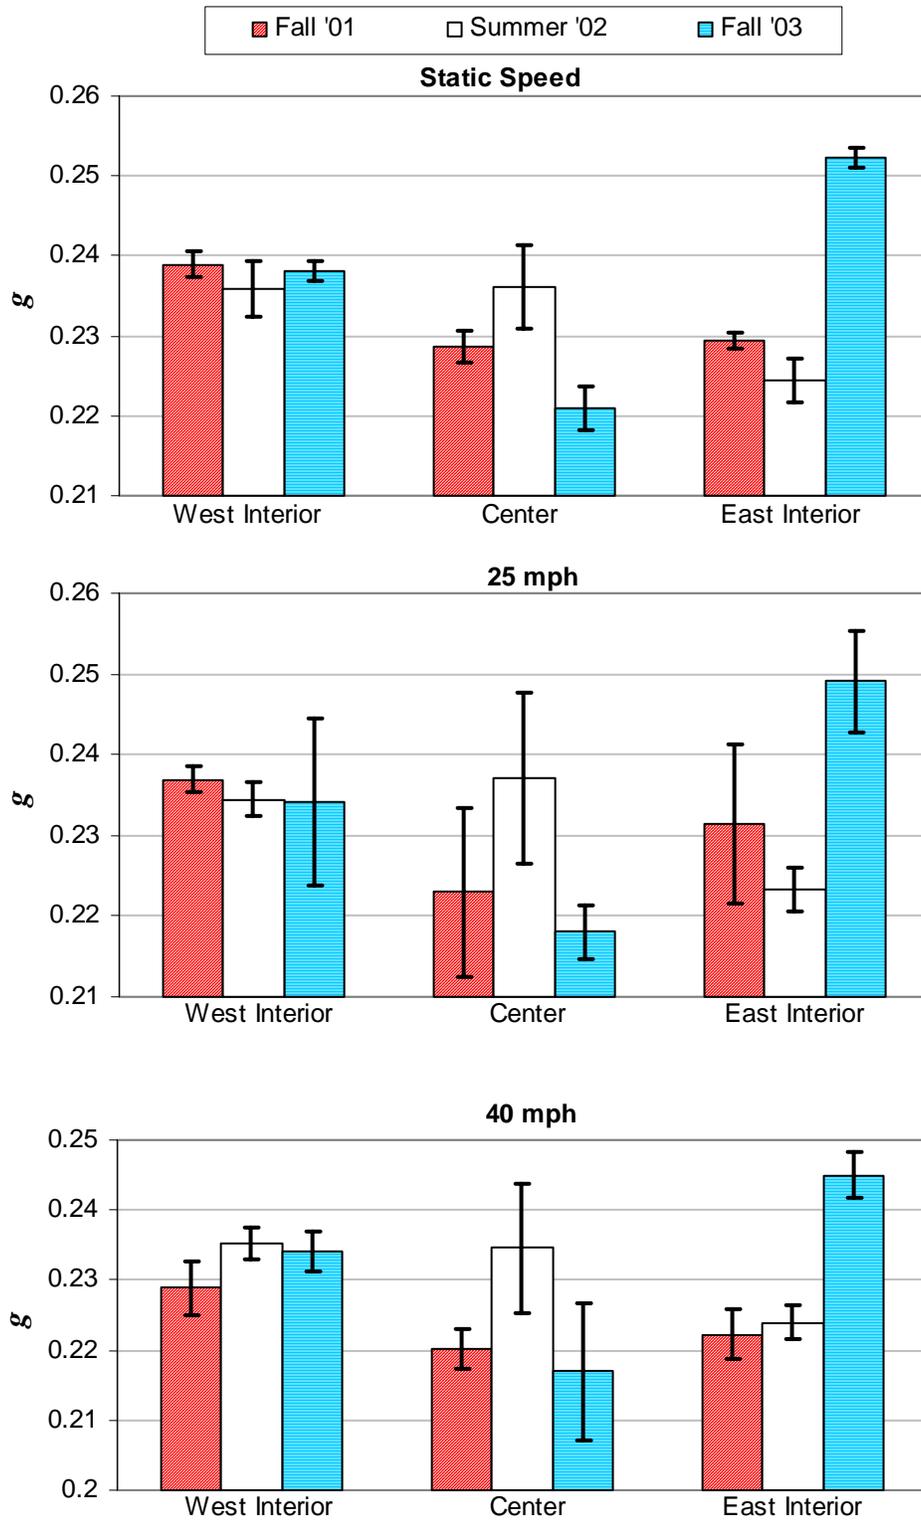
**Figure 4-18.** Error bars for average maximum wheel load distributions at three different speeds of the interior orientations in the Route 601 Bridge, based on deflection measurements.

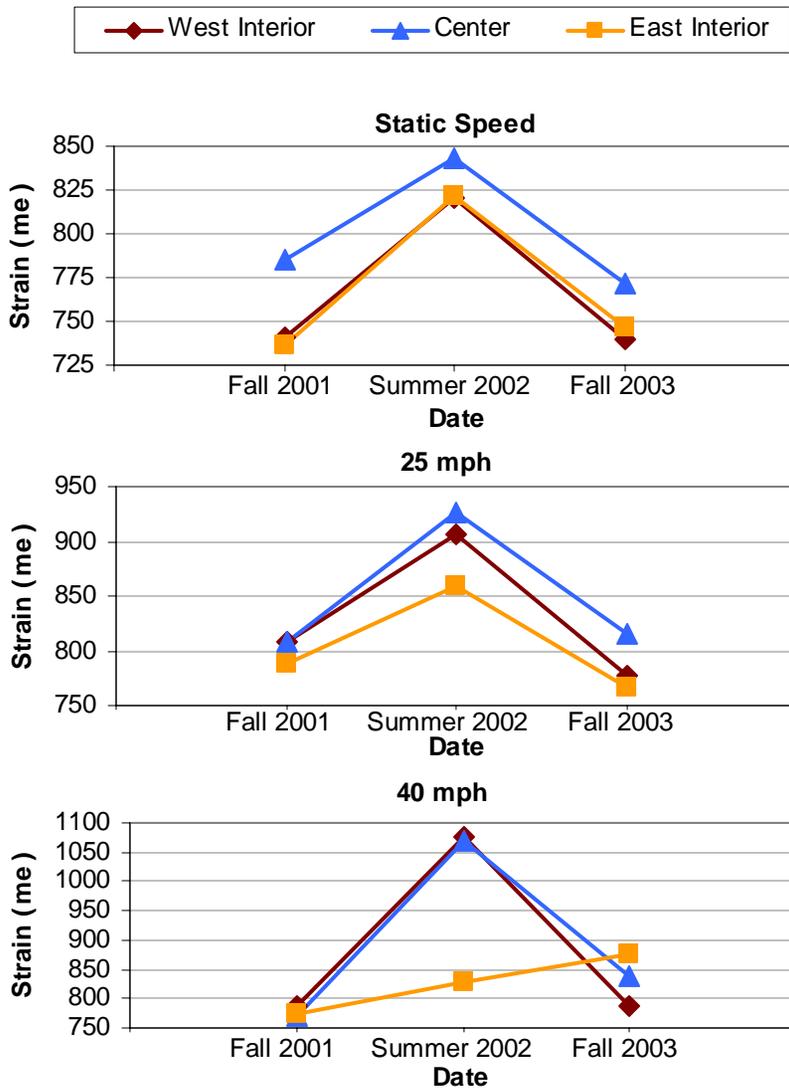
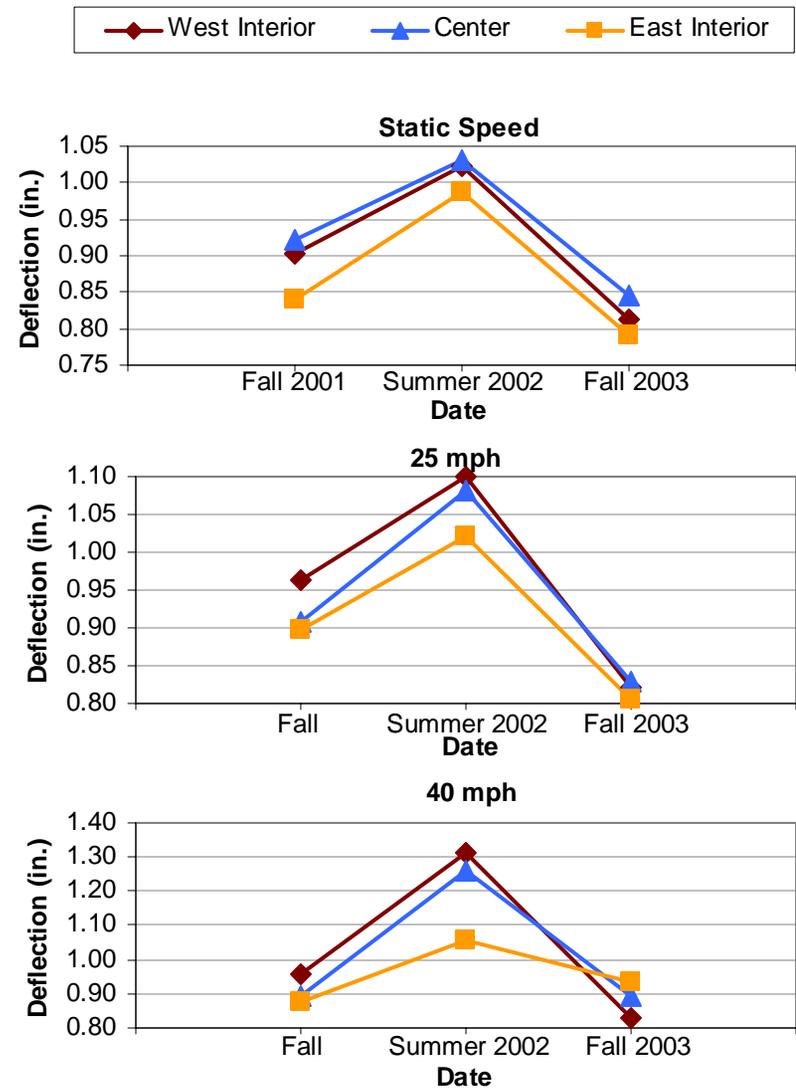
**Figure 4-19.** Average total peak (a) strain and (b) deflection in all of the girders for the Interior truck orientations at the various speeds in the Route 601 Bridge.

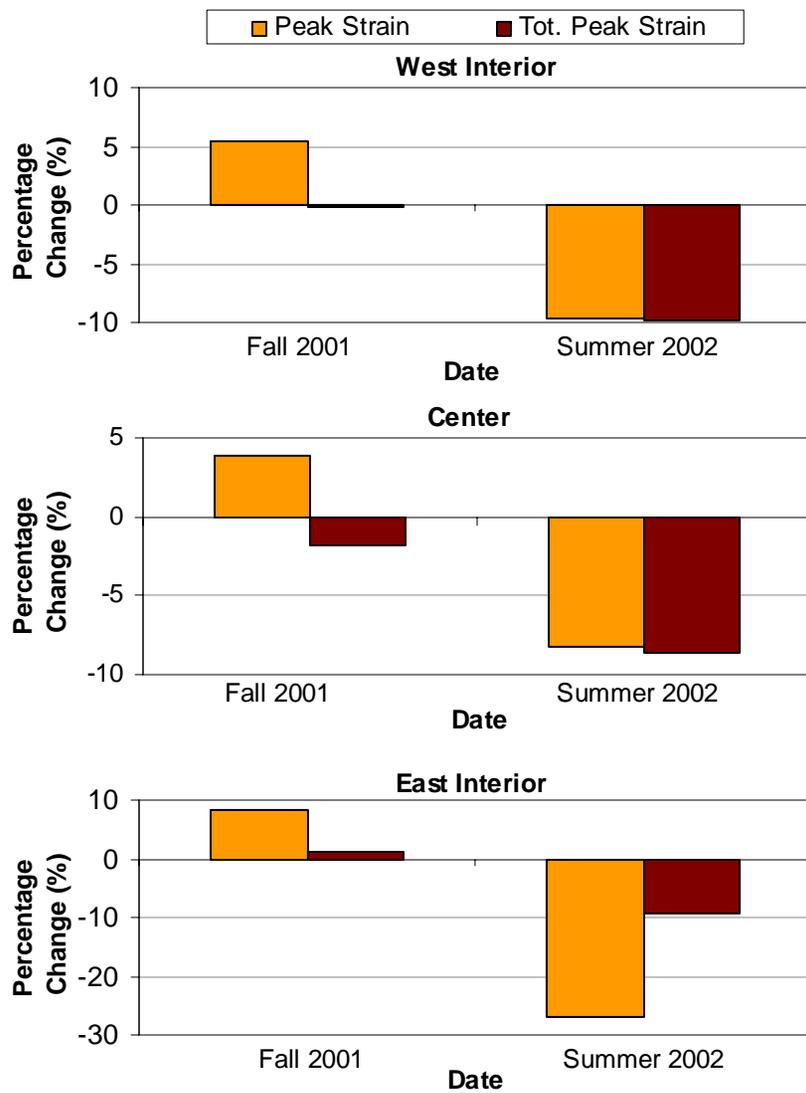
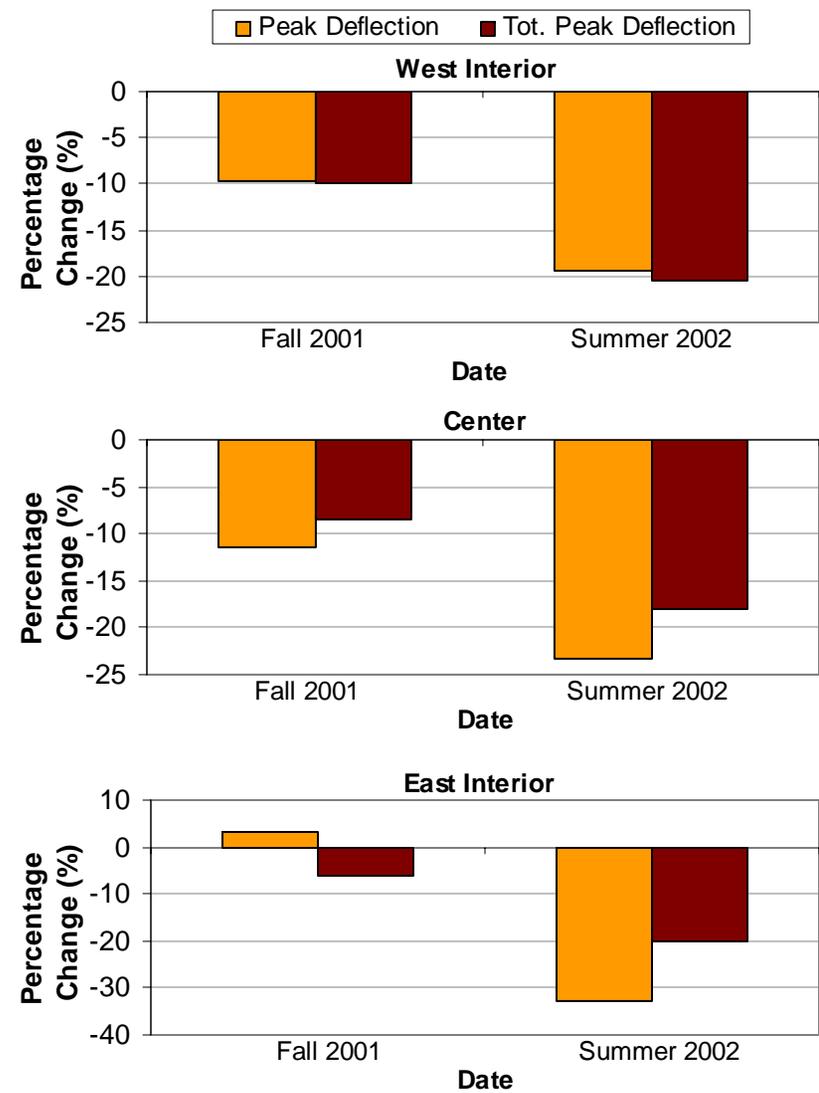
**Figure 4-21.** Percentage change of (a) peak strain versus total peak strain and (b) peak deflection versus total peak deflection from the given test date to the Fall 2003 test for the various interior truck orientations in the Route 601 Bridge at static speed.

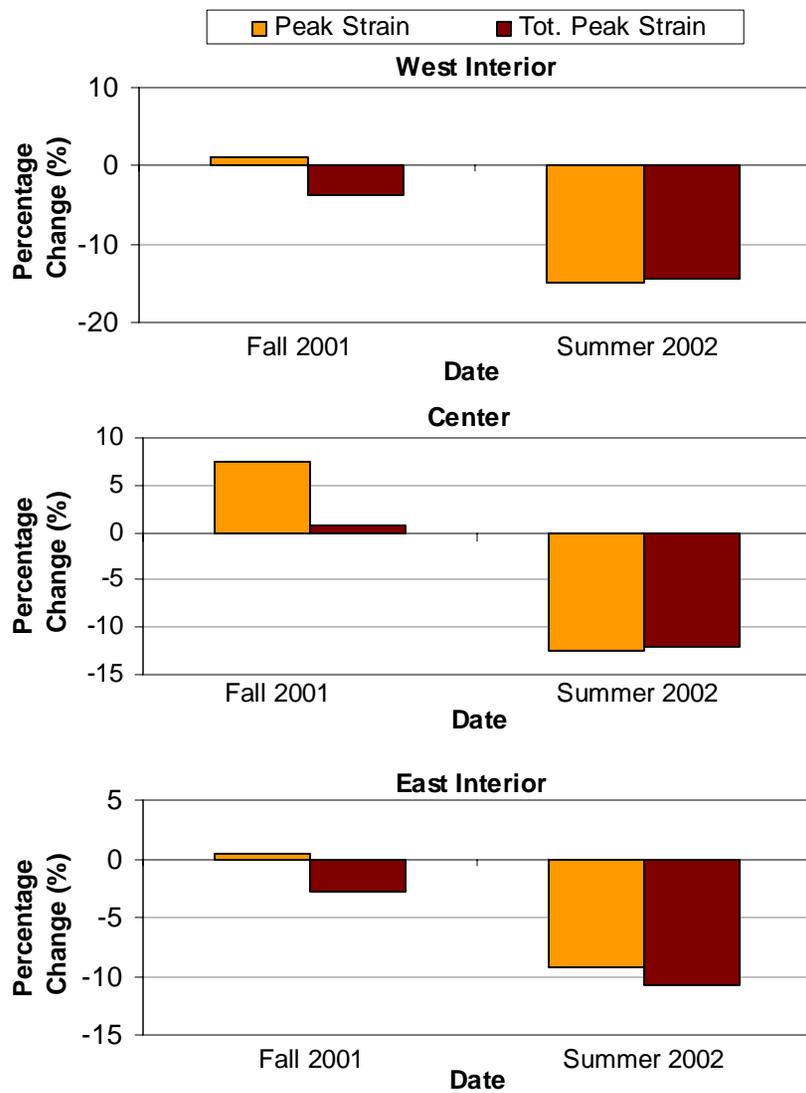
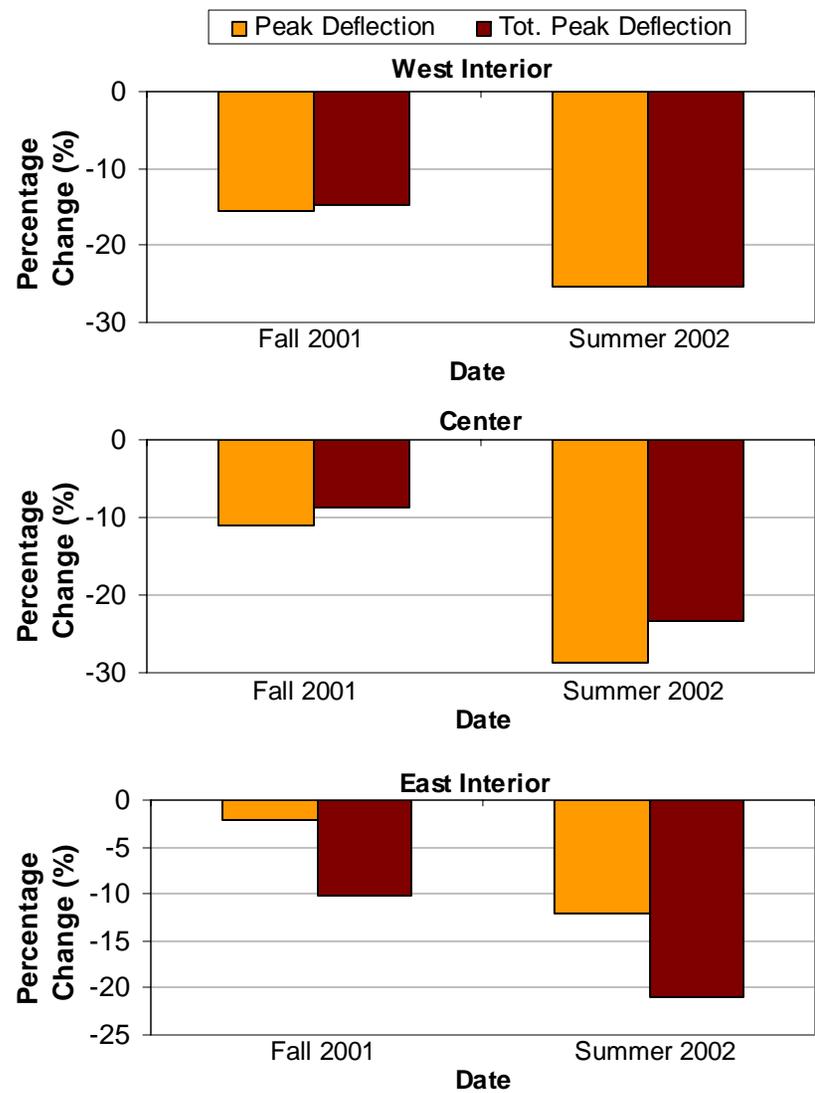
**Figure 4-22.** Percentage change of (a) peak strain versus total peak strain and (b) peak deflection versus total peak deflection from the given test date to the Fall 2003 test for the various interior truck orientations in the Route 601 Bridge at 25 mph (40 kph).

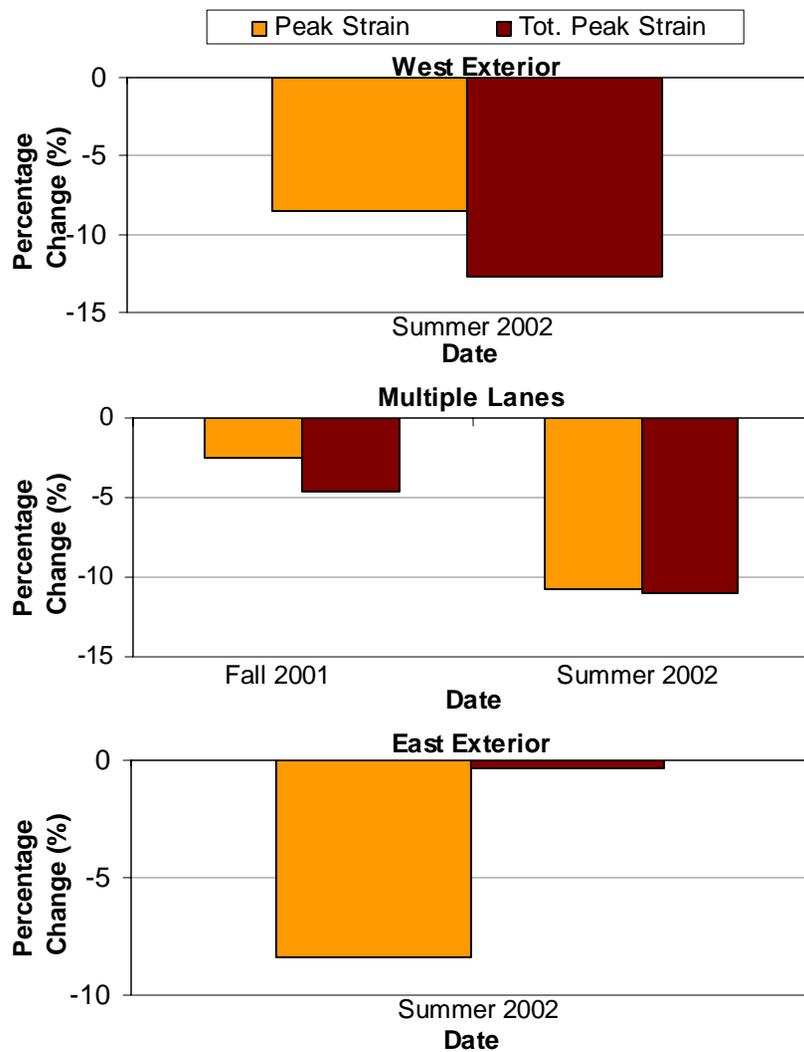
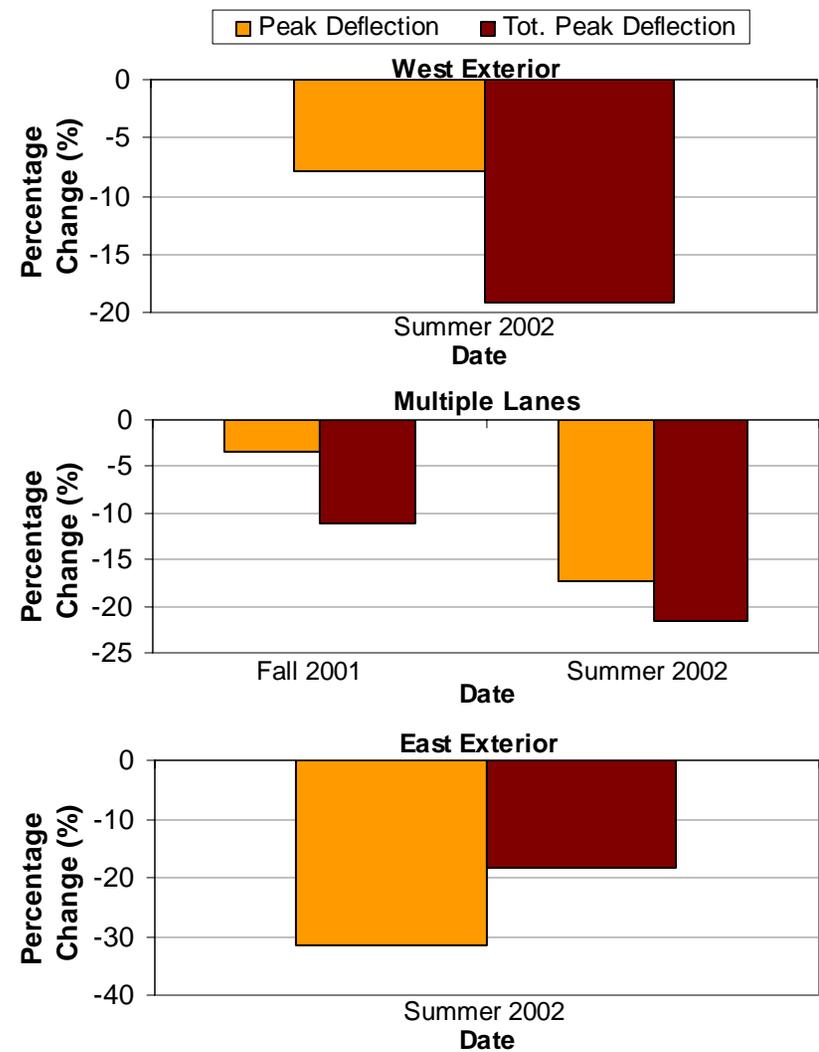
**Figure 4-24.** Percentage change of (a) peak strain versus total peak strain and (b) peak deflection versus total peak deflection from the given test date to the Fall 2003 test for the exterior truck orientations in the Route 601 Bridge at static speed. Note that the East and West Exterior orientations were not tested in the Fall of 2001.

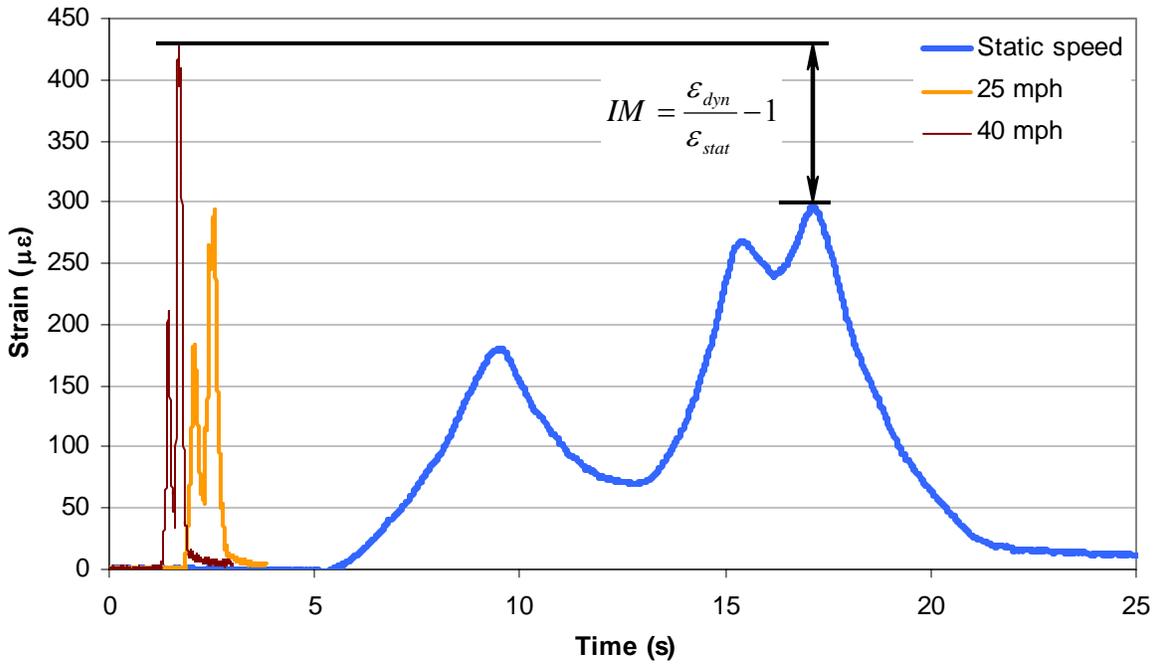
**Figure 5-1.** Typical comparison of peak dynamic loading versus static loading for the Toms Creek Bridge, with the *IM* factor based on strain measurements.

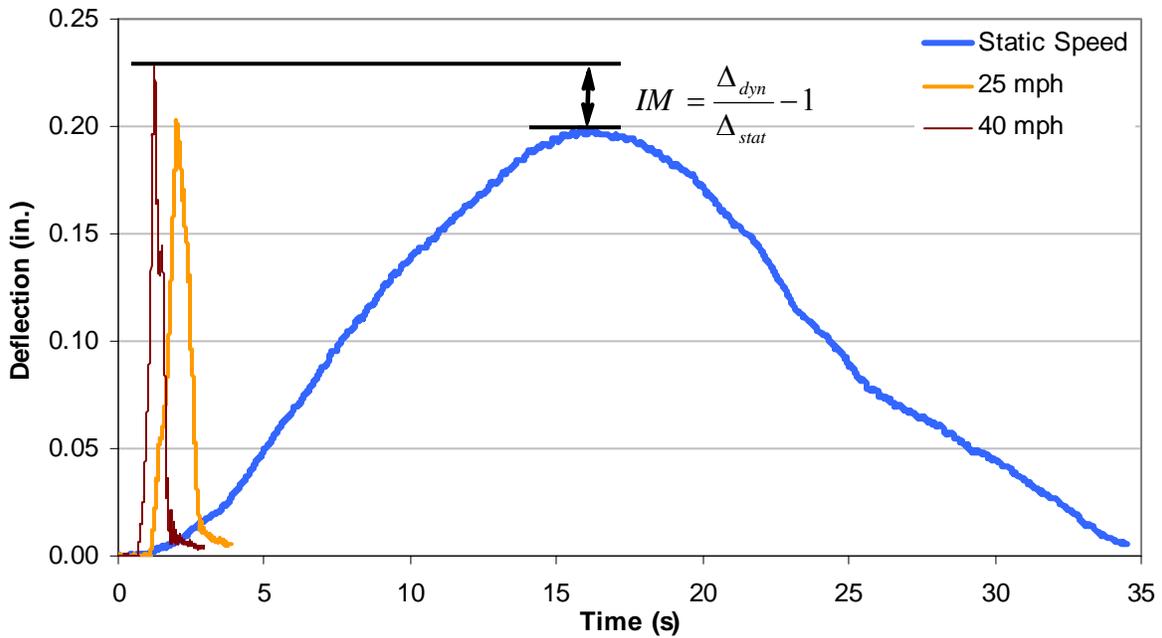
**Figure 5-2.** Comparison of peak dynamic loading versus static loading for the Route 601 Bridge, with the *IM* factor based on deflection measurements.

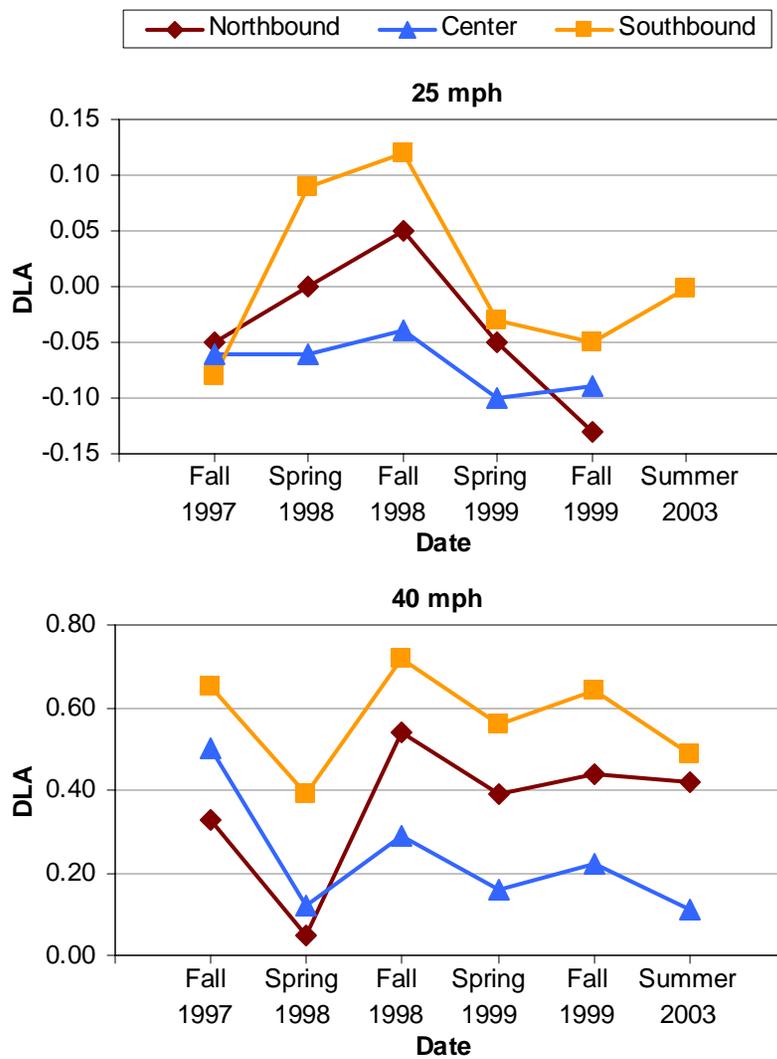
**Figure 5-3.** Average dynamic load allowance over time for the Toms Creek Bridge for two different speeds, based on strain data.

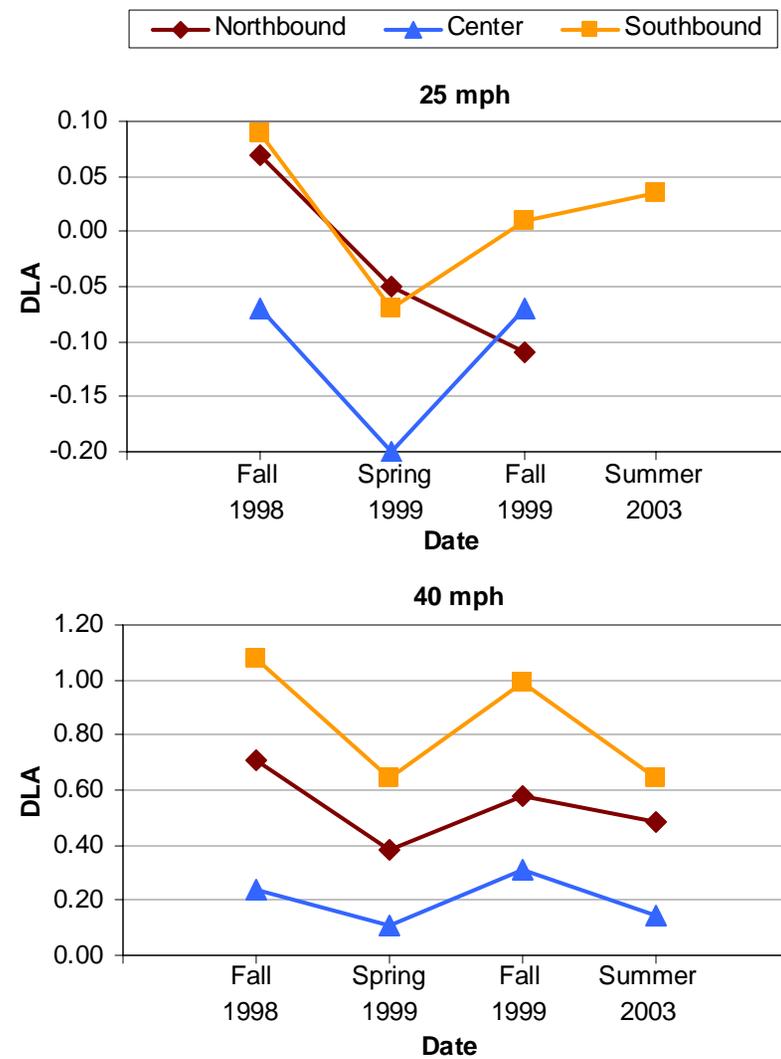
**Figure 5-4.** Average dynamic load allowance over time for the Toms Creek Bridge for two different speeds, based on deflection data.

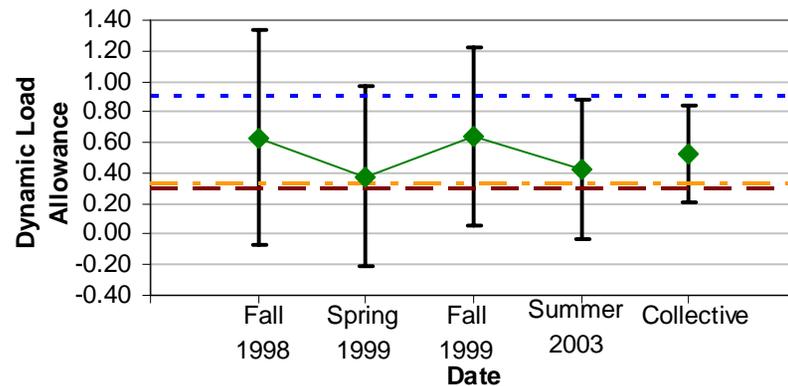
**Figure 5-7.** Overall dynamic load allowances calculated at (a) 25 mph and (b) 40 mph, averaged for all of the truck orientations on a given test date, shown with error bars, both AASHTO Specifications recommendations, and Neely's proposed IM. Averages shown here are based on deflection measurements, which tend to give the worst-case results.

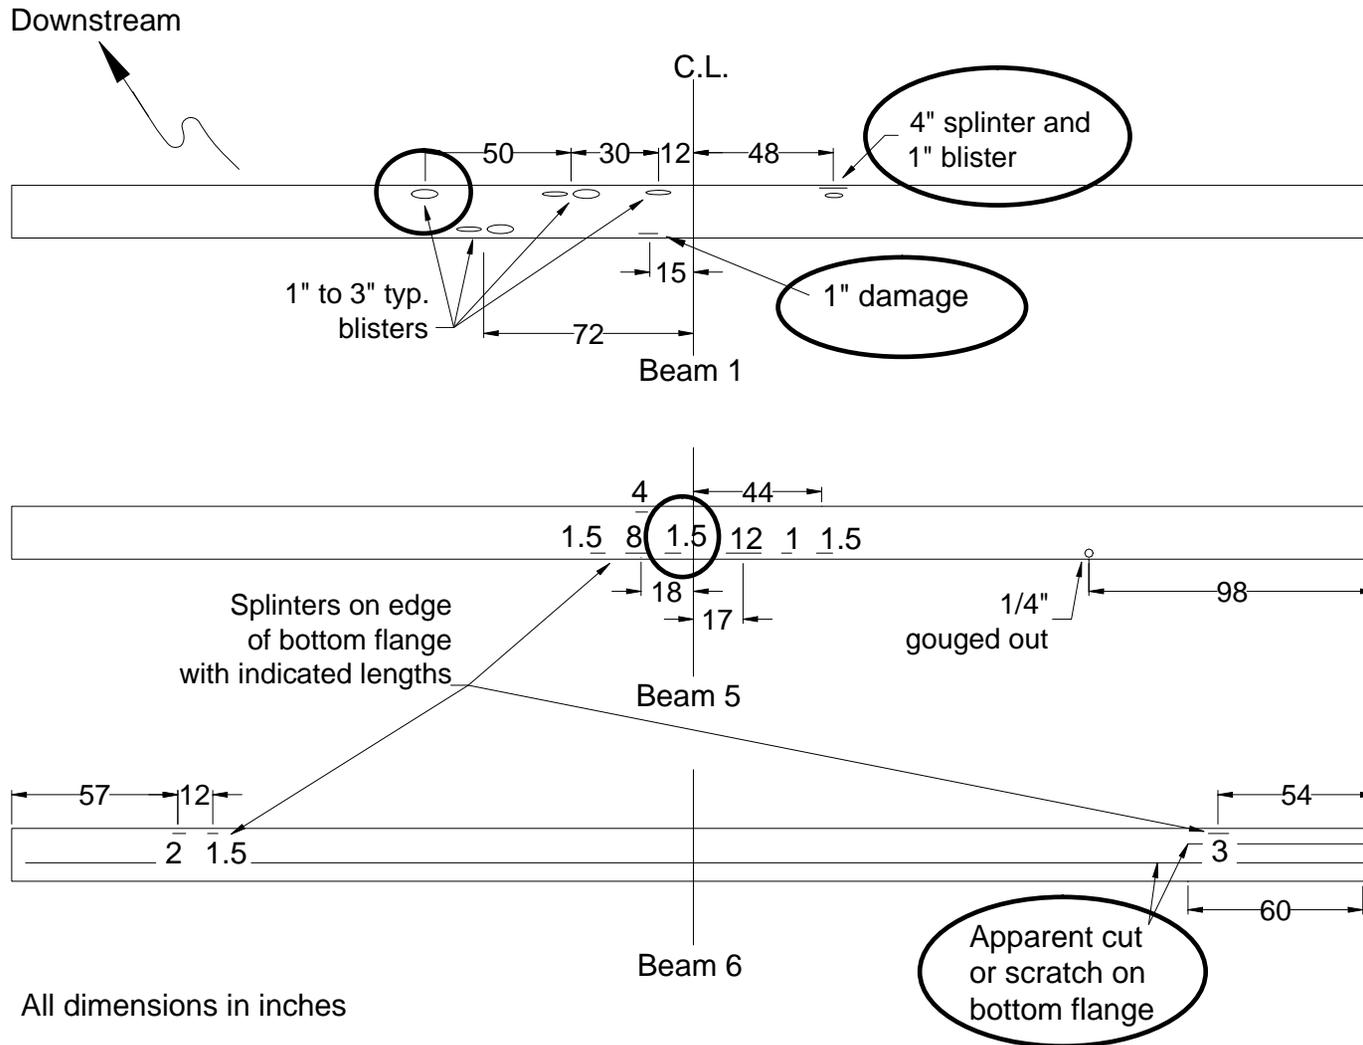
**Figure 6-1.** Detail of locations for damage or deterioration in Beams 1, 5, and 6 in the Route 601 Bridge. Circled items were discovered during the Spring 2004 inspection; all other items were noted during the Fall 2003 inspection.

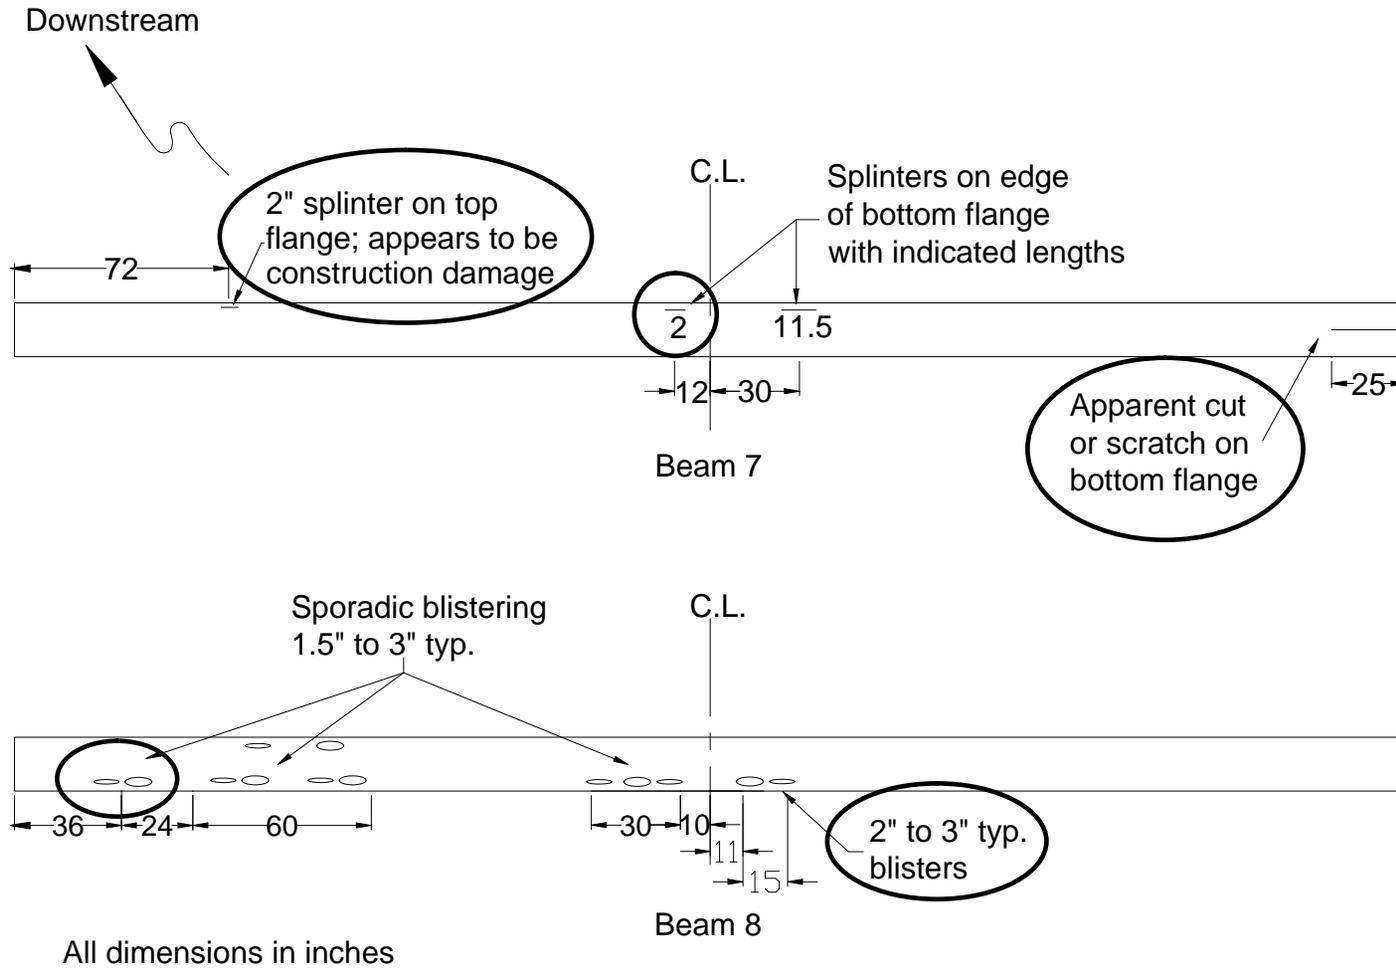
**Figure 6-2.** Detail of locations for damage or deterioration in Beams 7 and 8 in the Route 601 Bridge. Circled items were discovered during the Spring 2004 inspection; all other items were noted during the Fall 2003 inspection.

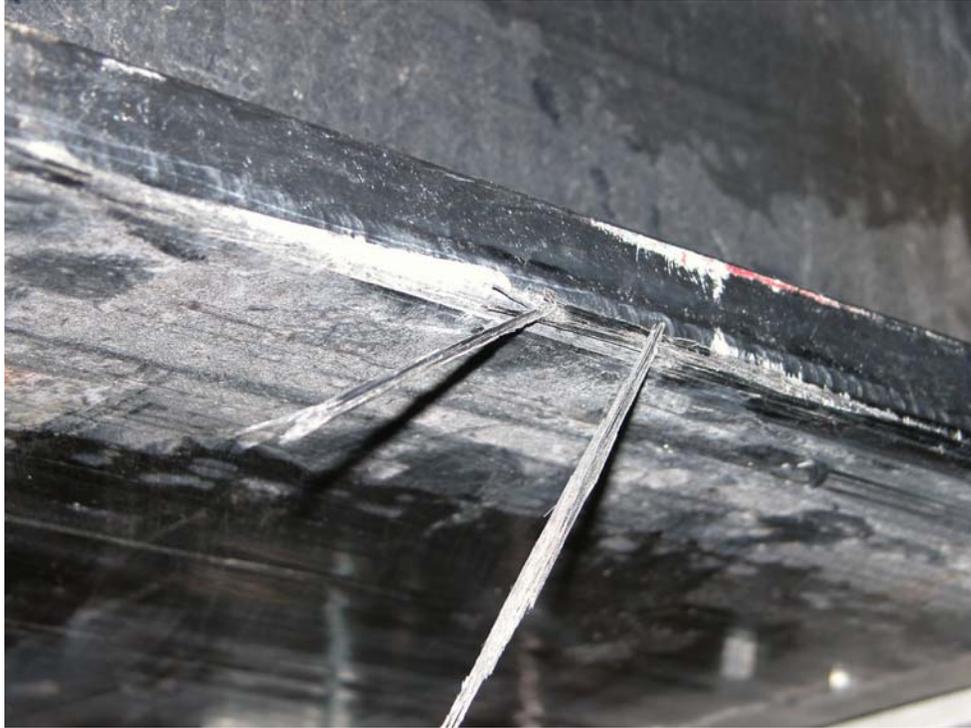
**Figure 6-3.** Matrix resin material splintering off from Girder 5 of the Route 601 Bridge (courtesy of Strongwell Corp).

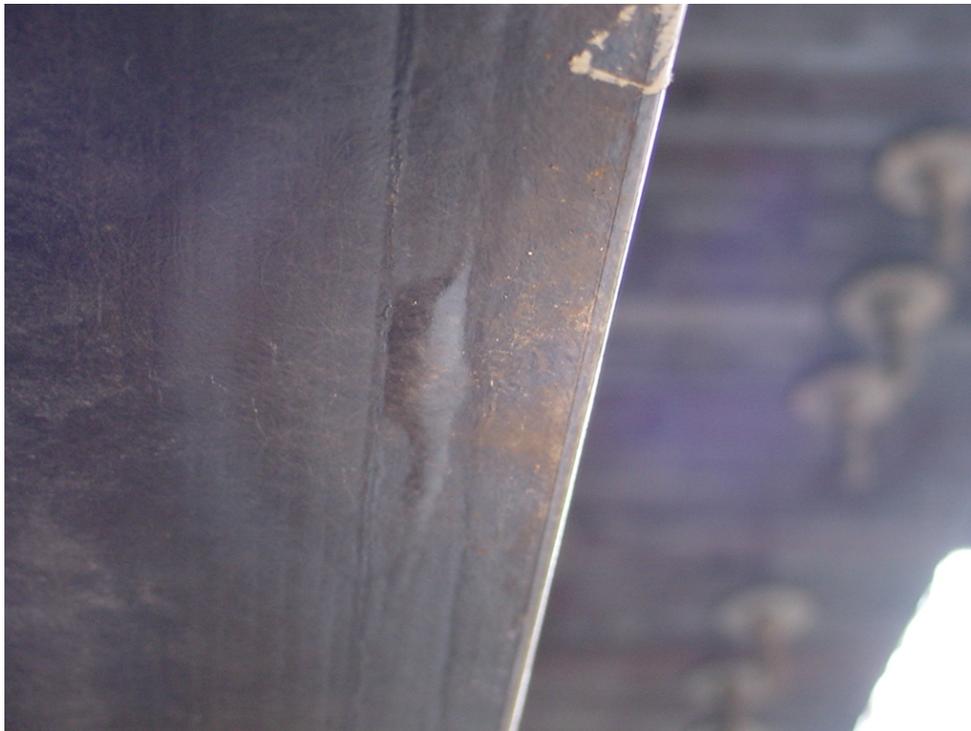
**Figure 6-4.** Typical blister on the surface of the bottom flange in an exterior girder for the Route 601 Bridge.

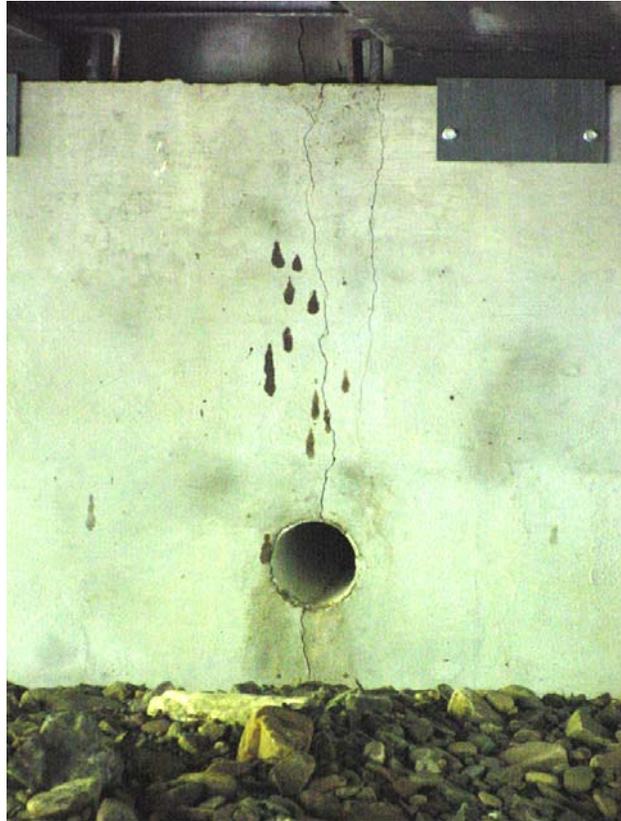
**Figure 6-5.** Crack down center of east abutment of the Route 601 Bridge.

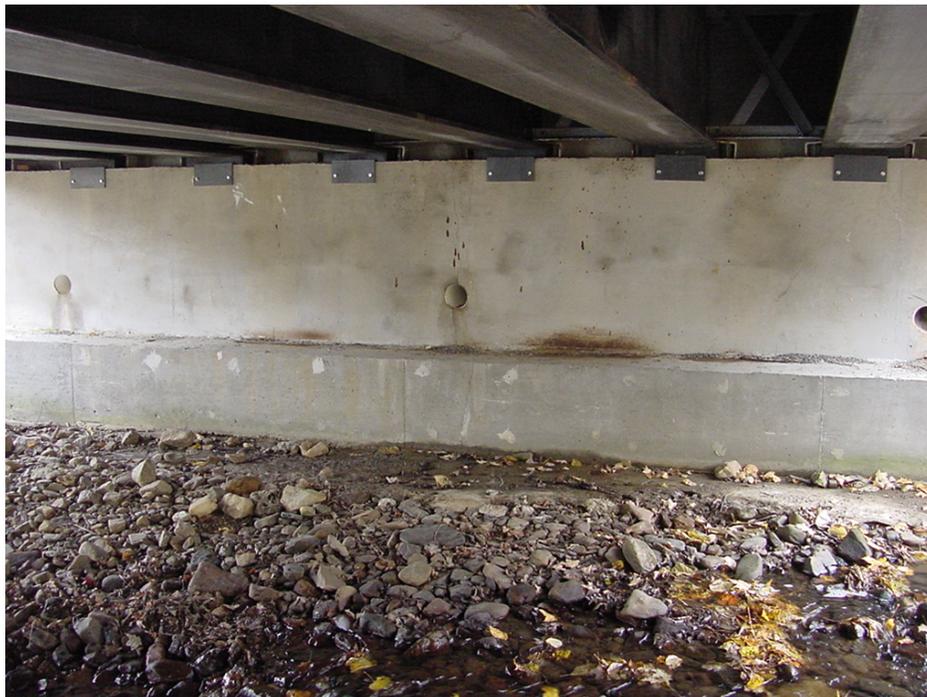
**Figure 6-6.** Extent of river stone pile-up at east abutment during Fall 2003 inspection of the Route 601 Bridge.

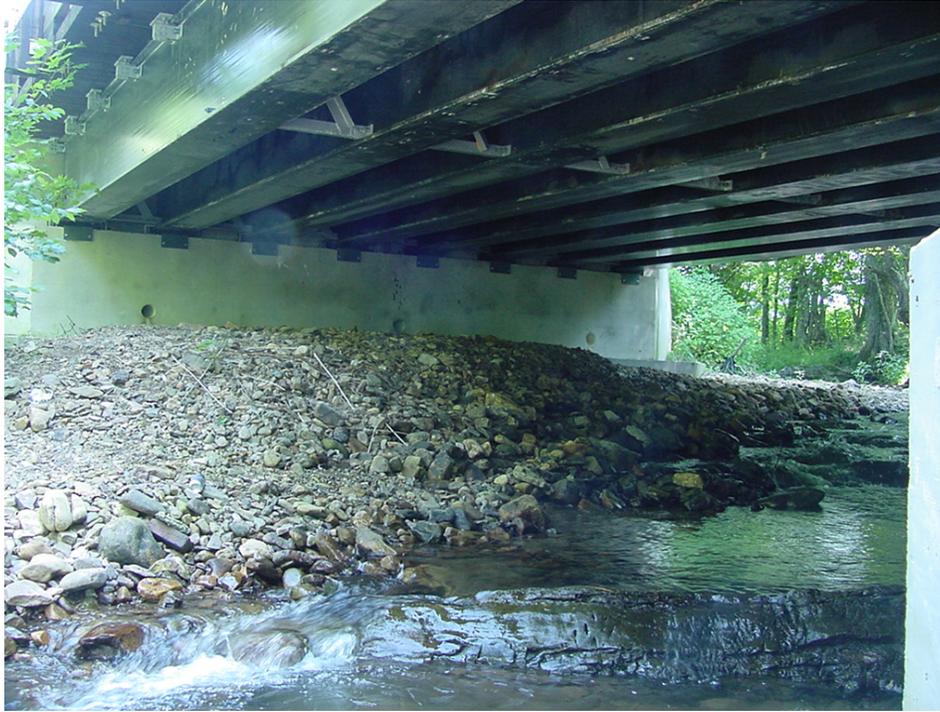
**Figure 6-7.** Extent of river stone pile-up at east abutment during Spring 2004 inspection of the Route 601 Bridge.

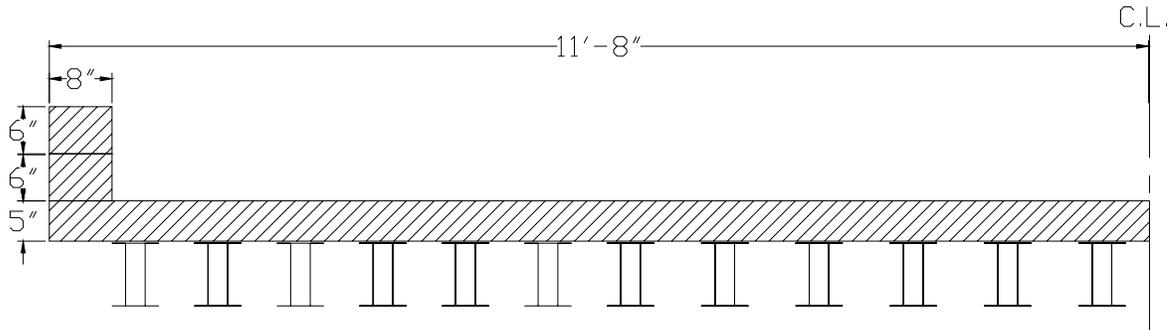
**Figure A-1.** Cross-section used for calculating the effects of moisture content on the deflection of the Toms Creek Bridge.

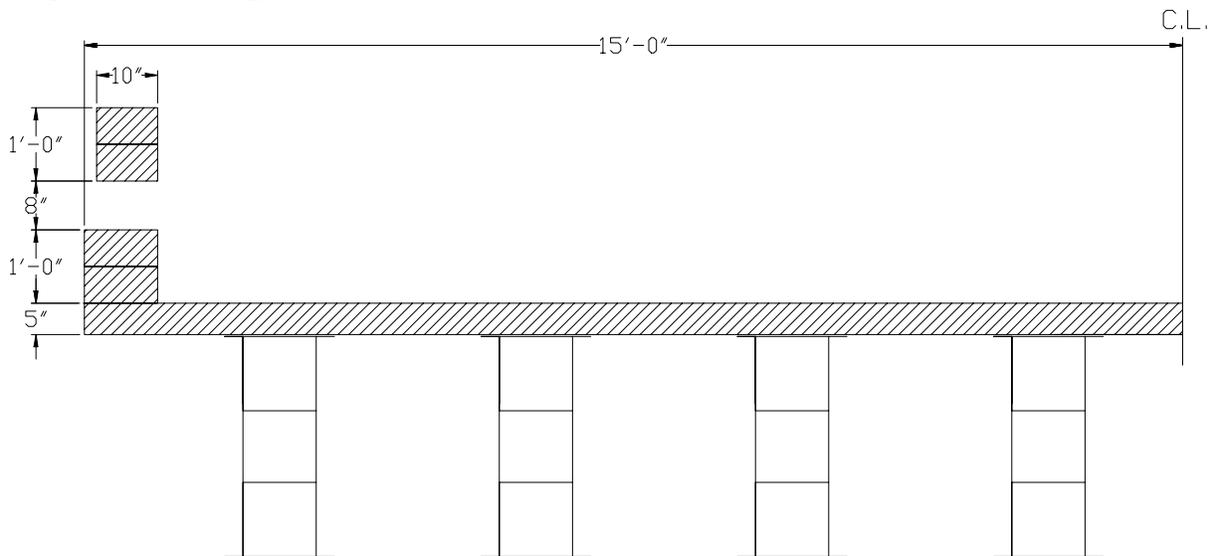
**Figure A-2.** Cross-section used for calculating the effects of moisture content on the deflection of the Toms Creek Bridge.
