CHAPTER 3.

STATE OF THE ART LITERATURE AND PRACTICE REVIEW FOR WATER SYSTEM PIPELINES

Kristi K. Steiner* and Sunil K. Sinha

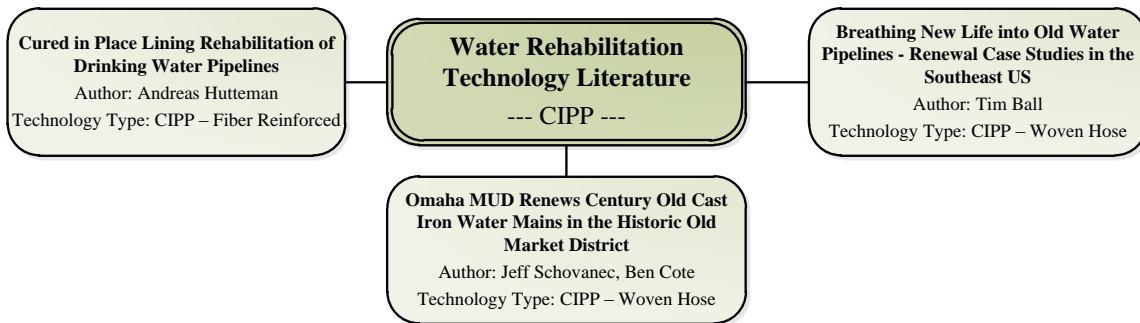
Figure 3-7. Pipe Rehabilitation Technology Use Literature Sources

potable water applications. The two common types of CIPP Liner for water pipe applications are woven hose liners and fiber-reinforced hose liners. It was surprisingly difficult to find publications documenting the use of these technologies within utilities in North America which is an indication of the innovative nature of the technologies. Examples for water pipe CIPP installations are shown in Figure 3-7 below.

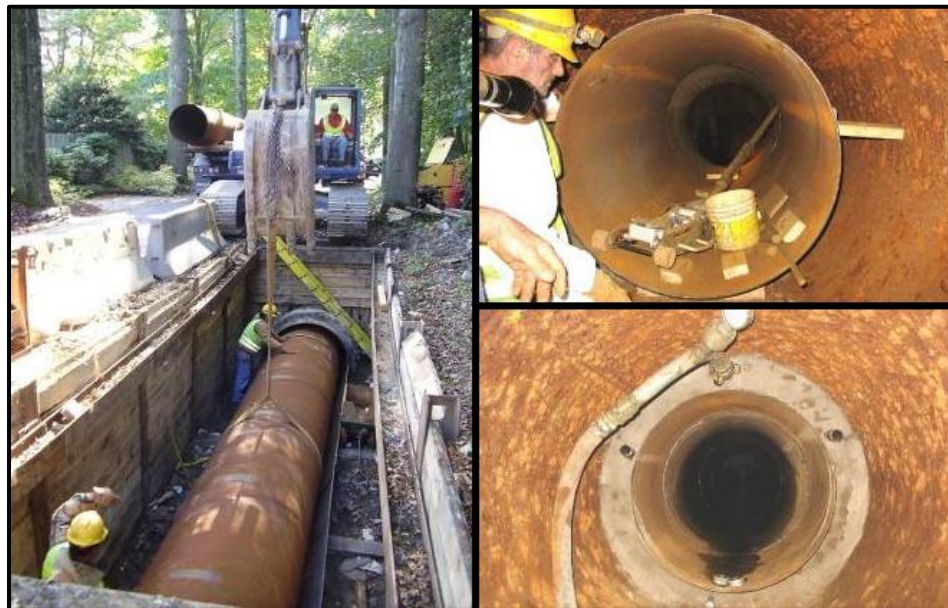
Figure 3-26. Segmental Sliplining Operations (Authority, 2009)

The Massachusetts Water Resources Authority (MWRA) used segmental sliplining to rehabilitate one segment of a 54-inch water main as part of a much larger rehabilitation project. The new pipe had a smaller diameter than the host pipe and was installed in segments that were hand-welded together from within the pipeline. Man entry was required for welding of the liner pipe ends, and once inside the host pipe, the new liner pipe was held in position with spacers,

securing it for grouting of the annular space. The grout provided additional strength for the new liner pipe and also had a corrosion inhibitor that acted as part of an integrated corrosion protection system. This particular segment needed structural renewal due to its location beneath Route 9. Figure 3-26 below shows a picture of the liner pipe insertion and man-entry for welding and grouting.
