FINAL  
CONTRACT REPORT  
VTRC 09-CR15

**ANCHORAGE ZONE DESIGN  
FOR PRETENSIONED PRECAST BULB-T  
BRIDGE GIRDERS IN VIRGINIA**

1. Report No.: FHWA/VTRC 09-CR15		2. Government Accession No.:		3. Recipient's Catalog No.:	
4. Title and Subtitle: Anchorage Zone Design for Pretensioned Precast Bulb-T Bridge Girders in Virginia				5. Report Date: June 2009

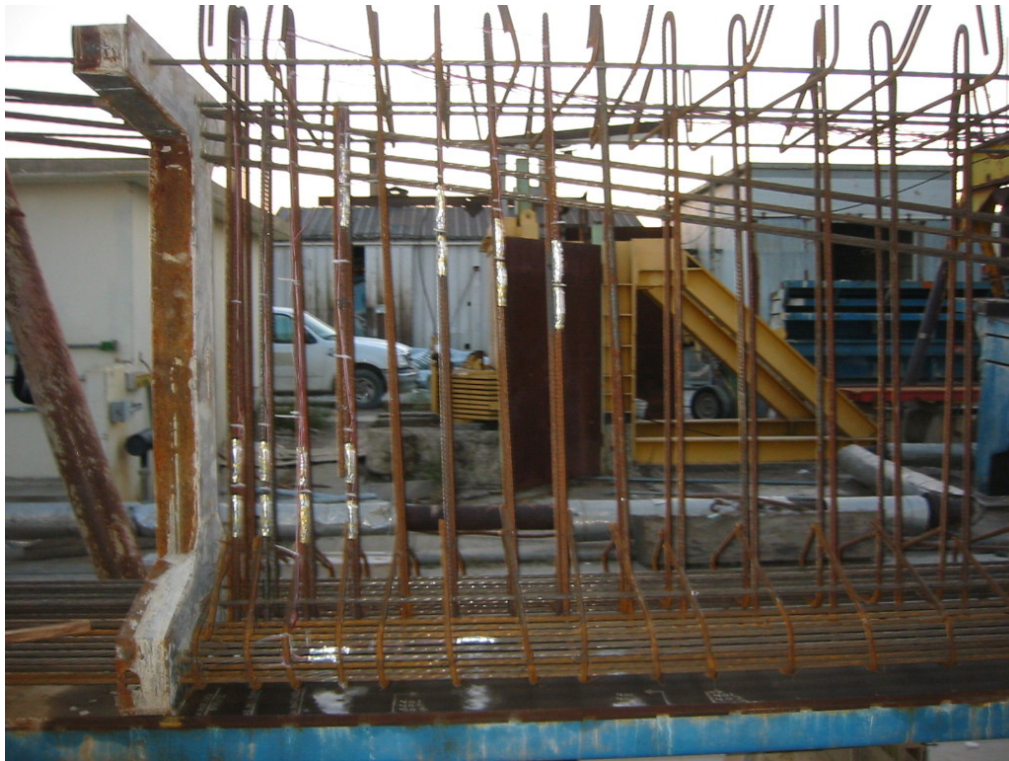
**Figure 13. Strain Gages Installed at the 12 ksi Anchorage Zone**

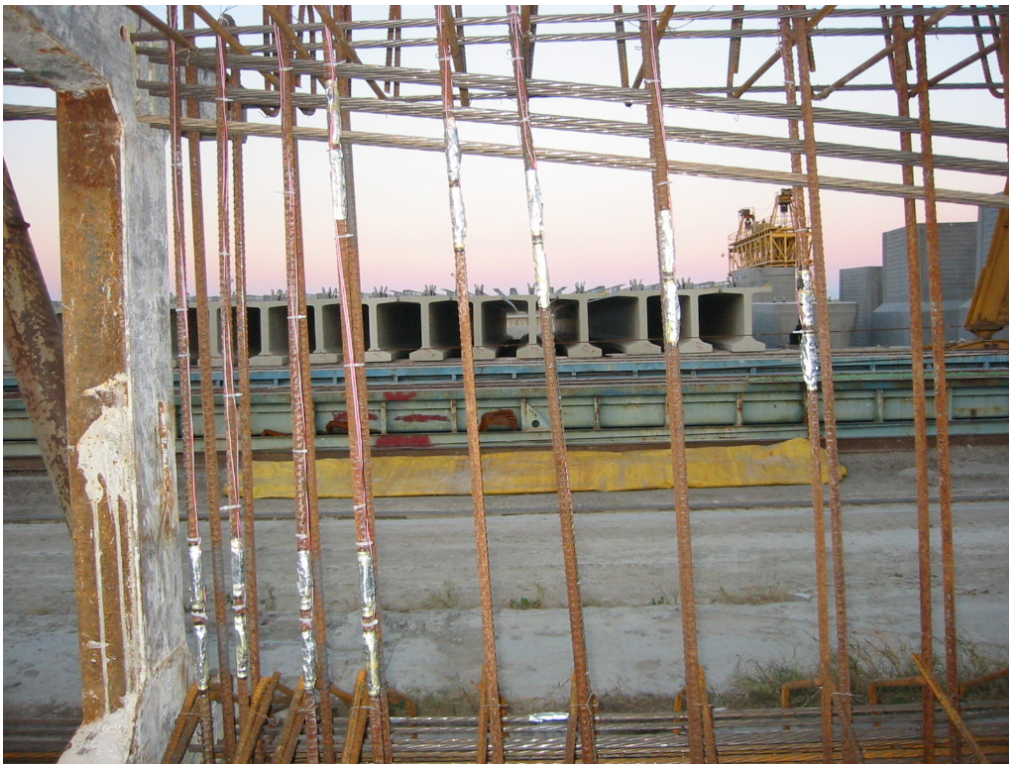
**Figure 14. Strain Gages Installed at the 18 ksi Anchorage Zone**

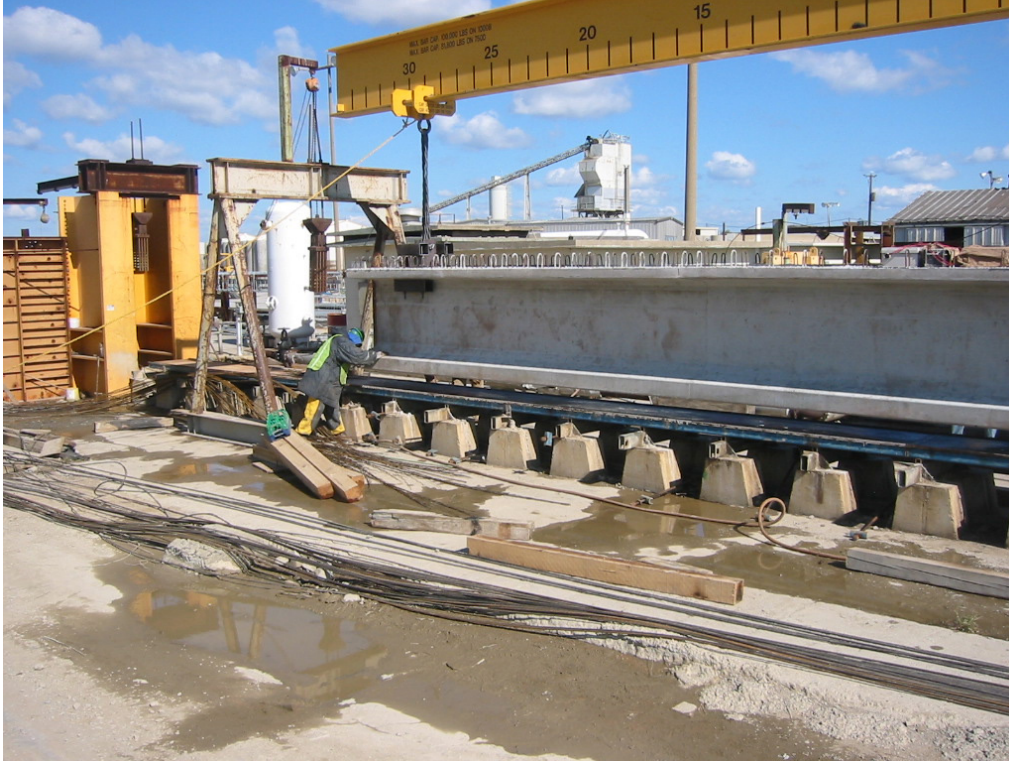
An important component in this test was the initial lift from the casting bed. During this first movement, the girder is most vulnerable because the prestress force is the highest, since long term prestress losses have not started, and the concrete is relatively weak. Bayshore planned to leave the girder in the casting bed until it was transported to Virginia Tech, but since lifting the girder was necessary to verify the anchorage zone model, they agreed to lift the girder briefly. The readings from the strain gages were monitored throughout casting, transfer, and the first lift of the girder. After the girder was lifted, the data acquisition system was adjusted to take readings every 90 minutes and the strain gage readings were recorded throughout the life of the gages.

Figure 15. Test Girder Lifted From Casting Bed on October 25, 2006

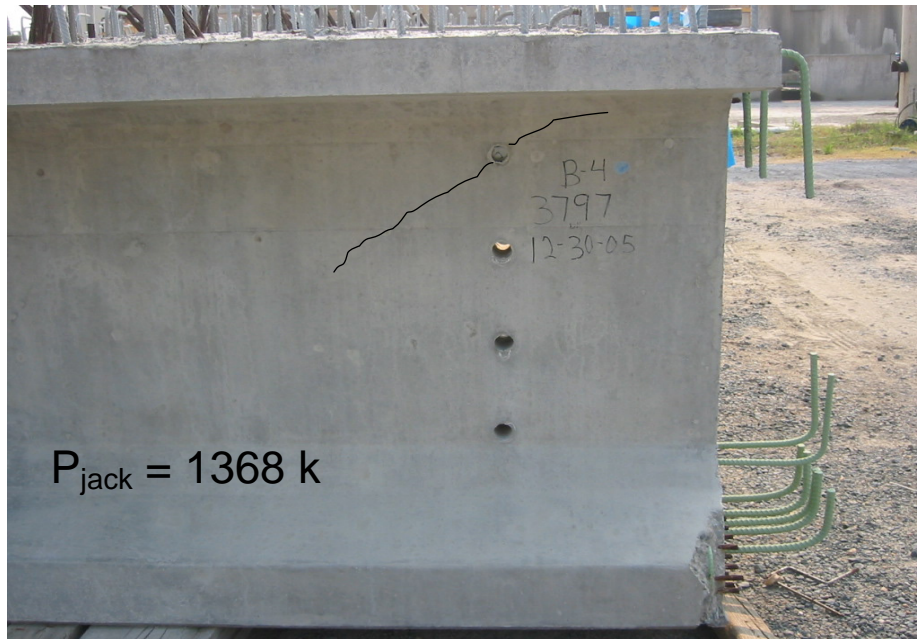
The girder shown in Figure 16 is a 53-in bulb-T with 44 ½-in strands, 6 of which were harped. The total prestress force was 1,368 kips at the time the strands were tensioned. The crack pattern shown in Figure 16 was typical of eight other beams with the same magnitude of prestress force and stirrup arrangement. The area of vertical reinforcement within a distance of  $h/4$  from the end of the girder was 3.1 in<sup>2</sup> and this region was free of cracks. A diagonal crack formed near the top flange-web interface several inches in from the end of the beam and extended a length of almost 60 percent of the girder height. The widest portion of this crack measured approximately 0.010 in. This crack width would be acceptable for most bridge girders not exposed to salt water environments. This girder was classified as fair because of the length of the diagonal crack. It is desired for any diagonal cracks that develop near the top flange to terminate within  $h/2$ . Diagonal cracks that terminate within  $h/2$  are often tighter and are less of a concern to bridge inspectors. The diagonal crack in this girder was not repaired.

**Figure 16. PCBT-53 Anchorage Zone Case Study – Fair Condition**

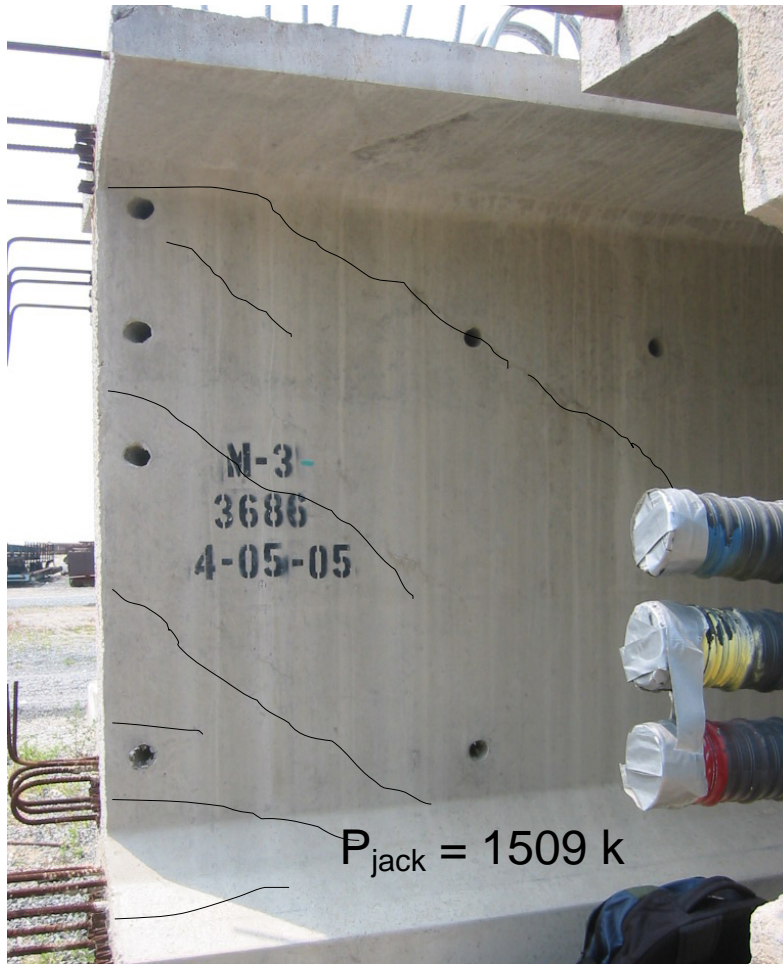
Figure 18. PCBT-77 Anchorage Zone Case Study – Poor Condition

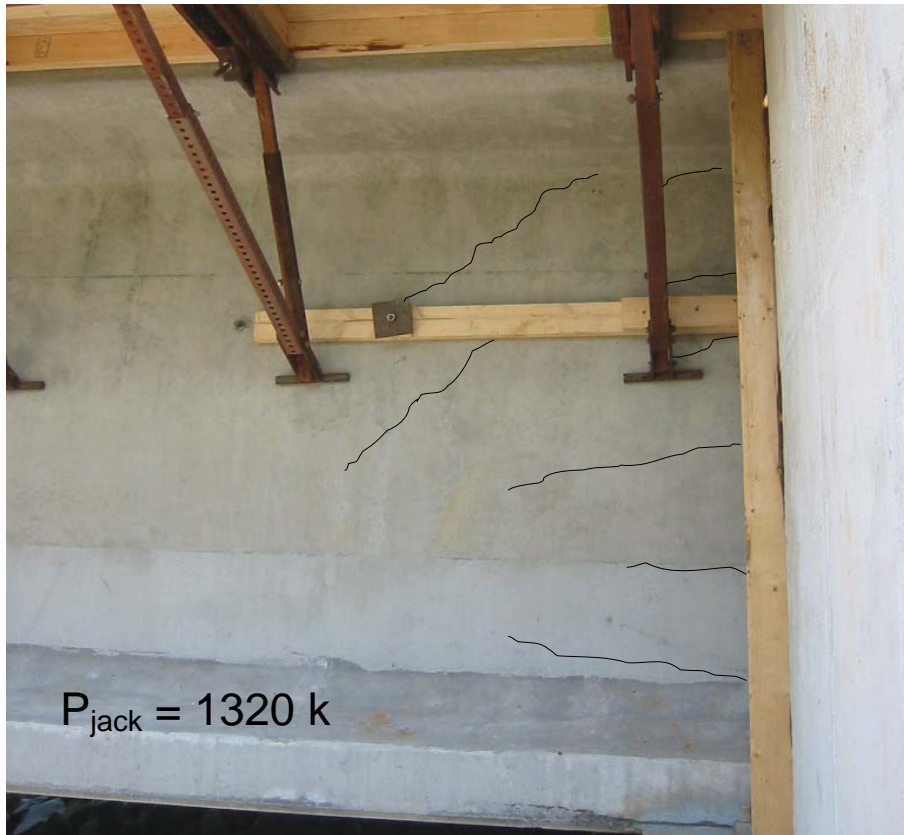
Another example of a poor beam end is shown in Figure 19. This girder is also a PCBT-77. It was 106 ft long and contained a total of 30 0.6-in-diameter strands. Twenty-four of the strands were straight and six were harped. The magnitude of prestress force at the time the strands were tensioned was 1,320 kips. The area of vertical reinforcement provided within  $h/4$  from the beam end was 2.0 in<sup>2</sup>. This is slightly below the minimum reinforcement requirement outlined in AASHTO LRFD. The cracking at the end of the girder was severe and is shown in Figure 19. The cracks in this girder were surveyed after it was placed on the bearing pads of a bridge recently constructed in Virginia. This span of the bridge contained five girders and all of them exhibited a similar crack pattern. The composite deck was not poured at the time the cracks were surveyed. The longest diagonal crack extended longitudinally into the beam almost 70 percent of the girder height. The horizontal crack near the bottom flange extended over 50

**Figure 19. PCBT-77 Anchorage Zone – Poor Condition**

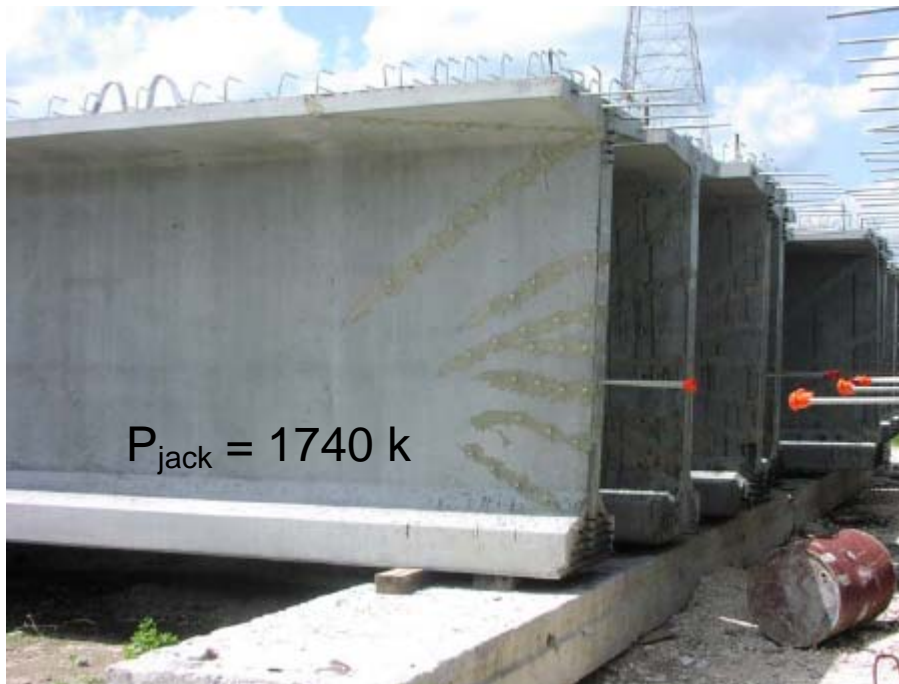
The next case study shows a girder that experienced severe anchorage zone cracking and was subsequently repaired by epoxy injection. The girder in Figure 20 is a 95.5 in PCEF Bulb-Tee girder constructed from lightweight concrete. The unit weight of the concrete was about 120 lb/ft<sup>3</sup> and the tensile strength of the concrete was approximately two-thirds that of normal weight concrete with the same design strength. It contained 56, 1/2-in-diameter strands with eight of the strands harped. The area of reinforcement within a distance of  $h/4$  from the beam end slightly exceeded the minimum requirement from AASHTO LRFD. The reinforcement pattern was not sufficient to control crack lengths and widths. The diagonal crack near the upper flange extended 69 in in length and had a width up to 0.025 in. As a result of the large crack widths, the girder was repaired by epoxy injection as seen in Figure 20.

**Figure 20. 95.5 in PCBT Beam Ends with Repairs. Photograph from Davis et al. (2005)**

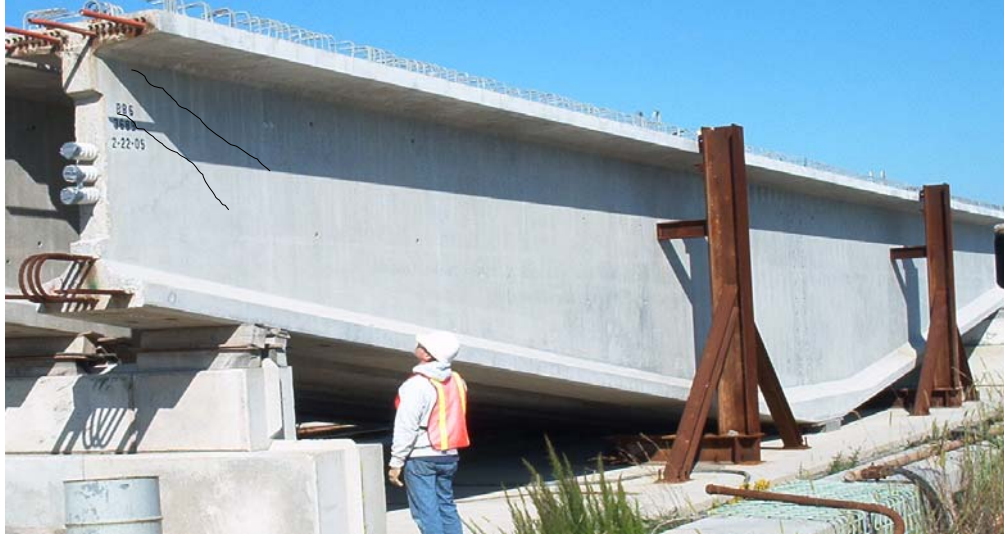
Pier segments with anchorage zone cracking are also an area of concern. During site visits to Bayshore, diagonal and horizontal cracks were observed on deep haunched girders as shown in Figure 22. Cracking of this type could be detrimental to girder strength. When a girder with this type of cracking is in service, tension must cross the crack. As a result the crack could open and close as traffic crosses the bridge.

**Figure 22. Anchorage Zone Cracking Observed in Deep Haunched Girders**

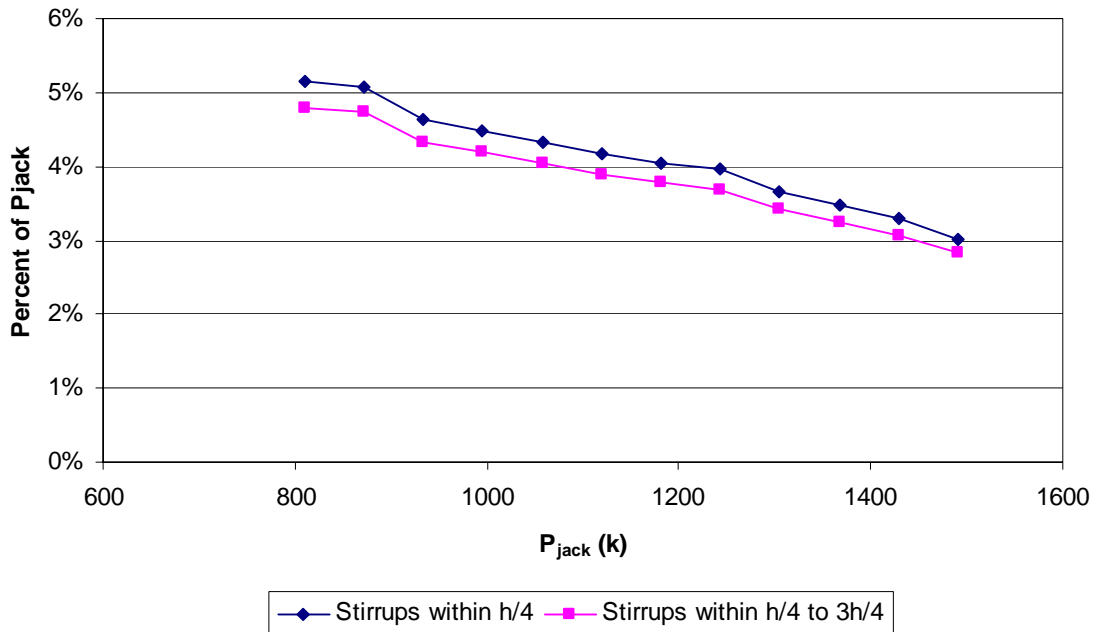
In general, as the level of prestress force increased, the required bursting resistance decreased relative to the jacking force. However, the total magnitude of the bursting force increased as shown previously. Figure 25 shows the bursting resistance required in the region from the beam end to  $h/4$  and the region from  $h/4$  to  $3h/4$  for a PCBT-61 girder. The current AASHTO LRFD provisions only consider the region from the beam end to  $h/4$  as part of the anchorage zone, and these provisions require a minimum of 4 percent resistance. As Figure 25 shows, the resistance levels required within  $h/4$  ranged from 3 percent to 5 percent of the jacking force. Figure 26 shows the required bursting resistance for the PCBT-85 sample girders. For this group of girders the level of bursting resistance required within  $h/4$  ranged from approximately 4.75 percent to 5.5 percent of the jacking force.

Figure 25. Required Bursting Resistance, PCBT-61, LWC, 1/2-in strand

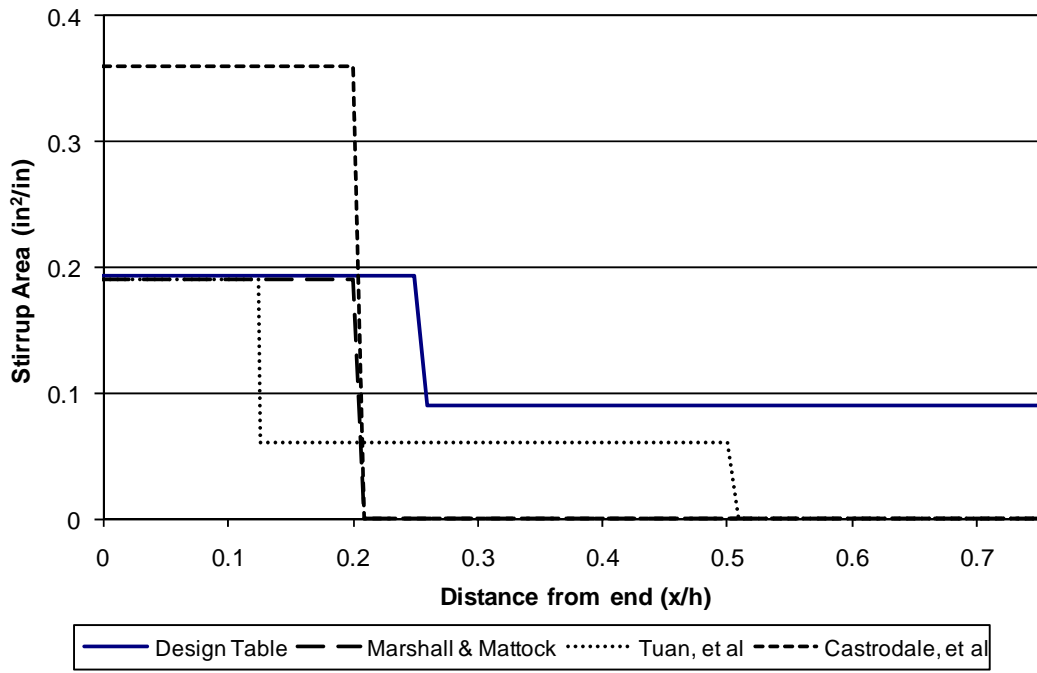
The comparison of the four design methods for the sample PCBT-45 girder, given in Figure 27, showed the required stirrup area per linear inch within  $h/8$  from the end of the girder obtained from the parametric study was very similar to the required stirrup area per linear inch obtained when using the Marshall and Mattock and the Tuan et al. methods. The Marshall and Mattock method includes the ratio of the girder height to the transfer length in the equation for the stirrup area. For the purpose of this comparison, the transfer length was assumed to be 60 strand diameters as specified in the AASHTO LRFD specifications. The strut-and-tie model developed by Castrodale et al. produced the most conservative results of all four design methods. This occurred because of the close placement of the tie to the loaded face in this strut-and-tie model. Figure 27 shows the new anchorage zone design model is not significantly different from these previously developed models when applied to a small girder. Typically, small girders, such as the PCBT-45, have minimal anchorage cracking, which suggests good calibration of the proposed model.

Figure 27. Design Method Comparison, PCBT-45, NWC, 34 1/2-in strands

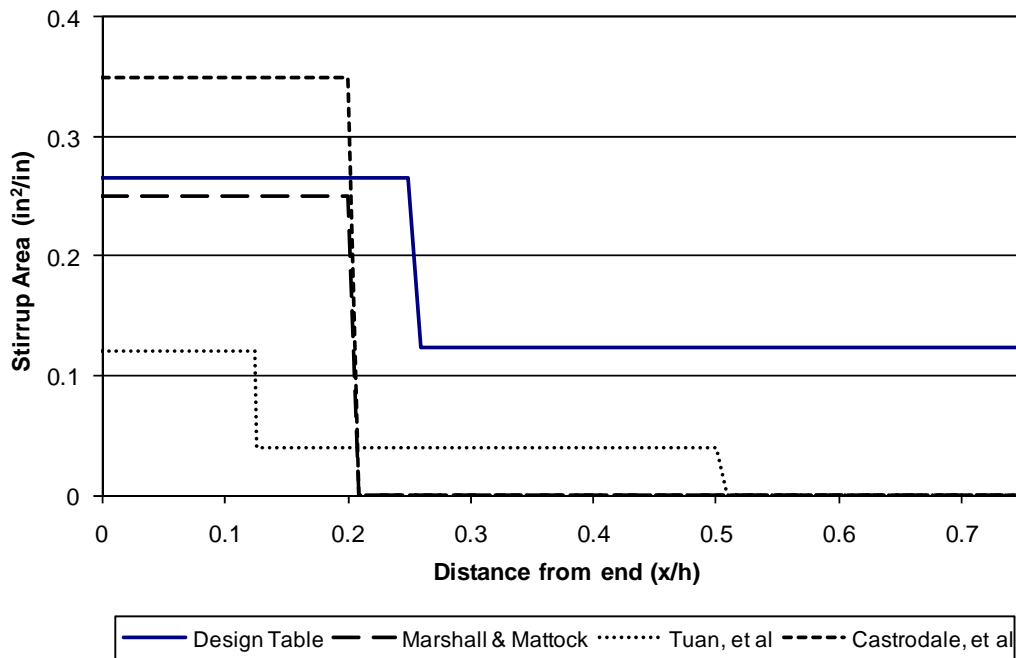
**Figure 29. Design Method Comparison, PCBT-93, LWC, 46 1/2-in strands**

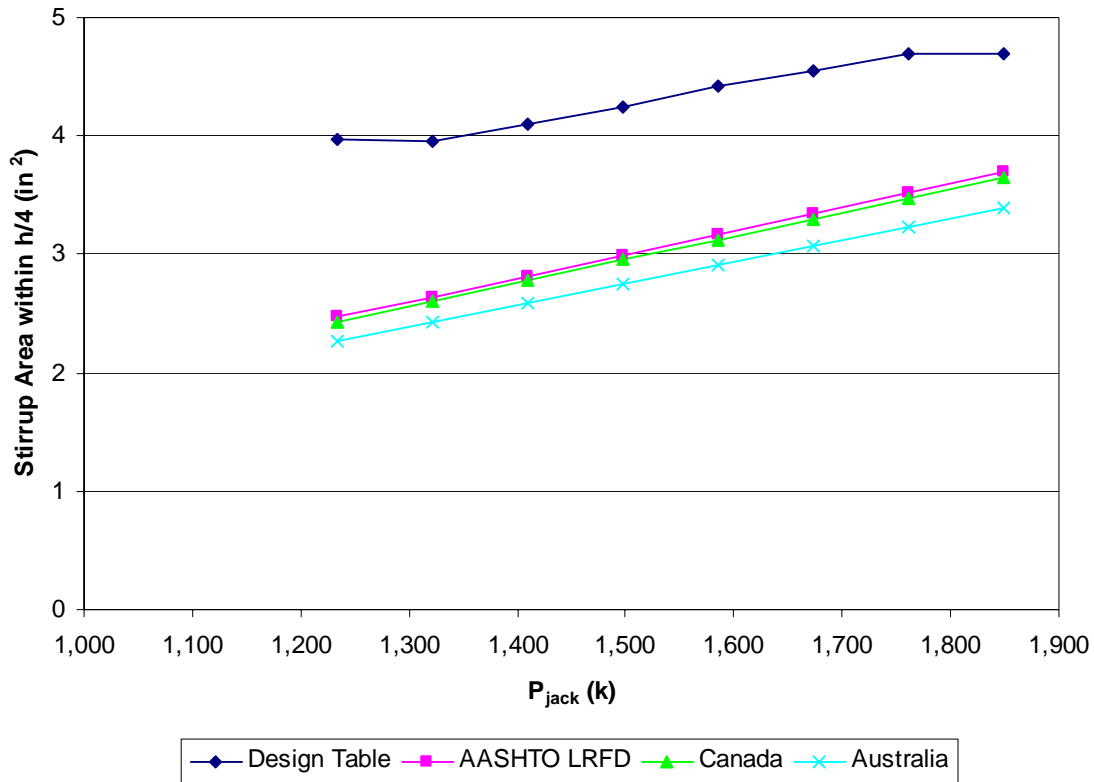
Figure 31. Design Code Comparison, PCBT-77, NWC, 0.6-in strand

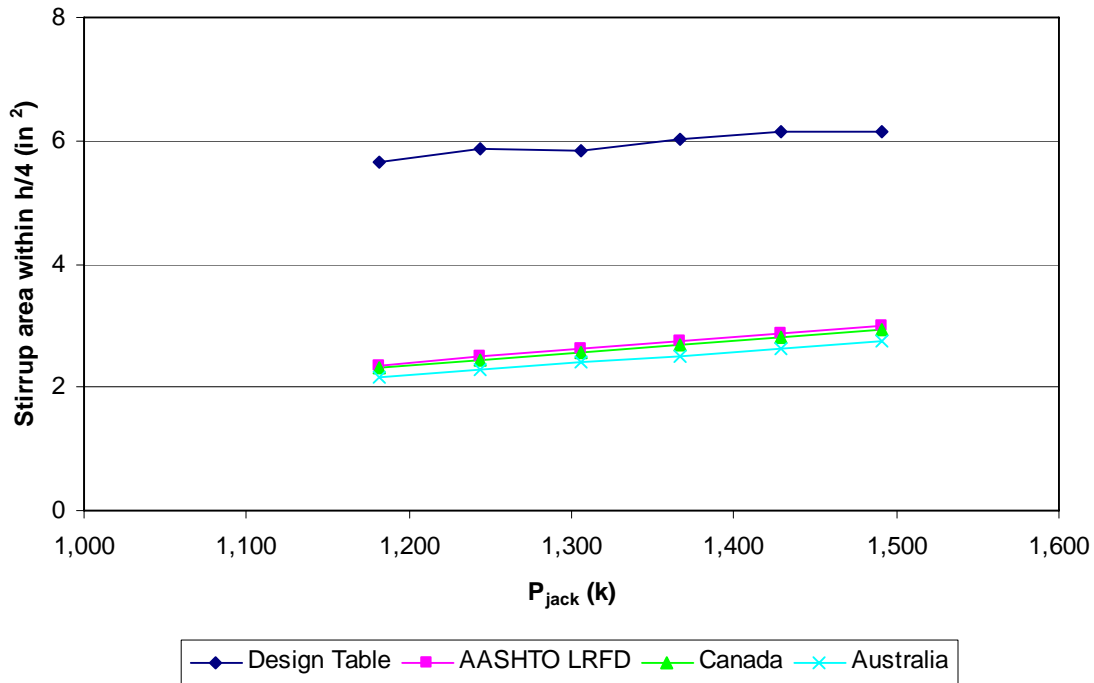
The final design code comparison included the group of sample PCBT-93 girders with lightweight concrete and 1/2-in strands. This comparison is shown in Figure 32. While there is little difference among the three design codes, the stirrup requirement obtained with the proposed model was significantly higher. In some cases the difference was almost a 140 percent increase in the required stirrup area from the design codes to the proposed value.

Figure 32. Design Code Comparison, PCBT-93, LWC, 1/2-in strand.

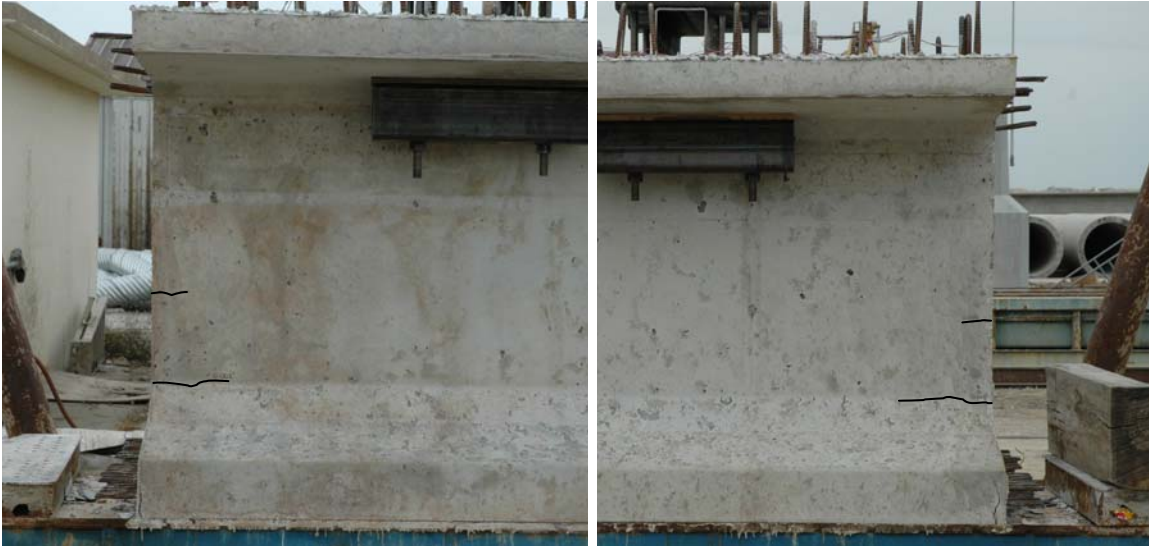
design model. The cracks were very fine and the largest crack width measured was 0.003 in. This crack width is well below an acceptable width for almost any environmental conditions to which the girder could be exposed. As Figure 37 shows, a horizontal crack developed at the bottom flange-to-web interface. This crack extended longitudinally for approximately 9 in, which is about 17 percent of the girder height. This crack length is within the prescribed crack length limits for the design model. The cracks at this end developed as the girder was lifted from the casting bed. No cracks were observed to develop in this anchorage zone during the three hour process of cutting the strands.

**Figure 37. Crack Pattern in the 12 ksi Anchorage Zone After Lifting**

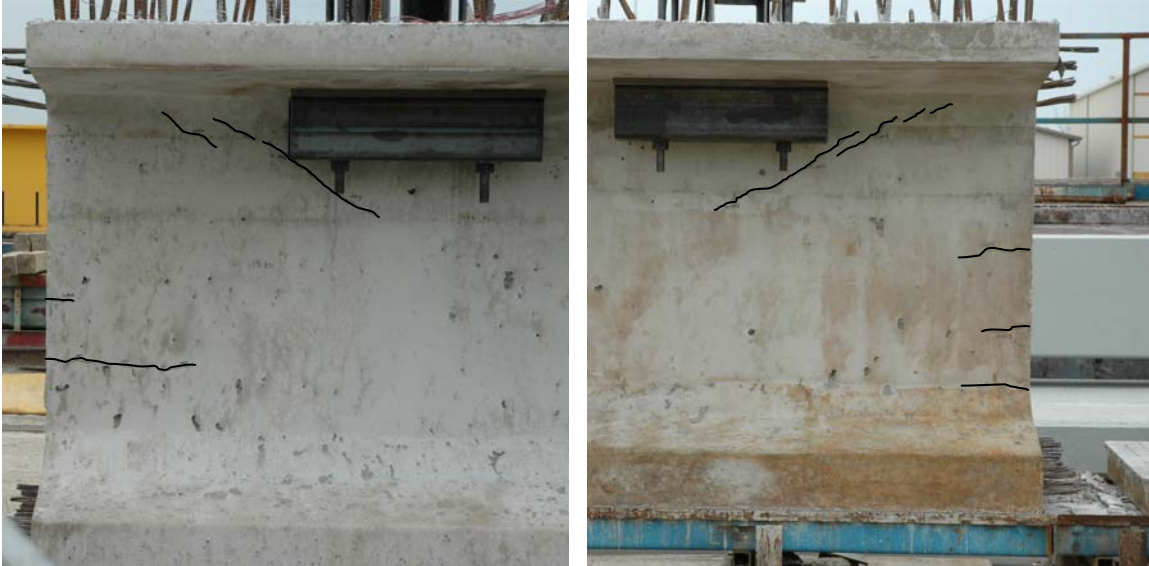
The anchorage zone designed with a stirrup working stress of 18 ksi did not meet the acceptable crack levels. Photographs of both faces of this anchorage zone are shown in Figure 38. These photographs were also taken after the girder was first lifted from the casting bed. As Figure 38 illustrates, the cracking in this anchorage zone was much more pronounced. The largest crack width measured on this end was 0.005 in. This size crack width would be acceptable for any exposure condition. The lengths of the cracks that developed in this end of the girder did not meet the limits from the design model. A diagonal crack opened near the top flange, several inches in from the end of the girder. The crack extended longitudinally 37 in, or 70 percent of the girder height. The acceptable crack length of a diagonal crack is 50 percent of the girder height. Several smaller horizontal cracks also developed lower in the web. The longest of these cracks extended longitudinally 15 in, or 28 percent of the girder height. This also exceeds the limitations on crack lengths from the design model. In this anchorage zone, all cracks also developed during the lifting process.

**Figure 38. Crack Pattern in the 18 ksi Anchorage Zone After Lifting**

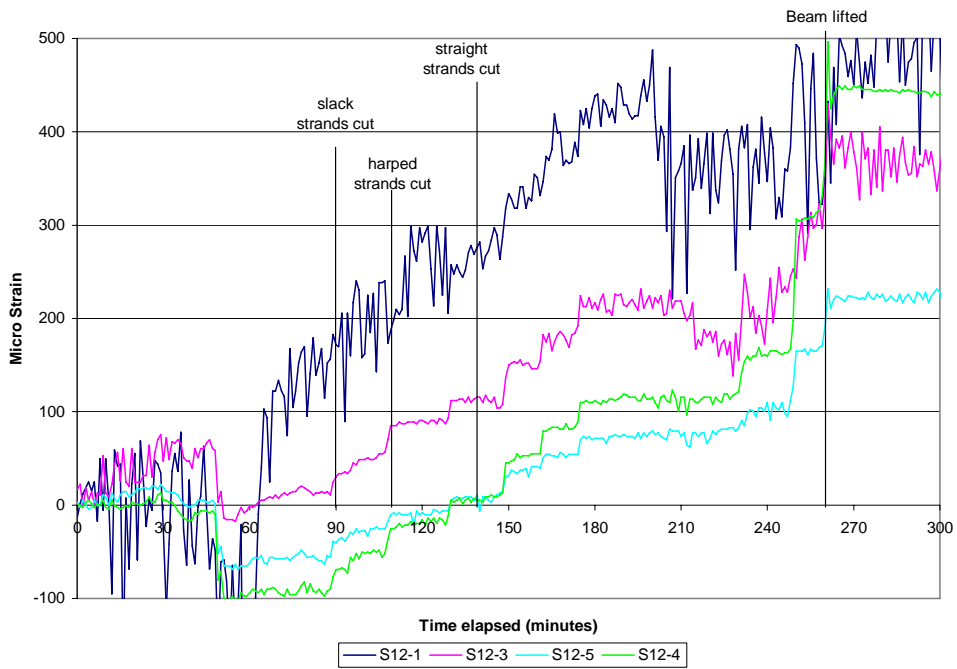
The gages in the 12 ksi anchorage zone located in both the lower portion and the upper portion of the web displayed a steady increase in strain over the time period in which the strands were cut. The gages in the lower portion of the web were closest to the end of the girder and displayed the highest level of strain, as shown in Figure 39. These gages were located very close to the small horizontal cracks in this end of the girder shown in Figure 37. The gages in the upper portion of the web did not measure strain readings as high as those lower in the web. The strain values measured in the upper portion of the anchorage zone were all below 200 microstrain as illustrated by Figure 40. This region was also free of cracks.

**Figure 39. 12 ksi Anchorage Zone – Gages in Lower Portion of Web**

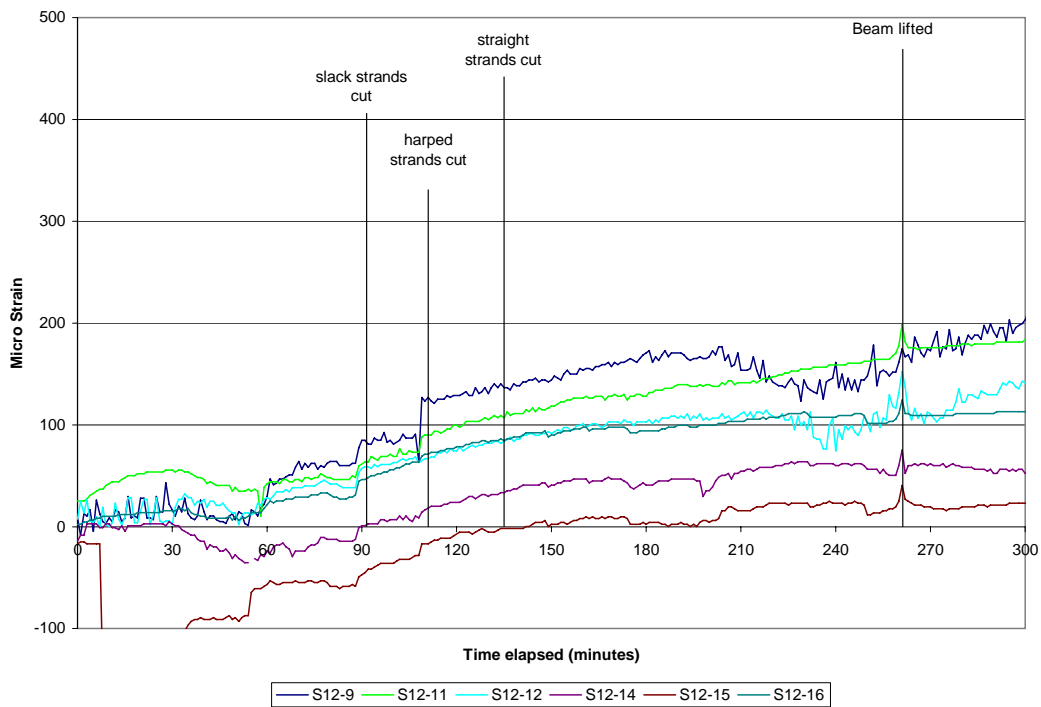
**Figure 40. 12 ksi Anchorage Zone – Gages in Upper Portion of Web**

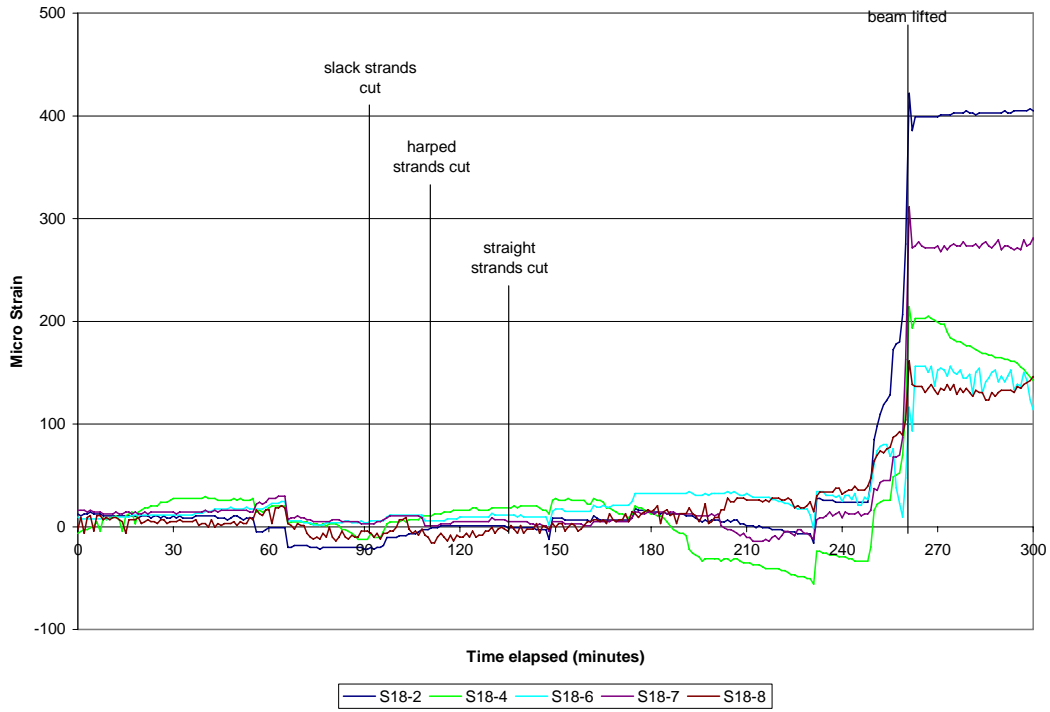
**Figure 41. 18 ksi Anchorage Zone – Gages in Lower Portion of Web**

The strains measured in the stirrups in the 18 ksi anchorage zone displayed a different trend. Figure 41 and Figure 42 show that the strain was very small and changed very little while the strands were cut. There was a very large and sudden increase in the strain in the stirrups when the girder was lifted. After the girder was placed back on the casting bed, the strain decreased slightly and then remained constant. The strain that remained after the girder was lifted was relatively high. The strain in the gages located in the lower portion of the web ranged from 150 to 400 microstrain, with the gage located closest to the end experiencing the highest strain. The gages located in the upper portion of the web measured strains that varied from 0 to 300 microstrain. The gage located farthest from the end recorded the lowest strain reading. The cracks in this anchorage zone all developed at the time the girder was lifted. This sudden increase in the strain when the girder was lifted serves to confirm the assumption for the design model discussed previously.

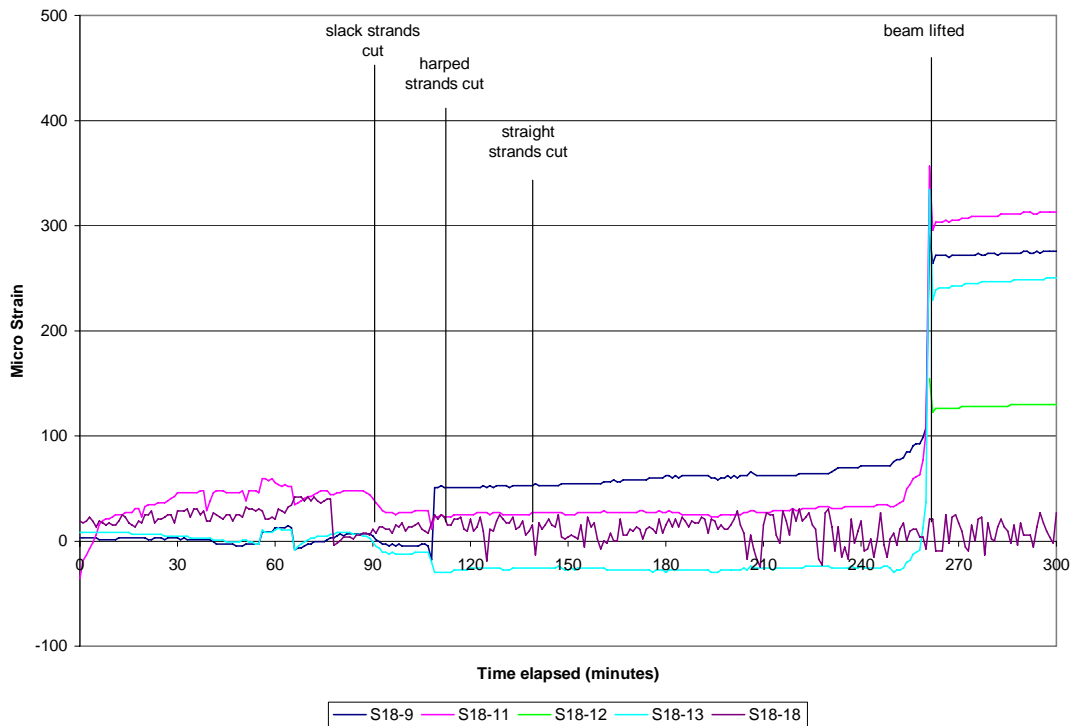
**Figure 42. 18 ksi Anchorage Zone – Gages in Upper Portion of the Web**

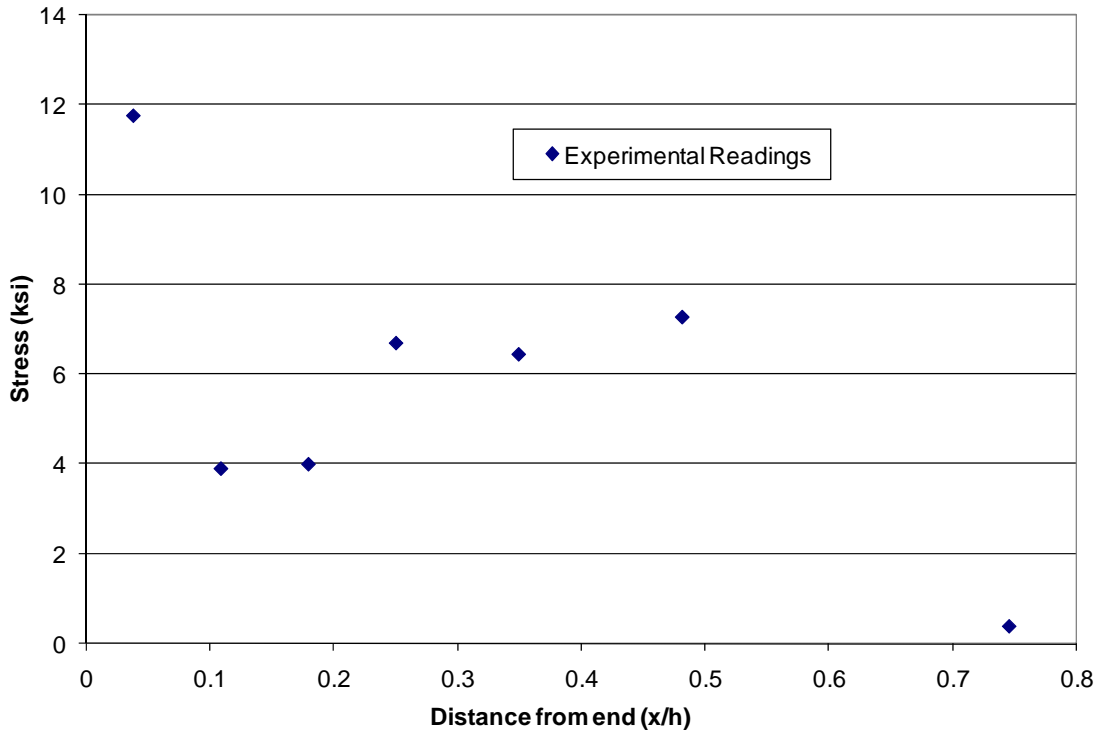
The strain readings from the gages in this anchorage zone were also translated into stresses. The distribution of the stresses in the anchorage zone is shown in Figure 44. The stresses in these stirrups ranged from 11.8 ksi to 0.38 ksi. The stress values did not decrease smoothly as the distance from the end increased as illustrated in Figure 43. In this anchorage zone, the stresses decreased within  $h/4$  but then increased at the distance where the diagonal cracks developed. The stresses in this anchorage zone were all below the average working stress assumed in the design phase, which indicates the actual bursting force was lower than that predicted by the design model. This is expected, since strut-and-tie models tend to produce conservative results. The conservatism is in large part due to the assumption that concrete carries no tension.

**Figure 44. Distribution of Tensile Stress Over the Anchorage Zone After Lifting – 18 ksi End**
