Multispectral Imaging for Identification of High-Water Marks in Postdisaster Flood Reconnaissance

Note. This manuscript was submitted on August 11, 2022; approved on December 22, 2022; published online on February 25, 2023. Discussion period open until July 25, 2023; separate discussions must be submitted for individual papers. This technical note is part of the *Natural Hazards Review*, © ASCE, ISSN 1527-6988.

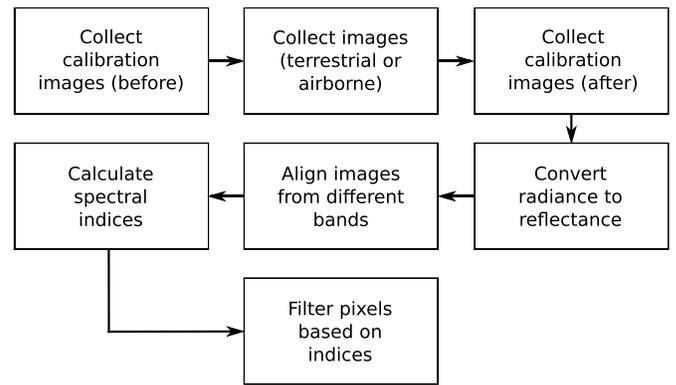
Fig. 1. Overview of image collection and processing methodology. Image collection, as shown on the first row, is discussed in the “Data Collection” section, and image processing, as shown on the second and third rows, is discussed in the “Data Processing” section.

The methodology for image collection and processing is illustrated in Fig. 1. The image collection process, as shown on the first row, is discussed in the “Data Collection” section. The steps for transforming raw radiometric images into calibrated reflectance images, as shown on the second and third rows, is discussed in the “Data Processing” section.

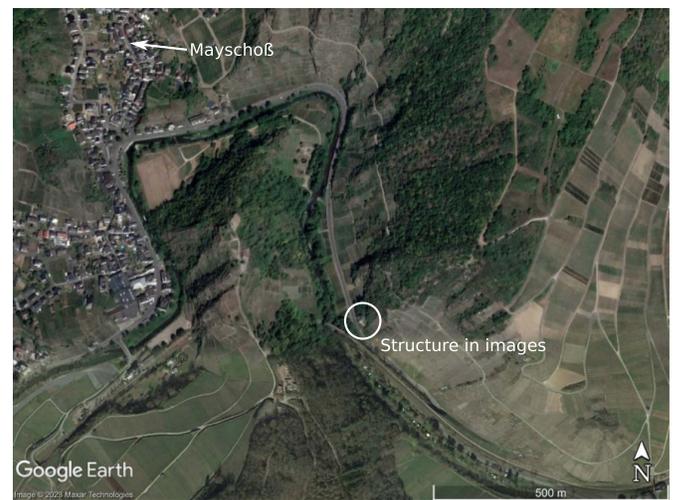
Fig. 2. Location of data collection near Mayschoß, Germany. Images were collected looking east on the western side of the structure. (Image by Google, Image © 2023 Maxar Technologies.)

the flooded building used to extract the high-water mark. The multispectral imagery collection was limited to a section of the Ahr River south of Mayschoß (Fig. 2).

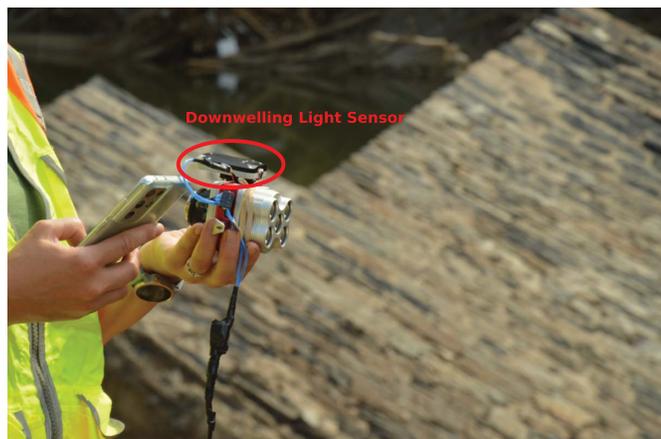
Fig. 3. MicaSense Altum with downwelling light sensor (DLS) connected directly to camera. The DLS is the flat plastic piece connected to the wire above the camera, as indicated on the image. A cellphone used to manually trigger camera through Altum Wi-Fi. (Image by Michael Gardner.)

Additionally, as shown in Fig. 3, the downwelling light sensor (DLS) was connected to the camera to ensure it moved with the camera when images were taken. Although the setup shown in Fig. 3 ensured that the global positioning system (GPS) location

for the images was correct, the orientation of the DLS for measuring incident light was off by 90°, and thus did not provide accurate measurements of sun-to-sensor angle and the direct and diffuse irradiance components. As such, the DLS measurements were not used for time-varying calibration, which instead relied on calibrated reflectance panel images taken at the beginning and end of data collection to convert radiance images to reflectance.

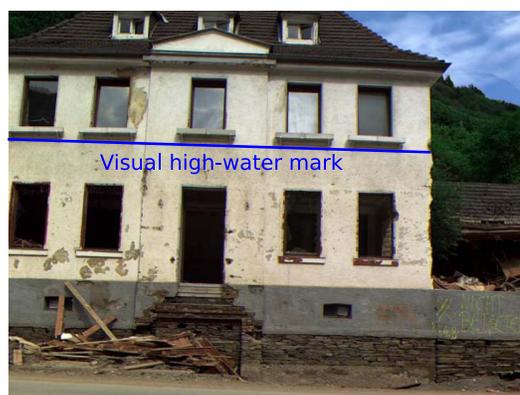
Fig. 4. True-color composite image created by combining the red, blue, and green band images. Here, the high-water mark was measured in the field, as indicated by the horizontal line. (Images by authors.)

The high-water mark from flooding is still visible to the trained eye in the red-green-blue (RGB) composite image (Fig. 4), but it manifests clearly in the blue band, where there is a visible difference in the reflectance for plaster portions of the structure that were above and below the physically mapped high-water mark. This signal also appears in the green and red bands, but not as strongly as in the blue band. Comparatively, the near-infrared and red edge bands show evidence of the high-water mark, but the signal is not as clear or consistent throughout the region of the building facade that was below the flood level. The high-water mark in the different bands is likely associated with increased adsorption with increased moisture content. This concept was illustrated by Conde et al. (2016), where the relative change in adsorption of concrete as a function of moisture content was shown to differ across wavelengths and shown to be more prominent in the blue and green bands compared with red and red-edge bands. This matches our observation where the blue

material-specific reflectance characteristics that modify reflectance in different bands. Additionally, as can be seen in Fig. 4, the coloration of the building was modified due to soil particles that adhered to the facade after flood levels subsided, which may also be contributing to the varying reflectance in different bands. Based on these observations, we calculated the difference between the red-edge and blue bands on a pixel-by-pixel basis. This combination of the blue and red-edge bands is designed to amplify the sections of the building facade that have increased adsorption in the blue band due to material-specific changes as a function of moisture content, as well as the increased adsorption in the red-edge band due to higher moisture content.

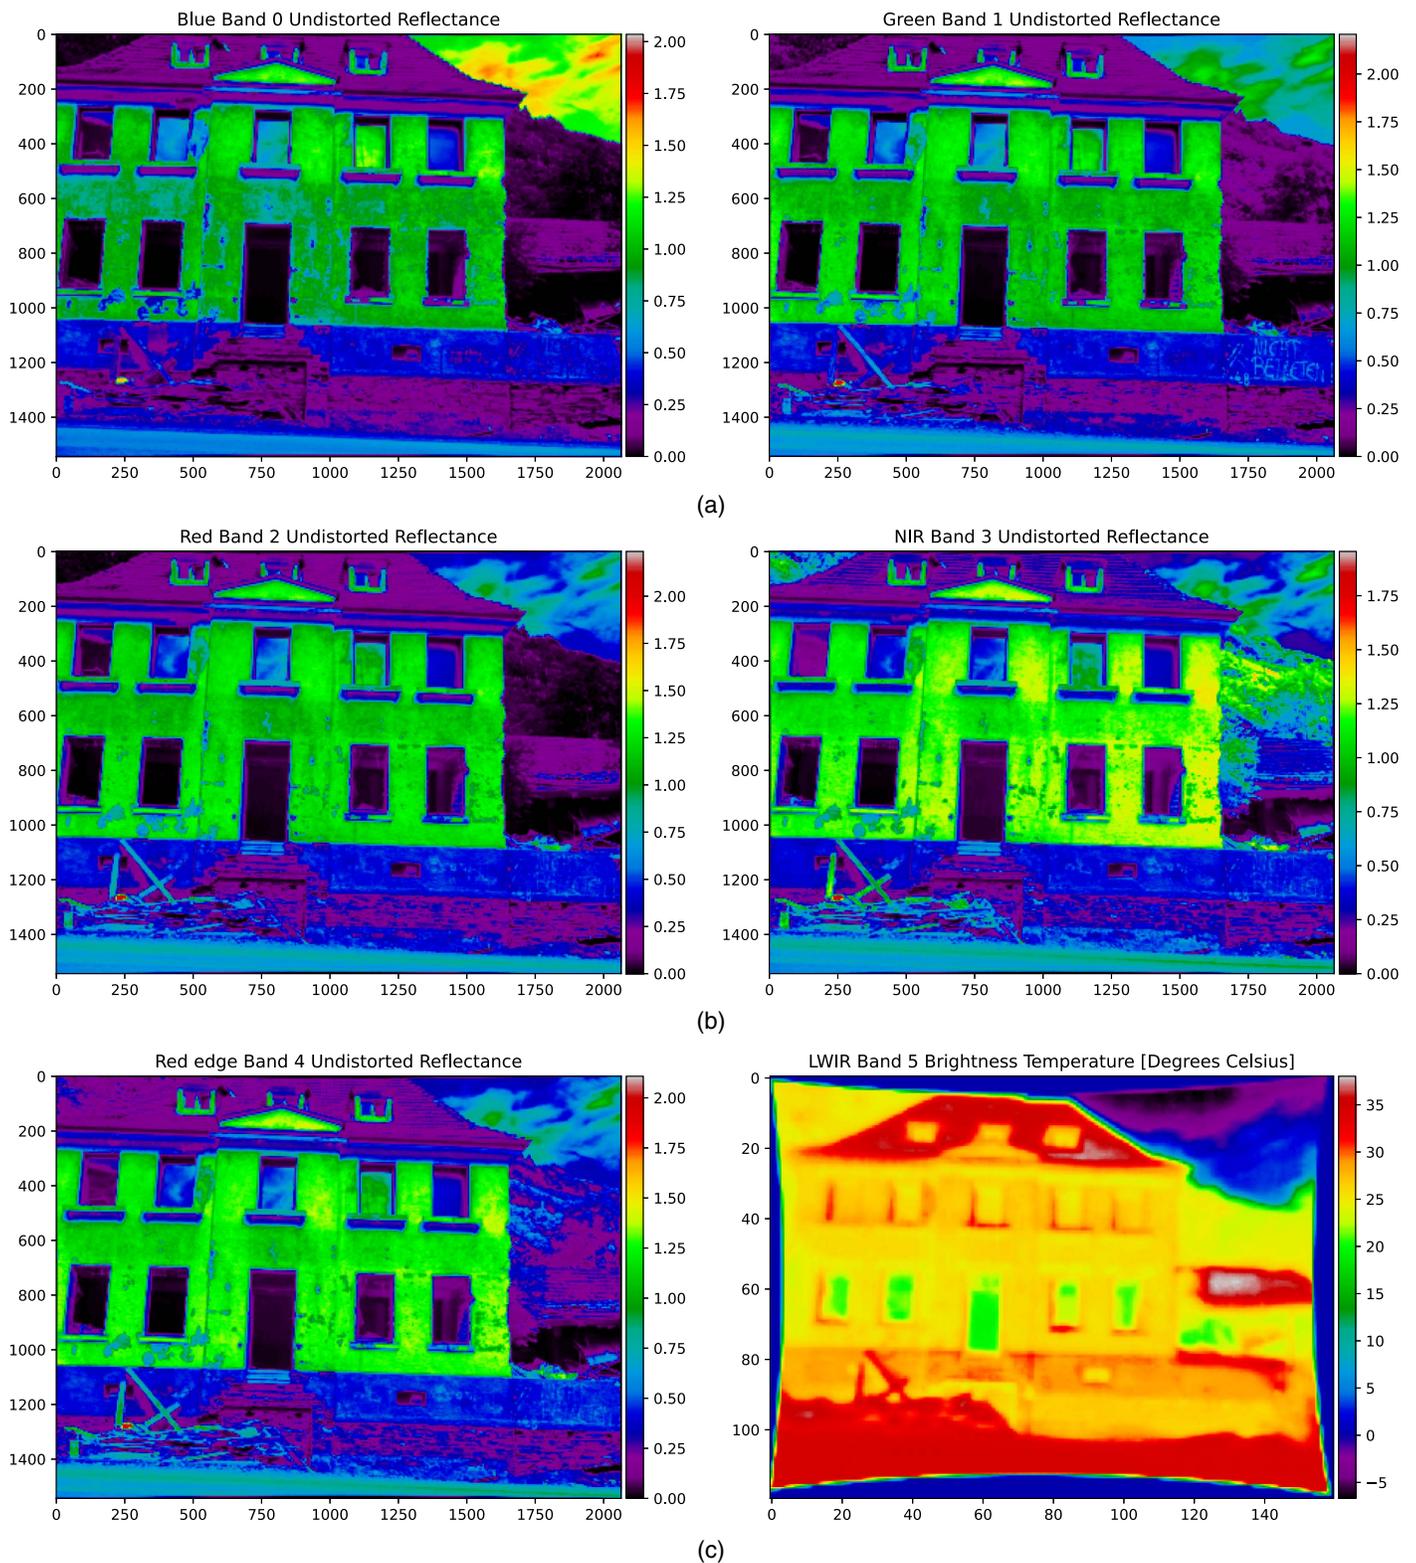
Fig. 5. (a–c) Calibrated reflectance images of western face of the building where x - and y -scales indicate pixel locations. A clear manifestation of the high-water level in the blue band is shown in plot (a). (Images by authors.)

band was displaying regions of the building facade below the high-water mark (which can be assumed to have a higher residual moisture despite the time passed since the event) most clearly. The exact composition of the building facade is unknown, but appears to be a painted plaster-material.

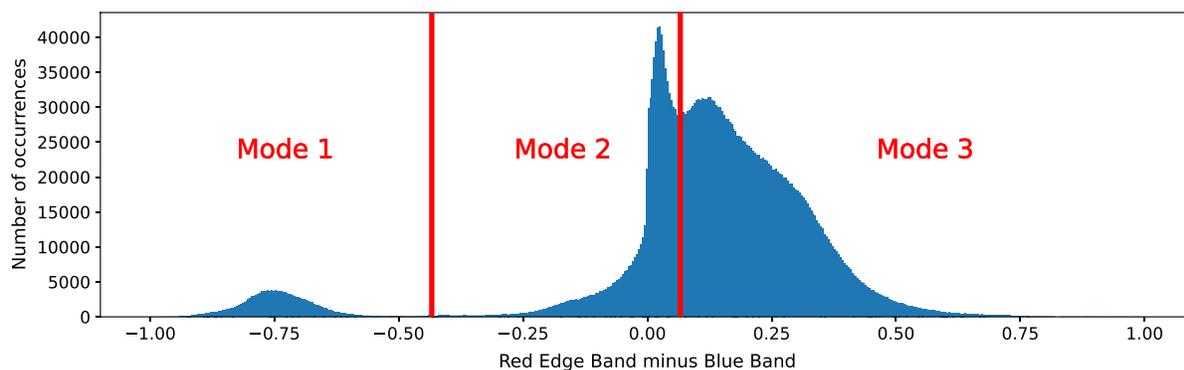
Fig. 6. Histogram on pixel-by-pixel basis of red-edge band minus blue band. Mode 1 is associated with pixels that contain portions of the sky, Mode 2 is associated primarily with concrete on the structure and reflections in the windows, and Mode 3 is excited by portions of the building facade.

Based on the initial manifestation of the high-water mark in the blue band, we explored combining different spectral bands to help isolate the signal associated with the water level on the building facade. Given that the high-water mark can be seen with varying levels of confidence across all bands, there likely are

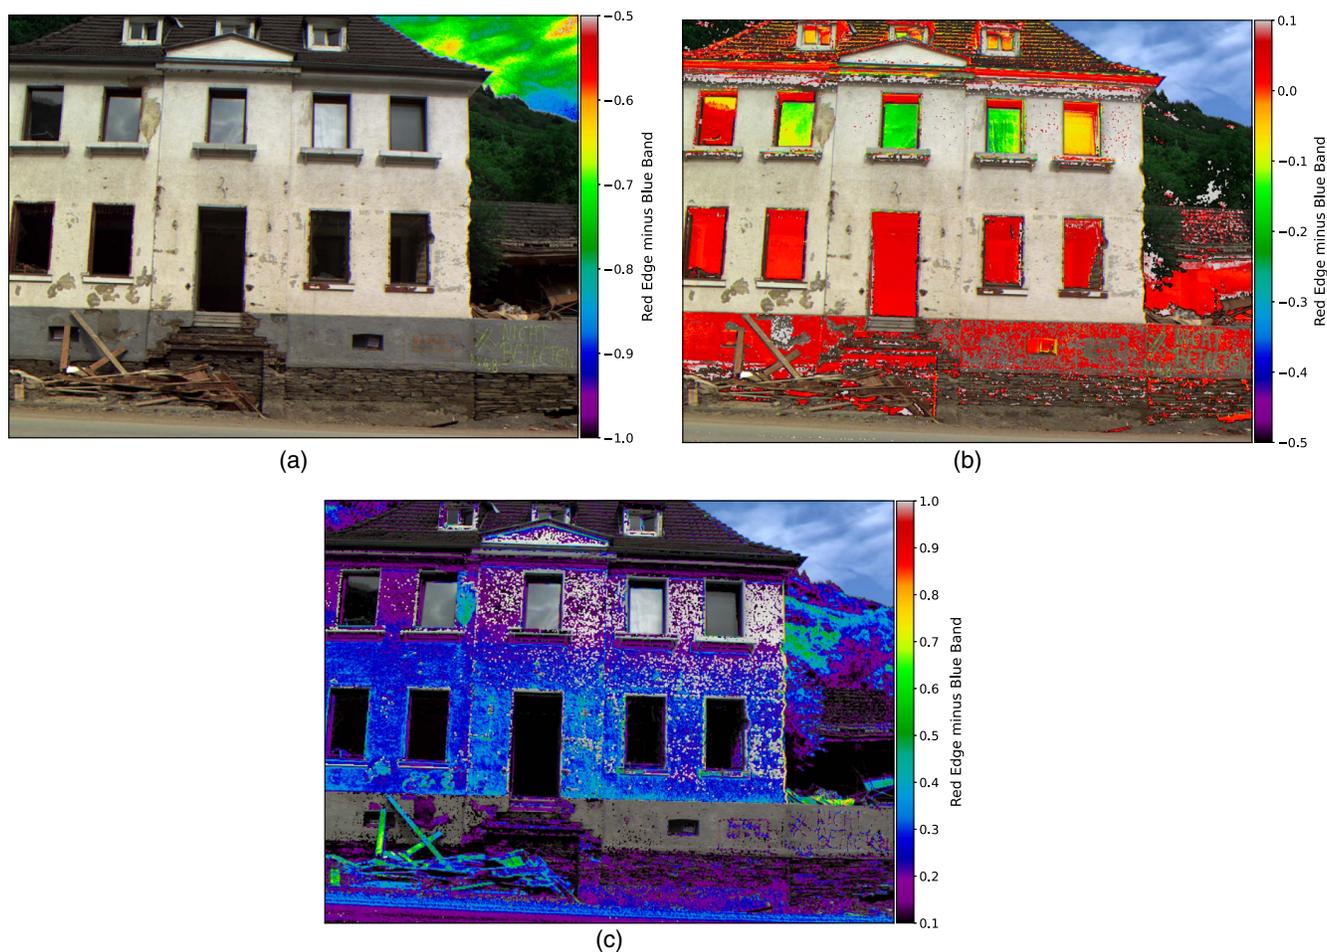
Fig. 7. Pixels associated with modes in Fig. 6: (a) Mode 1; (b) Mode 2; and (c) Mode 3. The contrast in index values can be seen for pixels above and below the high-water mark for Mode 3. (Images by authors.)

Fig. 7(c) shows a strong signal that appears to be associated with the flood level. Noise was removed from this image due to pixels that were either not part of the building or a distinctly different material that may have different reflectance characteristics than the building facade. To remove any plants from the index calculation, we masked pixels for which the Normalized Difference Vegetation Index (NDVI) (Tucker 1979) was greater than 0.2. This is based on observations that the NDVI for plants ranges from 0.2 to 1.0. Fig. 8(a) shows all pixels that have an NDVI of 0.2 or greater; these are the pixels that were masked to remove noise associated with pixels that contain plants.

To apply the technique presented in this paper more broadly, additional research is underway to establish the suitability of this approach for different building materials. As visible in Fig. 7, the concrete material located at the bottom of the building did not bin to the Mode 3 region (Fig. 6) like the plaster material, even though both materials were clearly below the high-water mark. This can also be seen in portions of these images where the plaster has been damaged and removed, yielding different reflectance values compared with immediately adjacent material. Thus, reflectance characteristics for commonly used building facade materials need to be established, particularly to develop an automated high-water mark detection procedure.

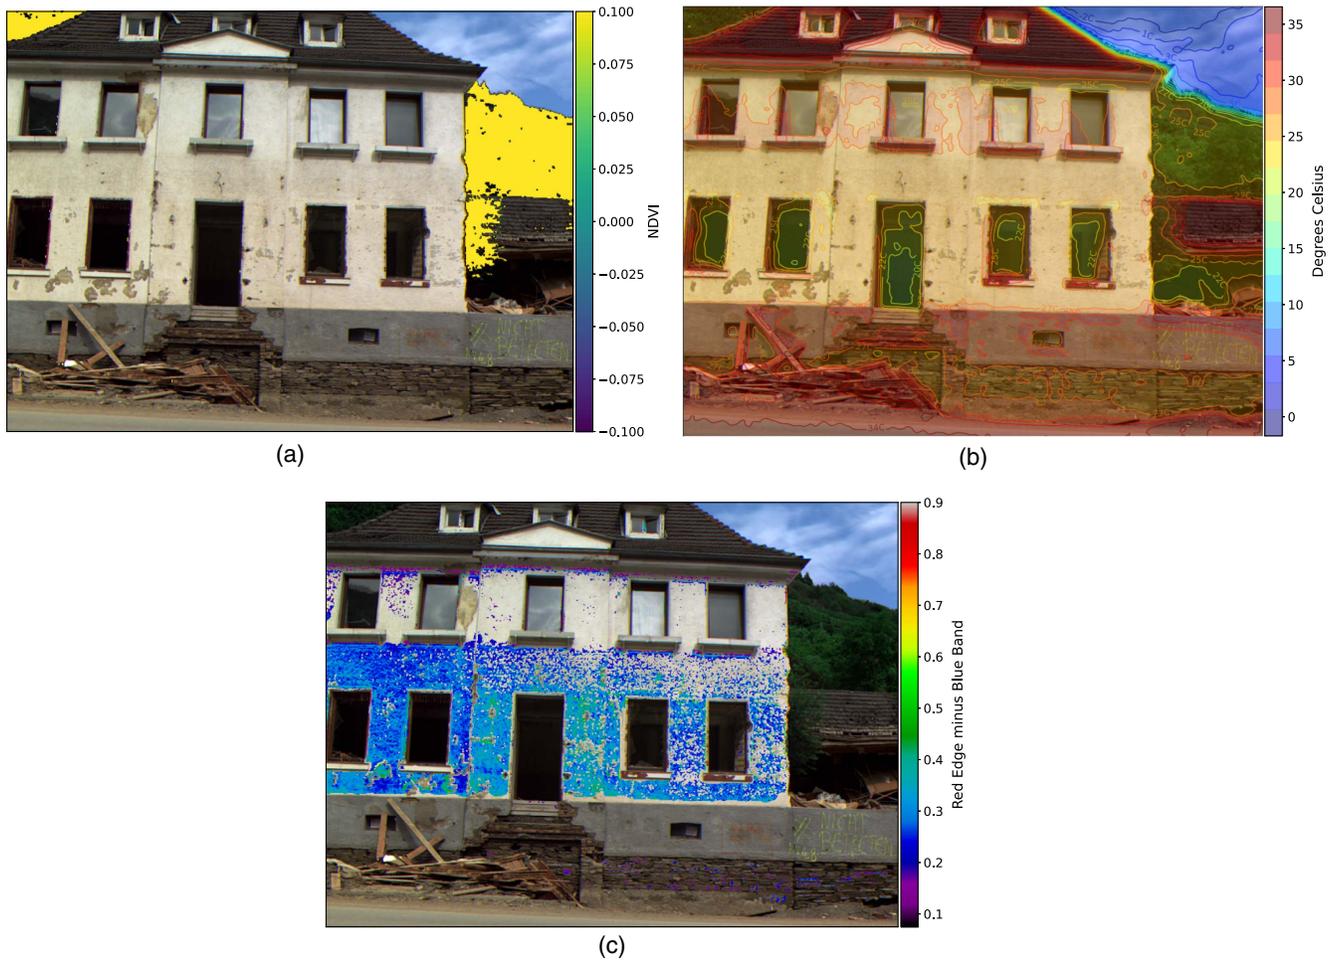
Fig. 8. Filtering to remove pixels associated with plants and building materials different from those in the building facade: (a) pixels with NDVI greater or equal to 0.2; (b) thermal contours ($^{\circ}\text{C}$); and (c) Mode 3 pixels with masking applied for pixels with NDVI greater or equal to 0.2 and temperature greater than 27°C . (Images by authors.)

To further remove noise due to soil pixels and building materials different from the plaster in the facade, we used patterns from the thermal images that were collected simultaneously with the other multispectral bands. Contours of the temperature are overlain on the true-color composite to illustrate the heat signature across the entire image [Fig. 8(b)]. Because the thermal images are a lower resolution compared with the other spectral bands, a Lanczos interpolation over a 8×8 pixel neighborhood was applied when

overlaying the thermal imagery on the multispectral images. The temperature across a building facade is generally lower in areas below the flood level, but significantly warmer areas on the same material can be identified above the flood level. Other building materials, such as concrete and roofing, also have substantially higher temperatures than the plaster on the building exterior. We suspect this difference in temperature is also at least partially due to moisture content within the building facade, as has been noted by others (Avdelidis et al. 2003; Moropoulou et al. 2018). Based on these observations, we further masked pixels where the temperature was higher than 27°C , as shown in Fig. 8(c), which almost entirely isolates the pixels that were below the high-water level and effectively depicts the high-water mark. The selected temperature threshold will be influenced by the time of day the pictures are taken because temperature differences potentially would be higher due to varied material heating rates during warmer parts of the day.

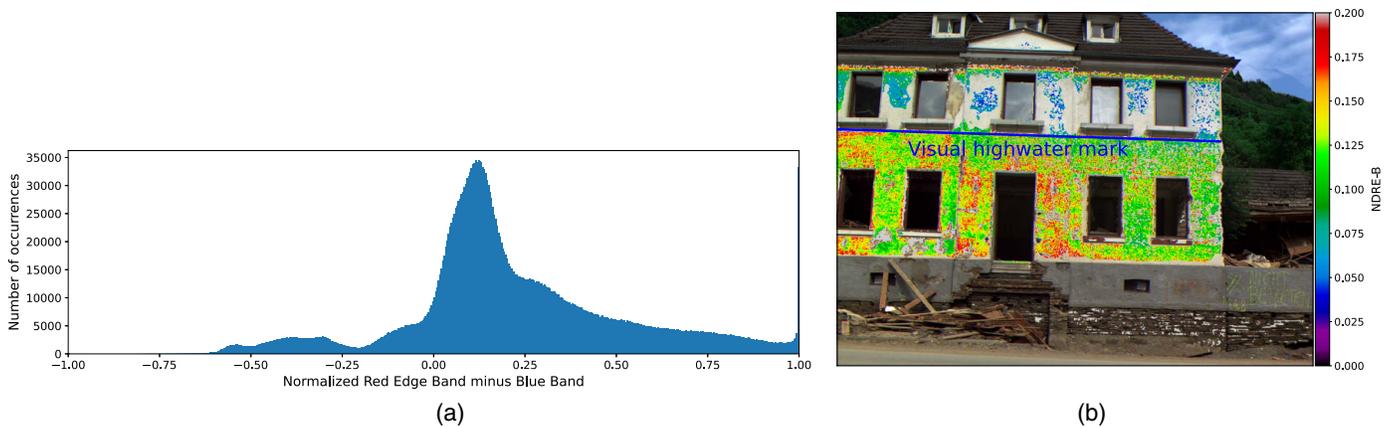
Fig. 9. Normalized difference between red-edge and blue bands (NDRE-B): (a) histogram of NDRE-B pixel values showing single mode ranging from approximately 0.0 to 0.2; and (b) pixels with NDRE-B ranging from 0.0 to 0.2. Shady areas immediately beneath roof also yielded a high value for this index. (Images by authors.)

where Red-Edge = calibrated reflectance in the red-edge band; and Blue = calibrated reflectance in the blue band. Fig. 9(a) shows the histogram of calculated pixel values for this normalized index, where a single mode can be seen ranging from approximately 0.0 to 0.2. Applying the same NDVI and temperature filters as were applied to the Mode 3 plots [Fig. 8(c)], NDRE-B is shown in Fig. 9(b). The high-water mark can also be clearly seen in this image, although it is important to note the high values of the index in the shaded regions just below the roof of the structure.

The initial results presented here promise potential for using multispectral imagery for postflood high-water mark display and mapping. This is illustrated in Figs. 9 and 10, which show the high-water mark estimated from the multispectral imagery using the proposed index calculation. Specifically, Figs. 9(b) and 10(c) show very good matching between the high-water mark estimated from the multispectral imagery and the physically observed value. The estimated values were within centimeters of those observed by the GEER team during the reconnaissance mission and are

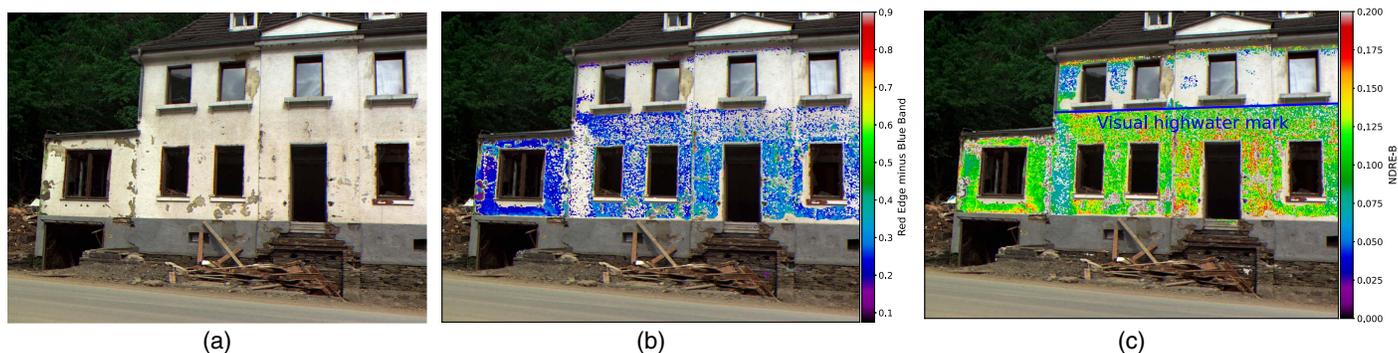
Fig. 10. Potential influence of sediment adhering to building facade: (a) true-color composite showing less discoloration and sediment adhesion to building at the single- and two-story interface; (b) weaker high-water signal in region near single- and two-story interface based on difference between red-edge and blue bands; and (c) NDRE-B showing similar weaker signal near single- and two-story interface. (Images by authors.)

Lastly, the reflectance characteristics of the building materials will be influenced by the amount and type of sediment transported during flooding and how it adheres to building surfaces after flooding has subsided. Based on the authors' preliminary analyses, it was not immediately evident how much sediment adherence may contribute to the signal in the multispectral imagery; however, it is likely an effect that cannot be ignored. This is illustrated in Fig. 10, where the true color composite and the difference between the red-edge and blue bands are shown side by side. The lighter-colored region near the interface between the single- and two-story portions of the structure does not show the below-flood level as clearly as other regions of the building facade [Fig. 10(b)]. However, this is not the case for the lower signal strength in the lower right portions of the building facade shown in Fig. 8(c), where the discoloration is uniform, indicating the decrease in signal is associated with a different characteristic—potentially moisture content, as discussed previously.
