## **Towards a Better Estimation of Inspection Intervals for Cracking Steel Railroad Bridges**

# TOWARDS BETTER ESTIMATION OF STEEL RAILROAD BRIDGE LIFE

Matthew H. Hebdon, PhD, PE – Virginia Tech  
Robert J. Connor, PhD – Purdue University  
AREMA 2015 Annual Conference

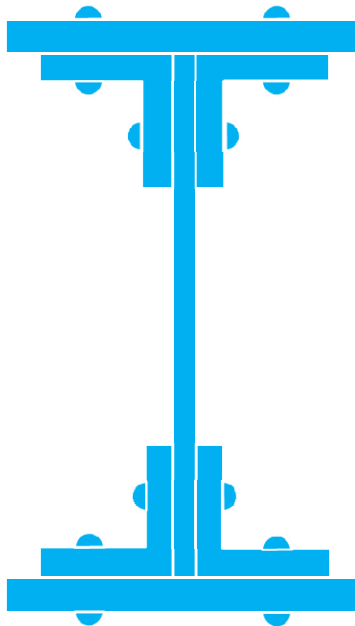
**Figure 1 Typical built-up girder cross-section**

Rather than utilize a traditional FFS approach which relies on detecting small cracks and knowledge of material toughness, a different strategy is presented in this paper. It is well known that a large number of steel bridges (virtually all steel bridges constructed prior to the early 1960s) were fabricated with mechanically fastened built-up steel members. Built-up members are composed of multiple components, typically plates and angles fastened with hot-driven rivets (see Figure 1). More recently high-strength bolts have been used in built-up member fabrication. The number of components in a built-up member and the faying surfaces between each component create multiple load paths and therefore an inherent redundancy in the member. It is proposed in this paper that rather than attempt to detect small cracks before they become critical, it may be possible to exploit this internal redundancy within the member and evaluate the strength and fatigue performance of the member assuming failure of any one component has occurred. This redundant behavior has been recognized by the engineering community. However it has not been utilized to its full potential because, until recently, no known research has investigated the ability of built-up members to redistribute load between components.

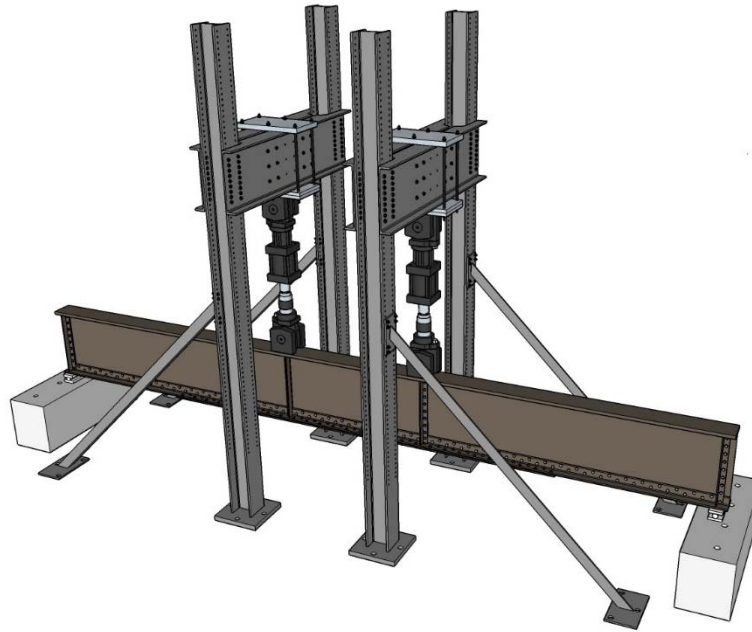
**Figure 2 Test setup**

In order to investigate this behavior, large-scale built-up bridge girders have been tested at the Robert L. and Terry L. Bowen Laboratory for Large-Scale Civil Engineering Research (see Figure 2 for a schematic of the test setup). Experimental specimens consisted of 14 girders, three of which were from a recently retired bridge (originally built in 1925), and the remaining specimens were fabricated for the research test. The specimens from the retired bridge consisted of 23"x3/8" web plate, with two 5x3 1/2"x7/16" flange angles (long legs vertical) on the top and bottom flange. A 12"x1/2" cover plate was added to the bottom flange of two specimens to increase the redundancy. A 12"x5/8" cover plate was added to the bottom flange of the remaining specimen. Three different geometries were used for the fabricated specimens. Because the bottom (tension) flange was the area of interest, each of the fabricated specimens had a 14"x2" top flange which was welded to the web plate. A single specimen was fabricated with a 30"x1/2" web plate, 6x6x3/4" flange angles and a 14"x1" cover plate. Five specimens were fabricated with a 36"x1/2" web plate, 6x6x3/4" flange angles and two 14"x3/4" cover plate. Five specimens were fabricated with a 46"x1/2" web plate, 6x6x3/4" flange angles and a 14"x3/4" cover plate.

Each of the test specimens were tested in four-point bending to create a constant moment region (see Figure 2). This facilitated the measurement of the redistribution of stress at each stage of the test through strategic strain gage placement in the constant moment region. The goal of the project was to first fracture a single component of each specimen to observe its fracture resilience – its ability to arrest a crack without other components fracturing. Next, each specimen was cyclically loaded to determine the fatigue life after failure of one of the components occurred.

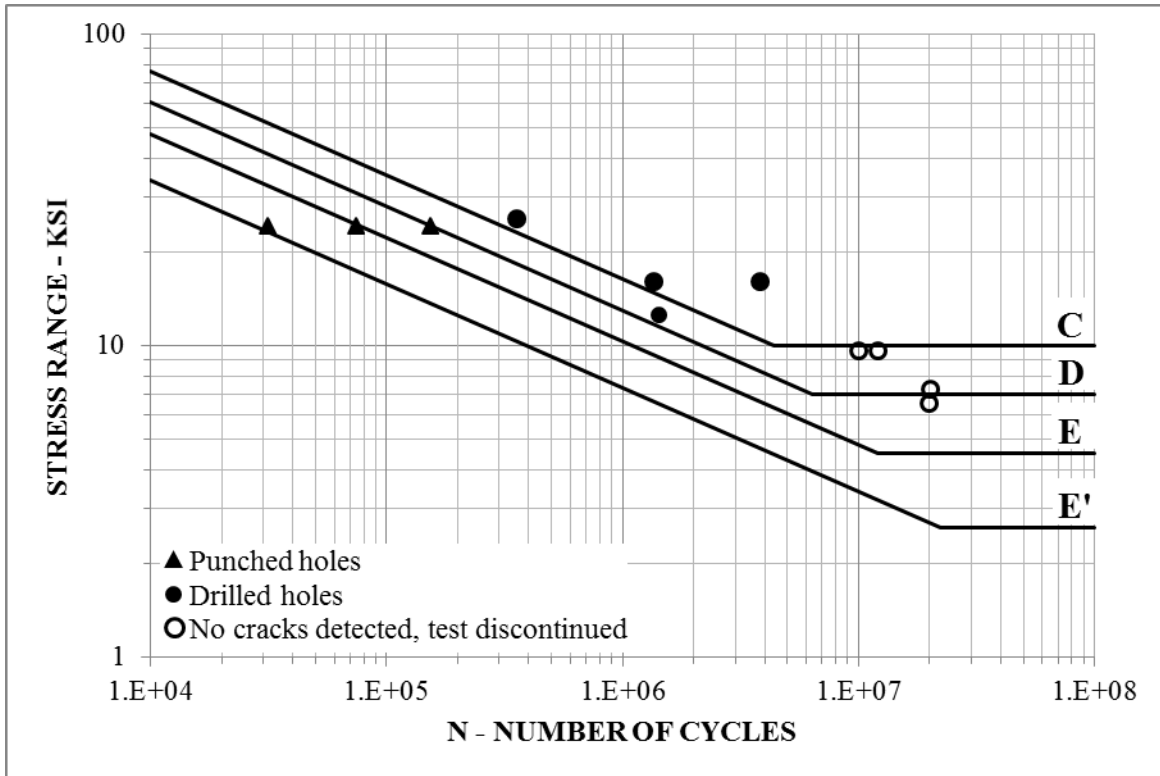
Figure 3 After-failure fatigue life

After the failure of the first component, whether due to fatigue or fracture, each specimen was cyclically loaded to determine the remaining fatigue life. The results of the fatigue tests were plotted with the AASHTO fatigue design curves and can be seen in Figure 3. The stress range is calculated based on the after-fracture remaining net section (i.e., including holes and not including the failed component).

Specimens included both drilled and punched holes. As shown in Figure 3, the AASHTO Category E' fatigue curve represents a conservative lower bound for specimens containing punched holes, and the Category D fatigue curve is a conservative lower bound for specimens containing drilled holes. The stress range is calculated based on the remaining cross section using basic mechanics of materials.

4. After the failure of a component of a built-up member, significant fatigue life may remain. The remaining fatigue life can be characterized by the AASHTO Category D fatigue curve for drilled holes, and the Category E' fatigue curve for punched holes.

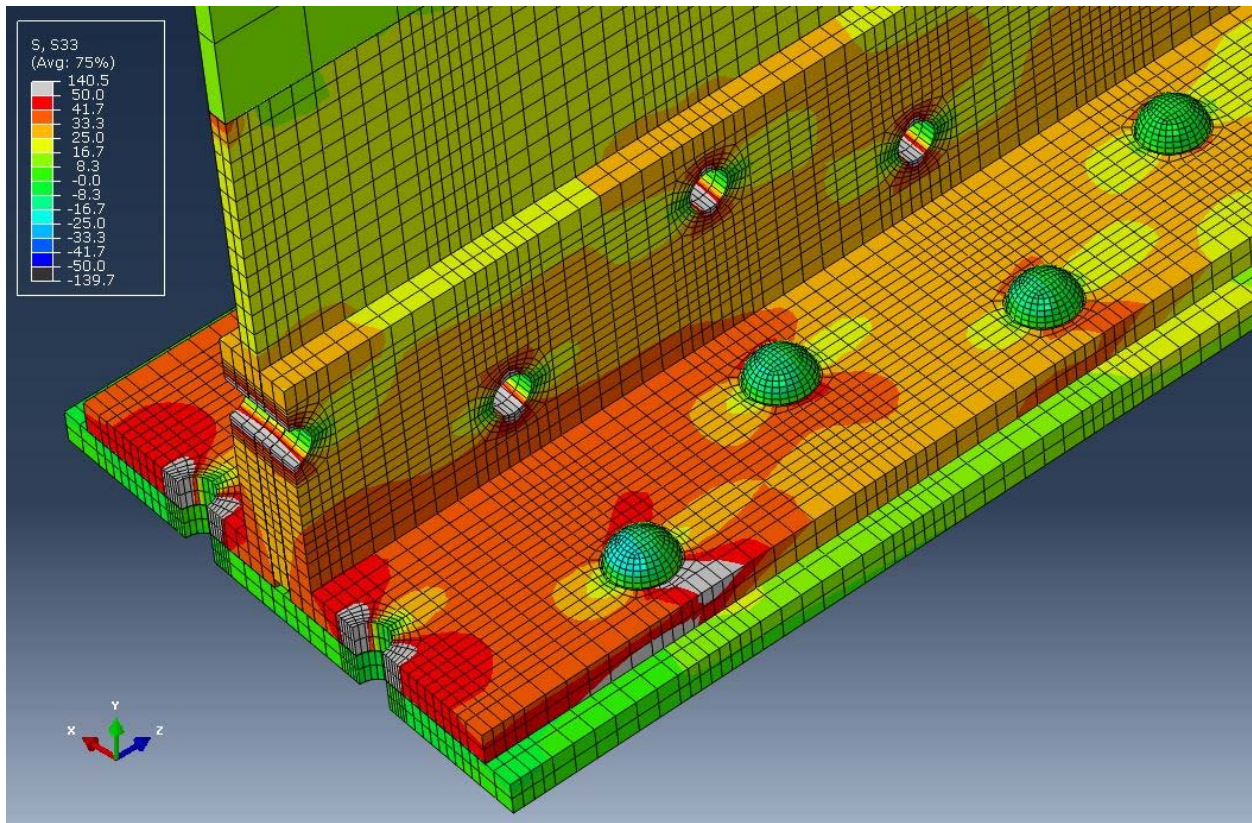
Figure 4 Typical FE model with failed cover plate

The FE models were first benchmarked with stress data obtained from the experimental tests. Figure 4 shows a contour plot of longitudinal stresses in a half symmetry FE model with a failed cover plate. Note the increase in the localized longitudinal stress in the flange angles when the cover plate has completely fractured. The longitudinal stresses in the flange angles begins to dissipate as the distance from the fracture increases. This is as expected since load is transferred back into the cover plate through friction and the fasteners.

Based on the parametric study, it was found that the primary factors influencing the stress distribution in partially failed built-up members were the number of components (flange angles and cover plates) and out-of-plane effects resulting from failures that resulted in a non-symmetric cross section (i.e., a broken angle or cracking across only a portion of a cover plate).

A non-symmetric cross section could result from a failed flange angle or a partially failed cover plate. The stress increase resulting from a non-symmetric cross section was not significant for a failed flange angle. Interestingly, it was found that a partially cracked cover plate with a crack extending more than 60% of the width had an influence greater than the fully failed cover plate. Note though, the amount of time it takes the crack to grow from 60% of the width to full width is very short due to the fact that such large cracks grow very quickly. Based on a study of crack growth rates in plates of various widths, it was determined that the rate at which the stresses were increased were an insignificant portion of the fatigue life and hence, the fatigue cycles which would accumulate at these higher stress ranges due to the non-symmetric cross-section could be ignored.

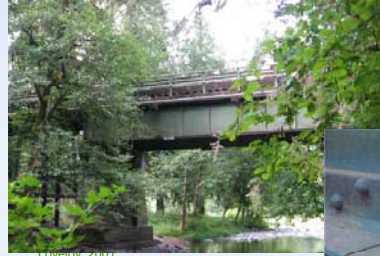
LeBejeux, 2001

- North Fork Mollala River Bridge, OR
  - Fracture in bottom flange of riveted built-up two-girder bridge

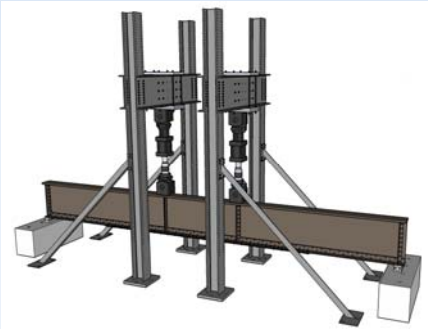
- Test setup

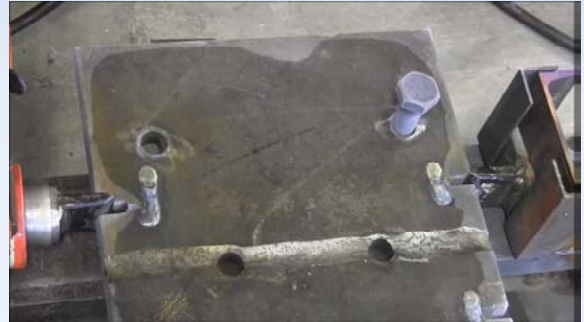
- Driven wedge to increase stress concentration

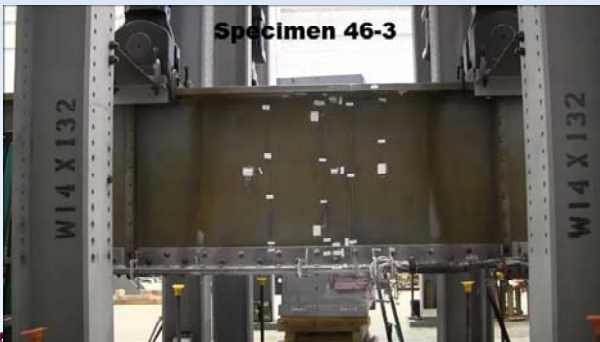
- Fracture resilience

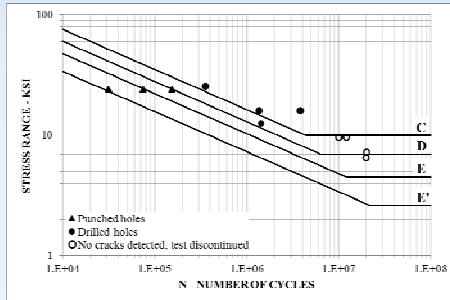
- CALCULATED Fatigue life AFTER 1<sup>st</sup> component failure

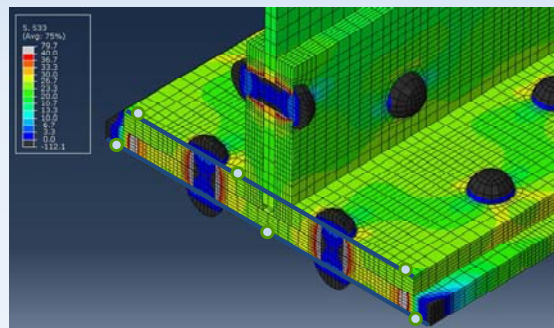
- Model validation

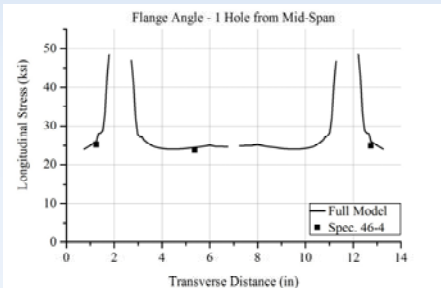
- Model validation
  - Average difference of 1.1 ksi (4.9%)

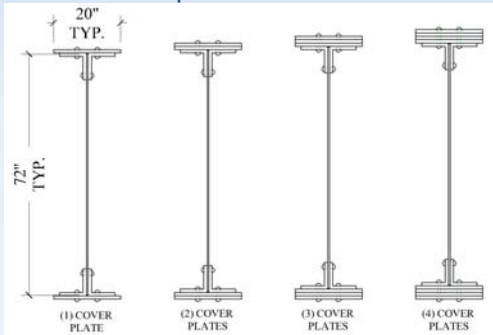
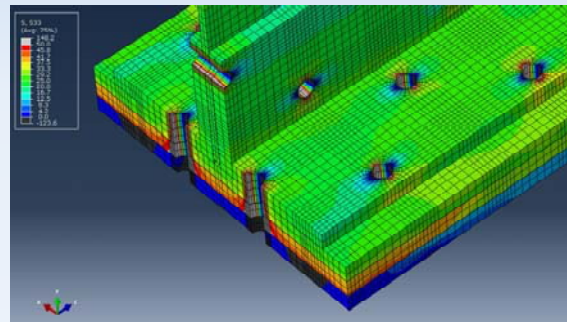
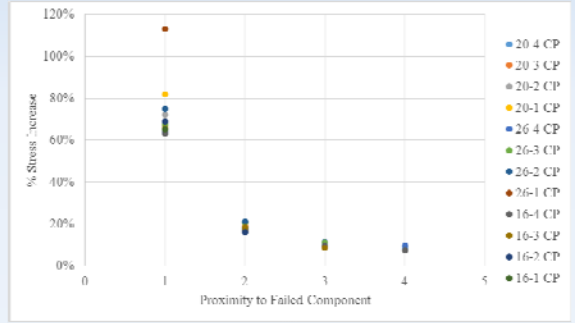
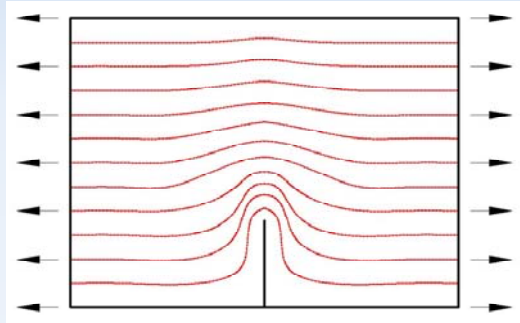
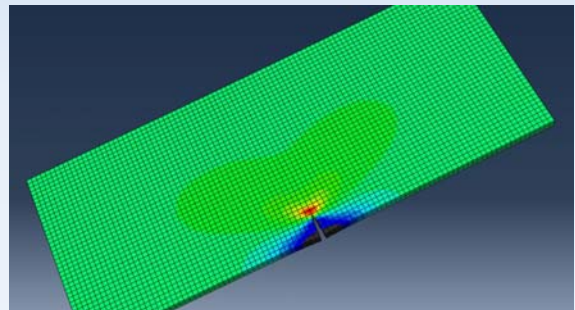
- Number of cover plates

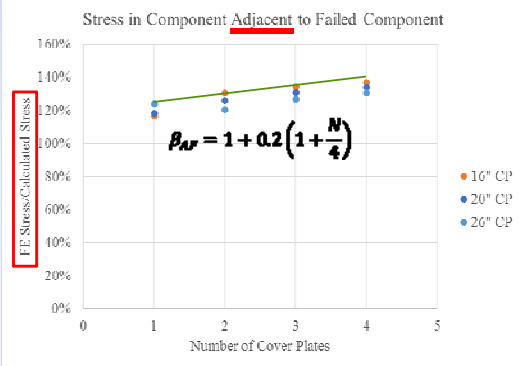
### FE Parametric Study Effect of # of CPs on Stress Amplification

- Insignificant affect from:
  - Height of girder (web height)
  - Unbraced length of tension flange
- Non-symmetric failed cross-section
  - Due to crack growth rate, can be ignored
- Number of cover plates
  - Adjacent component has largest stress increase
  - Simple equation to account for this was developed

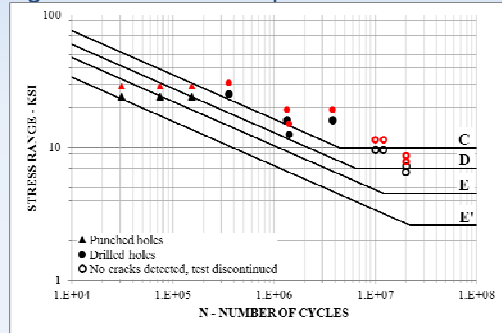
- Fatigue life after 1<sup>st</sup> component failure

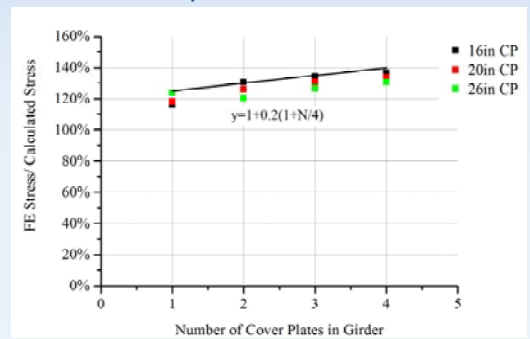
- Number of cover plates
