**Appendix B. Stream crossings summary**

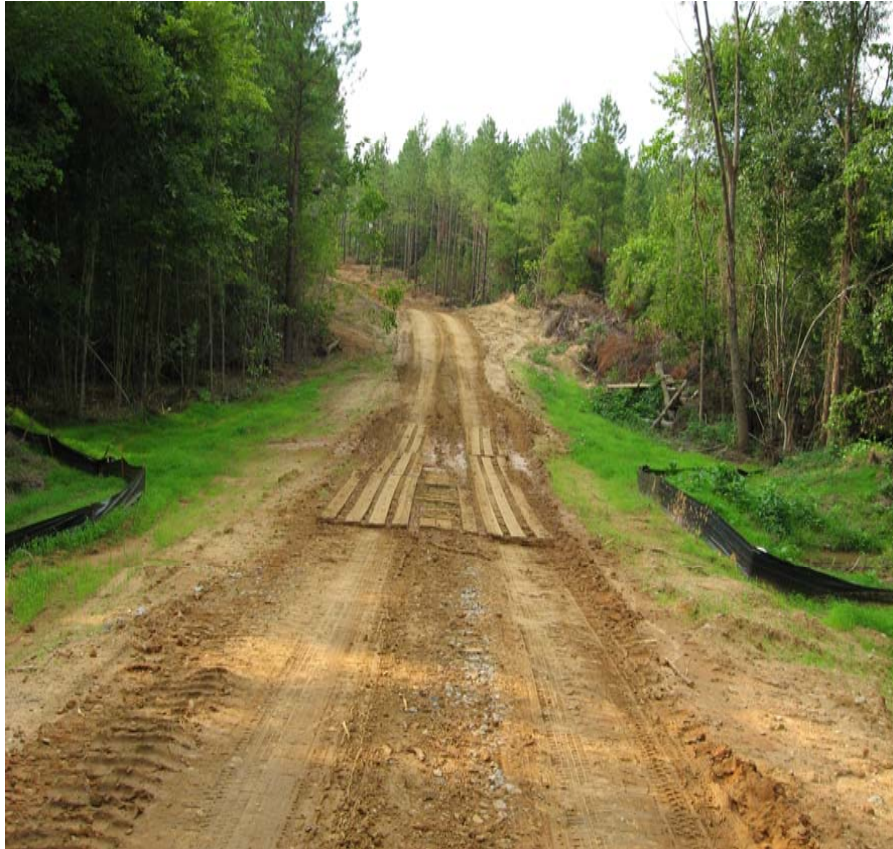
Crossing ID: Purcell  
 Crossing Type: Culvert  
 Location: Amelia Co.  
 Installation: Good  
 Approach: Fair

Figure A1. Purcell culvert crossing during harvest.

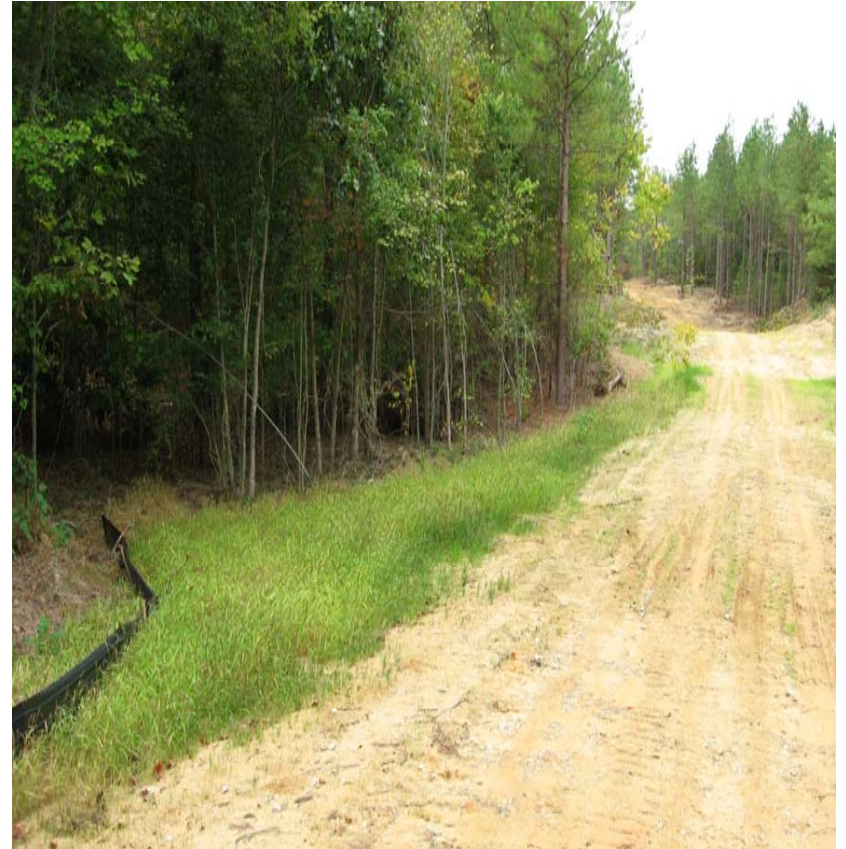
Figure A2. Culvert crossing with a variety of BMPs.

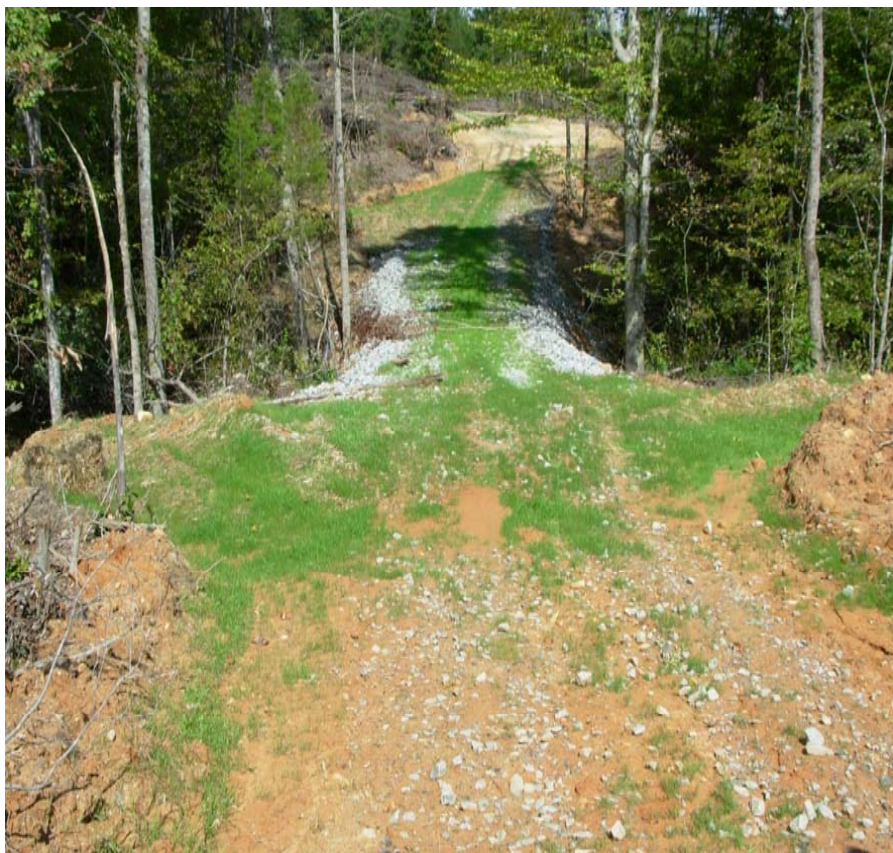
Crossing ID: Briery Creek  
 Crossing Type: Culvert  
 Location: Prince Edward Co.  
 Installation: Good  
 Approach: Good

Figure A3. Culvert crossing and left approach after harvest.

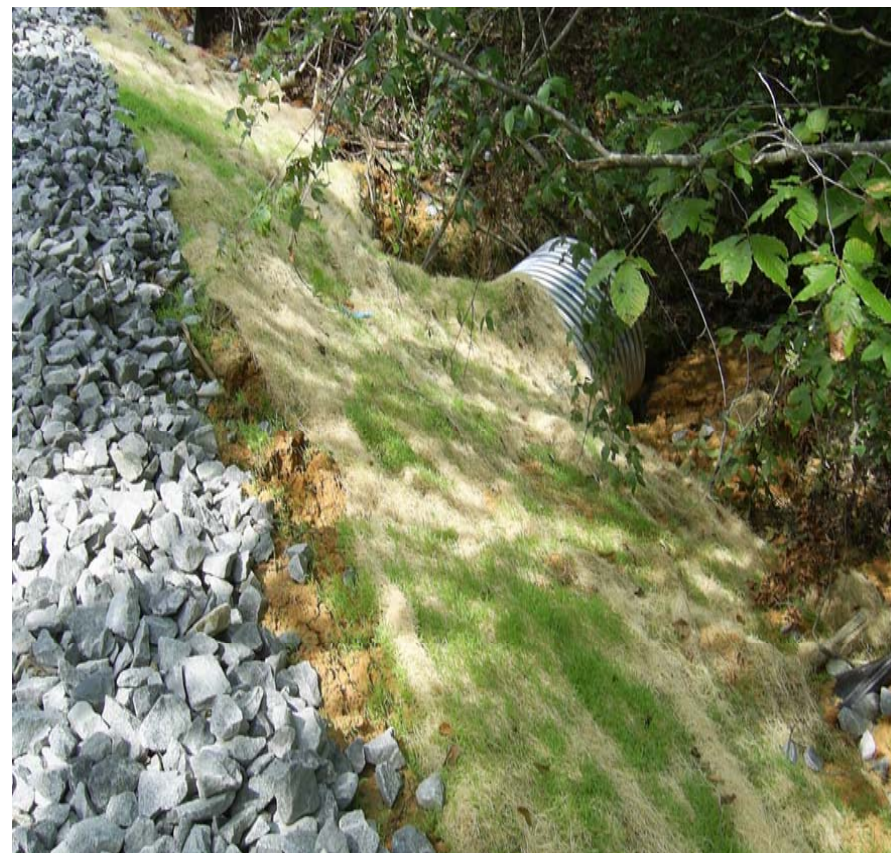
Figure A4. Curl-Ex material and rock used during harvest

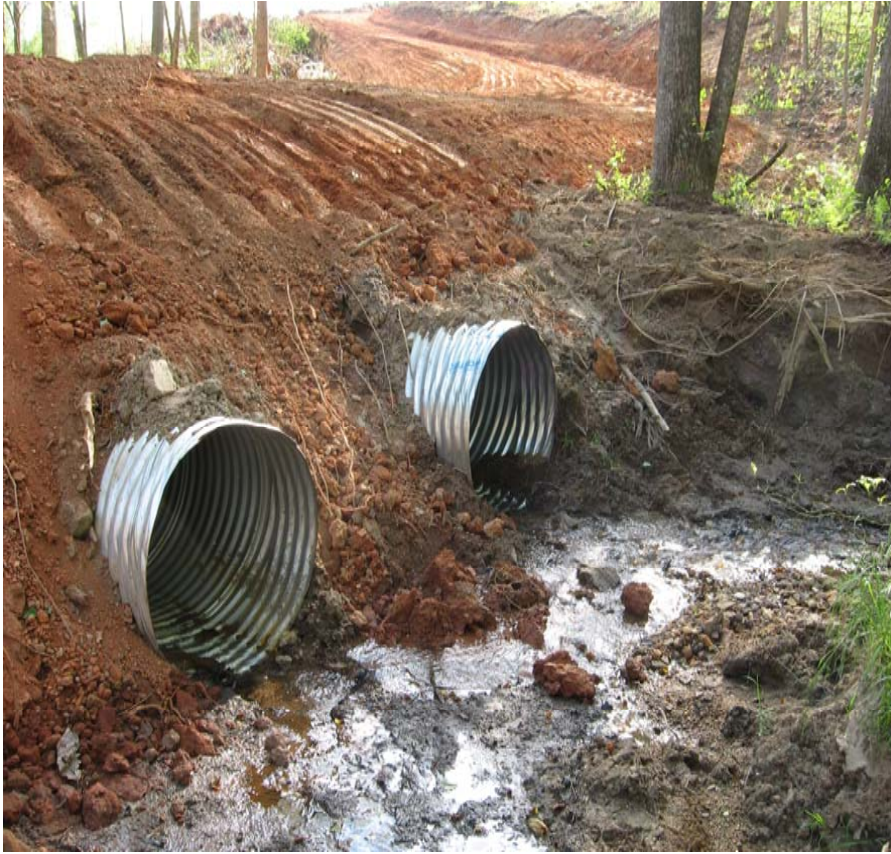
Crossing ID: Reynolds B<sub>A</sub>  
 Crossing Type: Culvert  
 Location: Pittsylvania Co.  
 Installation: Good  
 Approach: Poor

Figure A5. Double corrugated culvert pipes.

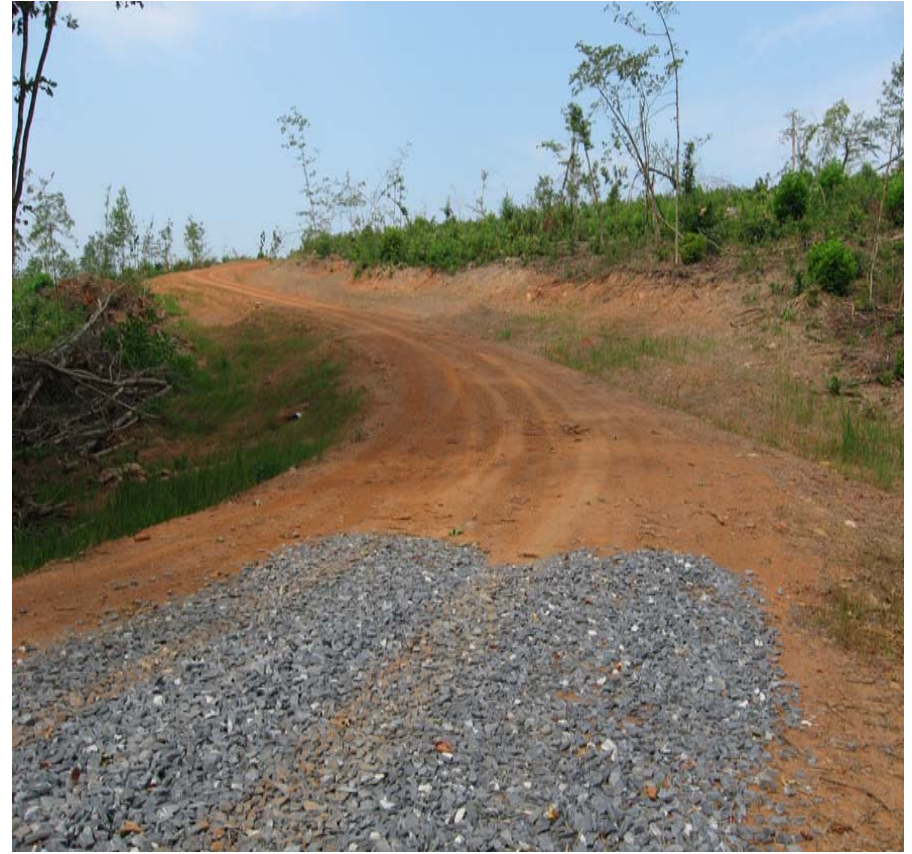
Figure A6. Partial gravel application on left approach.

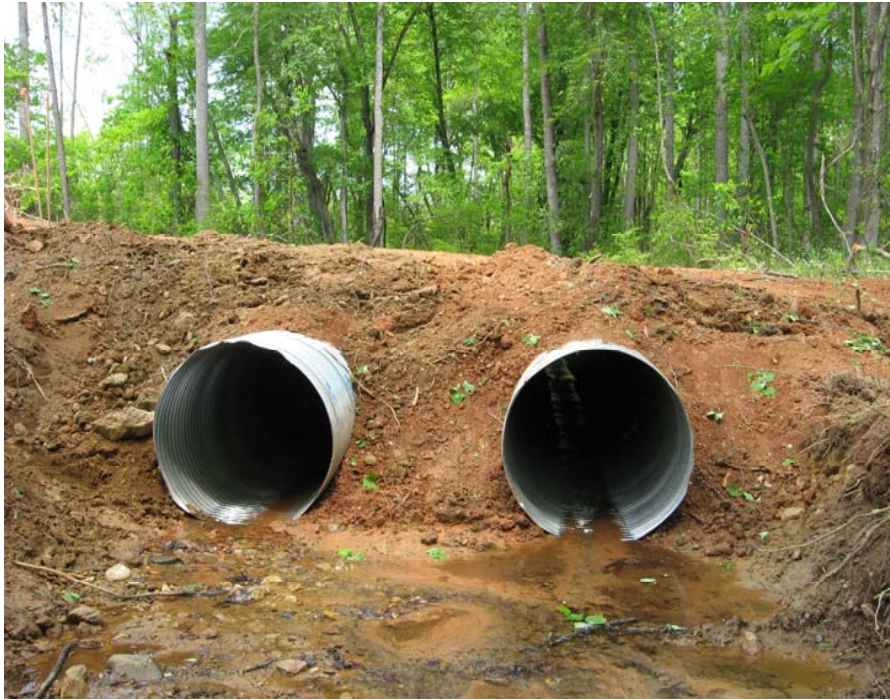
Crossing ID: Reynolds B<sub>B</sub>  
 Crossing Type: Culvert  
 Location: Pittsylvania Co.  
 Installation: Good  
 Approach: Poor

Figure A7. 48-inch culvert pipes installed in Pittsylvania Co.

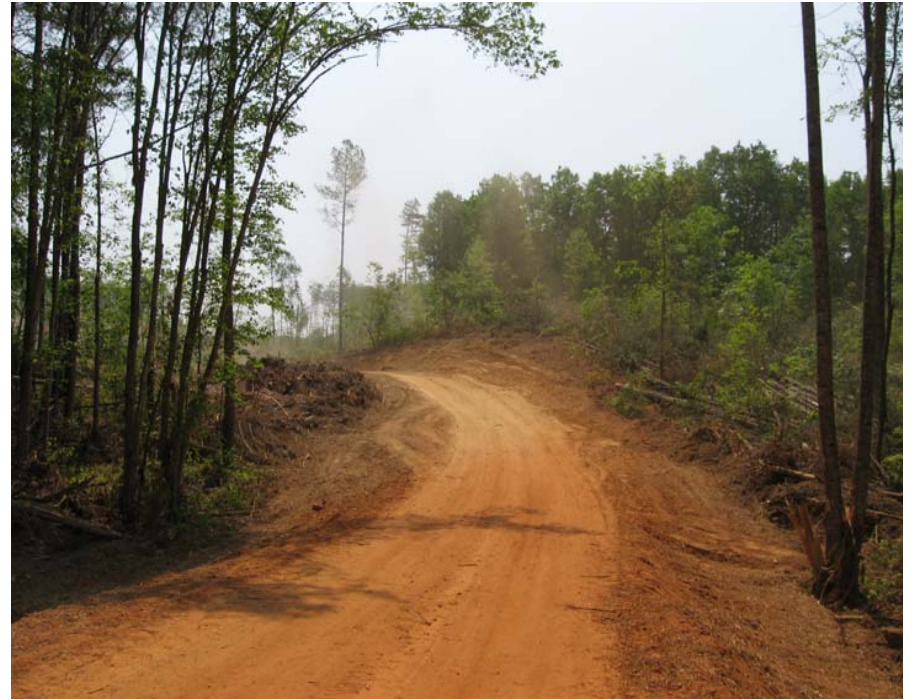
Figure A8. Right approach of culvert crossing.

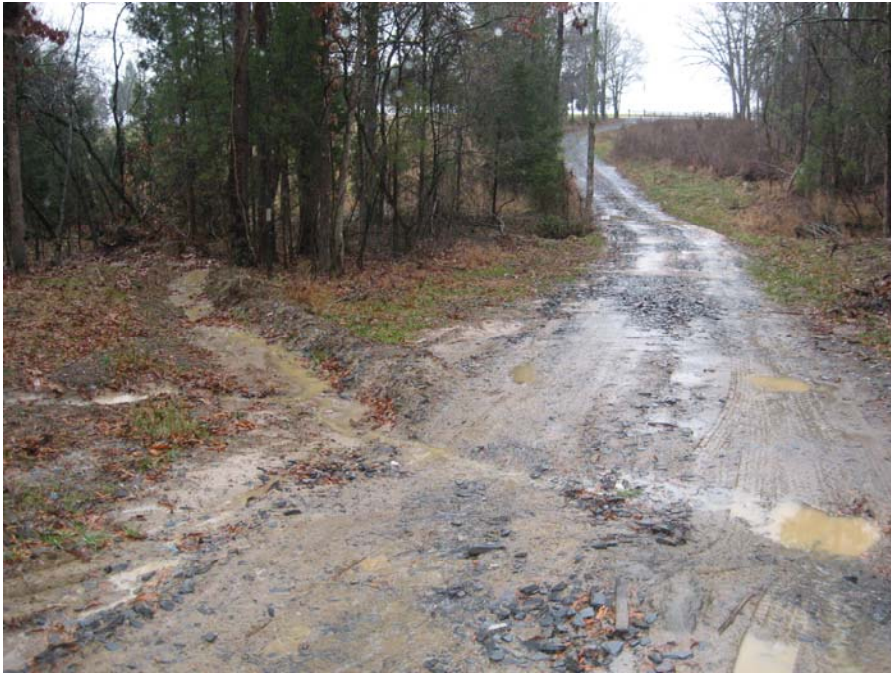
Crossing ID: Blue Rock-Curdsville  
 Crossing Type: Culvert  
 Location: Buckingham Co.  
 Installation: Fair  
 Approach: Fair

Figure A9. Culvert crossing with water control structures.

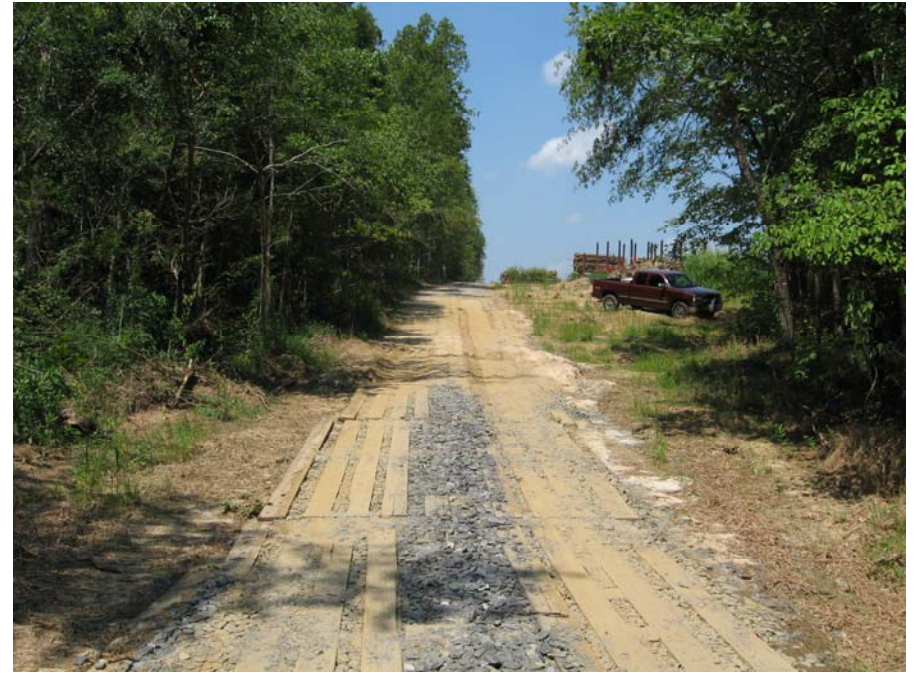
Figure A10. Right approach during harvest to crossing.

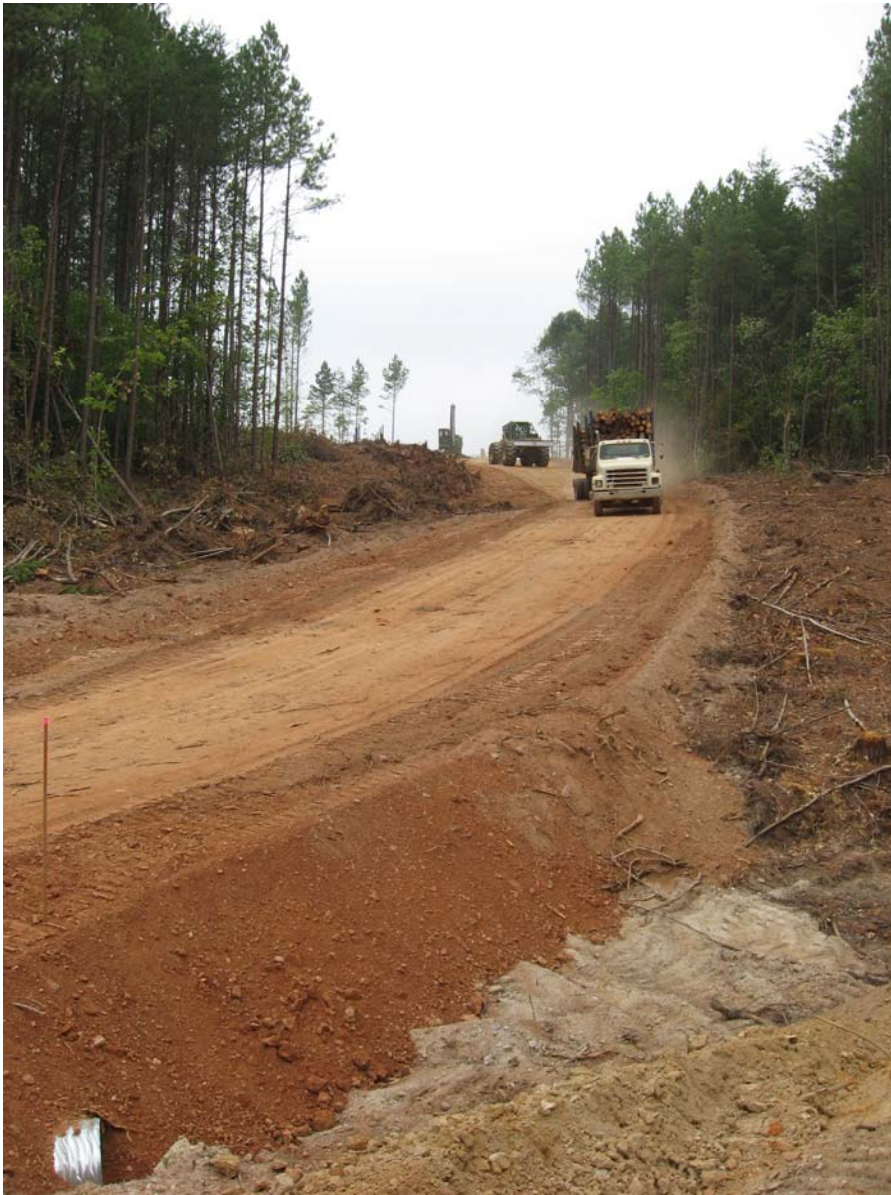
Crossing ID: Altavista (Perrow)  
 Crossing Type: Culvert  
 Location: Campbell Co.  
 Installation: Fair  
 Approach: Fair

Figure A11. Culvert crossing during harvest.

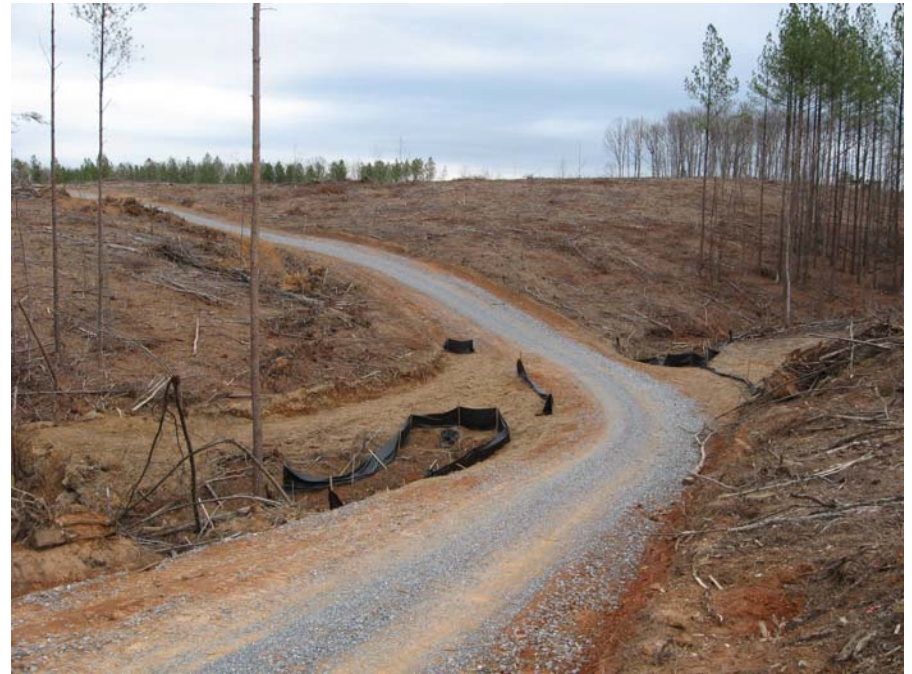
Figure A12. BMPs after harvest; gravel, seed, and silt fence.

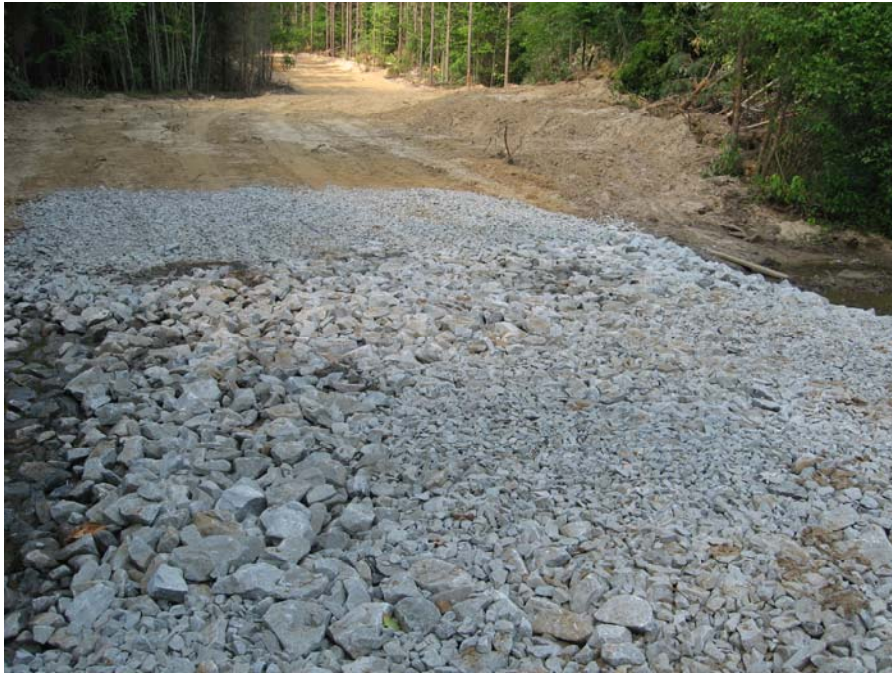
Crossing ID: Purcell  
 Crossing Type: Ford  
 Location: Amelia Co.  
 Installation: Poor  
 Approach: Fair

Figure A13. Re-enforced ford stream crossing in Amelia Co.

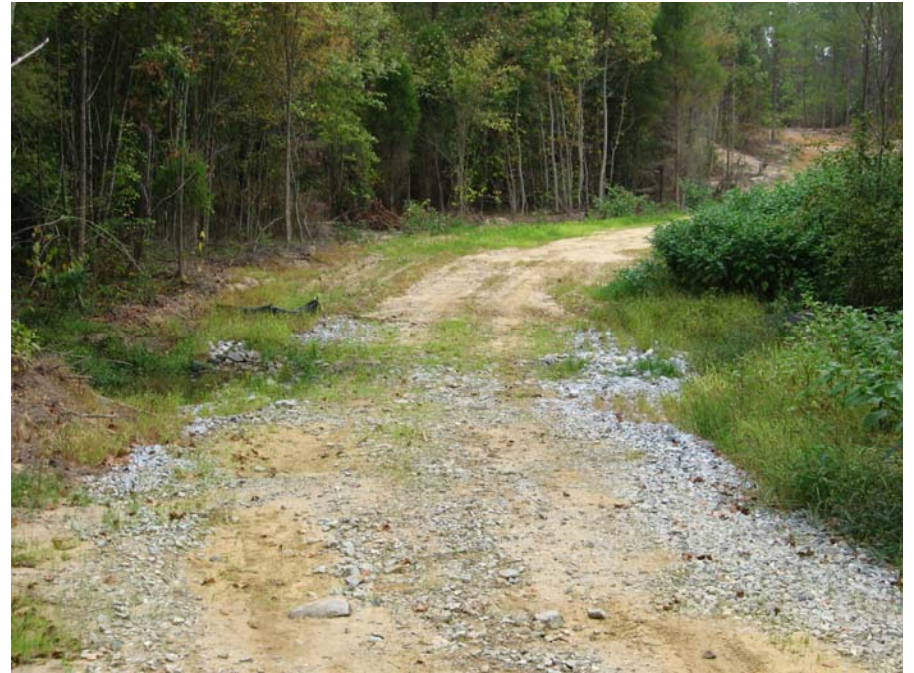
Figure A14. Ford crossing from left approach after harvest.

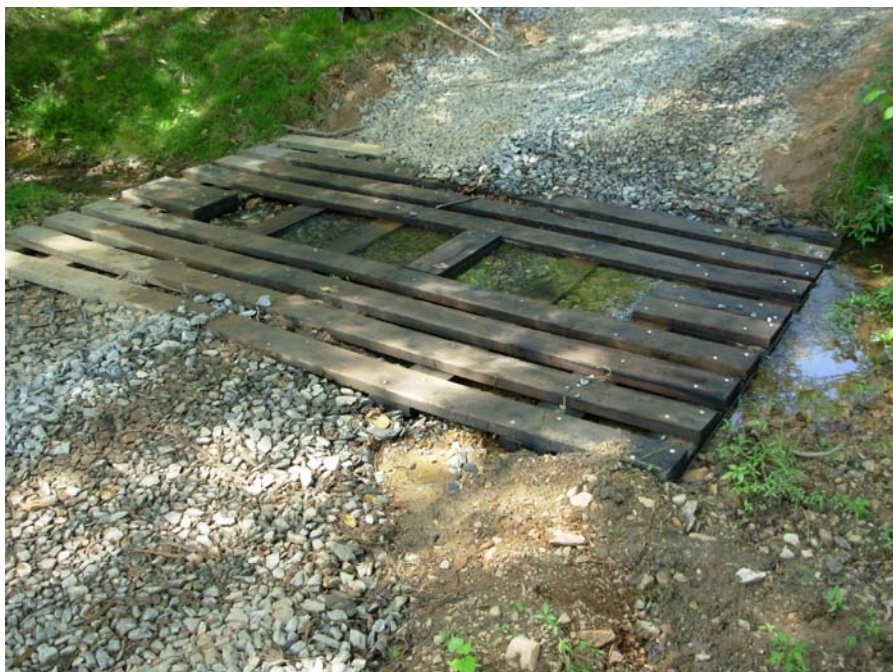
Crossing ID: Kyanite  
 Crossing Type: Ford  
 Location: Charlotte Co.  
 Installation: Good  
 Approach: Good

Figure A15. Re-enforced ford with logging mat during use.

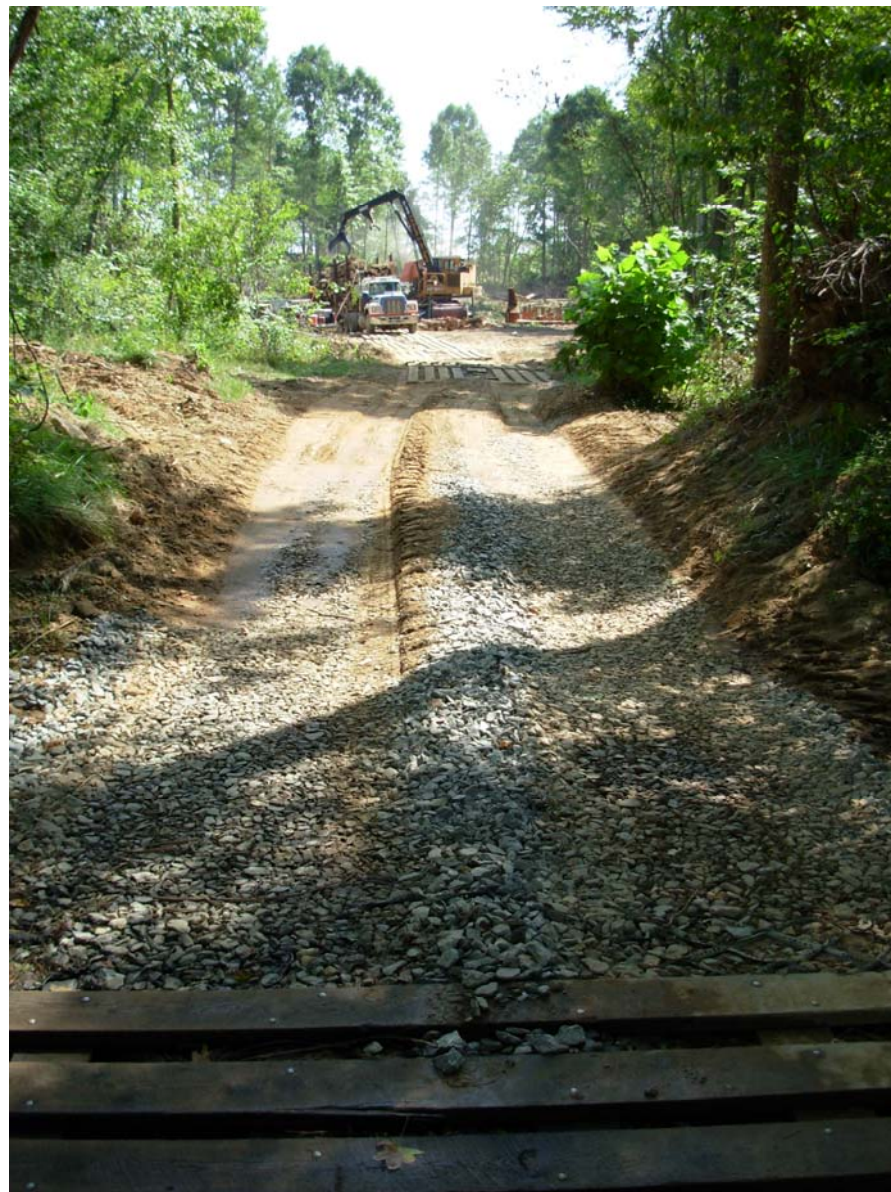
Figure A16. Right approach of ford crossing.

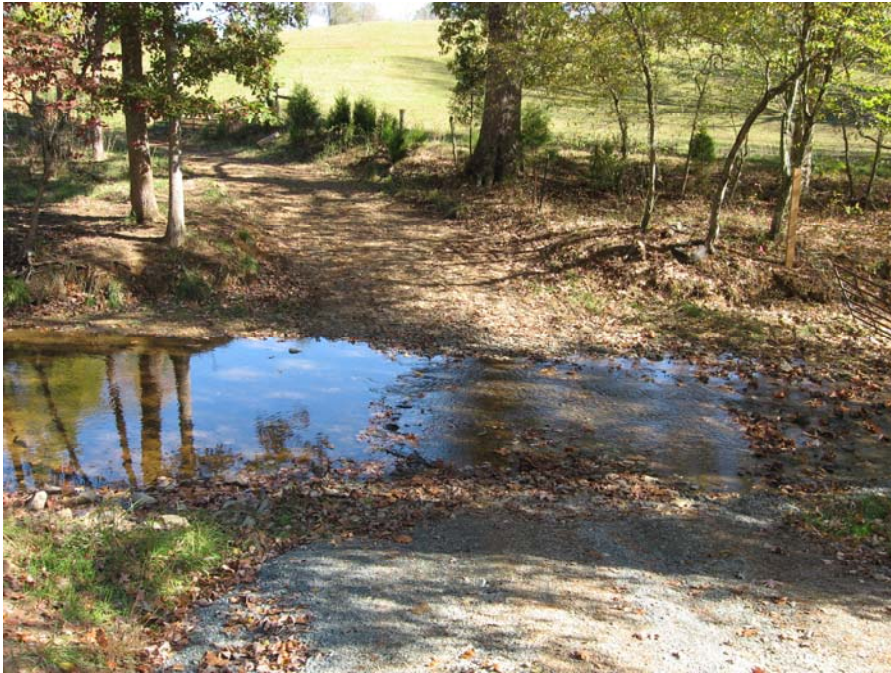
Crossing ID: Nicholson  
 Crossing Type: Ford  
 Location: Fluvanna Co.  
 Installation: Good  
 Approach: Poor

Figure A17. Ford stream crossing on Bremono Creek (Fluvanna Co).

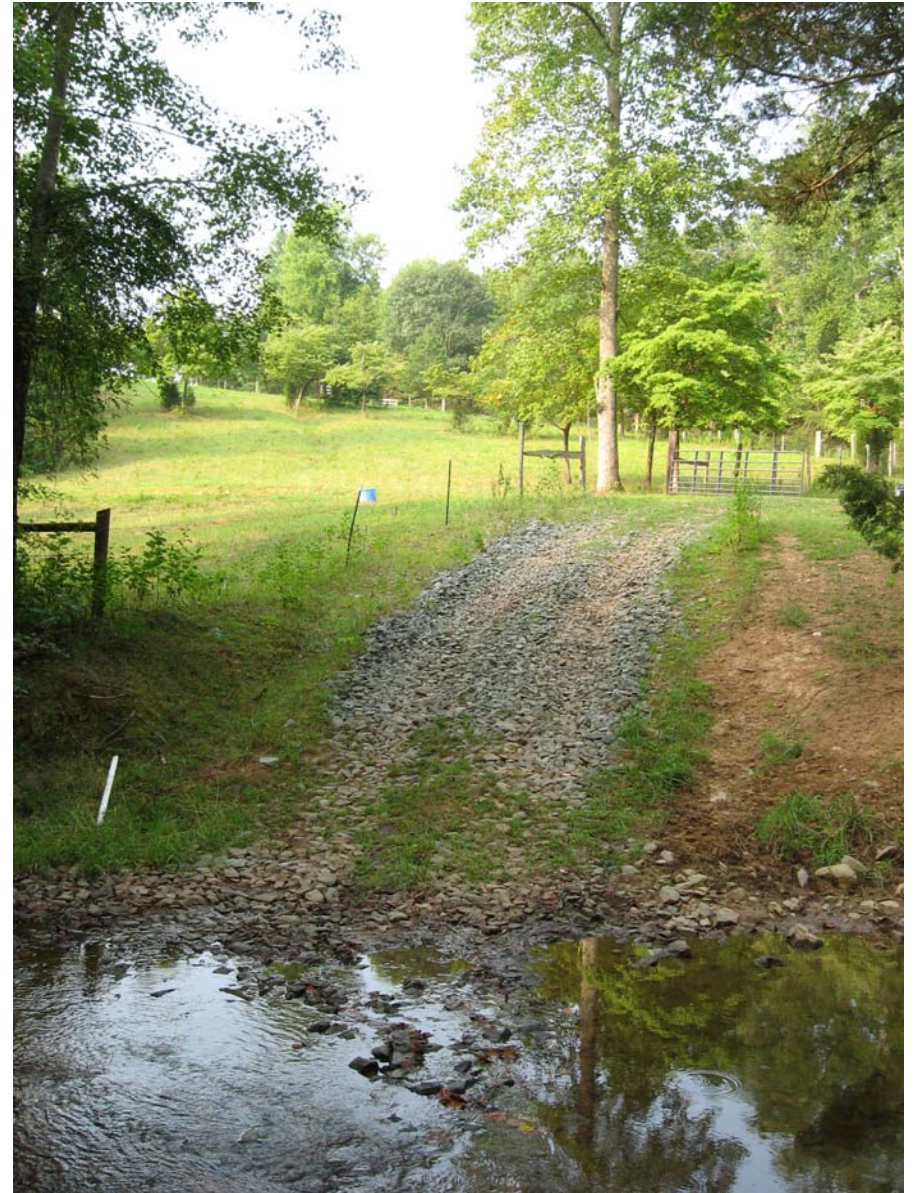
Figure A18. Left approach with a 20% grade.

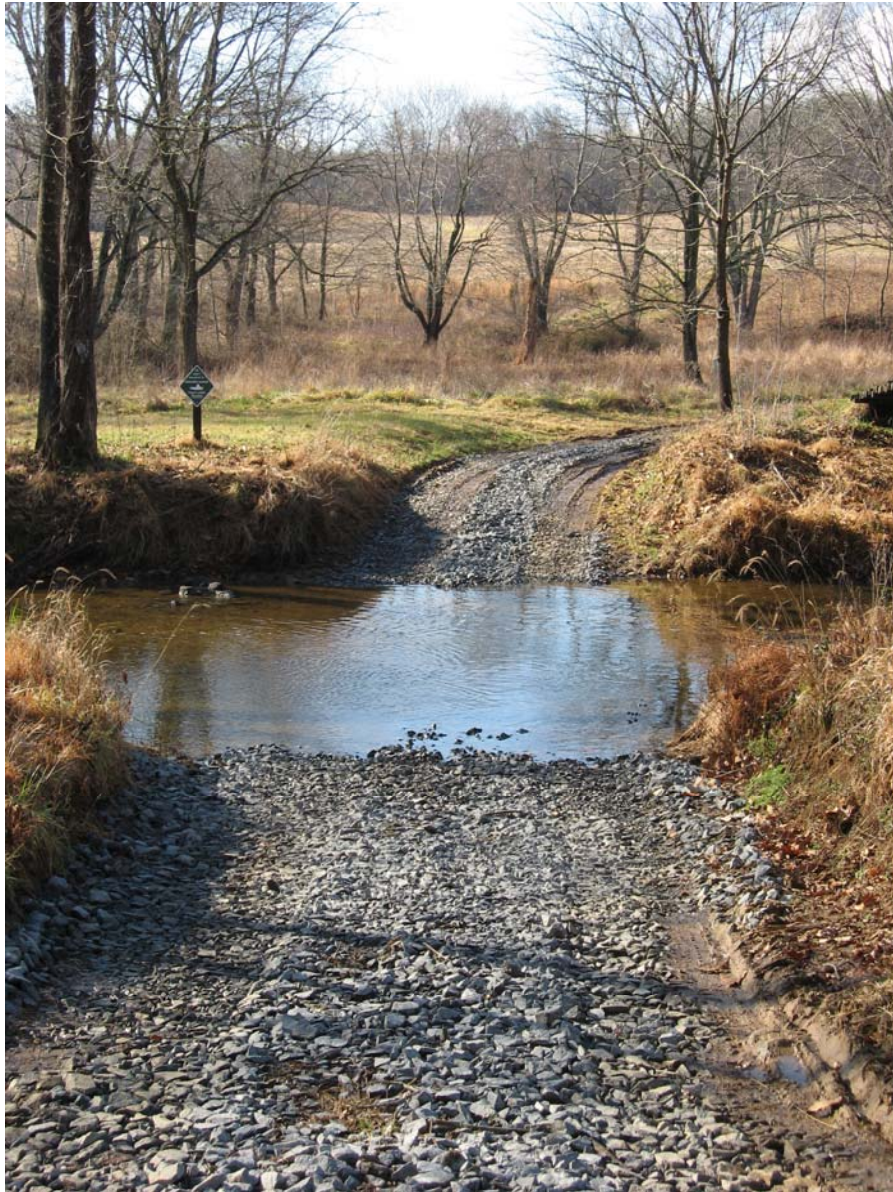
Crossing ID: Crummett  
 Crossing Type: Ford  
 Location: Fauquier Co.  
 Installation: Fair  
 Approach: Good

Figure A19. Ford crossing on Thumb Run (Fauquier Co.)

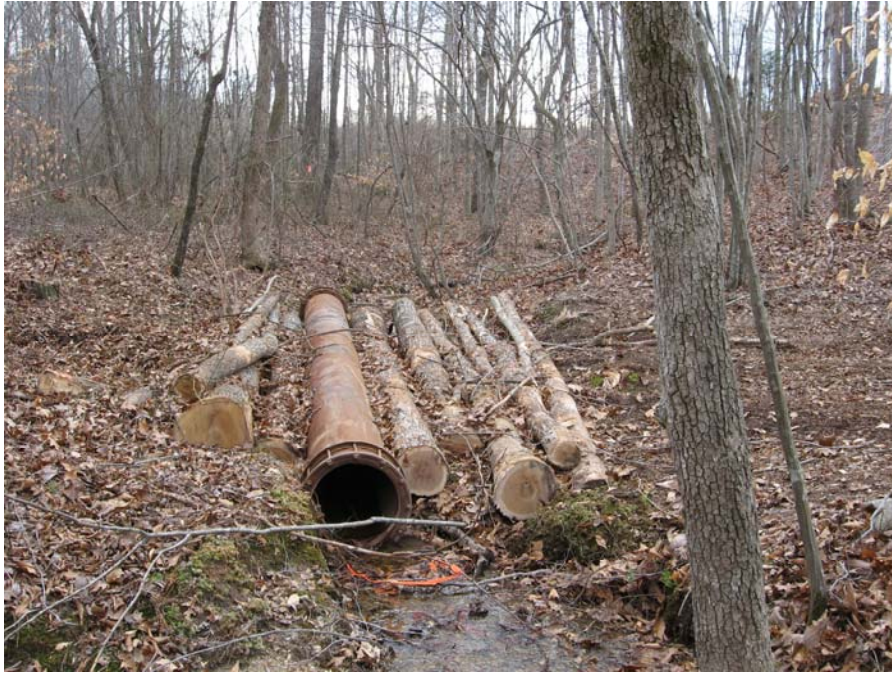
Crossing ID: Pearson  
 Crossing Type: Pole Bridge  
 Location: Buckingham Co.  
 Installation: Poor  
 Approach: Good

Figure A21. Pole bridge crossing after installation.

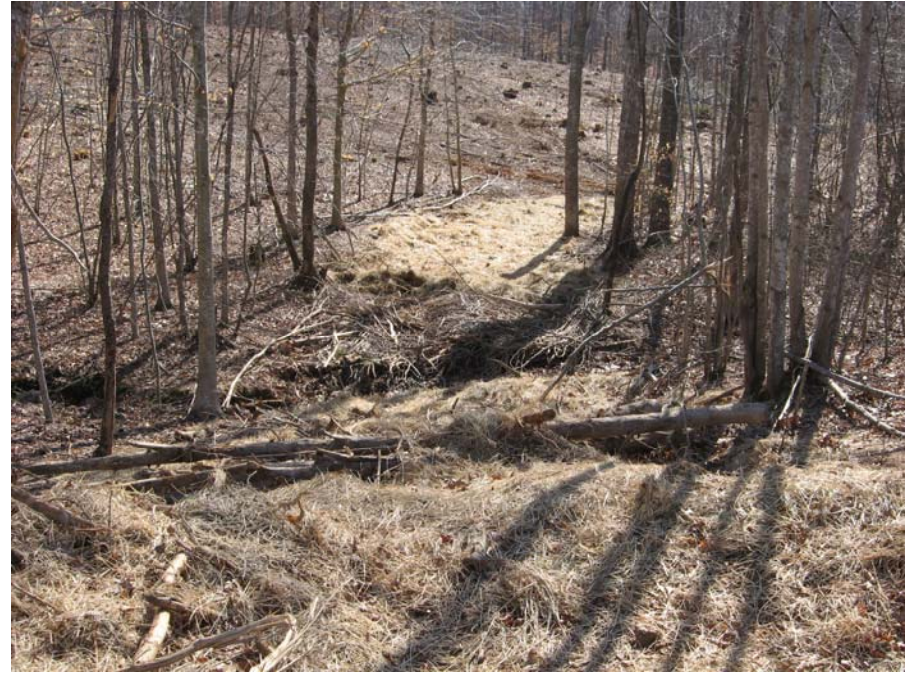
Figure A22. Pole bridge approaches after road closure.

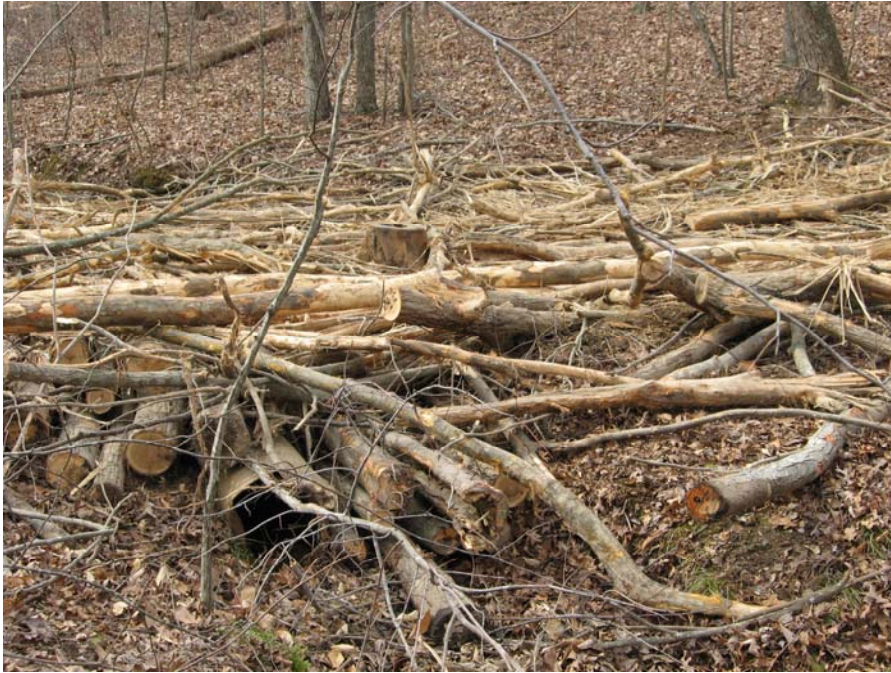
Crossing ID: Winterstein  
 Crossing Type: Pole Bridge  
 Location: Buckingham Co.  
 Installation: Poor  
 Approach: Good

Figure A23. Pole bridge crossing in an intermittent stream.

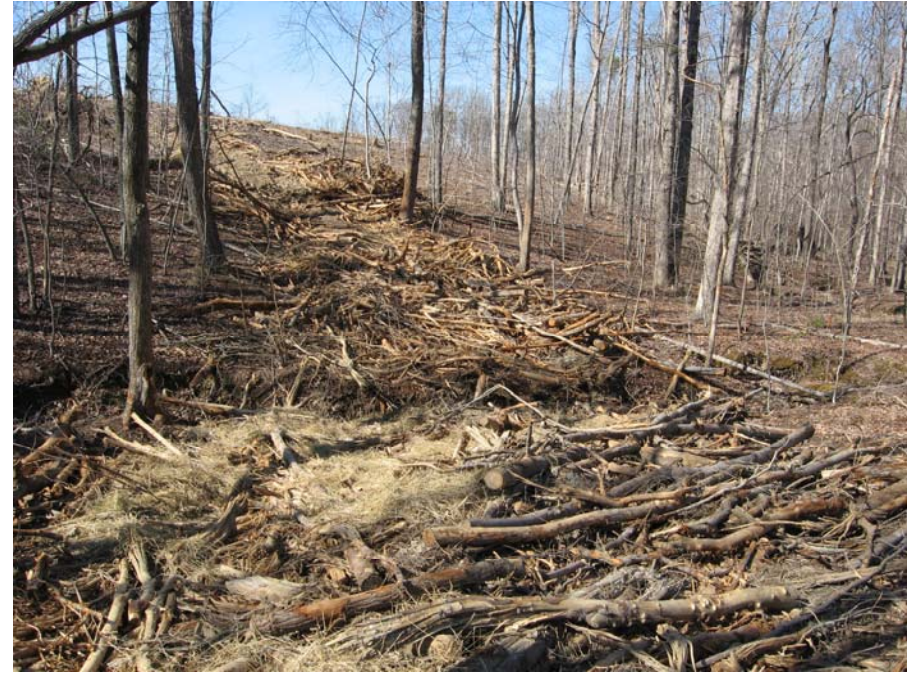
Figure A24. Pole bridge crossing after road closure.

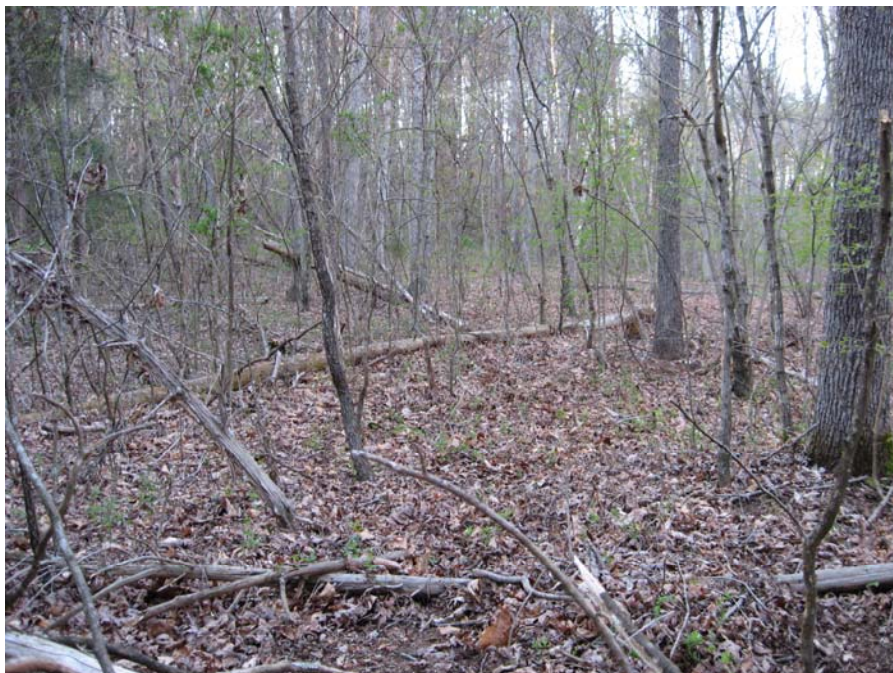
Crossing ID: Trent  
 Crossing Type: Pole Bridge  
 Location: Campbell Co.  
 Installation: Poor  
 Approach: Fair

Figure A25. Left approach of pole bridge before installation.

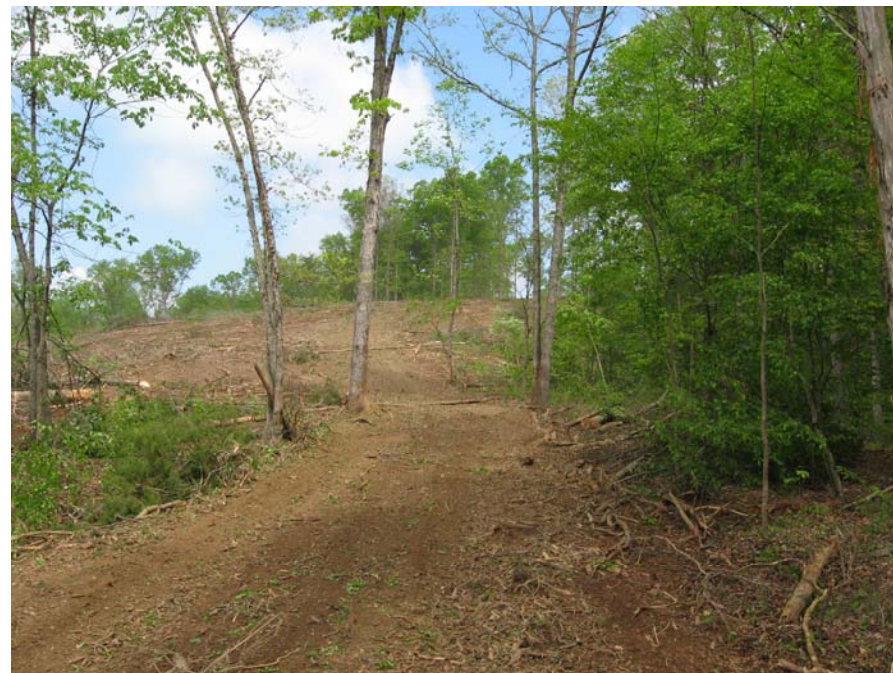
Figure A26. Left approach of pole bridge during harvest.

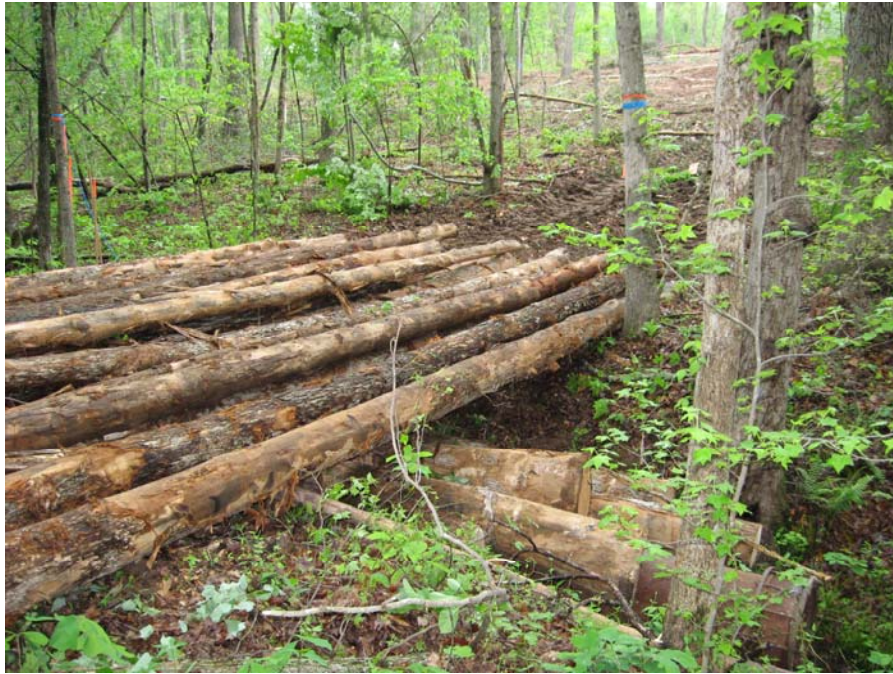
Crossing ID: Haley  
 Crossing Type: Pole Bridge  
 Location: Charlotte Co.  
 Installation: Good  
 Approach: Good

Figure A27. Unique pole bridge in Charlotte Co.

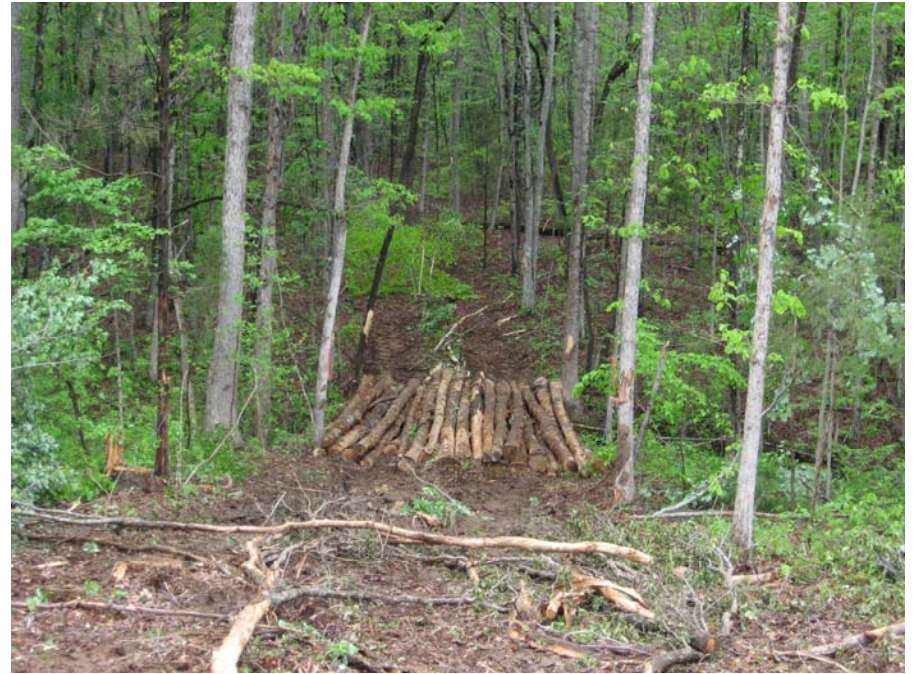
Figure A28. Left approach to pole bridge crossing.

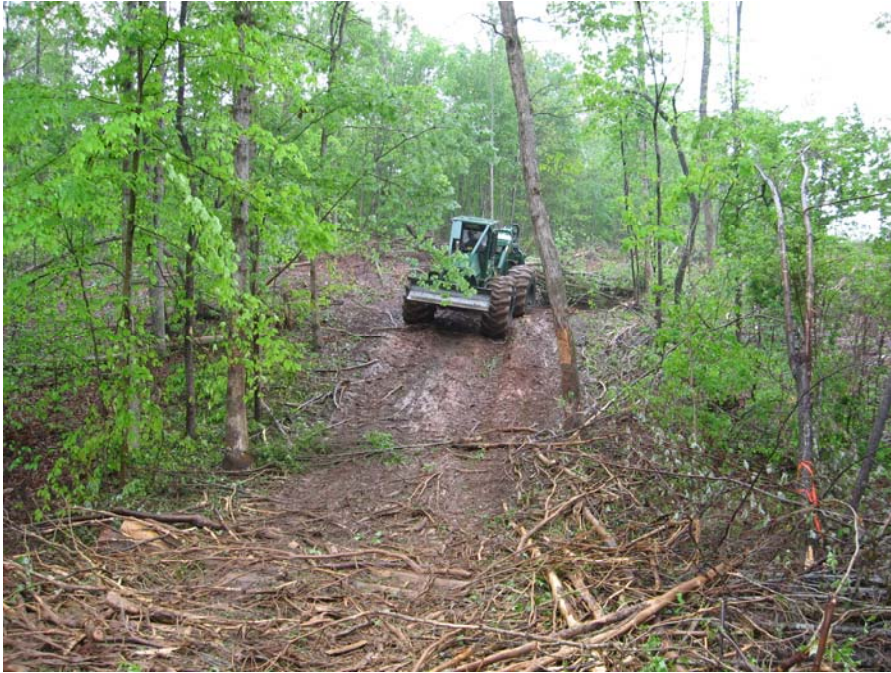
Crossing ID: Tharpe  
 Crossing Type: Pole Bridge  
 Location: Prince Edward Co.  
 Installation: Good  
 Approach: Good

Figure A29. Pole bridge crossing during use.

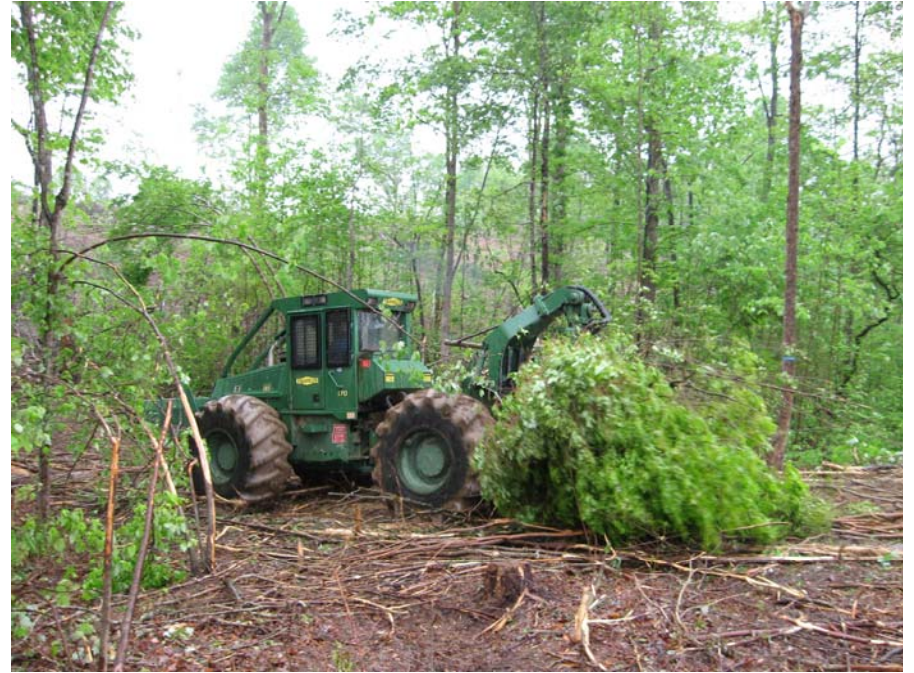
Figure A30. Application of slash to approaches during use.

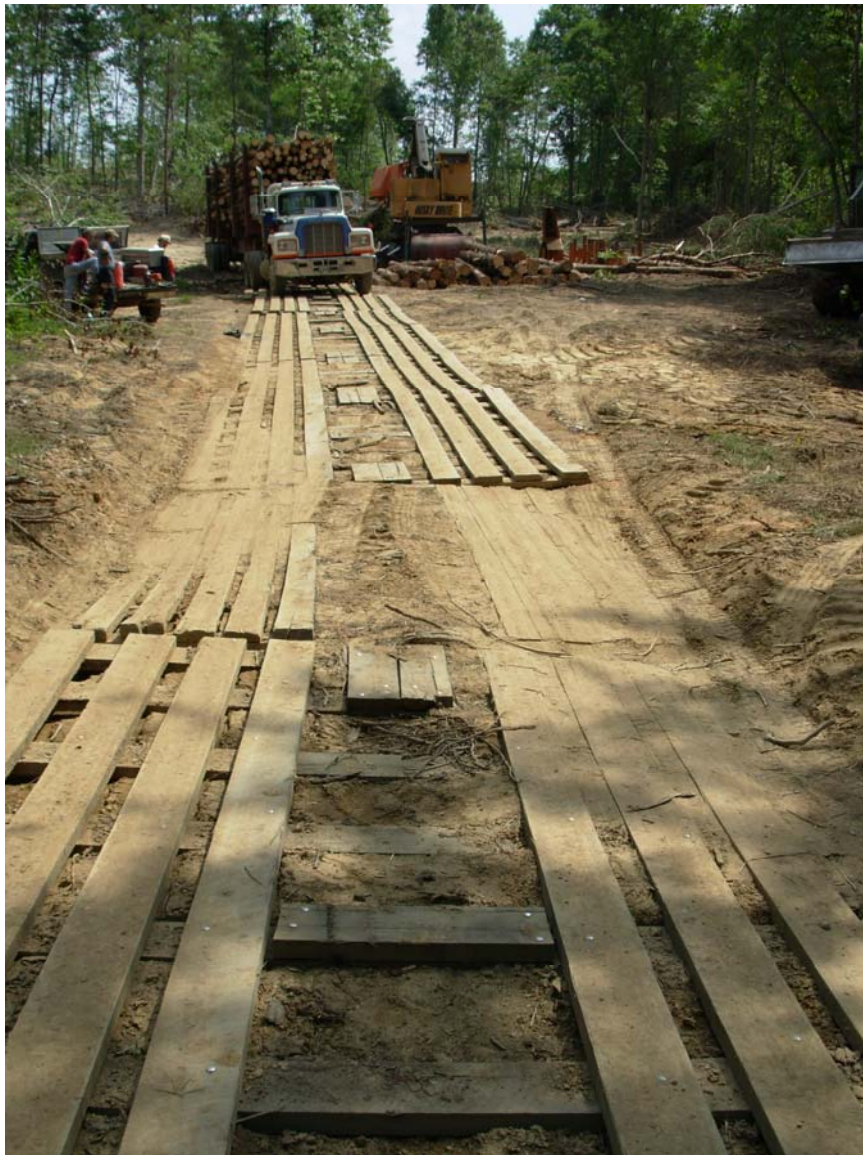
Crossing ID: Kyanite  
 Crossing Type: Pole Bridge  
 Location: Charlotte Co.  
 Installation: Fair  
 Approach: Good

Figure A31. Right approach to pole bridge during use.

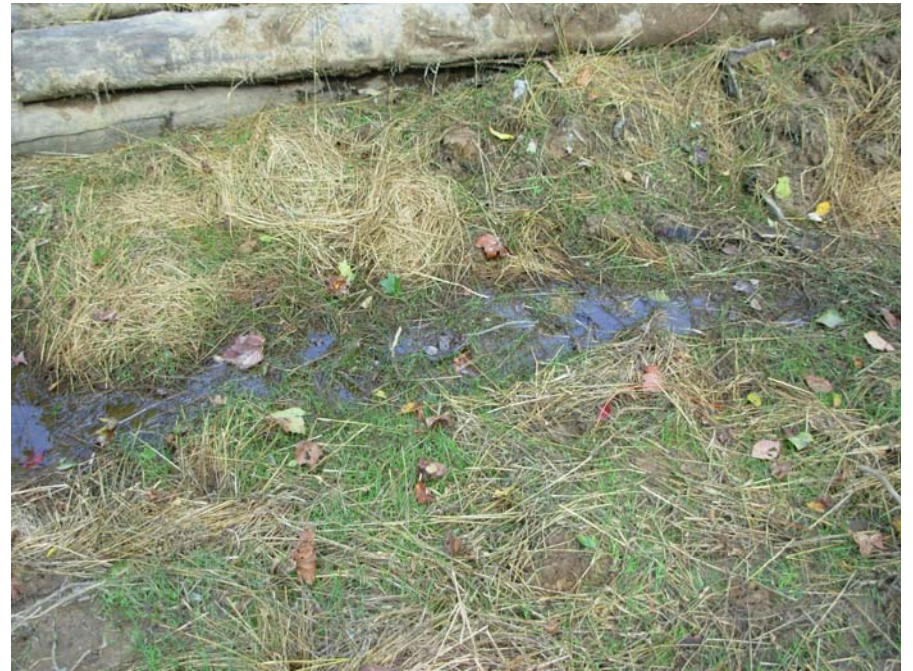
Figure A32. Ephemeral stream after pole bridge removal.
