**Appendix B. Stream crossings summary**

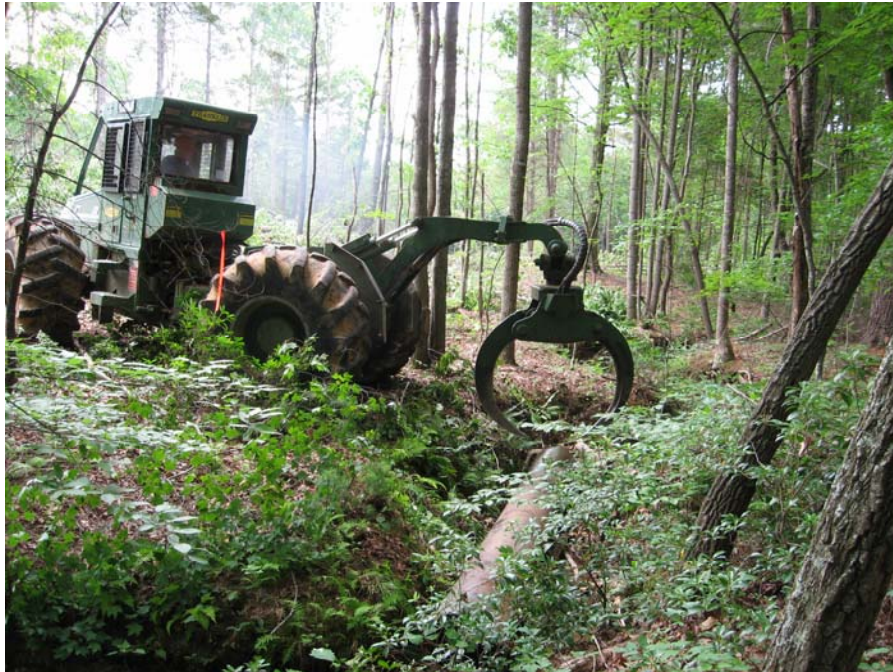
Crossing ID: Townley  
 Crossing Type: Pole Bridge  
 Location: Amherst Co.  
 Installation: Good  
 Approach: Good

Figure A33. Pipe installation of pole bridge crossing.

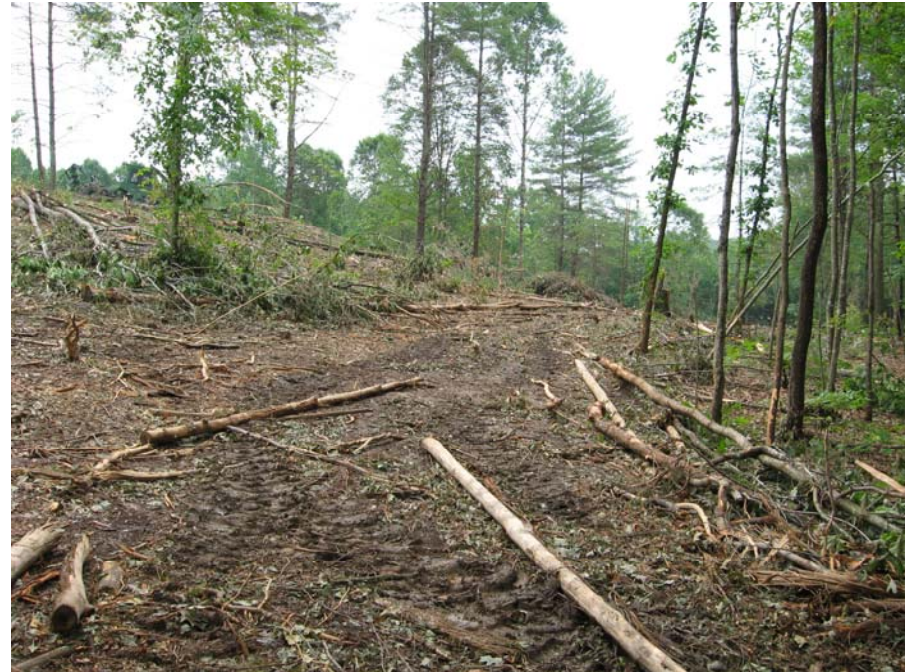
Figure A34. Right approach to pole bridge during use.

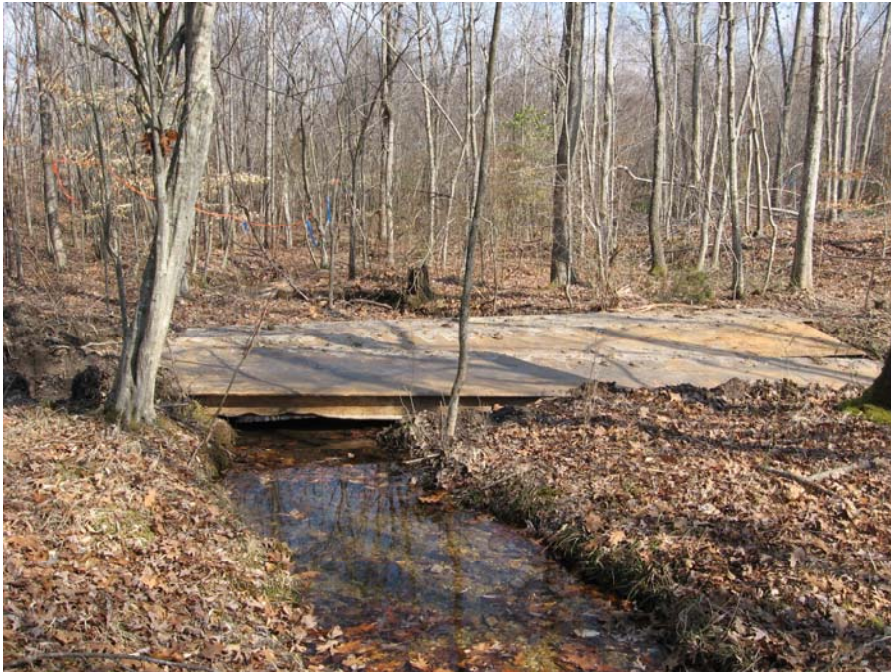
Crossing ID: Pearson  
 Crossing Type: Steel Bridge  
 Location: Buckingham Co.  
 Installation: Poor  
 Approach: Fair

Figure A35. Steel bridge crossing installed before harvest.

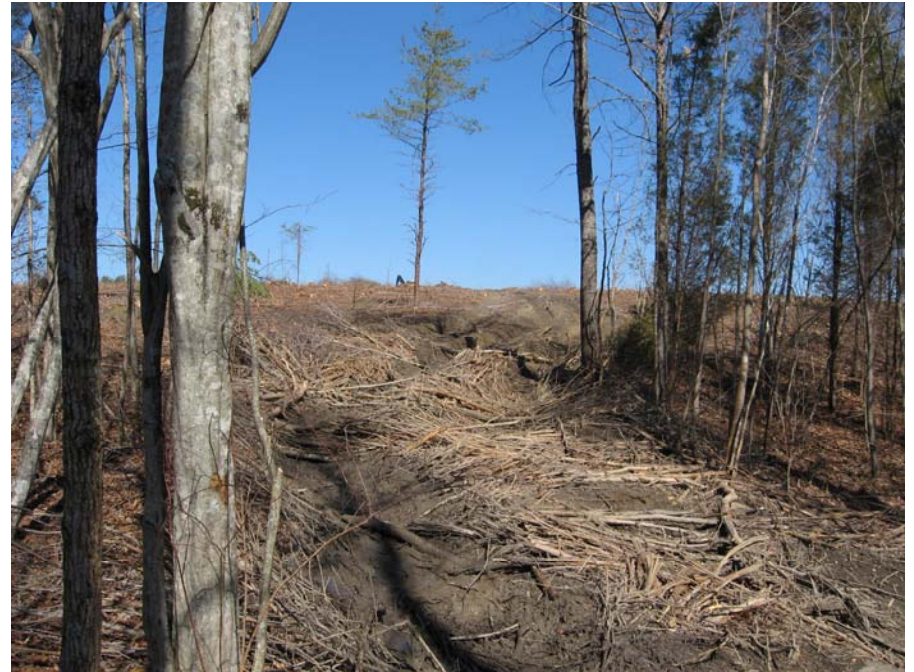
Figure A36. Right approach to steel bridge crossing.

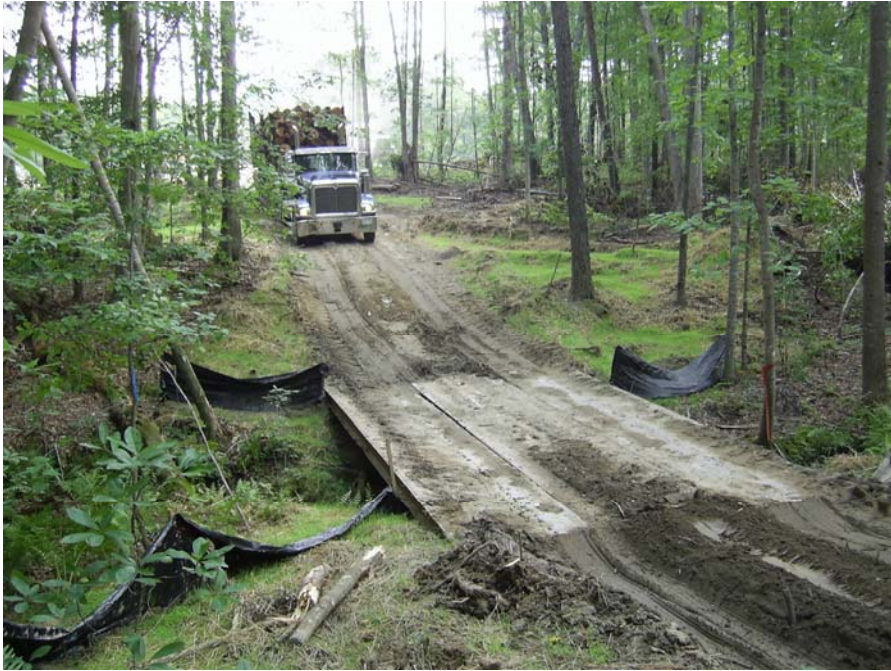
Crossing ID: Jordan  
 Crossing Type: Steel Bridge  
 Location: Prince Edward Co.  
 Installation: Good  
 Approach: Poor

Figure A37. Steel bridge crossing during log truck use.

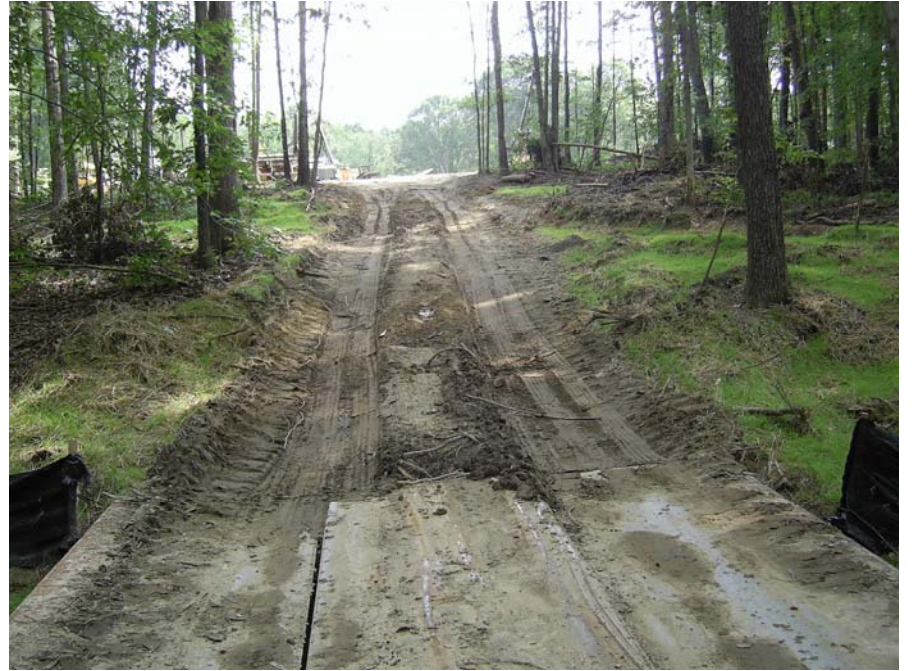
Figure A38. Left approach to steel bridge crossing.

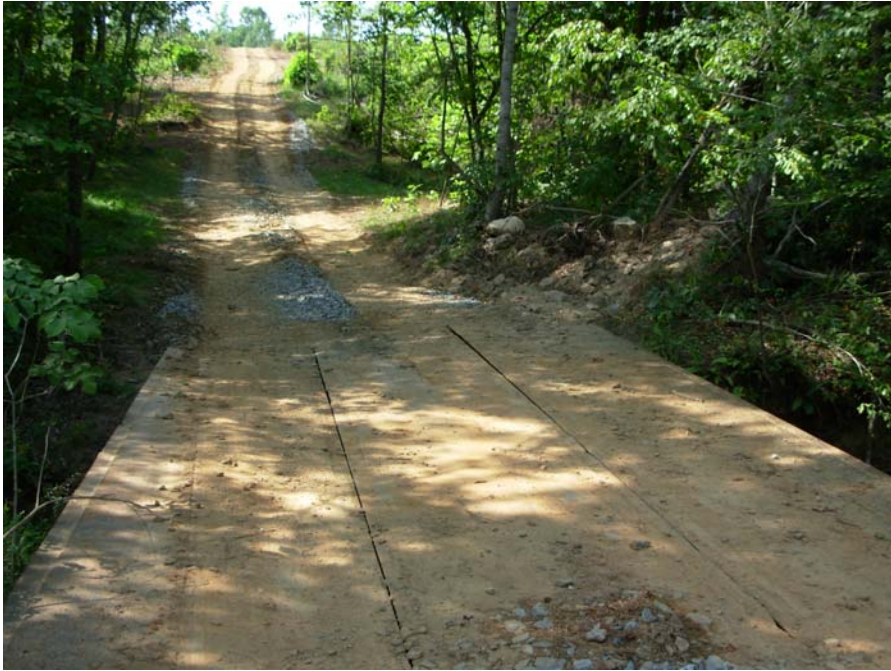
Crossing ID: Kyanite  
 Crossing Type: Steel Bridge  
 Location: Charlotte Co.  
 Installation: Good  
 Approach: Poor

Figure A39. Steel bridge crossing and approach.

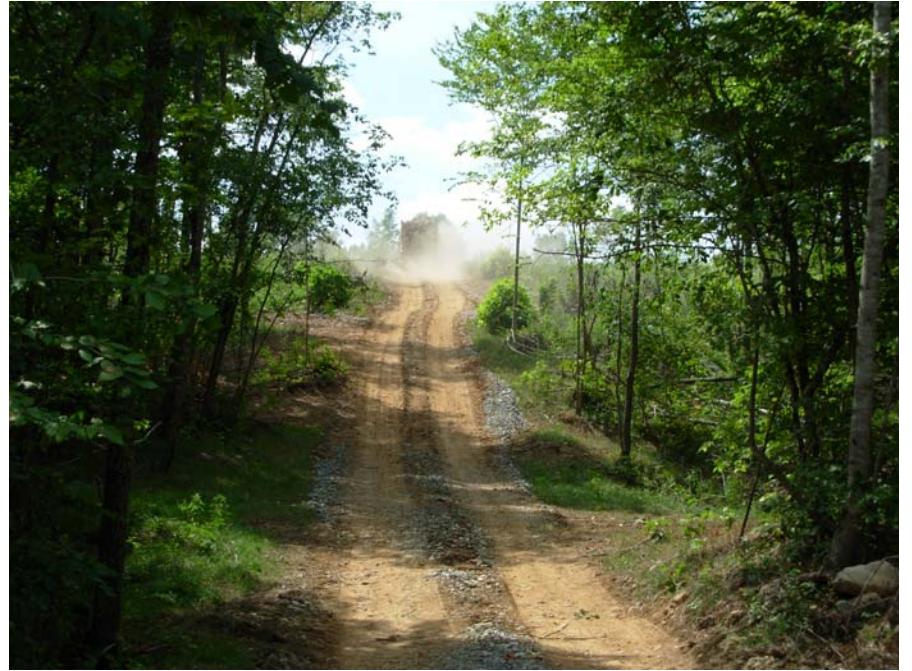
Figure A40. Left approach to steel bridge crossing.

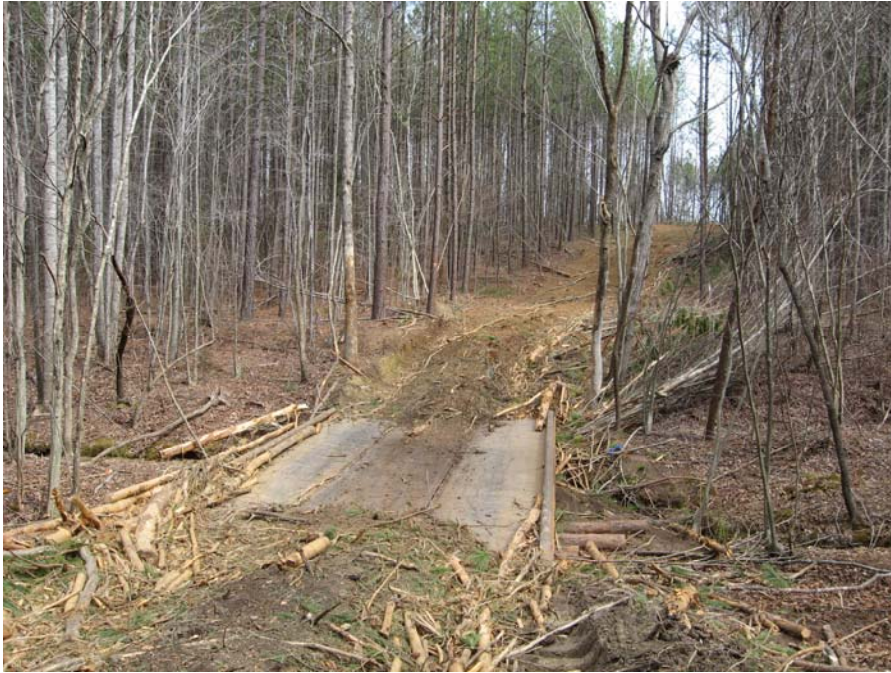
Crossing ID: Burke  
 Crossing Type: Steel Bridge  
 Location: Appomattox Co.  
 Installation: Good  
 Approach: Good

Figure A41. Steel bridge stream crossing during use.

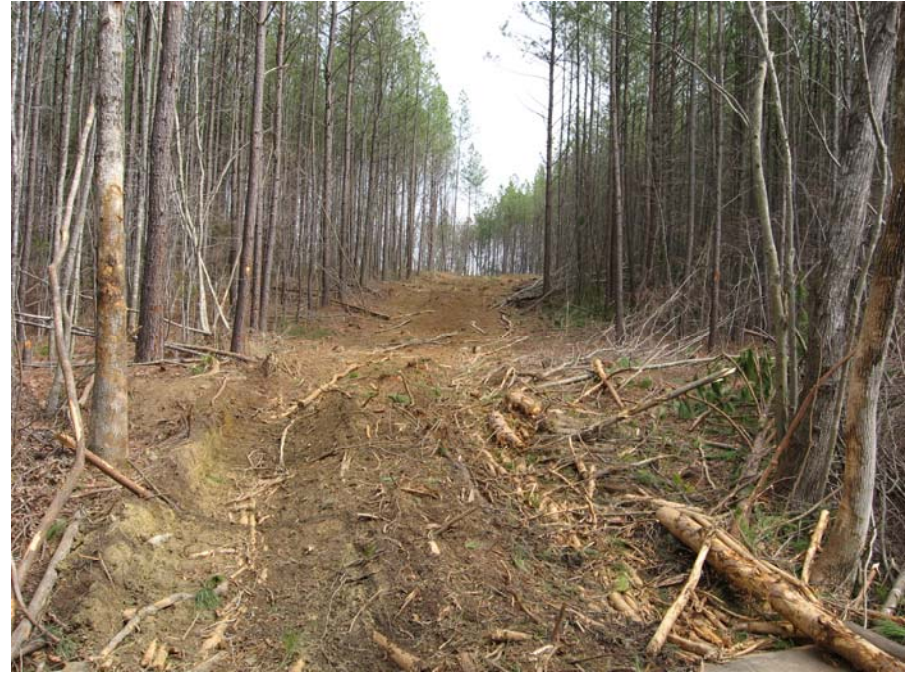
Figure A42. Left approach to stream crossing.

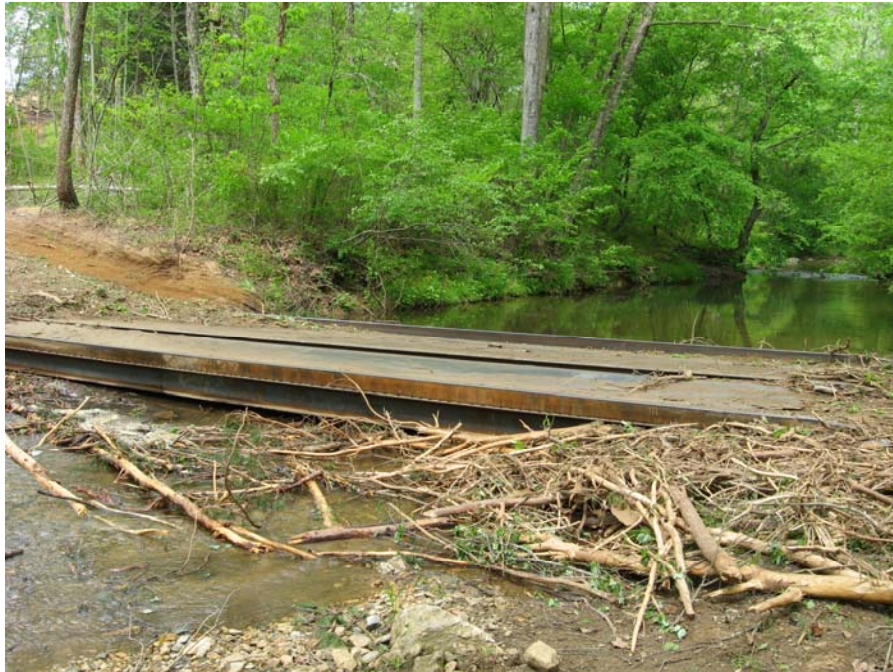
Crossing ID: Trent  
 Crossing Type: Steel Bridge  
 Location: Campbell Co.  
 Installation: Fair  
 Approach: Fair

Figure A43. Largest steel bridge crossing used for study.

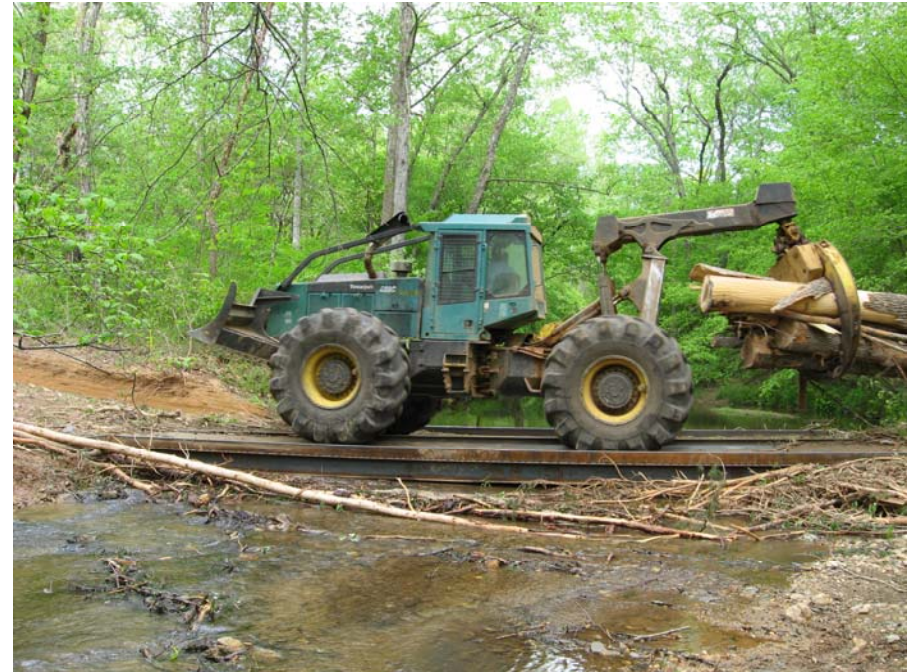
Figure A44. Steel bridge during skidder use.

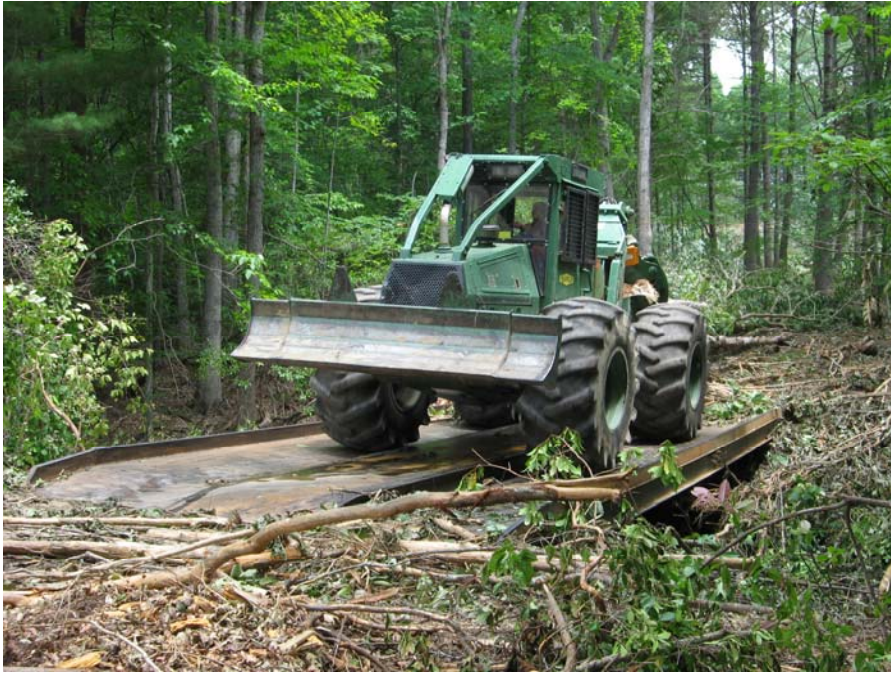
Crossing ID: Townley  
 Crossing Type: Steel Bridge  
 Location: Amherst Co.  
 Installation: Good  
 Approach: Good

Figure A45. Steel bridge during skidding operations.

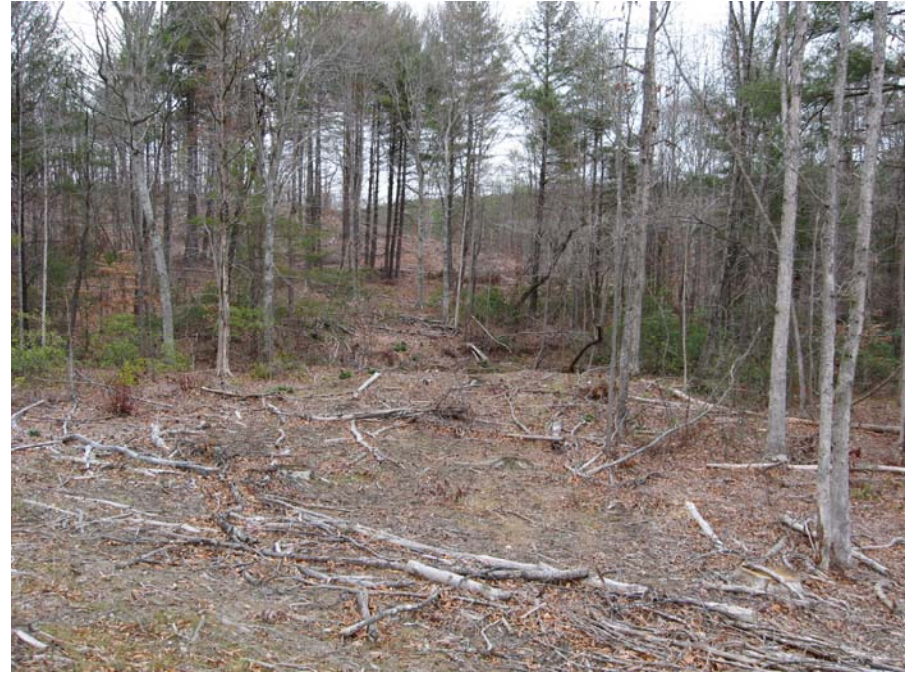
Figure A46. Steel bridge approaches after road closure.
