NON-UNIFORM COPPER CORROSION IN POTABLE WATER: THEORY AND PRACTICE

Thesis submitted to the Faculty of the
Virginia Polytechnic Institute and State University
In partial fulfillment of the requirements for the degree of

Master of Science
in
Environmental Engineering

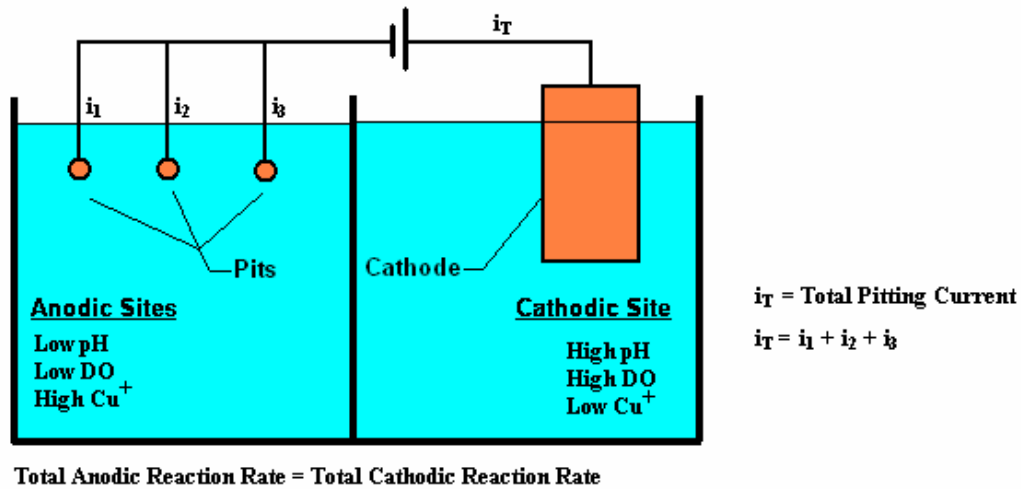
Figure 1-2: Divided Cell - Conceptual illustration of copper pitting process (Sheffer 2006).

To better conceptualize inhibitor action in relation to pitting corrosion, the schematic of a active pit in Figure 1-1 can be considered as a divided cell, in which two copper samples are exposed to different chemical environments representative of conditions at anodic and cathodic locations on the pipe (Figure 1-2). Specifically, the cathodic copper surface is in contact with water of relatively high pH, high dissolved oxygen and/or chlorine, and low Cu^+ and Cu^{2+} concentrations. However, the small anodic copper surfaces representing pits are exposed to an environment of low pH, low DO, and high Cu^+ and Cu^{2+} concentrations. As a result of the different chemical environments, the two pieces of copper essentially form a battery. In this representation of a pit, an ammeter can be connected between anodic and cathodic samples, and the measured flow of electrons can provide direct insight to the rate of pitting. In practice for a real pipe, it is not possible to measure the flow of electrons through the metal directly, although it is present.

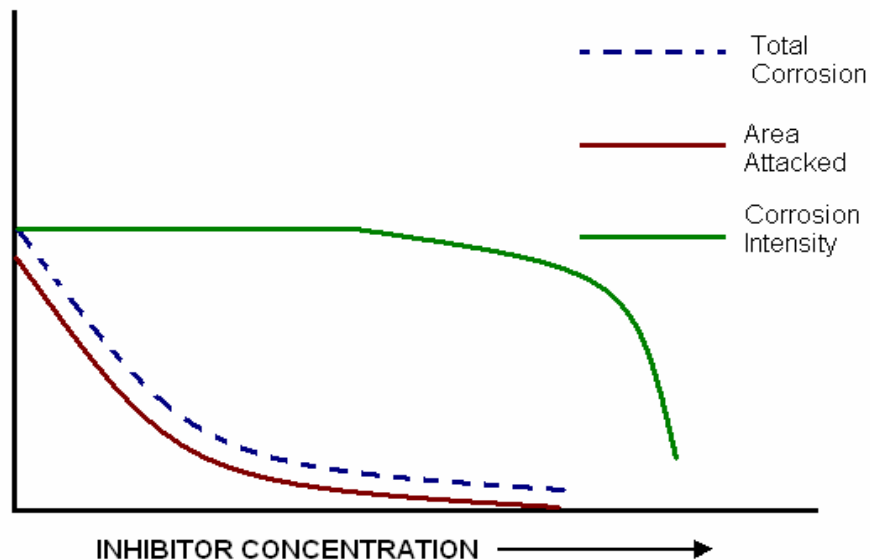
Figure 1-3: Case I - Anodic Control; Anodic Inhibitor

In this case, added inhibitor stifles the attack through an unknown reaction(s) at the anode. For instance, this could occur via orthophosphate addition, if orthophosphate formed an impermeable layer inside the pit or above the tubercle. As the level of inhibitor is progressively increased, more of the pits are affected, and the number of pit sites and anodic area is decreased. The overall amount of corrosion is decreased. Because the reaction is under anodic control, for the pits in which attack is not completely stopped, the intensity of attack will nonetheless decrease. The net result is that for addition of an anodic inhibitor to a situation under anodic control, all aspects of pitting improve with increasing inhibitor concentration. Figure 1-3 illustrates a qualitative plot of how each measure of corrosion is affected as inhibitor dose is increased for this case, with corrosion intensity indicating the rate of attack at the strongest anode in the system.

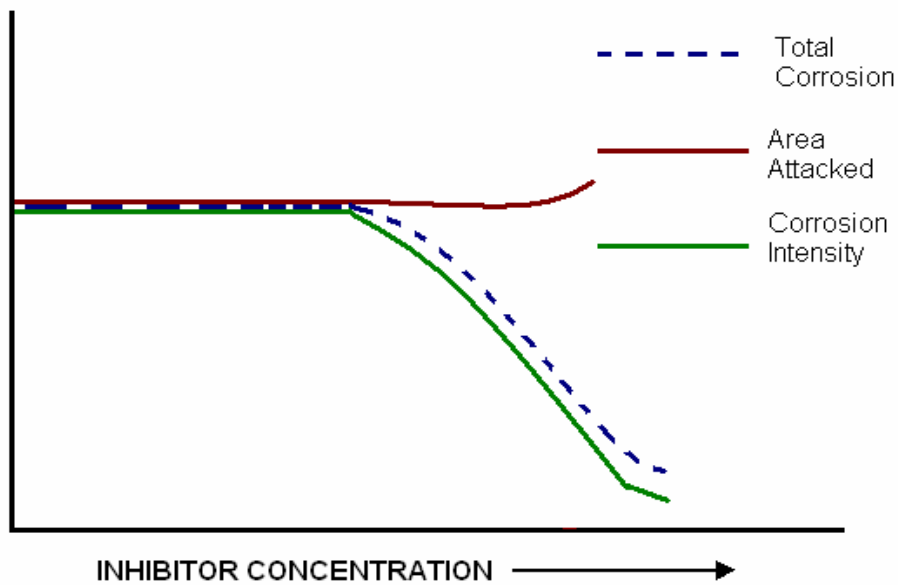
Figure 1-4: Case II - Anodic Control; Cathodic Inhibitor

In this situation, the addition of low levels of cathodic inhibitor will not immediately decrease the total corrosion, but as inhibitor dose is increased a point will eventually be reached at which

cathodic reactions becomes so impeded that the total corrosion will begin to decrease. As the number of cathodic sites or area decreases, if anything, the area subject to anodic attack will increase. The intensity of corrosion at the worst anodes is invariably decreased as the concentration of inhibitor increases. Thus, similar to Case I, addition of a cathodic inhibitor to a situation where pitting is under anodic rate control, is inherently safe and there is no threat of worsening corrosion. Figure 1-4 illustrates a qualitative plot of how each measure of corrosion is affected as inhibitor dose is increased in Case II conditions.

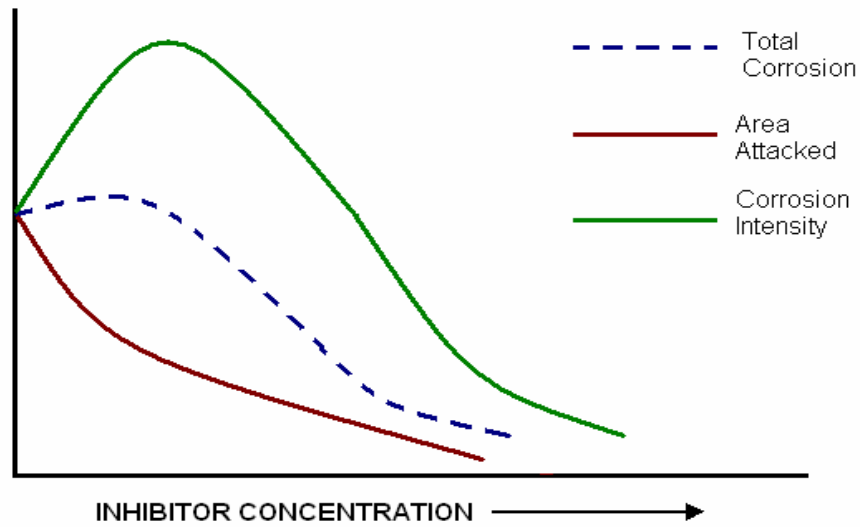
Figure 1-5: Case III - Cathodic Control; Anodic Inhibitor

cathodic control, will decrease the number of pits but will increase the rate of attack at those which remain. Only when a sufficient concentration of inhibitor is added to stop attack at nearly every pit, will benefits of the inhibitor become obvious (Figure 1-5).

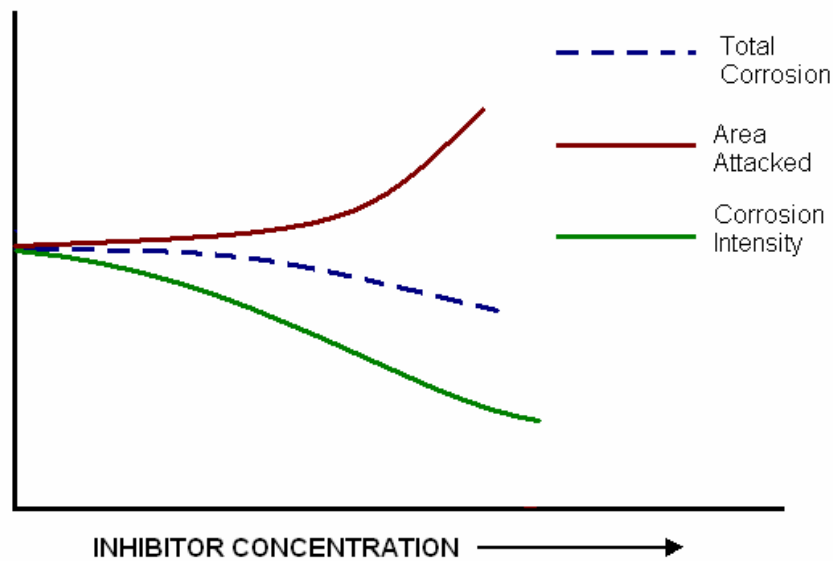
Figure 1-6: Case IV - Cathodic Control; Cathodic Inhibitor

In a corrosion process controlled by the cathodic reaction, the addition of a cathodic inhibitor will steadily decrease the overall rate of attack. Although the area subject to anodic attack will, if anything, slightly increase as seen in Case II, the intensity of attack will decrease steadily. Therefore, for corrosion controlled by the cathodic reaction, the addition of a cathodic inhibitor is a 'safe' approach and usually sufficient for practical purposes (Figure 1-6).

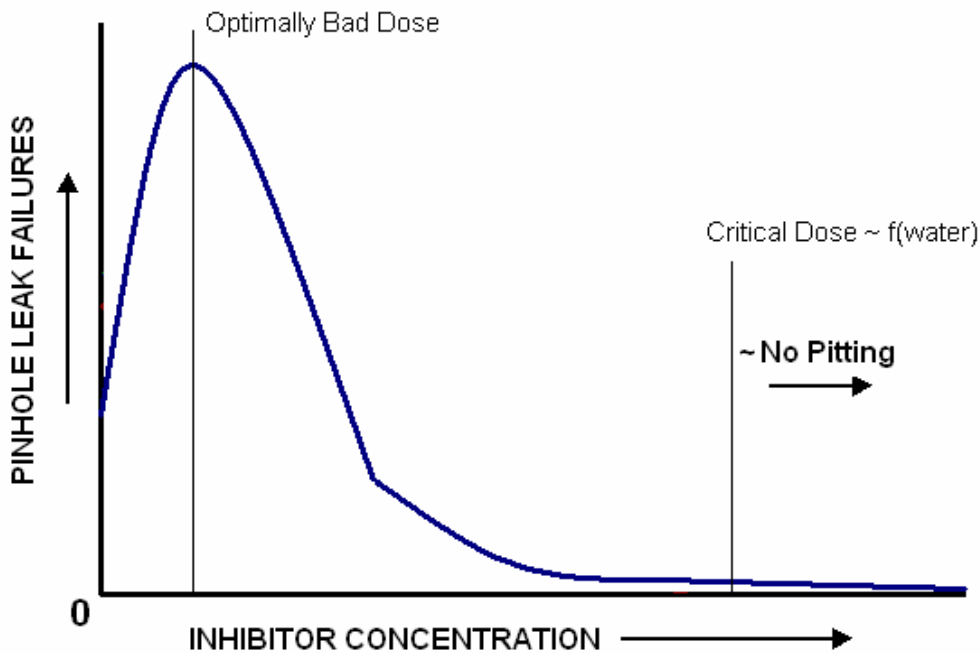
Figure 1-7: Predicted anodic inhibitor response curve for pitting under cathodic control (Sheffer 2006)

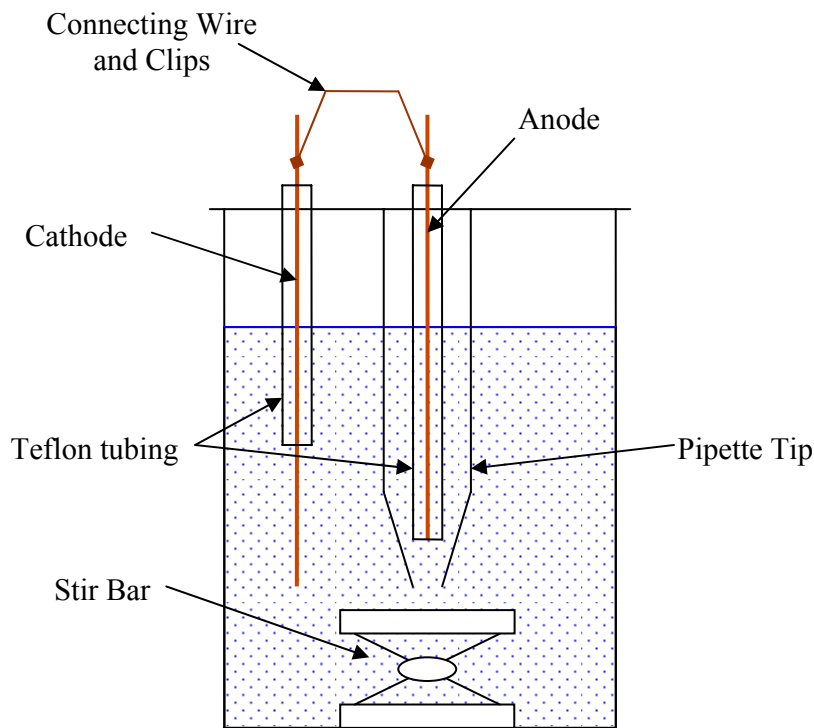
Figure 2-1: Schematic of Experimental Setup

Each test was conducted in 1 liter glass containers, covered with plastic to minimize air exchange, and stirred with a magnetic bar suspended in a plastic cage at 275 revolutions per minute (Figure 2-1 and Figure 2-2).

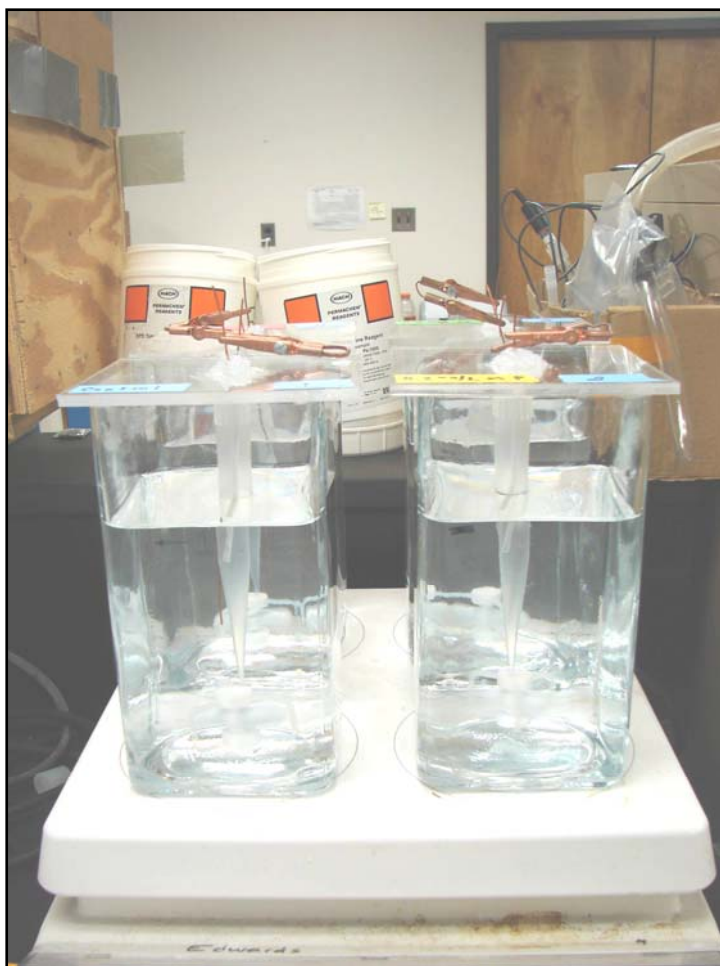
Figure 2-2: Experimental Setup with 4 Test Cells

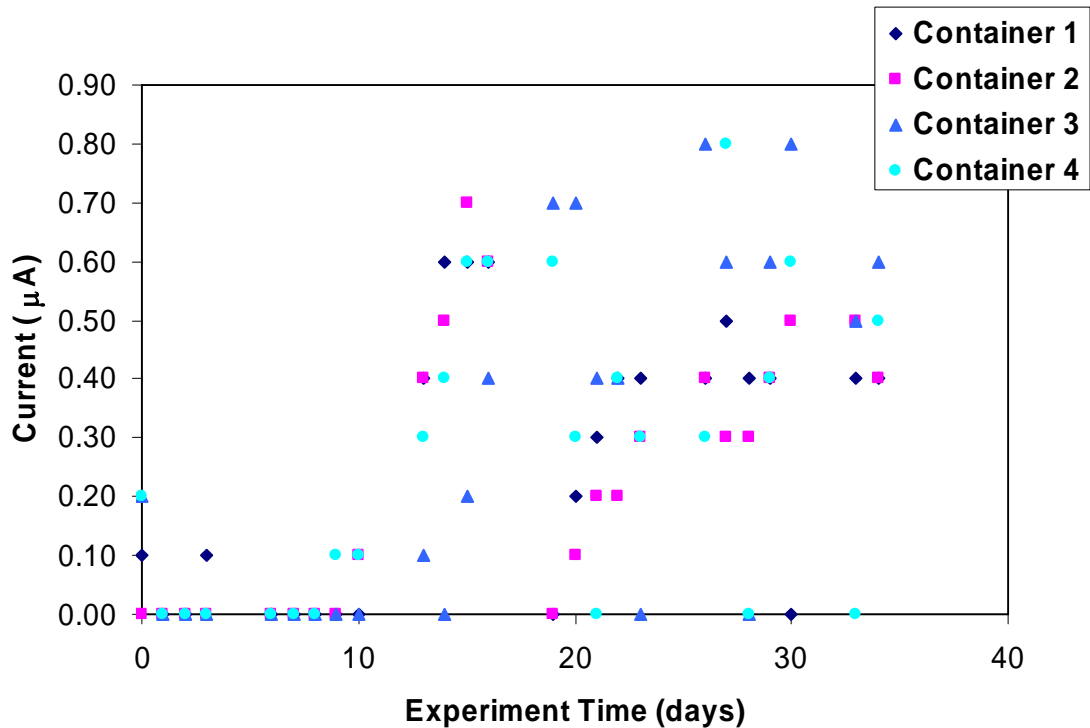
Figure 2-3: Baseline Currents Established before Inhibitor Addition

Typical behavior of the anode and cathode during the initial exposure period when no inhibitor was added, which lasted a minimum of 1 week, is illustrated in Figure 2-3. There is obvious statistical variability between measured currents in the otherwise identical cells in the early phases of an experiment, and indeed, it takes time before a significant pitting current is generated. But after the initial exposure the currents between the different cells rose to within +/- 50% of each other, and the experiment was initiated by dosing inhibitor to the water. Thus, the differential flow of water was successful in initiating non-uniform corrosion in this water.

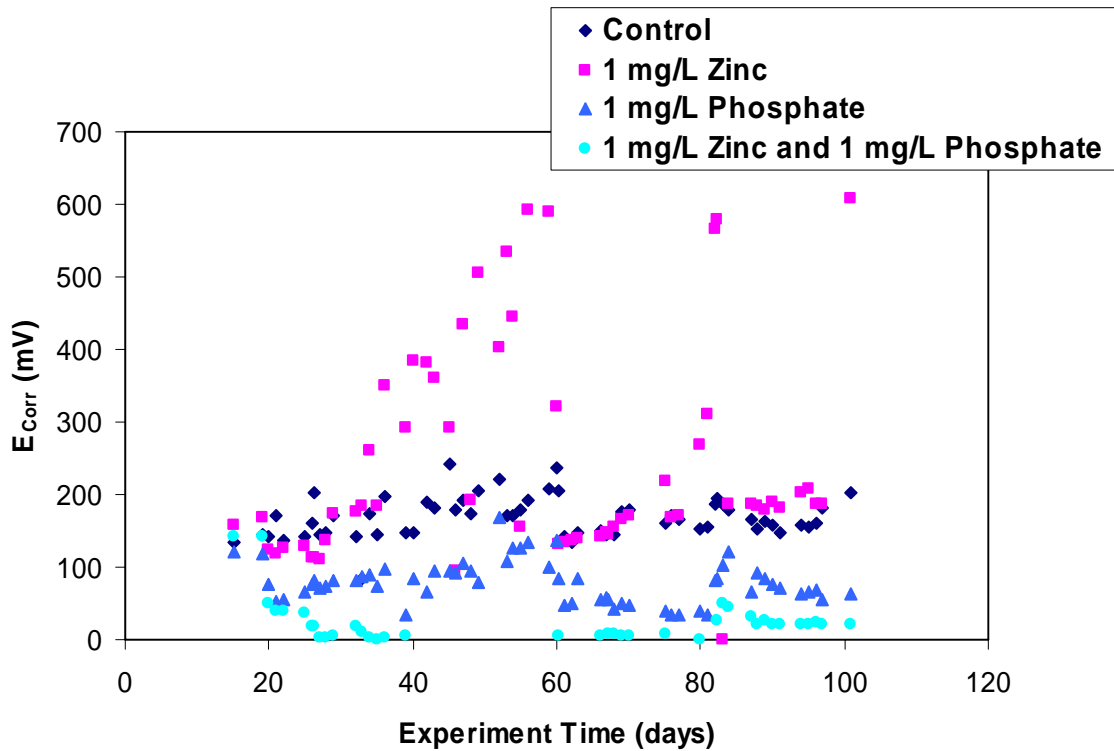
Figure 2-4: E_{Corr} Measurements for Zinc, Phosphate, and Zinc Phosphate Inhibitors

dosed with orthophosphate. Although the system dosed with zinc orthophosphate had the second highest E_{Corr} before adding the inhibitor, within 9 days it became the lowest and remained the lowest for the rest of the experiment. As a general rule, lower or more stable E_{Corr} is thought to be indicative of reduced pitting tendencies. In a normal situation on a pipe, it is not possible to measure ΔV and pitting current, but the divided cell apparatus allowed these measurements.

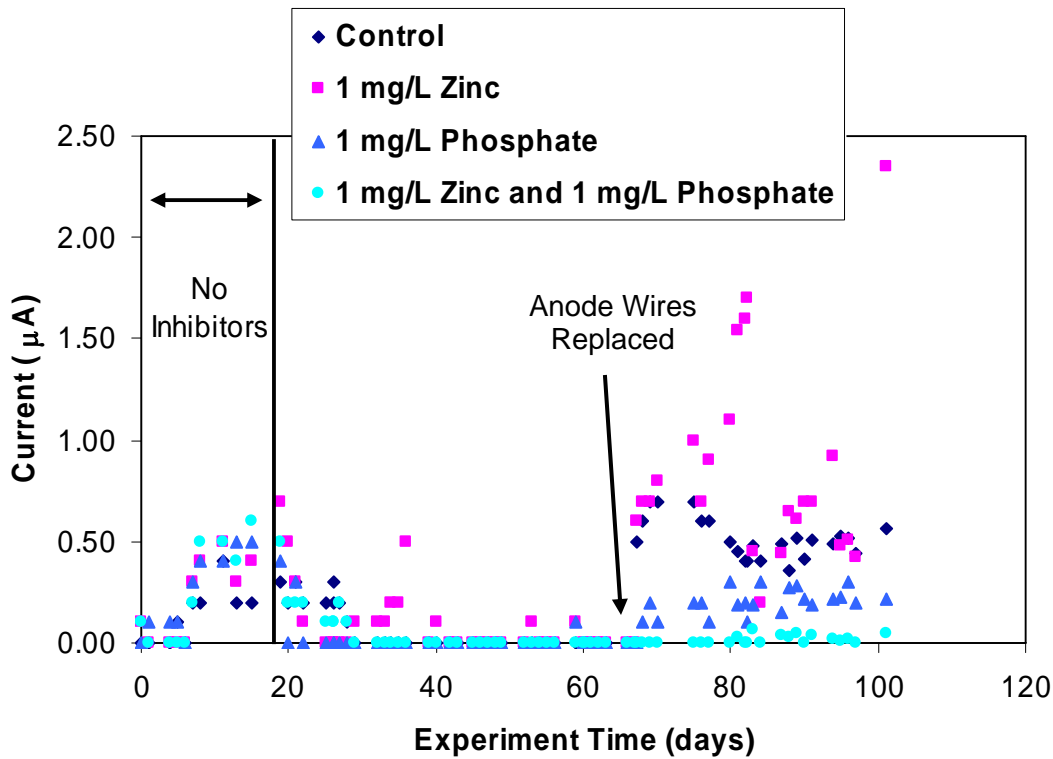
Figure 2-5: Pitting Currents for Zinc, Phosphate, and Zinc Phosphate Inhibitors

The anodes in the apparatus were replaced with new wires on day 67. This differed from the earlier approach in which pitting was established on the wires before exposure to the inhibitors. As before, pitting currents gradually developed on the wires after a period of time, in all cases except for the zinc phosphate. Thus, zinc phosphate had unique benefits in both speed of stopping established pitting currents and also in preventing new currents from arising when clean copper anode wires were added to the system.

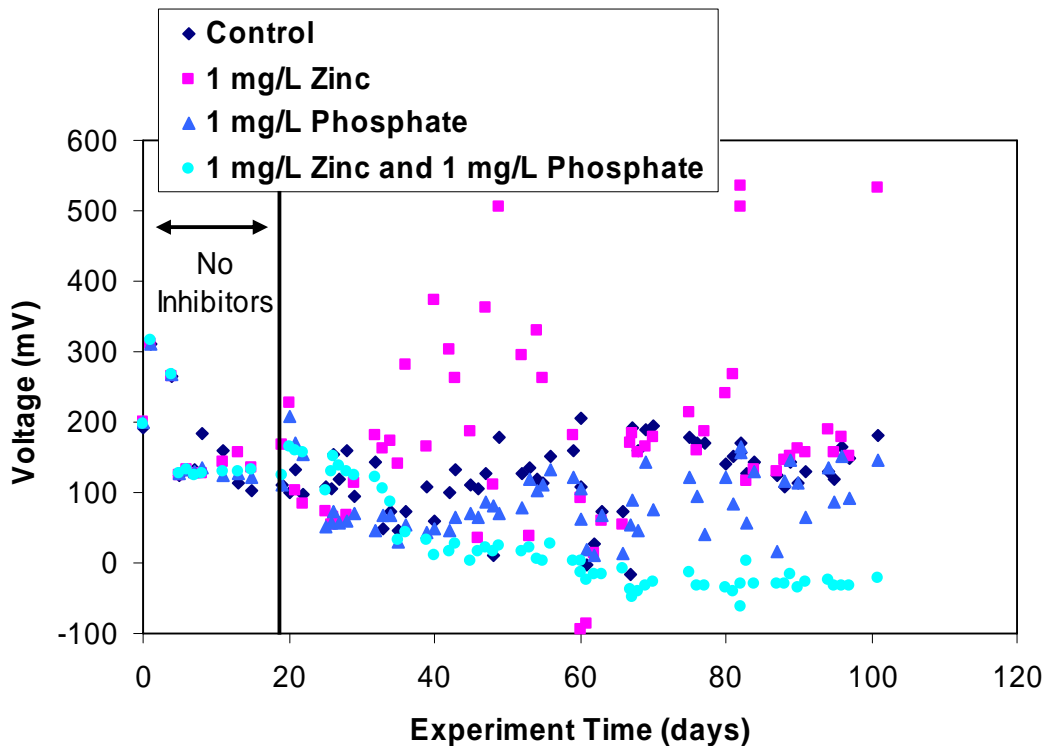
Figure 2-6: Voltages for Zinc, Phosphate, and Zinc Phosphate Inhibitors

The voltage between the anode and cathode for the phosphate, the control and the zinc all show relatively stable or upward trends, with the largest uptrend in the water with only zinc (Figure 2-6). The zinc voltage difference between the anode and cathode reached above 0.5 V. The water modified with phosphate had similar voltage drops relative to the control. The voltage drop in the system with zinc and phosphate, not only decreased, but eventually resulted in negative values. The negative sign indicates that the direction of the flow of electrons reversed, and the portion of the copper that was once anodic and was being sacrificed, was actually being protected. This is a unique advantage of zinc phosphate relative to other inhibitors in this system, and this tendency has also been observed previously in field studies.

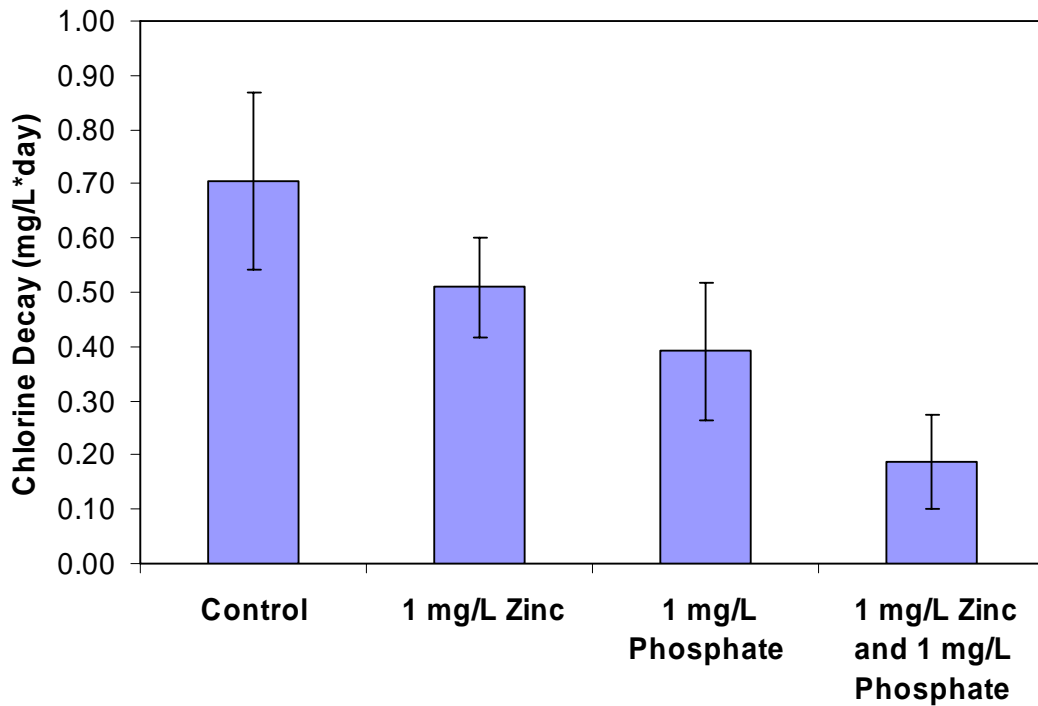
Figure 2-7: Chlorine Decay for Zinc, Phosphate, and Zinc Phosphate Inhibitors

zinc was used in combination with phosphate. This corresponds to earlier trends noting a unique benefit from the combination of zinc and phosphate, although it is not clear whether the benefit is additive or synergistic.

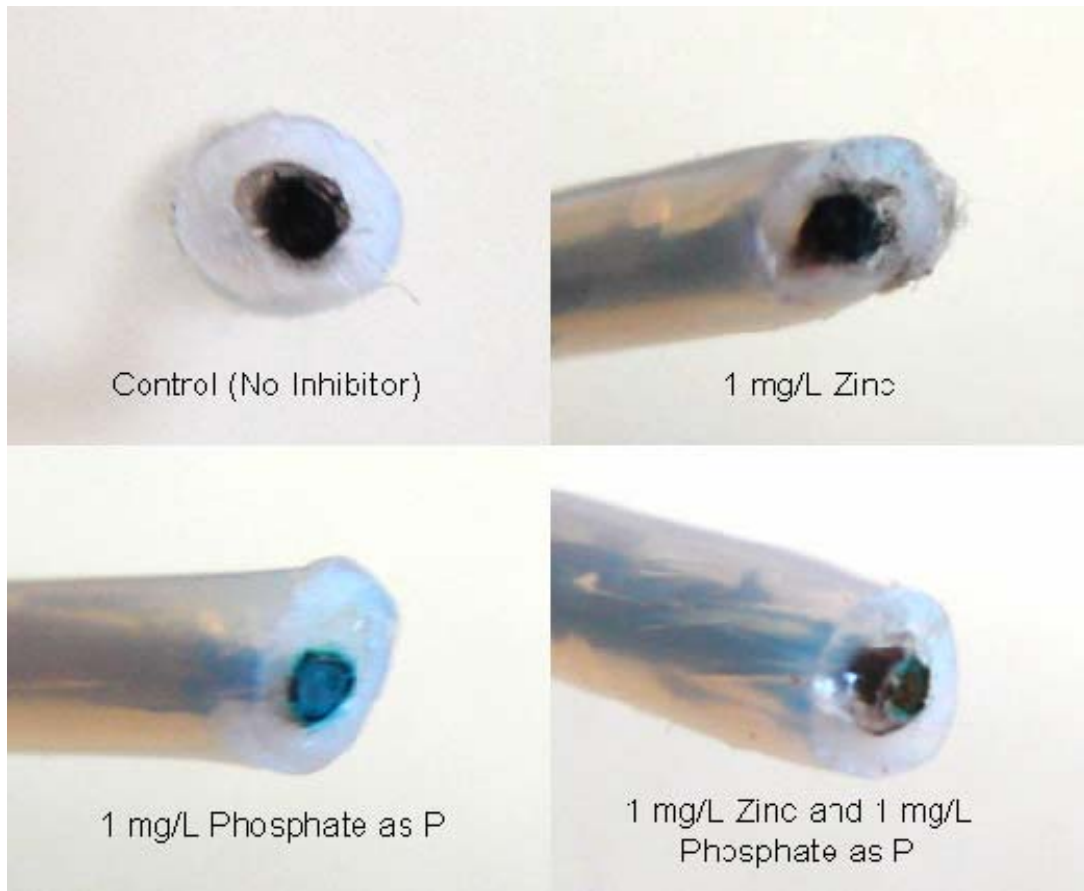
Figure 2-8: Scale on Pit Wires Removed from the Experiment

Midway through the experiment, the anode wires were removed and photographed (Figure 2-8). Both the control and the condition with only zinc showed a black scale on the anode, which is consistent with anodic deposits observed by Marshall over pits (2004). The condition with phosphate had a green scale similar to that observed by Marshall on pipes exposed to phosphate in this water type. Finally, the condition with both zinc and phosphate had little to no noticeable buildup of deposits.

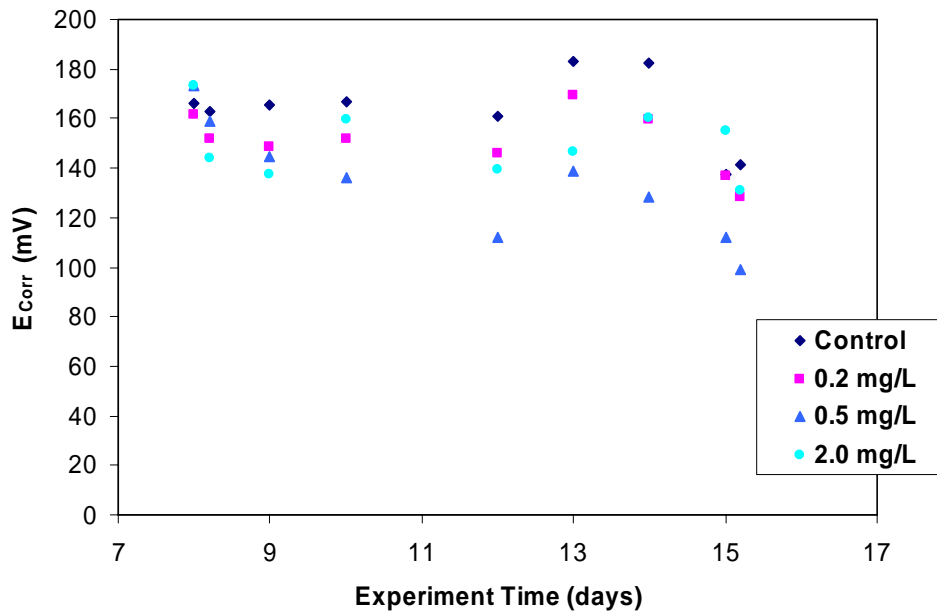
Figure 2-9: E_{Corr} Measurements for Phosphate Inhibitors at a pH of 9.2

concentration, 2.0 mg/L, had a more variable trend, but was consistently below the control. The greatest reduction in E_{Corr} arose from a dose of 0.5 mg/L $\text{PO}_4\text{-P}$.

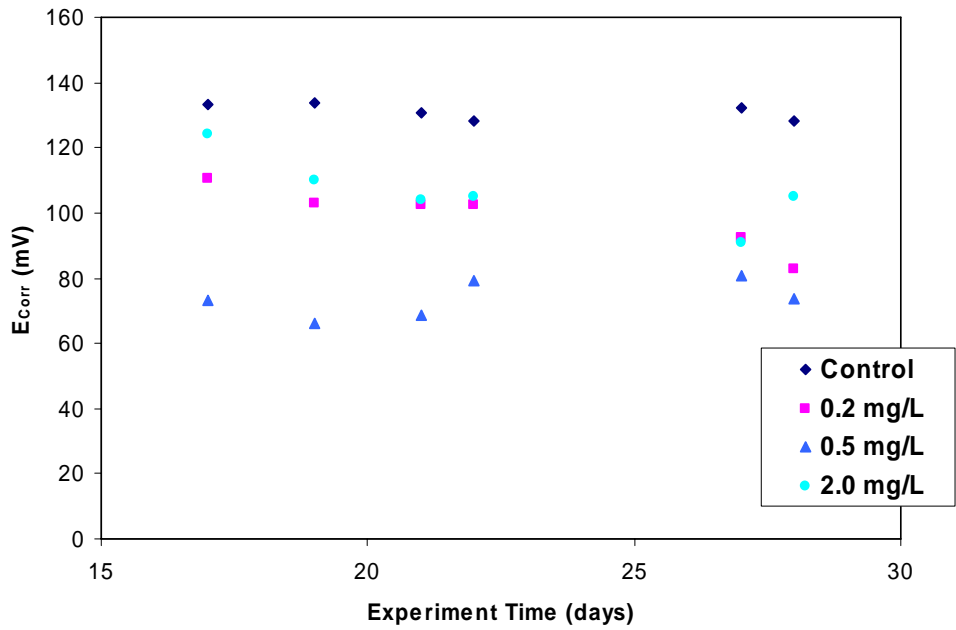
Figure 2-10: E_{corr} Measurements for Phosphate Inhibitors at a pH of 8.2

When the pH was dropped to pH 8.2 (Figure 2-10), the same trend was observed amongst the four conditions. E_{Corr} dropped overall relative to what was observed at pH 9.2, consistent with expectations based on Rushing et al. (2004) and Marshall (2004) regarding reduced pitting at lower pH in this water.

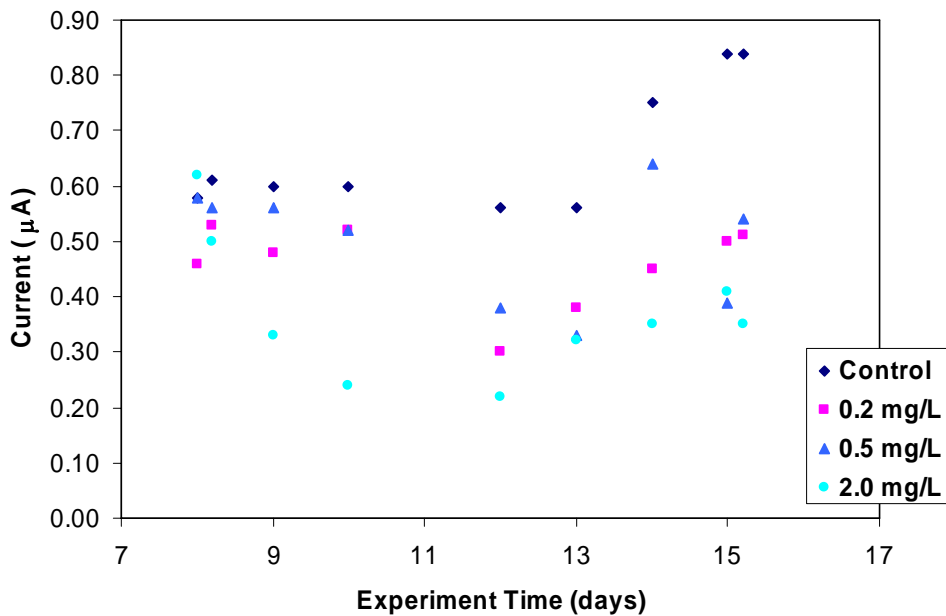
Figure 2-11: Pitting Currents for Phosphate Inhibitors at a pH of 9.2

The pitting currents at pH 9.2 were always lower in the presence of phosphate (Figure 2-11), consistent with expectations based on E_{corr}. The lowest pitting currents were measured at the highest phosphate dose.

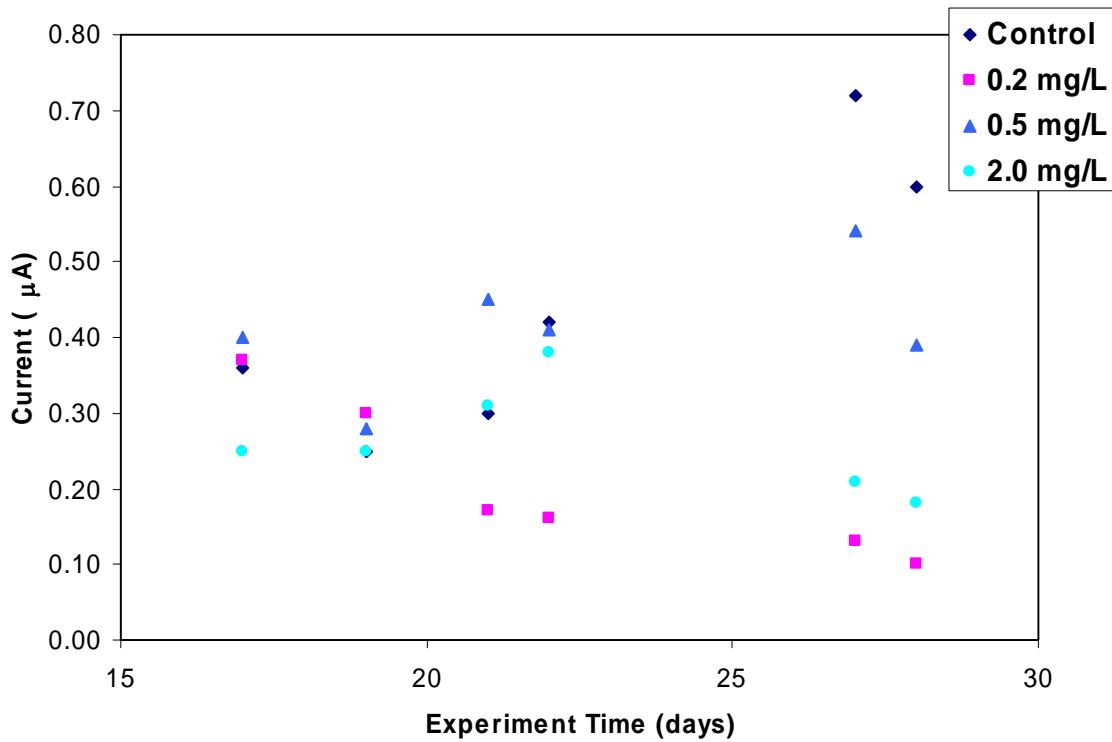
Figure 2-12: Pitting Currents for Phosphate Inhibitors at a pH of 8.2

Immediately after the pH was lowered to 8.2, the only clear trend in pitting current was a decrease observed at the lowest concentration of 0.2 mg/L (Figure 2-12). The initially large amount of scatter may have resulted from a water change which occurred on day 15 of the experiment. Once the values began to stabilize, all the concentrations resulted in values below the control with 0.5 mg/L having values closest to the control.

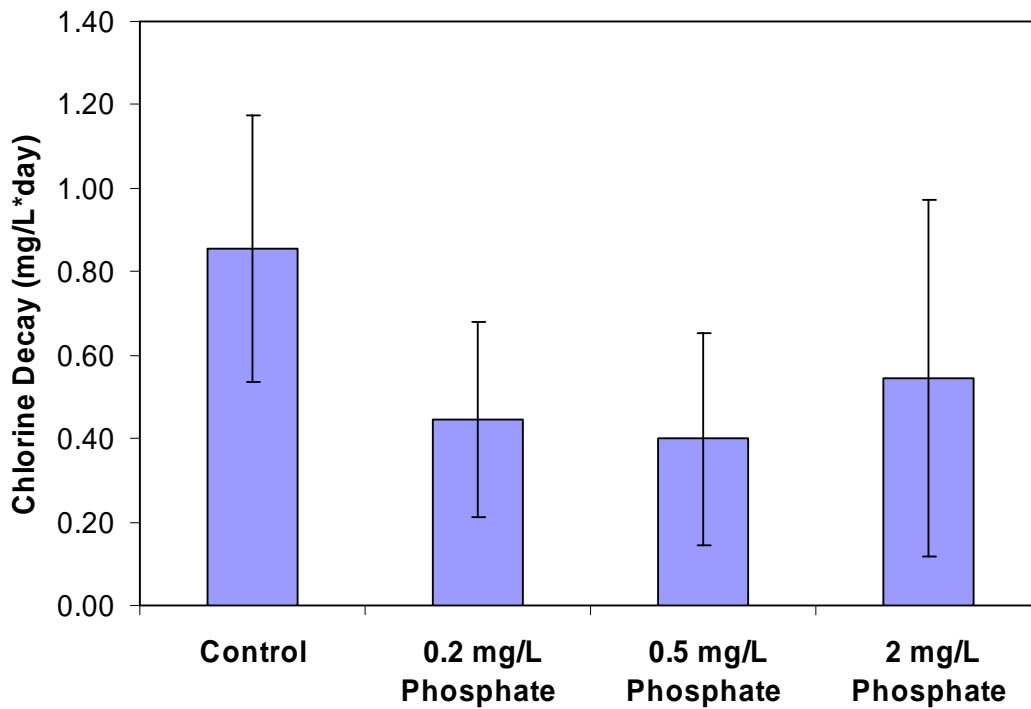
Figure 2-13: Chlorine Decay for Various Concentrations of Phosphate (in mg/L as P)

Although average chlorine decay rates decreased at all concentrations of phosphate tested, these trends were not statistically significant (Figure 2-13). The large amount of scatter, as seen by the error bars, was due to the limited number of data points collected in this very short term test.

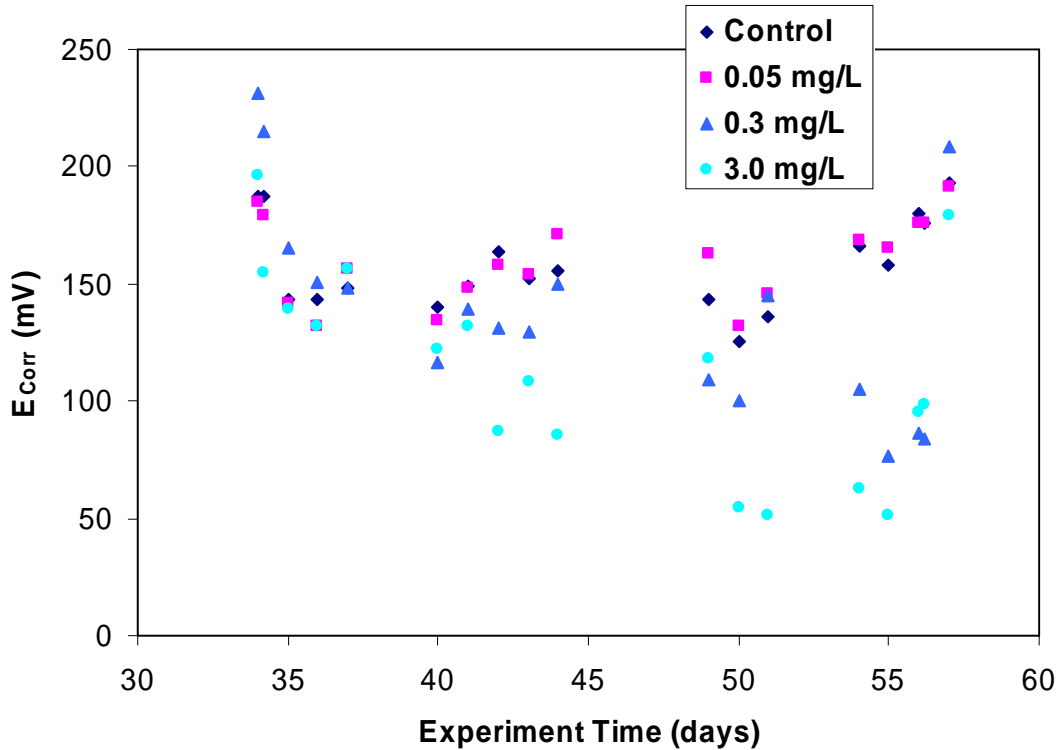
Figure 2-14: E_{Corr} Measurements for NOM Inhibitors at a pH of 9.2

Although there was much scatter in the data at a pH of 9.2, the highest concentration of 3.0 mg/L NOM had E_{Corr} values consistently lower than the control or the concentrations of 0.05 and 0.3 mg/L NOM (Figure 2-14). This suggests that higher levels of NOM in the water could help reduce pitting tendencies. The lowest concentration of 0.05 mg/L followed very closely with the control signifying that this concentration was too low to obtain the desired reduction in corrosion rates. The middle concentration of 0.3 mg/L had a slight downward trend, but occasionally had E_{Corr} values above the control which implies a variable effect.

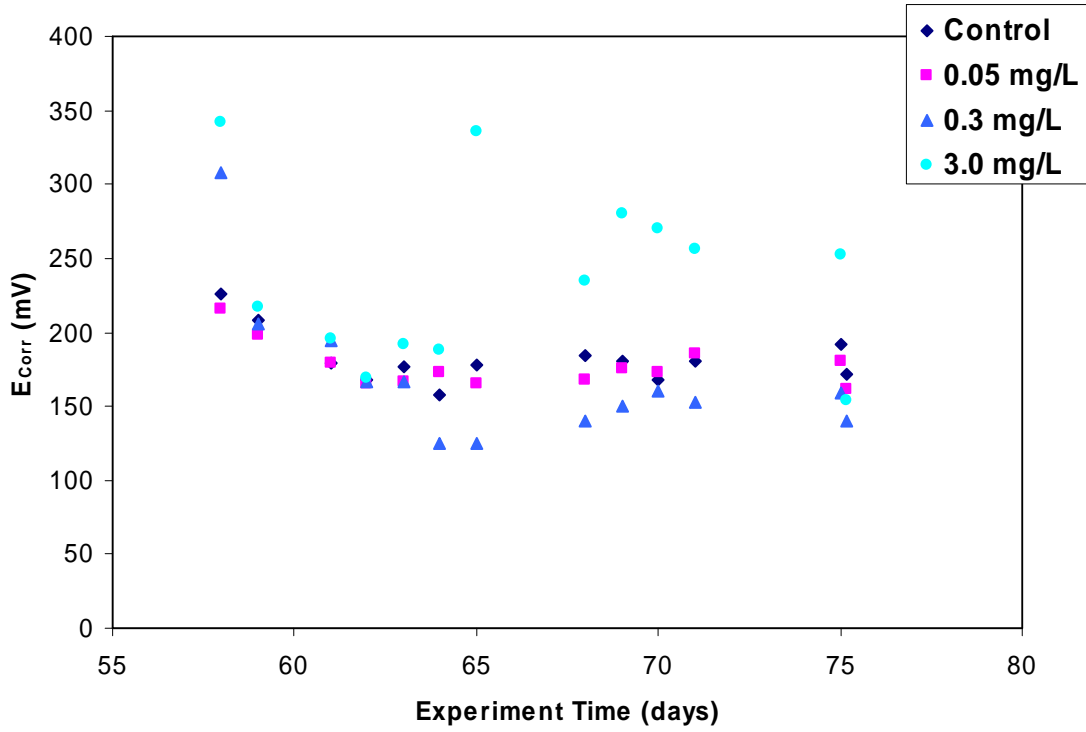
Figure 2-15: E_{Corr} Measurements for NOM Inhibitors at a pH of 8.2

A drop to a pH of 8.2 reversed some of the effects seen above (Figure 2-15). The lowest concentration still appeared to be too low to produce a significant difference from the control. However, the 3.0 mg/L had E_{Corr} values above the control in this very short term test while the 0.3 mg/L had a downward trend that fell slightly below the control. The trends continued to diverge when the pH was dropped even further to 7.2 (Figure 2-16). Here, both E_{Corr} values for the 0.3 and 3.0 mg/L, while having some scatter, were higher than the control. According to traditional interpretations of E_{Corr} , this would indicate that at a pH of 7.2 NOM does not act as an inhibitor.

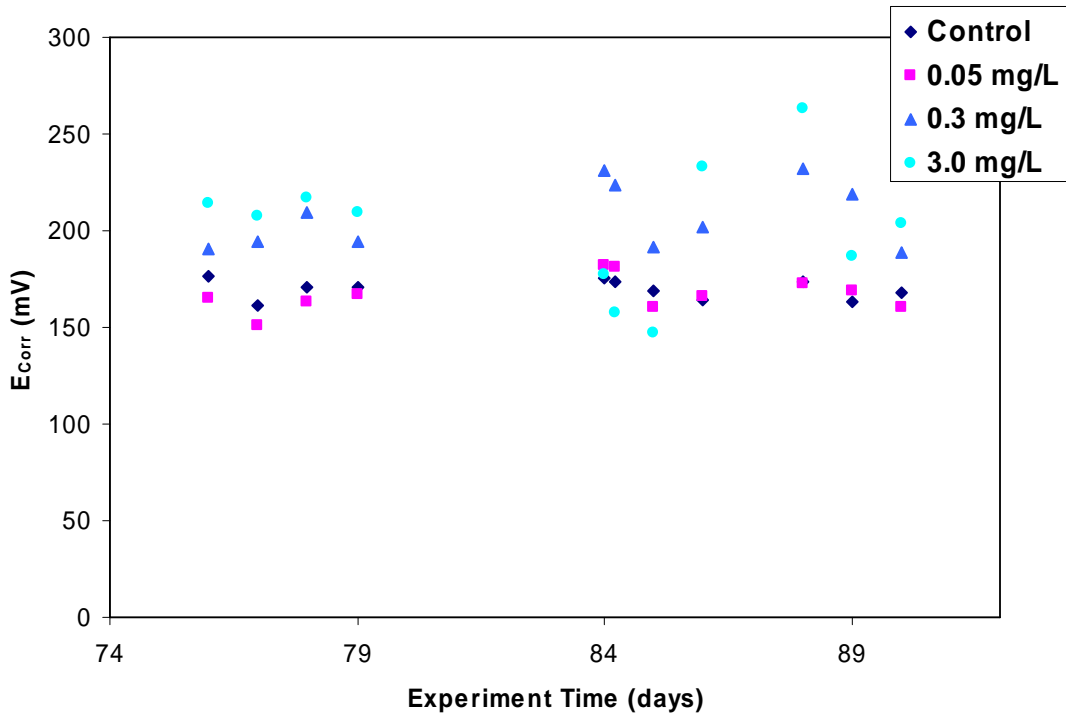
Figure 2-16: E_{Corr} Measurements for NOM Inhibitors at a pH of 7.2

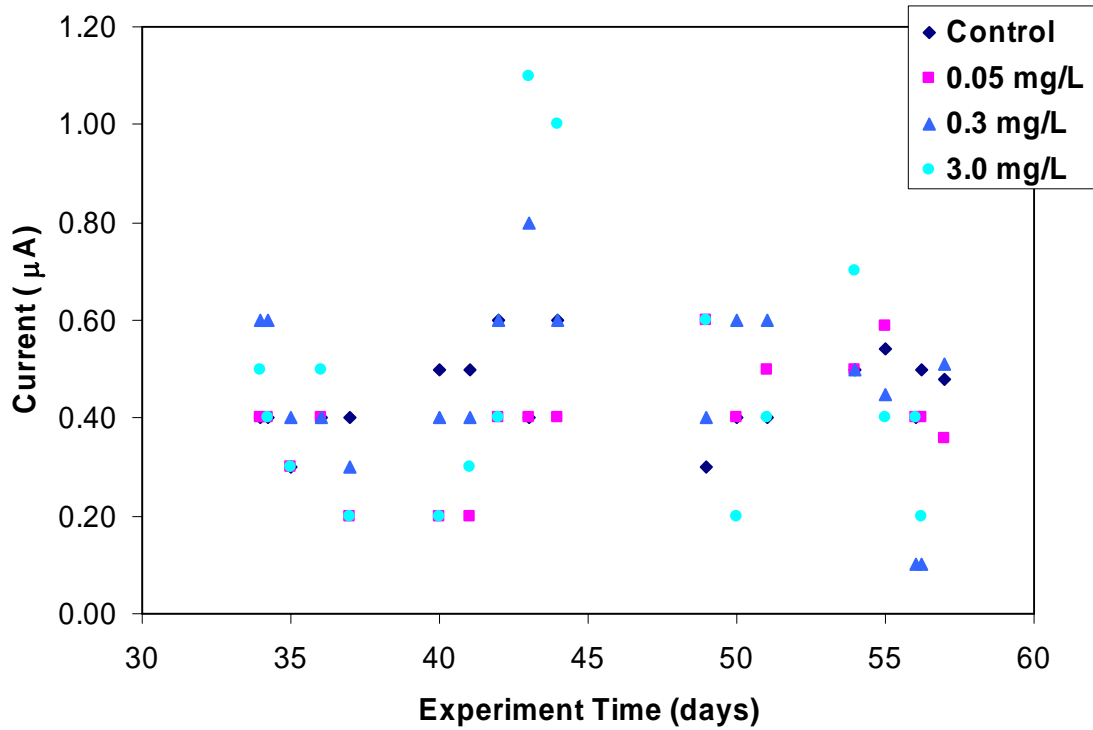
Figure 2-17: Pitting Currents for NOM Inhibitors at a pH of 9.2

Trends in the pitting current data in the presence of NOM at pH 9.2, pH 8.2 and pH 7.2 had too much scatter to allow clear conclusions to be drawn (Figure 2-17, Figure 2-18, and Figure 2-19). Overall, for this particular water, differences in NOM concentration did not have a strong influence on pitting.

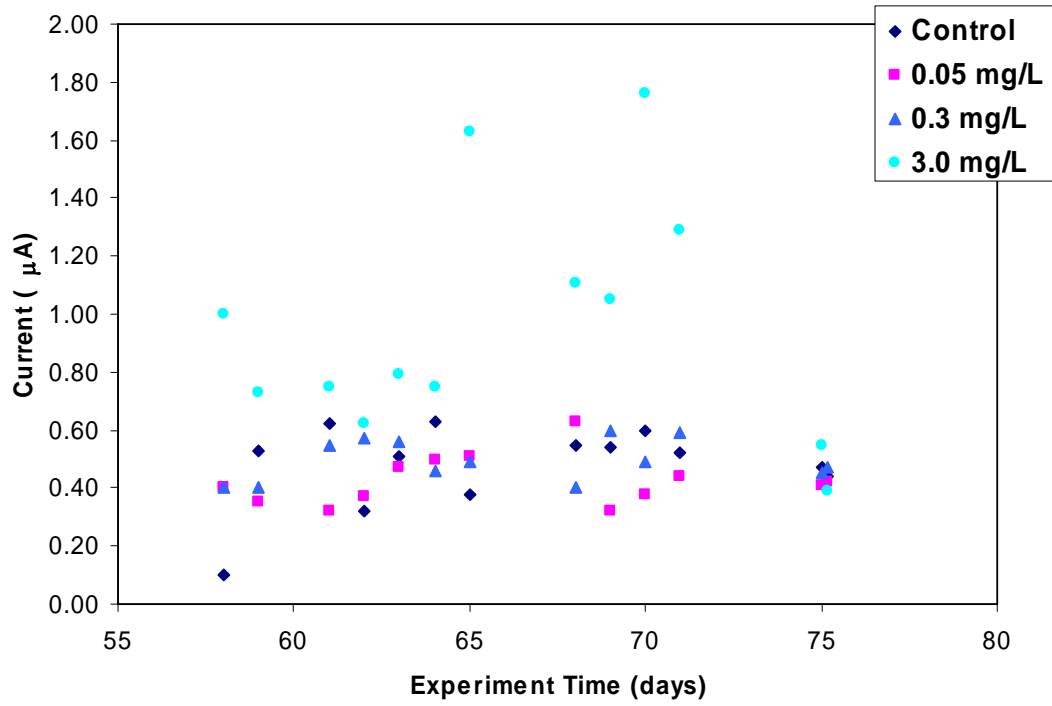
Figure 2-18: Pitting Currents for NOM Inhibitors at a pH of 8.2

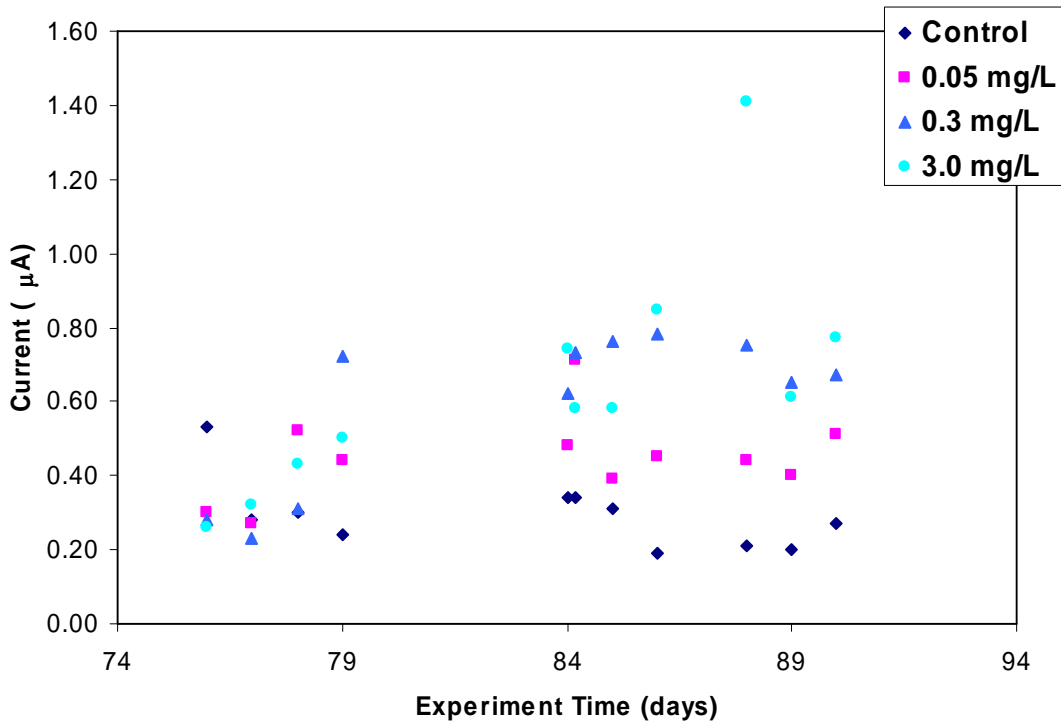
Figure 2-19: Pitting Currents for NOM Inhibitors at a pH of 7.2

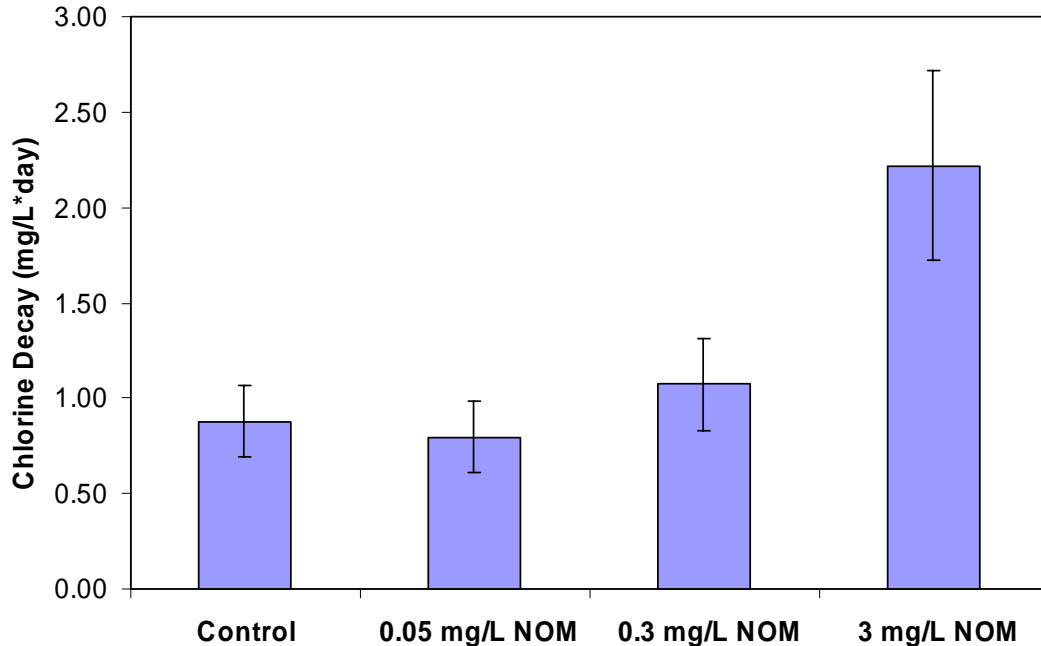
Figure 2-20: Chlorine Decay for Various Concentrations of NOM

Chlorine decay rates for NOM resulted in opposite trends than those observed for the zinc or phosphate conditions (Figure 2-20). The chlorine decay generally increased with concentration of NOM, perhaps because the natural organic matter itself has a chlorine demand. Therefore, the higher chlorine demand in the presence of NOM does not imply a higher rate of corrosion. Also, there is no statistical difference in chlorine decay between the lower concentrations of 0.05 and 0.3 mg/L and the control as indicated by the overlap in the error bars.

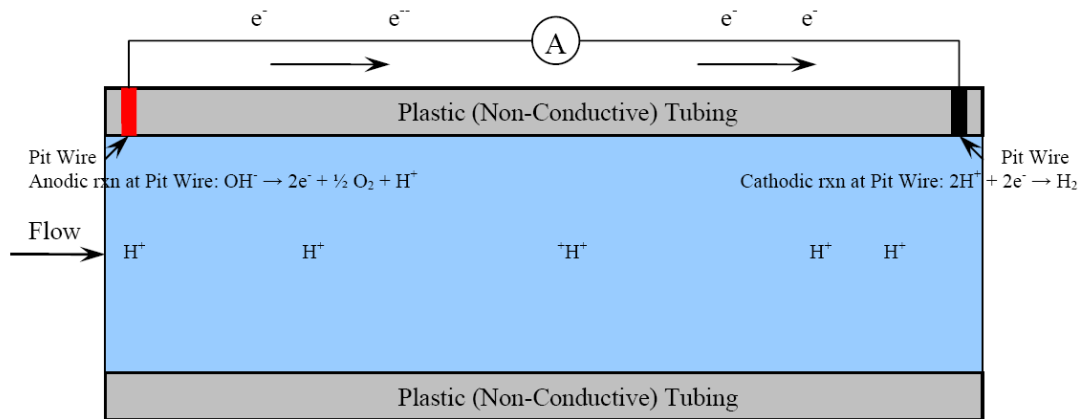
Figure 3-2: Streaming current schematic, section through pipe along flow (no O_2 or Cu)

If an ammeter is used to connect two noble metal wires along the pipe length such as platinum or gold and if the flow and surface charge are high enough to induce sufficient potential, a current can also be measured (Figure 3-2). The electron flow through the ammeter tends to reduce the voltage drop per unit length of pipe. The upstream noble metal wire becomes the anode where O_2 is created, whereas the downstream wire becomes the cathode where H_2 gas is evolved.

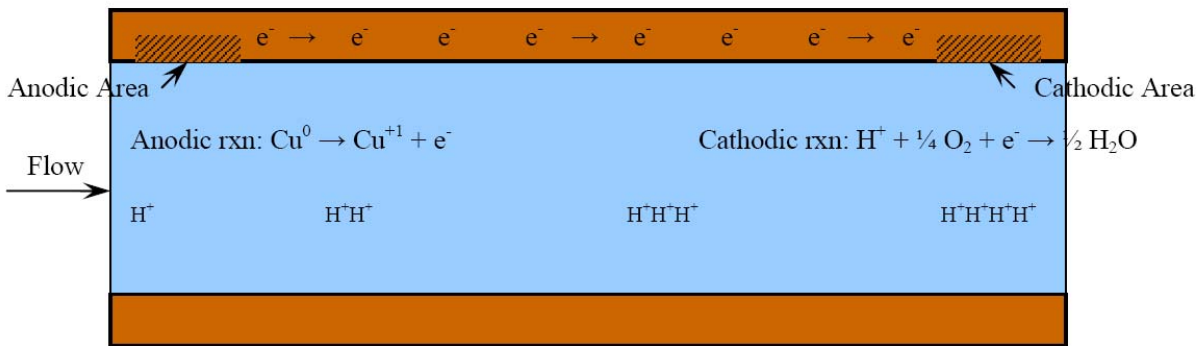
Figure 3-4: Conceptualization of electron flow through copper pipe that has a fixed negative surface charge, net excess streaming current of positive charge, and separation of anode and cathode along the pipe length.

Expanding this thought, if the plastic tube was replaced by a copper tube that has high conductivity, an alternative electron path exists through the metal. In such situations, the portion of the tube that first encounters flow is the site of anodic activity, whereas the downstream section of the tube becomes a site of excess cathodic activity (Figure 3-4).
