NON-UNIFORM COPPER CORROSION IN POTABLE WATER: THEORY AND PRACTICE

Thesis submitted to the Faculty of the
Virginia Polytechnic Institute and State University
In partial fulfillment of the requirements for the degree of

Master of Science
in
Environmental Engineering

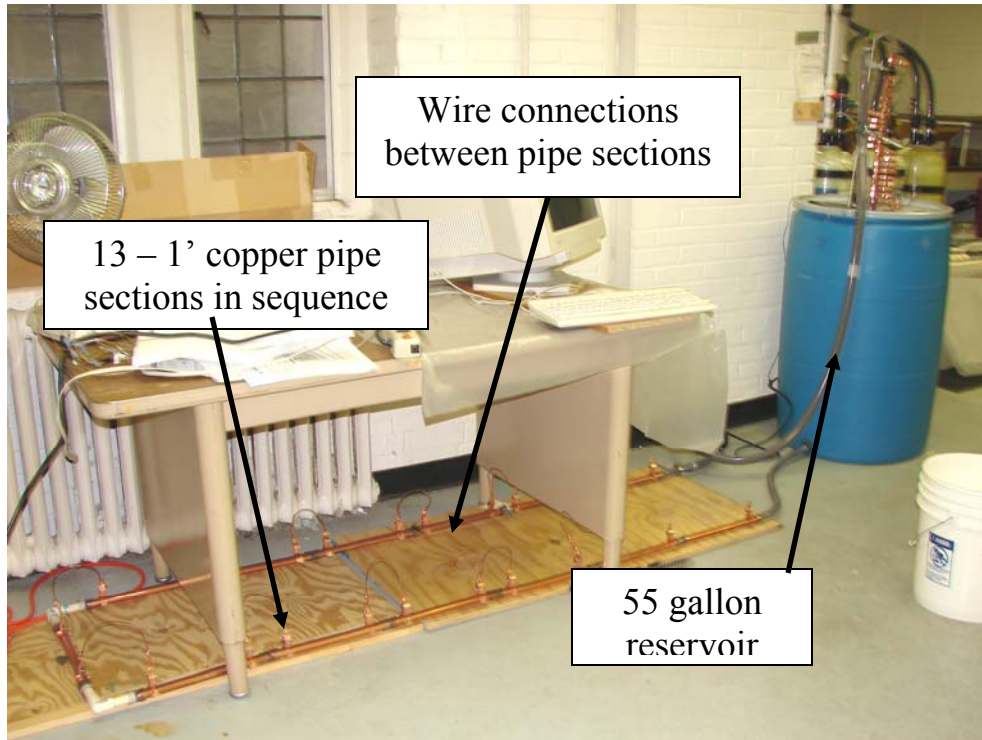
Figure 3-5: Setup of Large Scale Experiment to Test Inhibitors

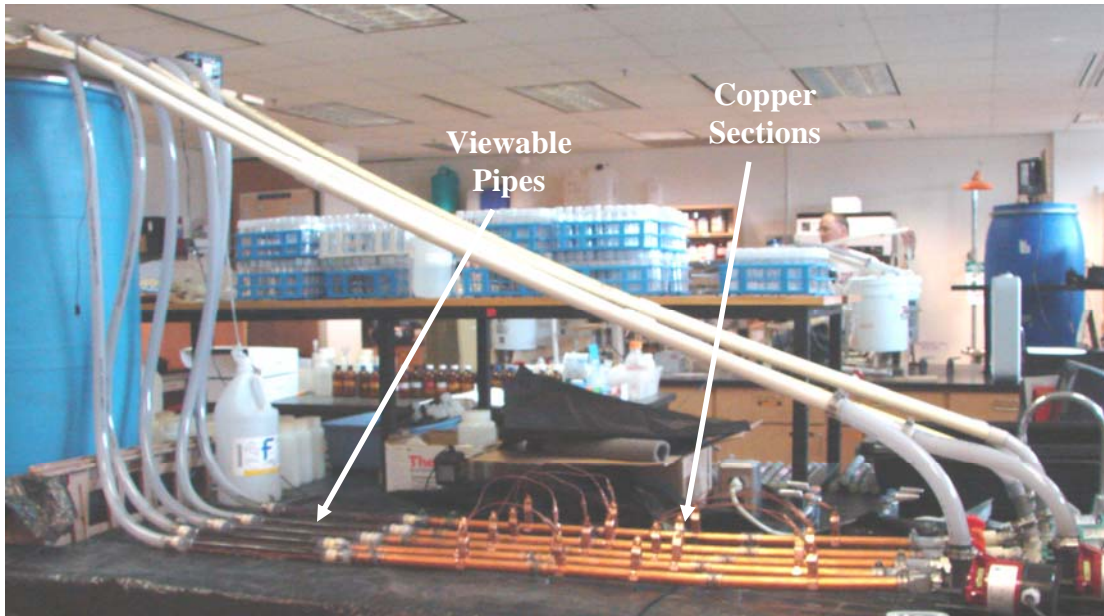
Figure 3-6: Experimental Setup

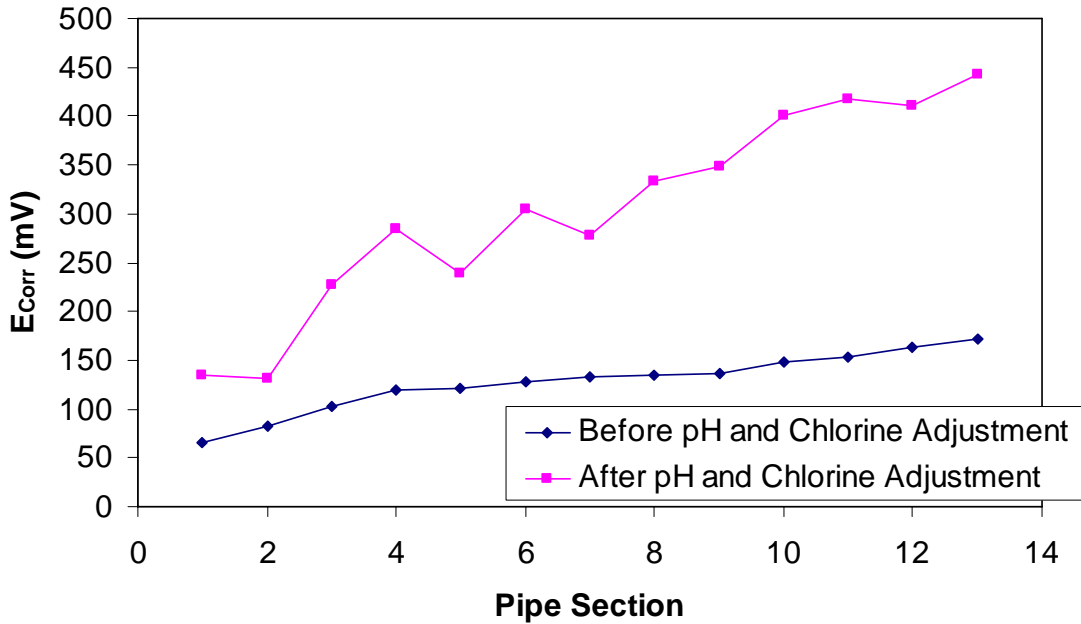
Figure 3-7: Profile of E_{Corr} Measurements before and after the Adjustment of pH and Chlorine

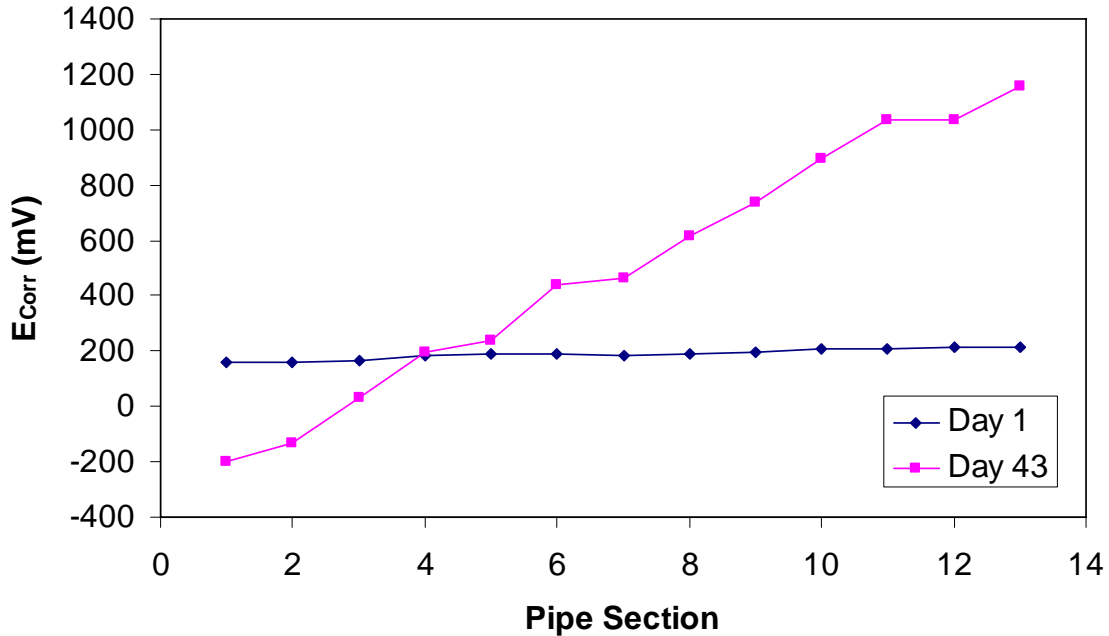
Figure 3-8: Profile of E_{Corr} Measurements on Days 1 and 43

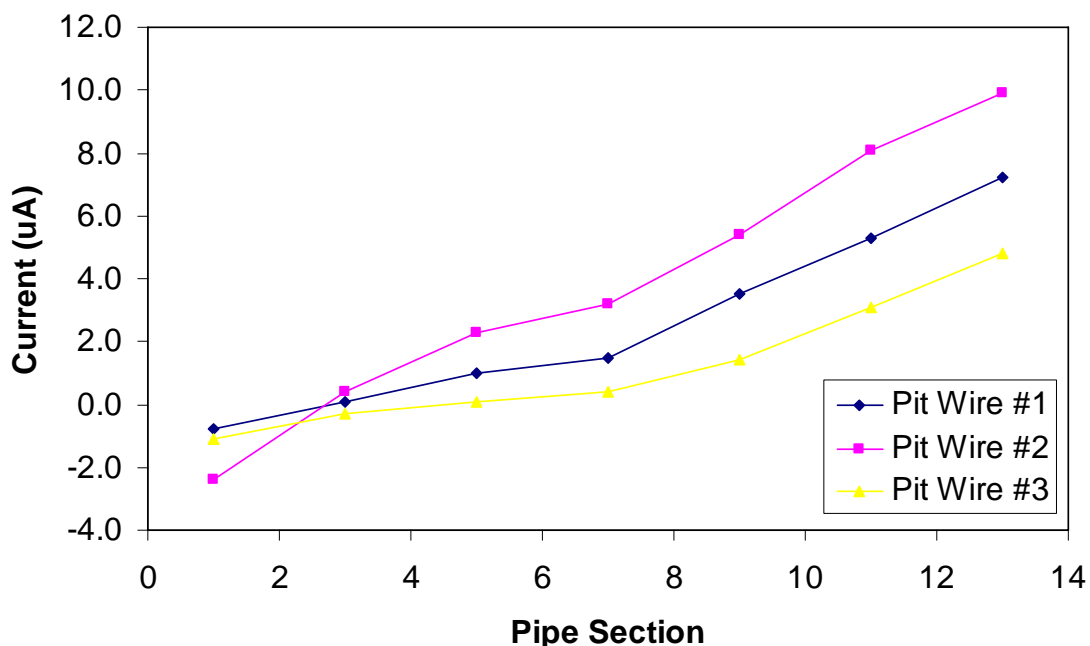
Figure 3-9: Profile of Currents between a Pit Wire and Each Successive Pipe Section

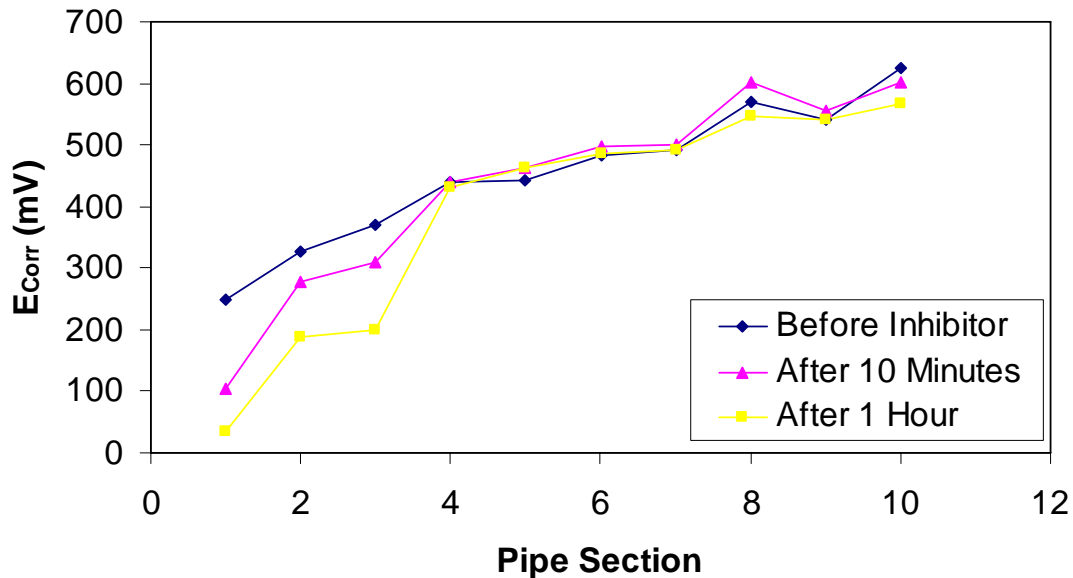
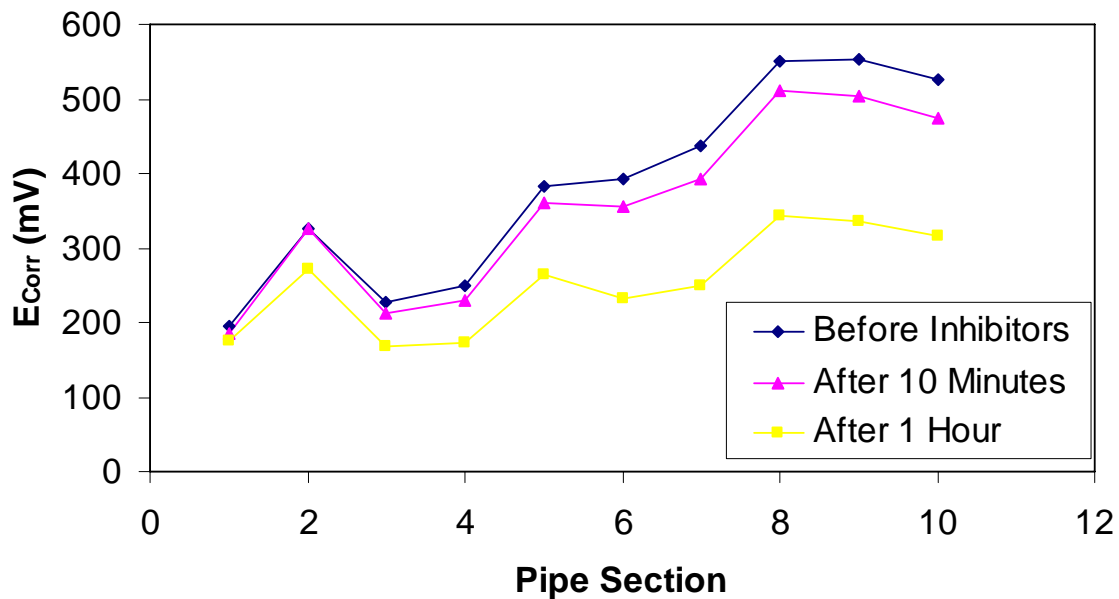
Addition of 1.0 mg/L Phosphate

Addition of 1.0 mg/L Phosphate and 0.5 mg/L Zinc

Figure 3-10: Profile of E_{Corr} Measurements before and after the Addition of Inhibitors

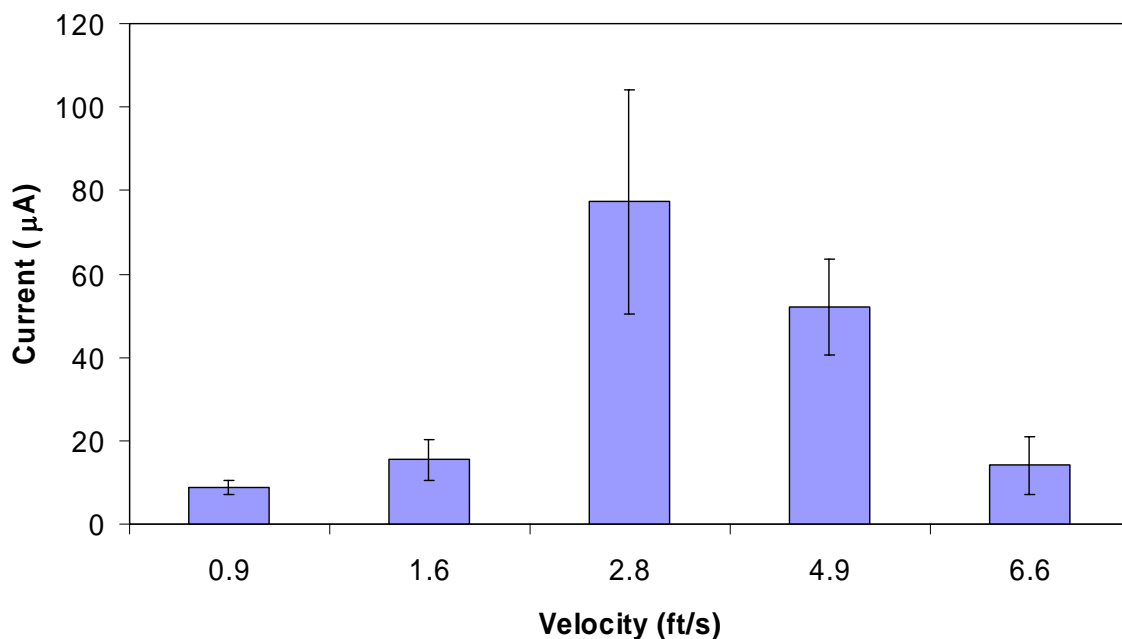
Figure 3-12: Average Currents Measured between the Coupon and Pipes A, B and C Connected

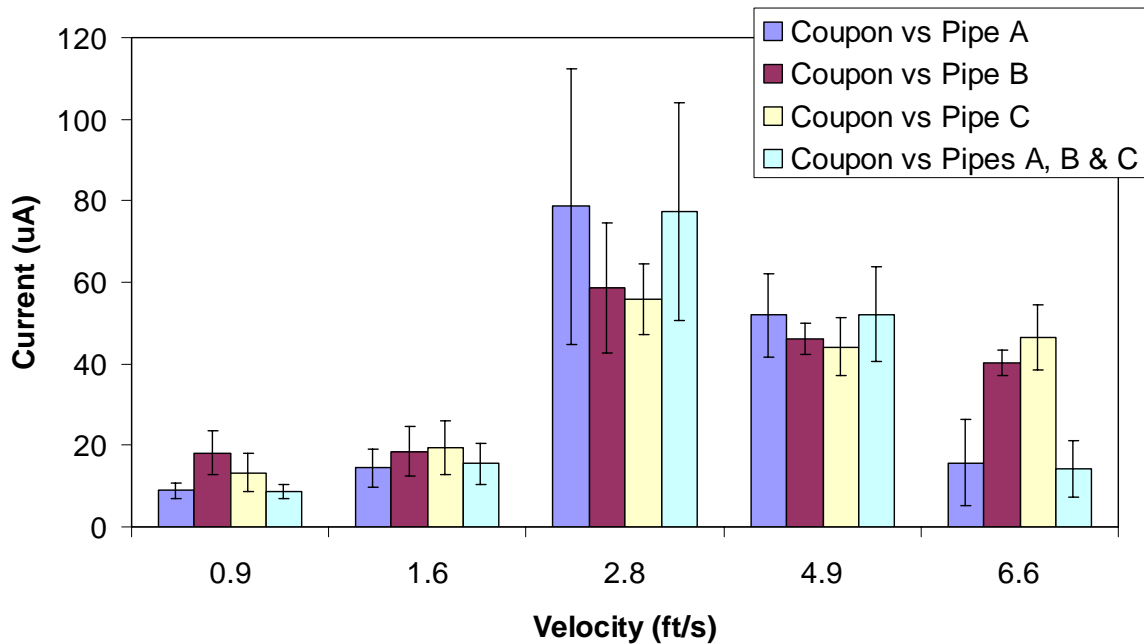
Figure 3-13: Average Currents Measured between the Coupon and Various Pipe Sections

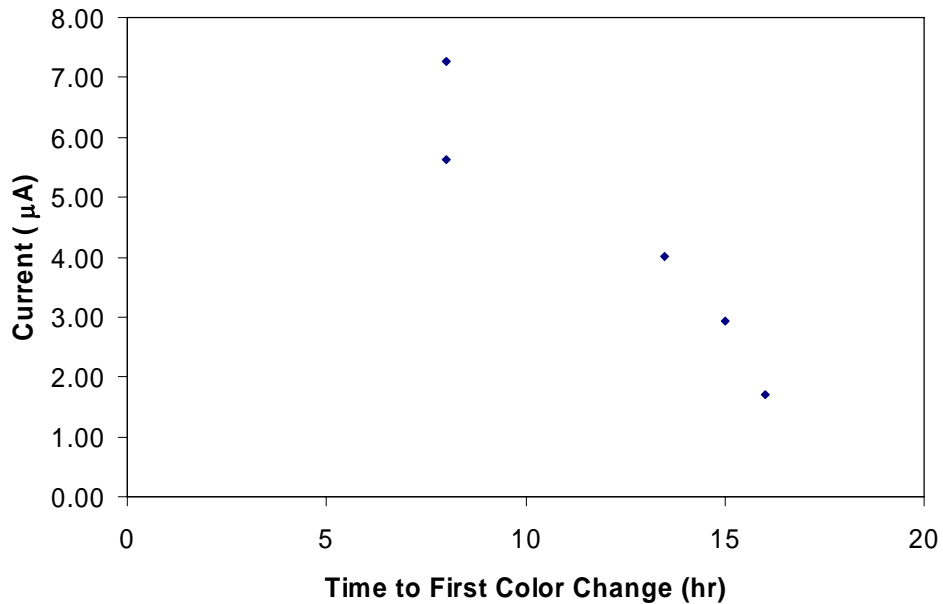
Figure 3-14: Relationship between Current (Measured between Viewable Pipe and Pipe C) and Time to First Observable Color Change in Viewable Pipe Sections

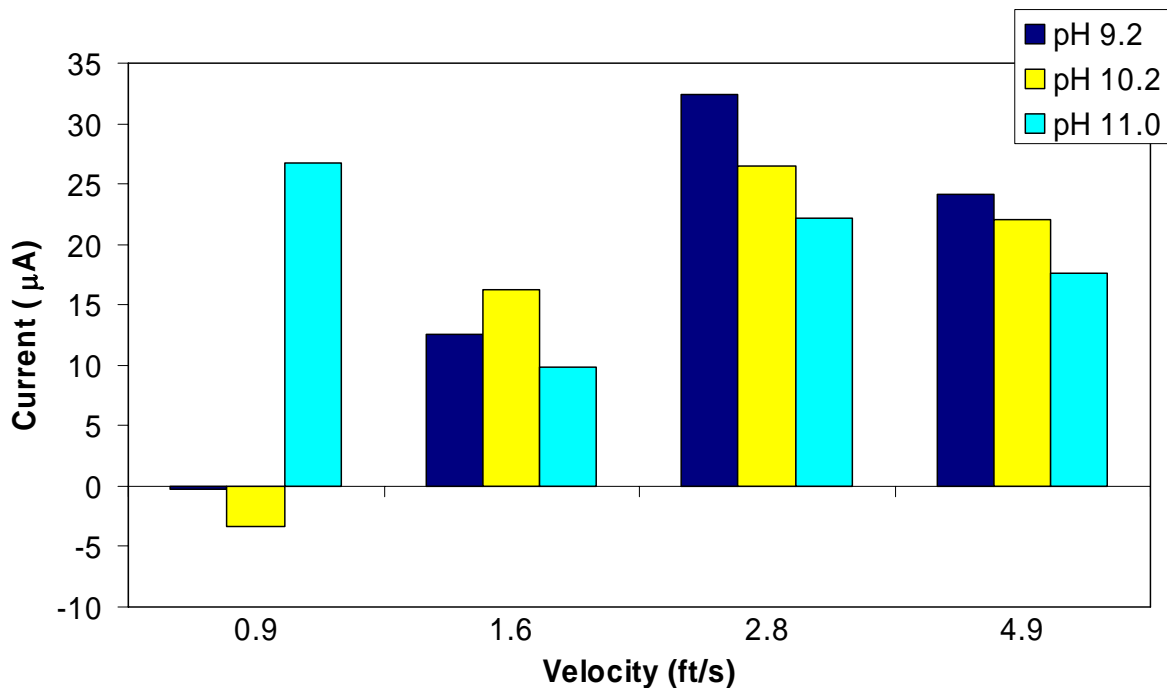
Figure 3-15: Currents Measured between the Coupon and Pipes A, B and C Connected at pH Values of 9.2, 10.2 and 11.0

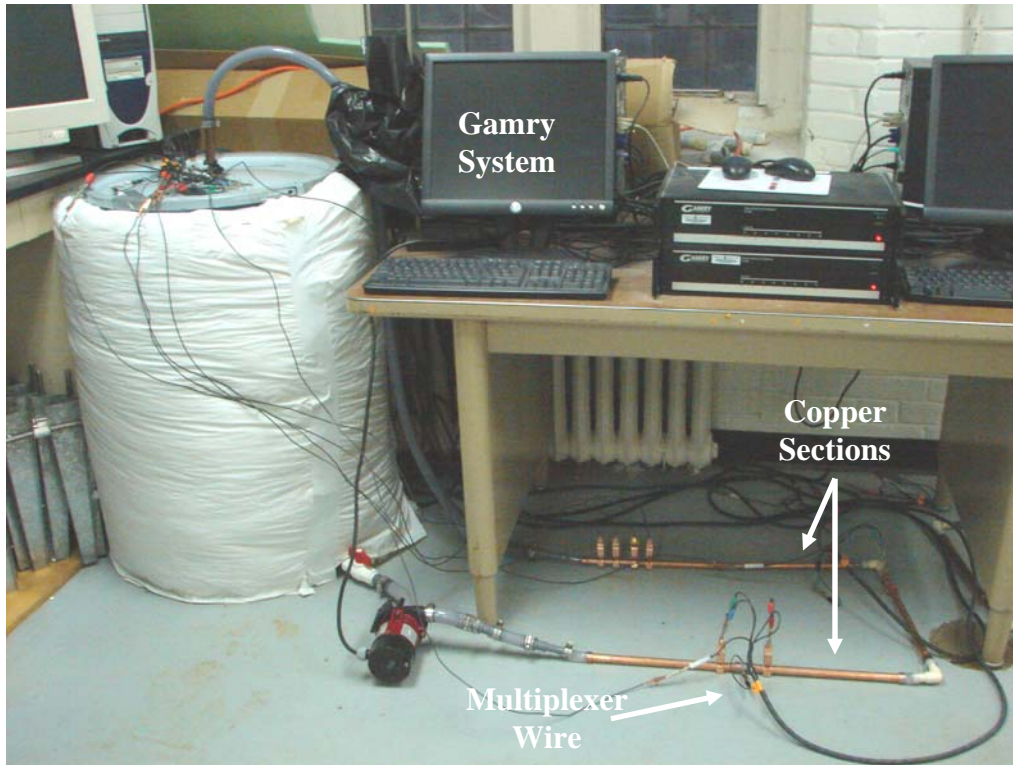
Figure 3-17: Experiment Setup

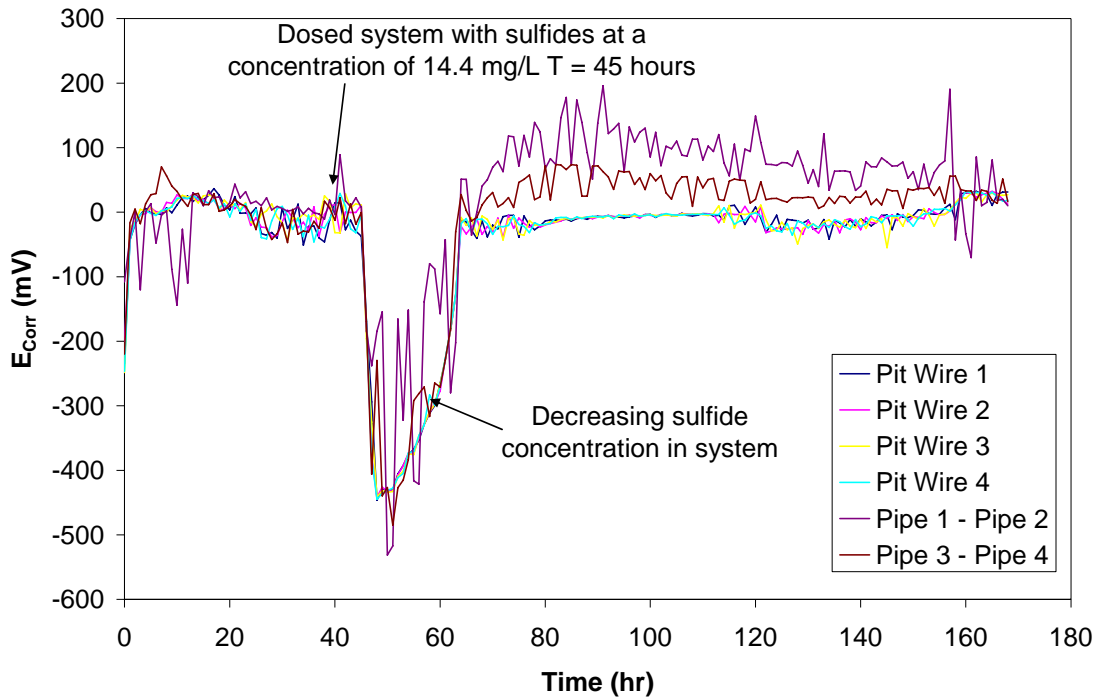
Figure 3-18: Real-time E_{Corr}

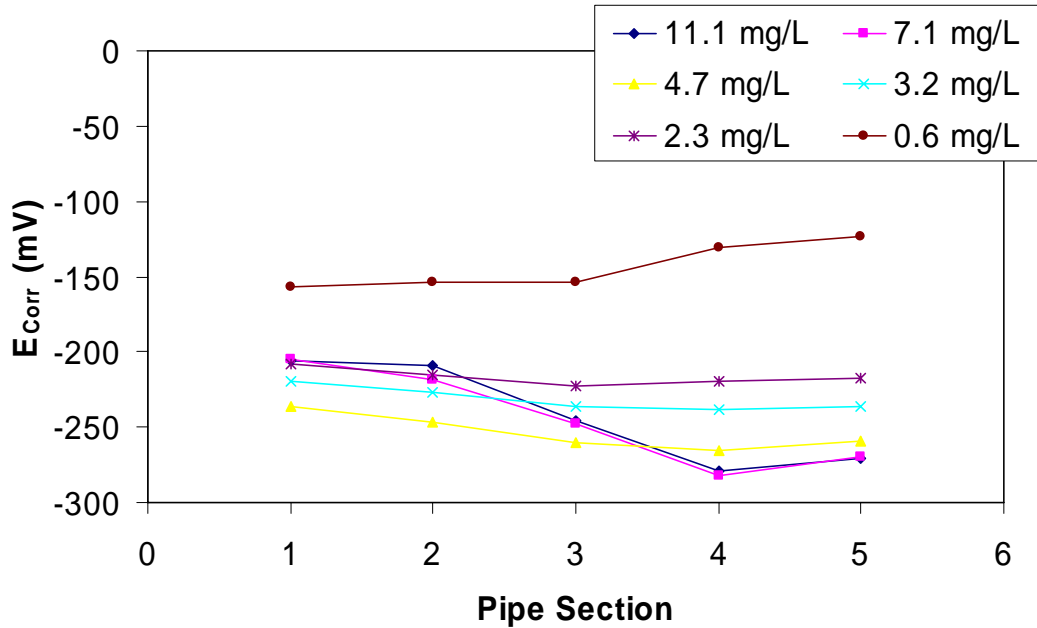
Figure 3-19: E_{Corr} Dependence on Sulfide Concentration

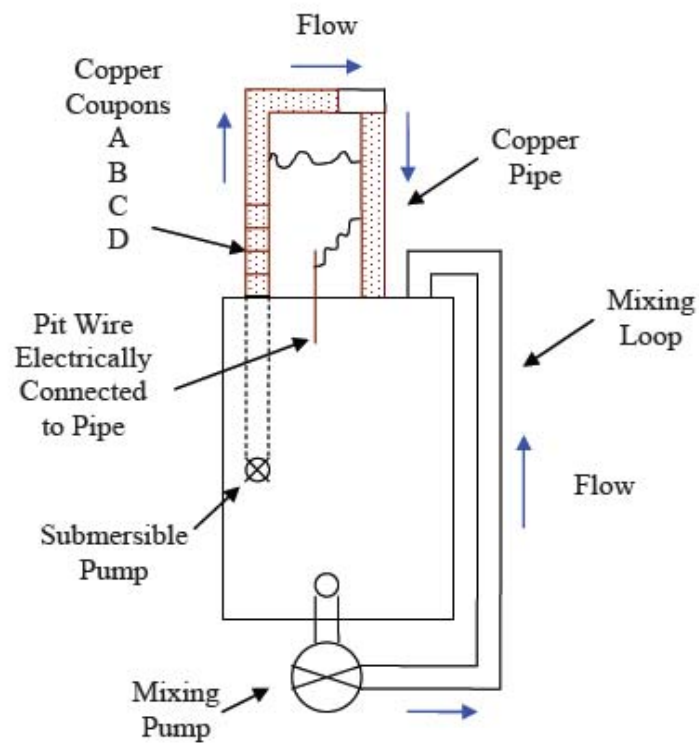
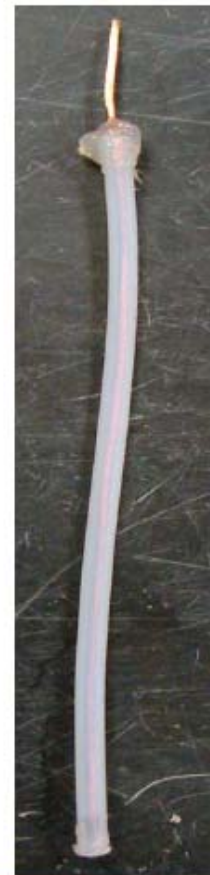
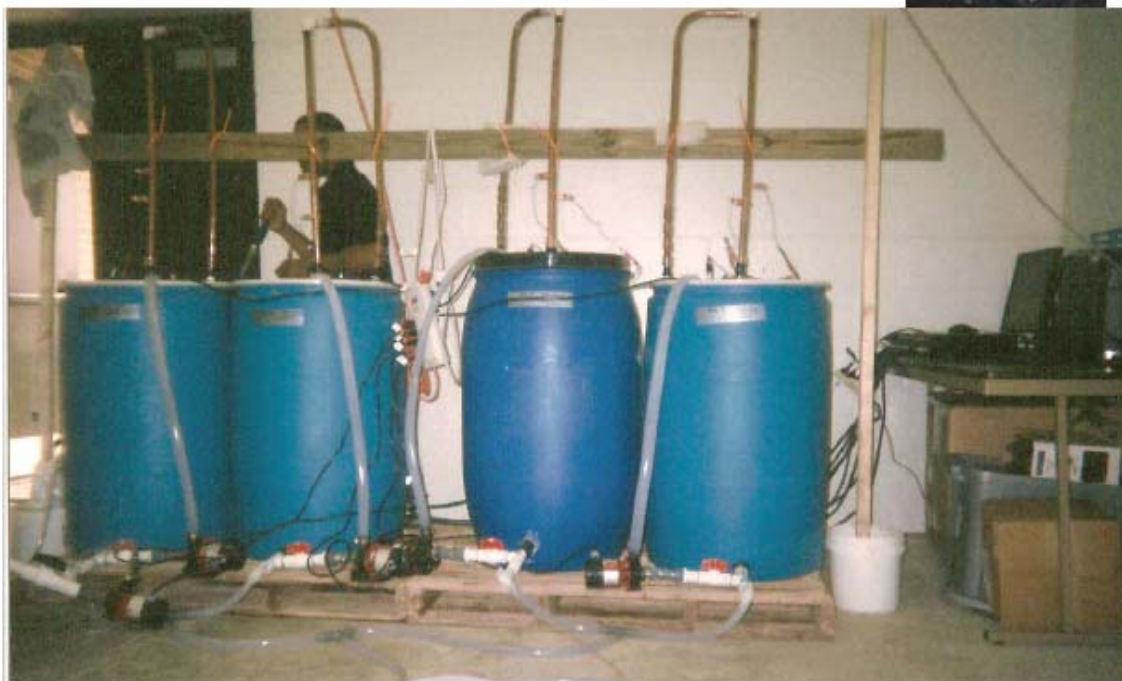
Figure 4-2: Experimental Setup and Pit Wire (Top Right)

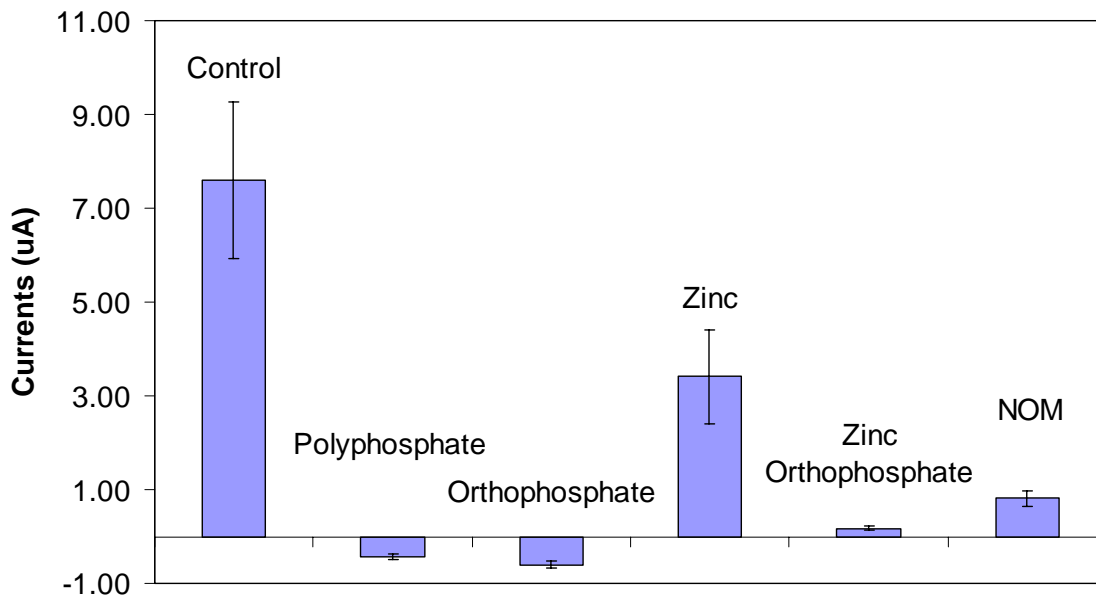
Figure 4-3: Average Currents from Phase I Testing
Error bars represent the 95% confidence interval.

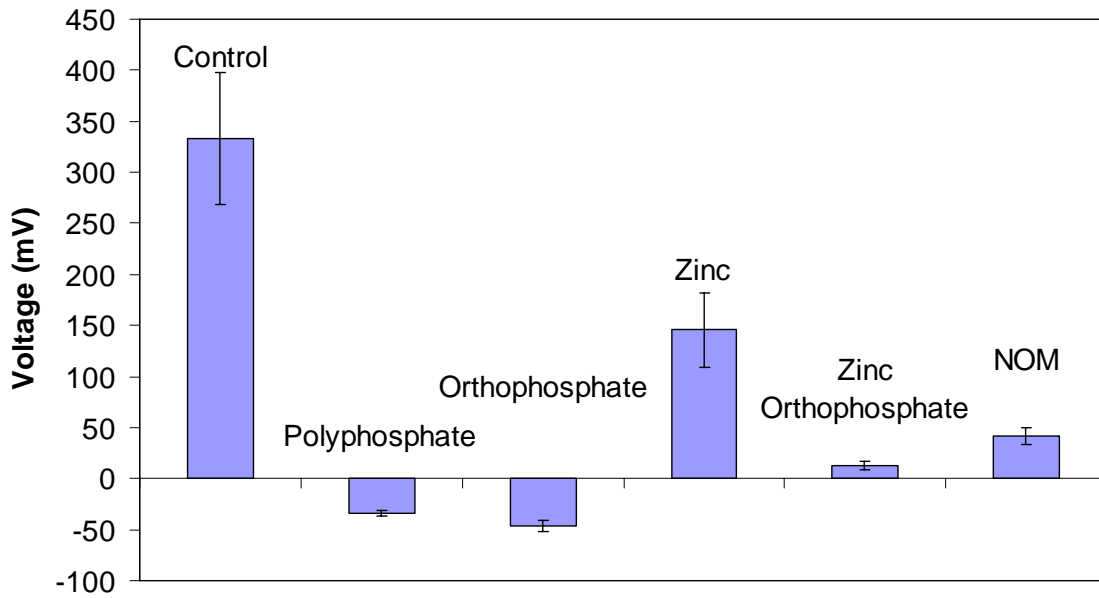
Figure 4-4: Average Voltage Differences from Phase I Testing
Error bars represent the 95% confidence interval.

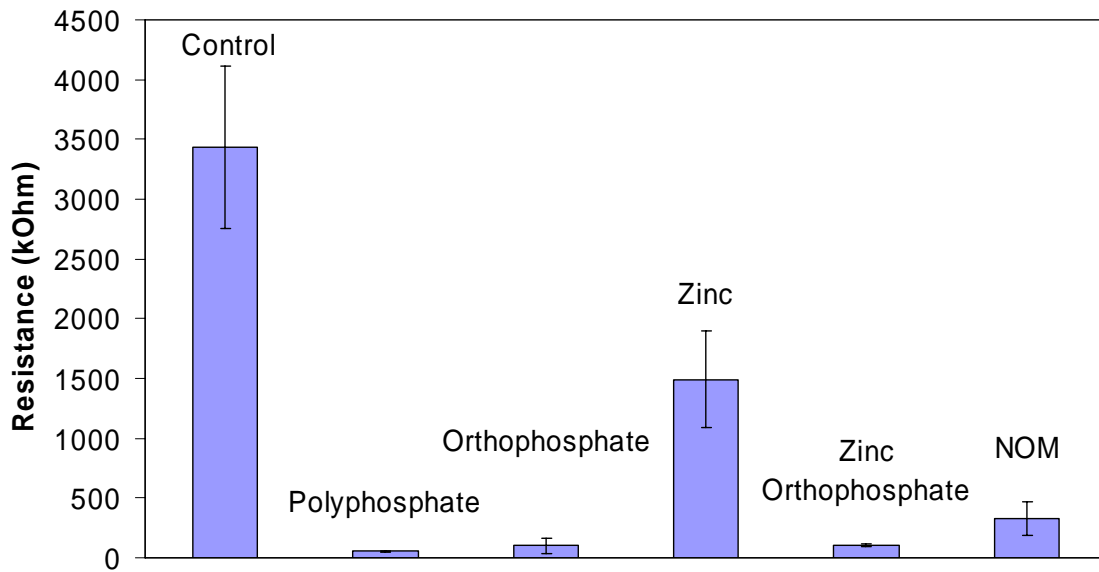
Figure 4-5: Average Resistance from Phase I Testing
Error bars represent the 95% confidence interval.

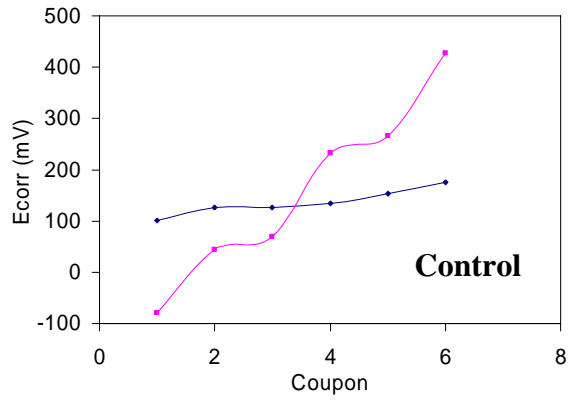
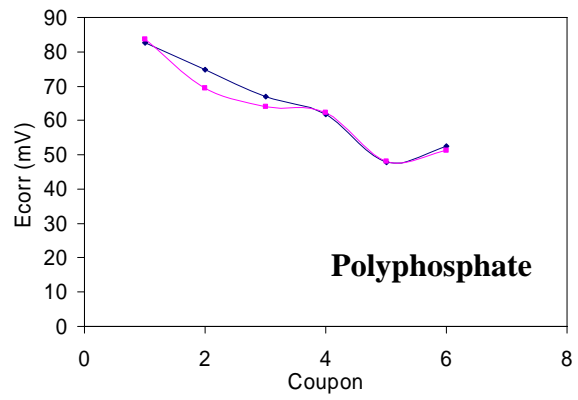
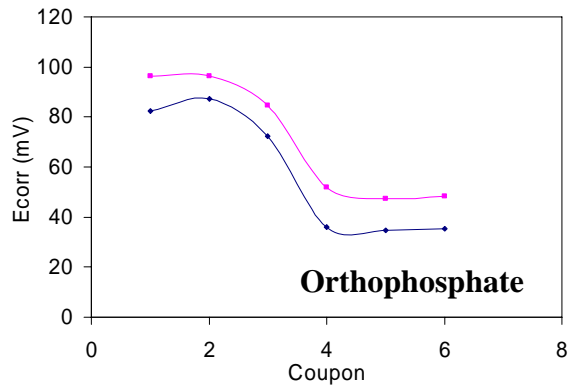
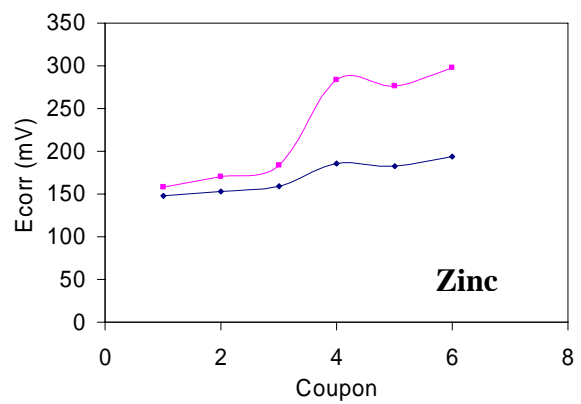
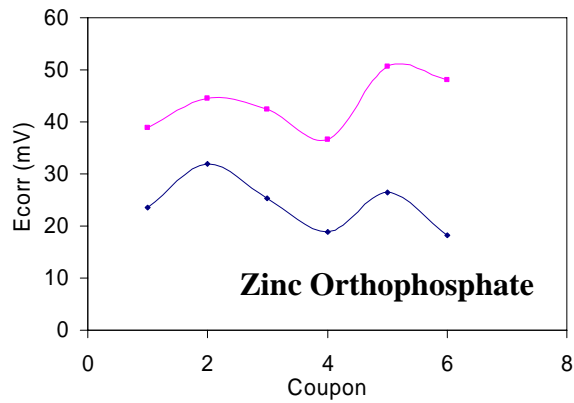
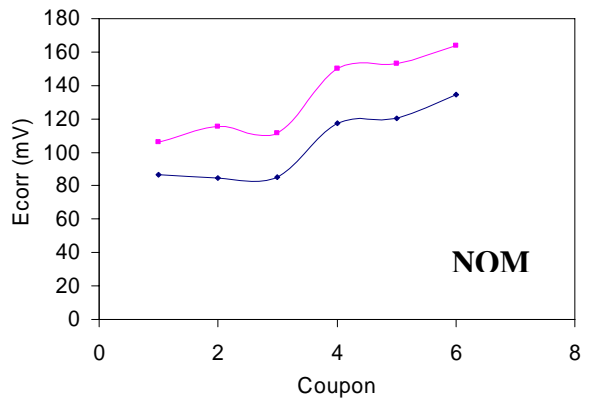
◆ Prior to Chlorine Adjustment ■ Following Chlorine Adjustment

Figure 4-6: E_{Corr} Profiles during Phase I

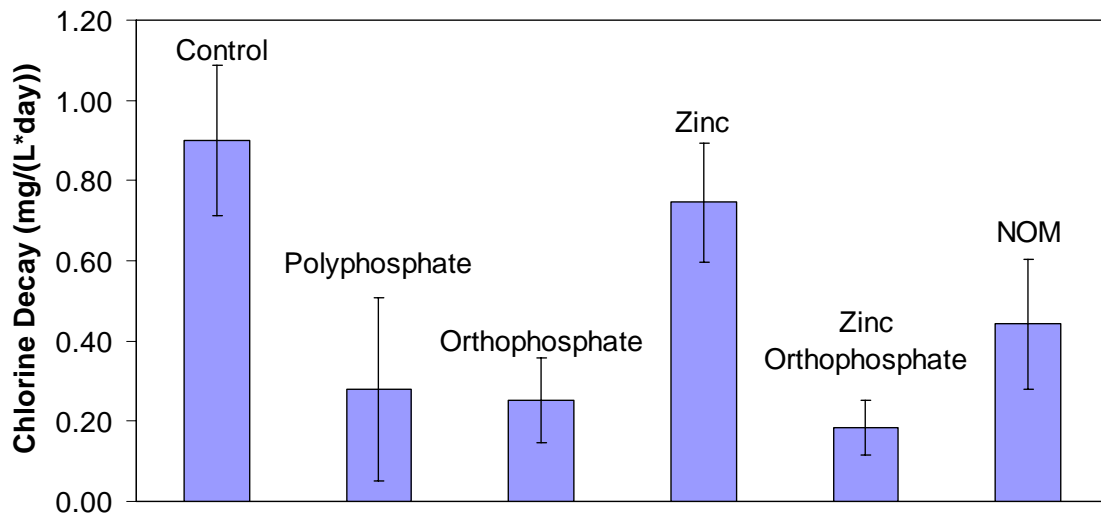
Figure 4-7: Average Chlorine Decay from Phase I Testing
Error bars represent the 95% confidence interval.

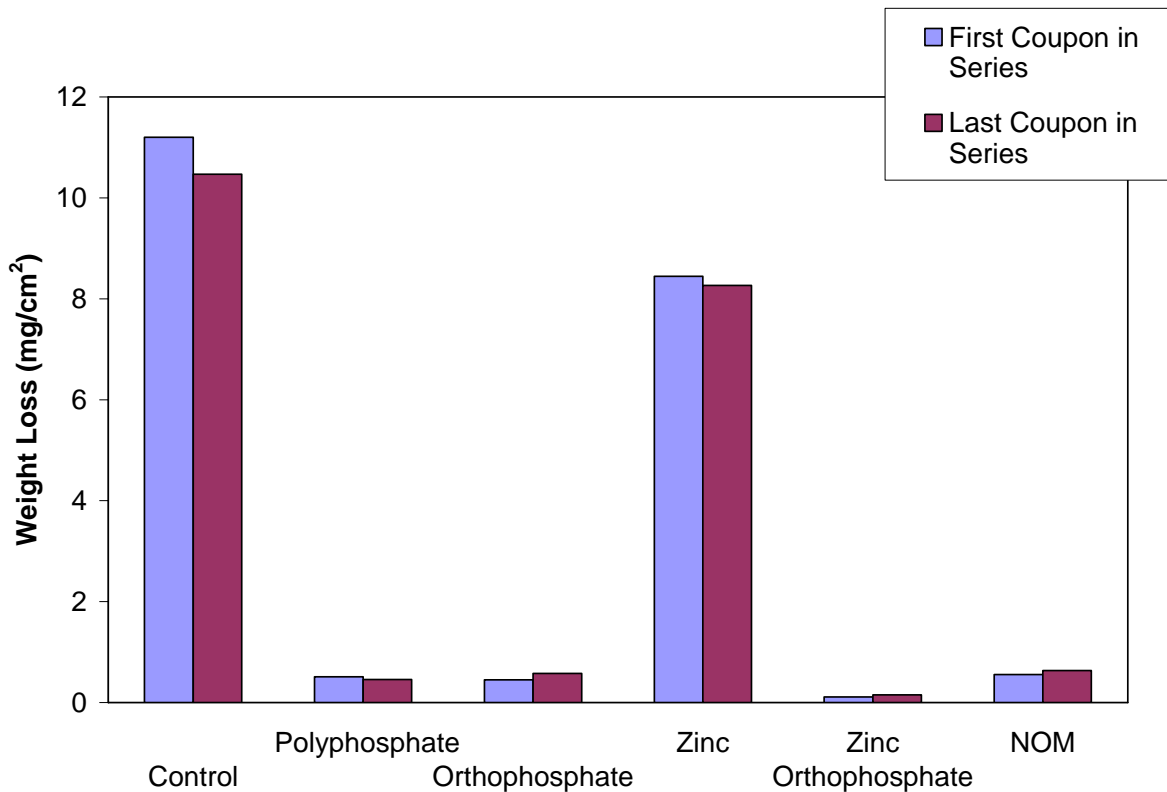
Figure 4-8: Coupon Weight Loss from Phase I Testing

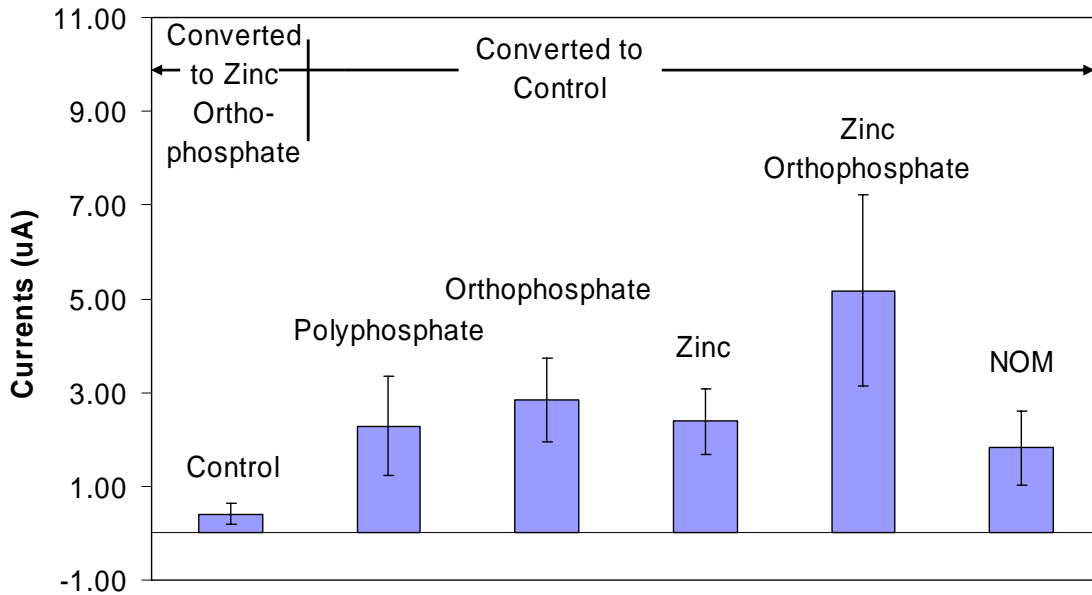
Figure 4-9: Average Currents from Phase II Testing

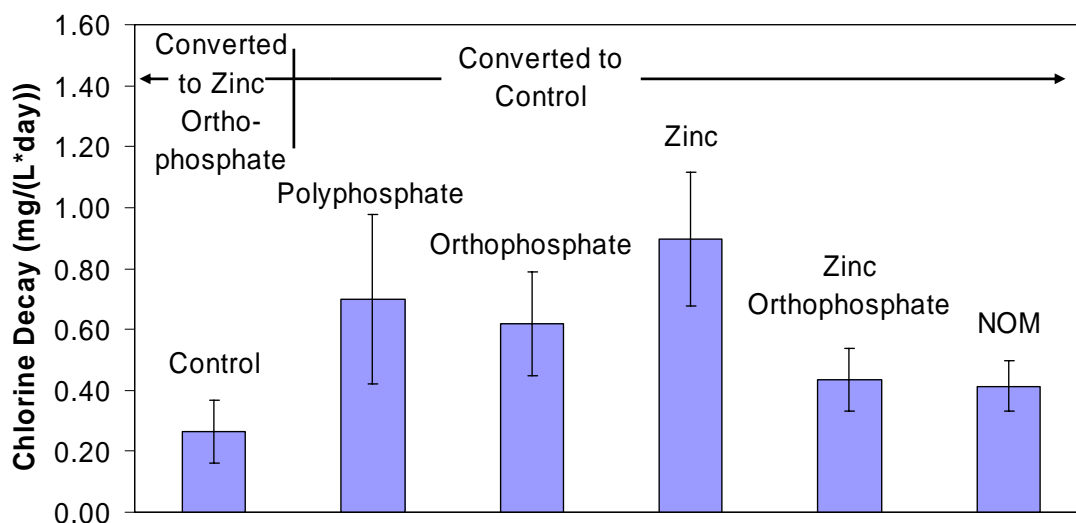
Figure 4-13: Average Chlorine Decay from Phase II Testing

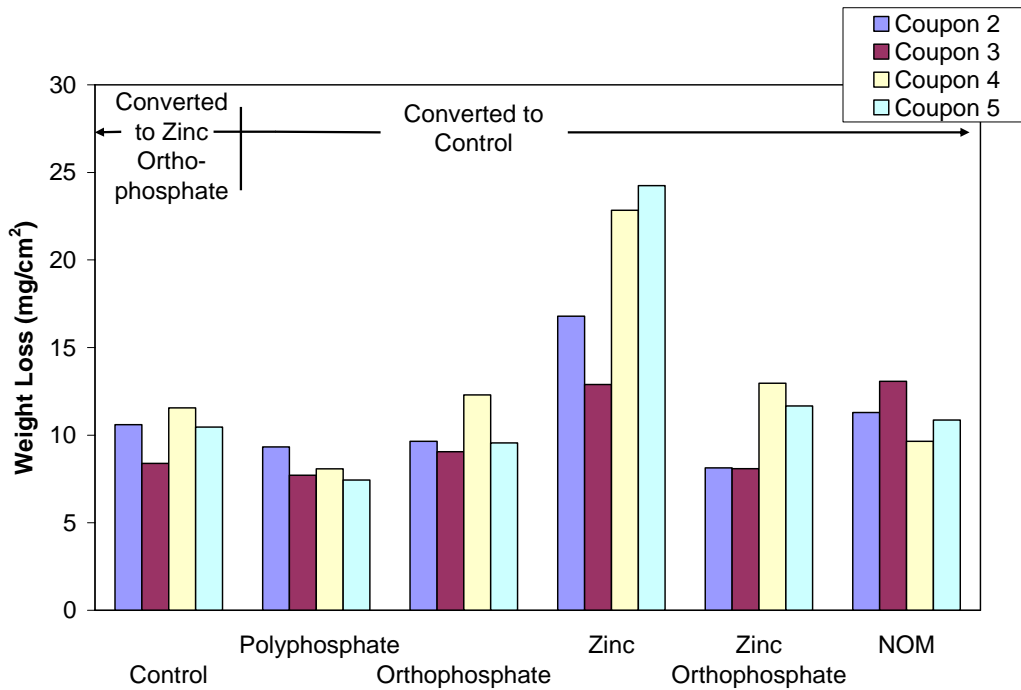
Figure 4-14: Weight Loss Data for Each Coupon from Phase II Testing
Labels along x-axis represent initial conditions while labels along arrows indicate final condition.

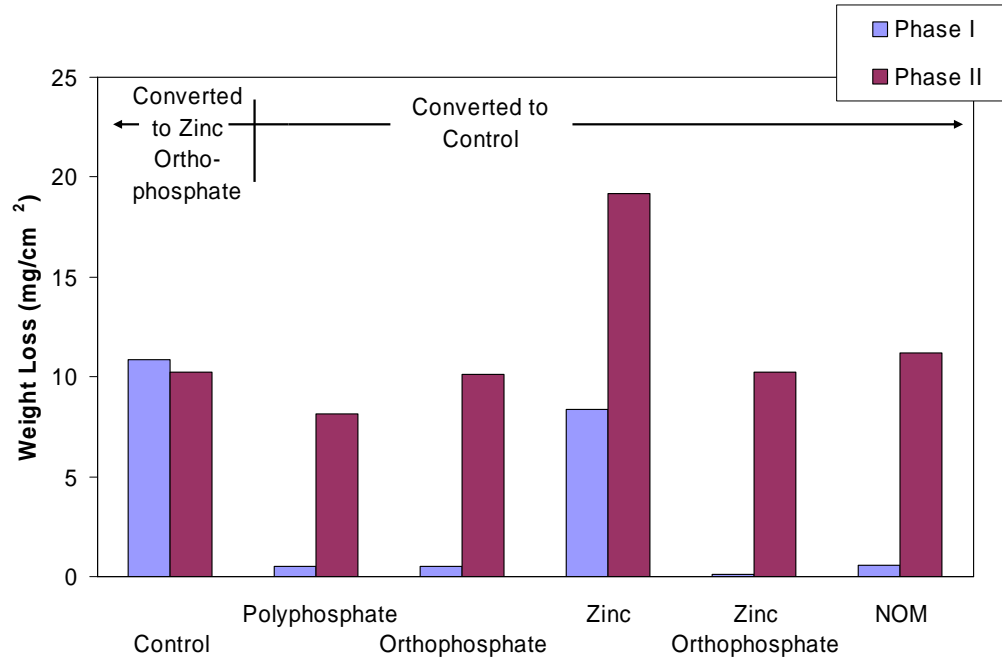
Figure 4-15: Weight Loss Data Comparing Phase I and Phase II Averages
Labels along x-axis represent initial conditions while labels along arrows indicate final condition.

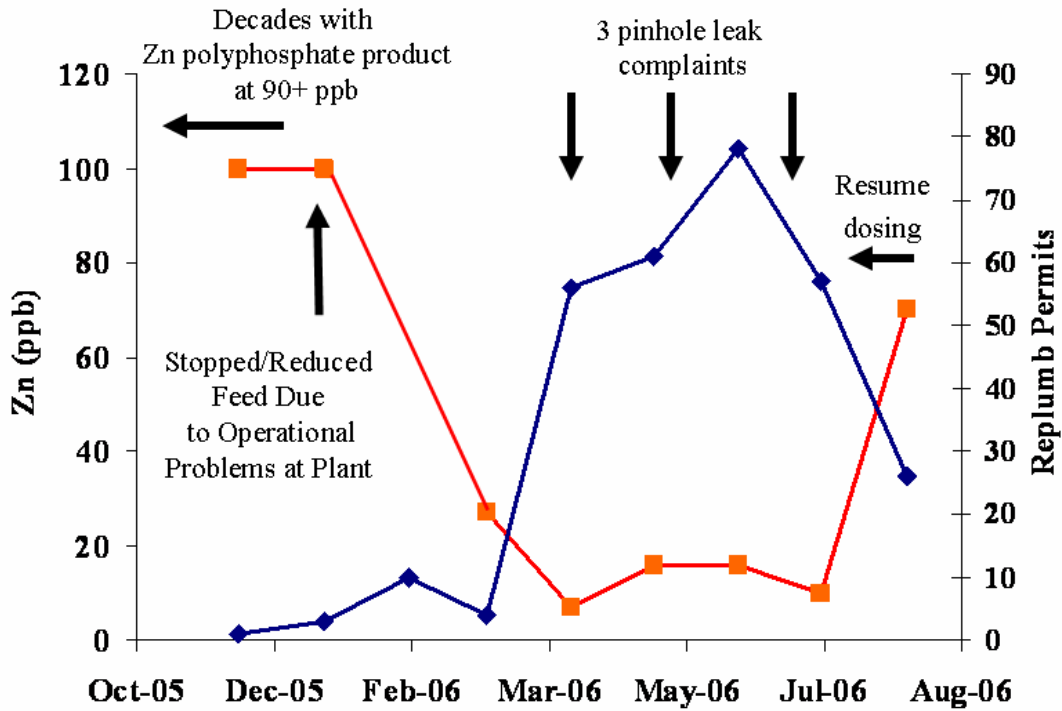
Figure 4-16: Zinc Concentration and Replumb Permits from a Water Utility Case Study in Florida

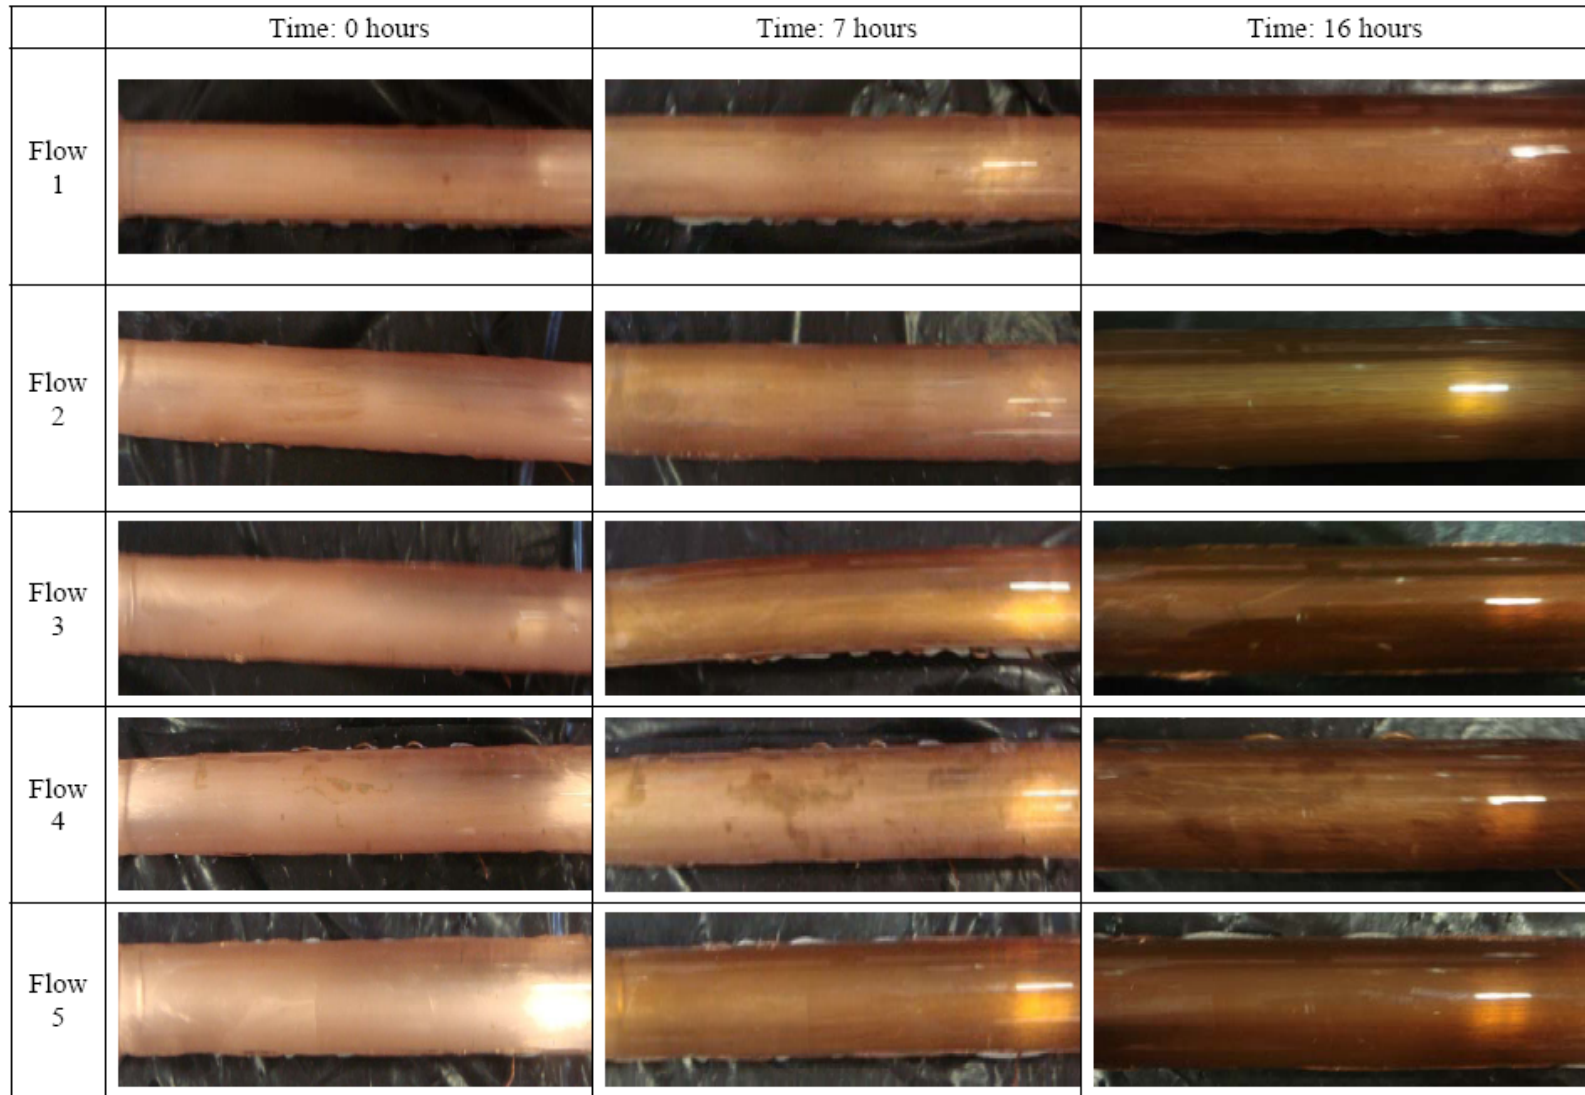
Figure A- 1: Scale Deposition on Viewable Pipe Sections
