REPAIR OF IMPACT-DAMAGED PRESTRESSED BRIDGE GIRDERS WITH STRAND  
SPLICES AND FABRIC REINFORCED CEMENTITIOUS MATRIX SYSTEMS

Master of Science  
In  
Civil Engineering

June 5, 2015  
Blacksburg, Virginia

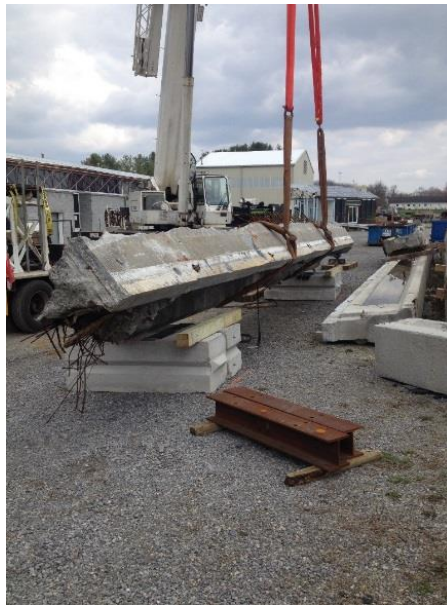
**Figure 26- 44 ft Section of Girder A**

Girder A was tested for the undamaged control test to provide a baseline for comparison with subsequent tests. Girder A was approximately 44 ft in length. It was originally 60 ft, but suffered collision damage during the bridge's service life and during transit from the site to the laboratory, and a 16 ft section broke off. The bottom flange of the girder was spalled at the damaged end for about 7 ft of length from that damaged end. To ensure that the control test would represent an undamaged girder, the section of girder from the undamaged end to 37 ft from that end was considered to be undamaged. The composite deck was cut during demolition

of the bridge, but some existing deck still remained intact and attached to the girder. The existing deck on Girder A was roughly cut, with approximate dimensions 9.5 in deep and 24 in wide. A view of the existing deck can be seen in Figure 26. Despite some damage to the concrete deck, it was assumed to act as a fully composite deck.

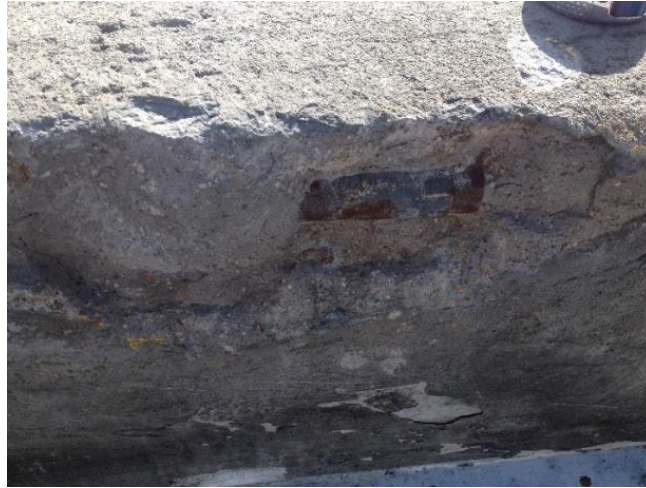
**Figure 27- Spall with Exposed Strand Splice Chuck**

Girder A had been previously damaged by vehicle impact and repaired by VDOT. As the exterior girder closest to the direction of traffic, it was the only girder used in testing that had been previously damaged by impact. At 31 ft from the undamaged end, a spall was observed on the bottom flange with an exposed strand splice chuck, shown in Figure 27. A section of an intermediate diaphragm was still partially intact at about 20 ft from the undamaged end, as shown in Figure 28.

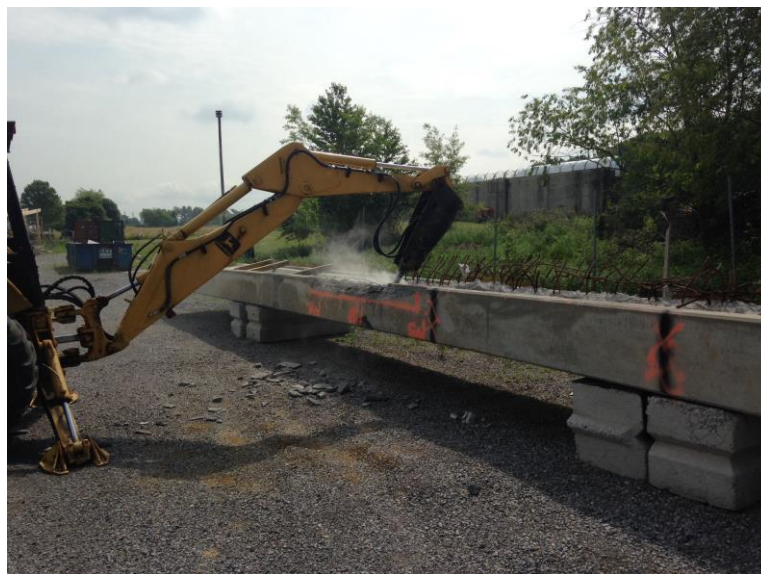
**Figure 35- Damaging Girder B with Hydraulic Hammer**

Girder B was a 60 ft long girder that was damaged at the midspan and repaired using the strand splice method. The applied damage consisted of removing 8 ft of concrete around the midspan, approximately 4 ft on either side of midspan, and severing eight prestressing strands. The damage location is shown in Figure 33, and a cross section view showing the damaged strands is shown in Figure 34. A length of 8 ft was chosen as the length the damage area, based on the average width of a semi-trailer (YRC Worldwide, 2015). Three strands were severed in the bottom row of strands, three strands were severed in the second row from the bottom, and two strands were severed in the third row from the bottom. To damage the girder, it was set on its side and struck with a hydraulic hammer attached to a backhoe, as shown in Figure 35.

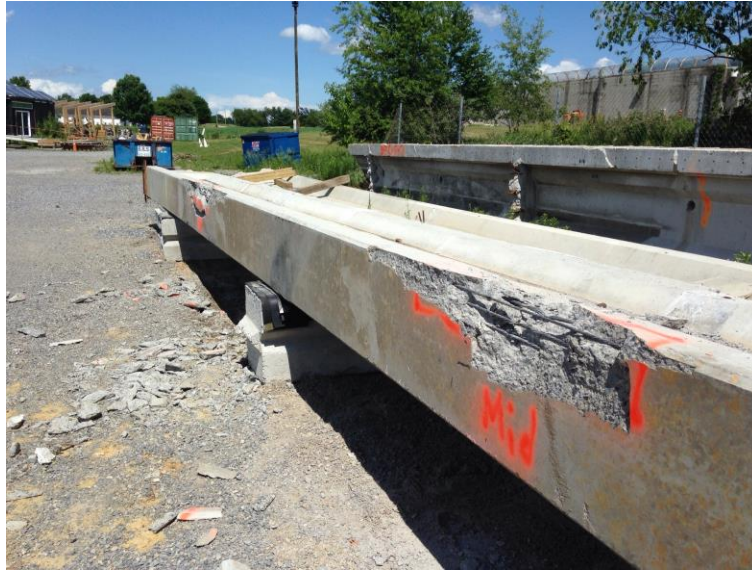
**Figure 48- Girder C after Damage from Hydraulic Hammer**

section at the damage locations. At each location, two strands were severed in the bottom row of strands, one strand was severed in the second row from the bottom, and one strand was severed in the third row from the bottom. To damage the girder, it was set on its side and struck with a hydraulic hammer attached to a backhoe. Figure 48 shows the girder after this damage.

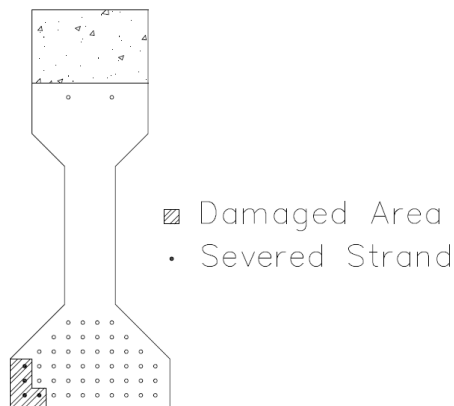
**Figure 64- Girder D Cross Section Through Damaged Area**

Figure 63 shows the damage locations along the length of the girder, and Figure 64 shows a cross section at the damage locations. At each location, two strands were severed in the bottom row of strands, one strand was severed in the second row from the bottom, and one strand was severed in the third row from the bottom. To damage the girder, it was set on its side and struck with a hydraulic hammer attached to a backhoe. After this damage from the hydraulic hammer, the concrete was sawed and chipped to provide a clean surface to repair. Saw cut lines are shown in Figure 65, with the cuts being performed in Figure 66. Before repairs, at least 1 in of concrete is chipped throughout the repair surface, shown in Figure 67.

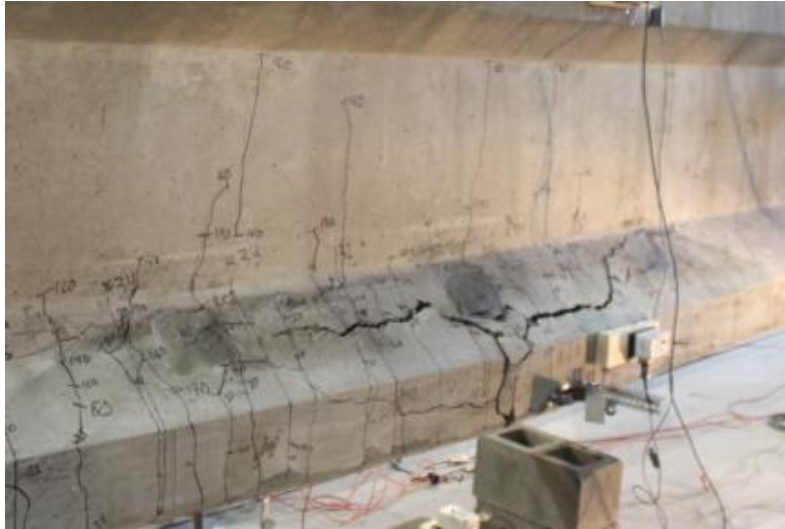
**Figure 104- Flexural Cracks in Patch Concrete at Failure**

The failure mode of Test 2 was a flexural tensile failure in which one repaired strand slipped out of its splice chuck and one strand ruptured. Cracks formed and widened in the repair area, showing signs of failure prior to reaching the ultimate load and providing warning of an imminent failure. Figure 104 shows the repair concrete at failure. After completion of the test, the repair concrete was chipped out to investigate the performance of the strand splices and observe the failure. Figure 105 shows the failure, with one repaired strand slipping out of the splice chuck and another prestressed strand rupturing. The picture was taken after the girder was removed from the testing area and stored outside for a period of time, causing rust to form. Many of the spliced strands experienced significant yielding, with permanent deformation evident.

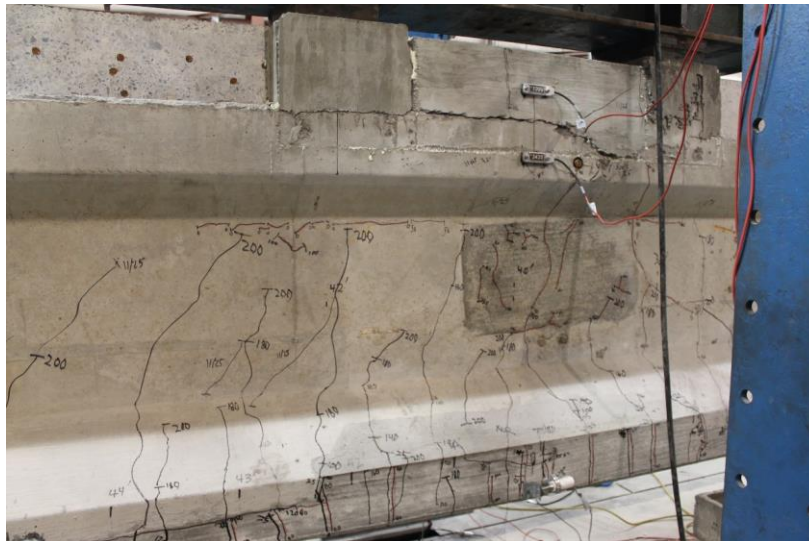
**Figure 109- Test 4 Cracking Patterns near Maximum Load**

The failure mode of Test 4 was a flexural compression failure in which the concrete in the deck between the load points crushed. This failure is shown in Figure 107. Flexural cracking was observed along the bottom flange, with widening cracks as the load increased near the ultimate capacity, as shown in Figure 108 and Figure 109. After completion of the test, the repair concrete was chipped out to investigate the performance of the strand splices. The splices showed no observable slipping, rutpuring, or excessive yielding.
