# Hurricane Michael in the Area of Mexico Beach, Florida

**Abstract:** Category 5 Hurricane Michael made landfall near Mexico Beach, Florida on October 9, 2018, with measured high water marks (HWMs) reaching 7.2 m NAVD88. The town itself received great damage, with many areas destroyed down to the foundations. In this study, we document the storm and its effects on the greater Mexico Beach area: hazard, structural damage, and their relationships. Wave and surge damage was nearly total for low-lying properties, but damage decreased greatly with increasing elevation. Major wave and surge damage was noted in Federal Emergency Management Agency (FEMA) X zones, which are out of the 100-year floodplain, and it is suggested that the 100-year storm is a deficient measure for categorizing flood risk. **DOI: 10.1061/(ASCE)WW.1943-5460.0000590.** This work is made available under the terms of the Creative Commons Attribution 4.0 International license, <https://creativecommons.org/licenses/by/4.0/>.

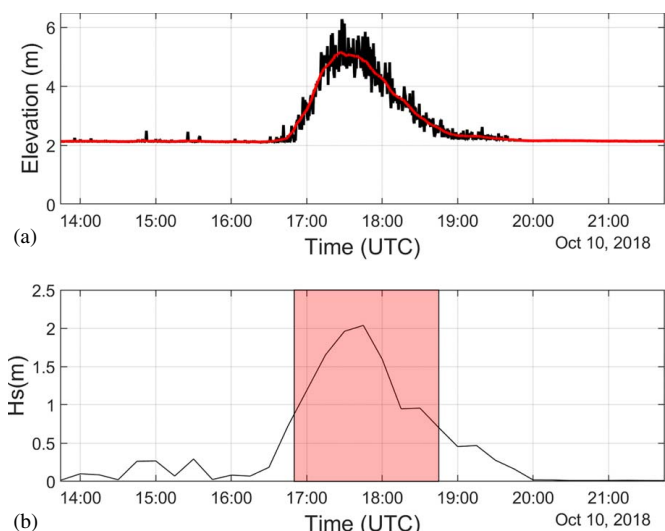
**Fig. 2.** (Color) Time series of water surface elevation (m) (NAVD88) from USGS gauge FLBAY03283 at the Mexico Beach Pier: (a) (—) unfiltered water level taken every 30 s; (—) moving 15 min average water level; and (b) significant wave height at pier. The shaded area represents the approximate time when the gauge did not go dry in wave troughs. Location is shown in Fig. 3.

elevation of 6.28 m (using the hydrostatic assumption) just before 17:30. These peaks were very short-lived, and by 19:00 only a few small wave crests were high enough to even reach the gauge. Realistically, most wave and surge damage probably occurred in the 1.5 h period between 17:00 and 18:30 UTC (12:00–13:30 local). This maximum wave crest of 6.28 m (20.6 ft) NAVD88 occurred in a National Flood Insurance Program (NFIP) 4.27 m (14 ft) VE zone (highest risk in the 100-year floodplain). No location in Mexico Beach (other than the pier in the ocean) had higher design elevations than this, while many inundated areas had much lower design elevations, and could be in the lower risk AE zones (moderate wave action in 100 year floodplain) or in Zone X (500 year floodplain) or Zone X (500-year floodplain) as shown in Fig. 3. Therefore, the conditions during Michael at Mexico Beach significantly exceeded design conditions for the 100-year flood plain.

Because water levels were only measured at 30 s intervals, no frequency information can be obtained about wave properties, but it is still possible to use the hydrostatic assumption to estimate time series of wave height at the pier. This is shown in Fig. 2(b), and was computed using  $H_s = 4\sigma_w$  (Dean and Dalrymple 1991; Kennedy et al. 2011) where  $\sigma_w$  = the standard deviation of water surface elevation over a 15 min period, after subtracting the filtered surge time series. Heights reached a maximum of just over  $H_s \approx 2$  m very near to the time of peak surge when mean water depths were probably  $> 3$  m above ground elevation (we do not know the ground elevation during the storm so it is not possible to say with certainty), therefore, these were highly nonlinear waves capable of causing great damage to structures and

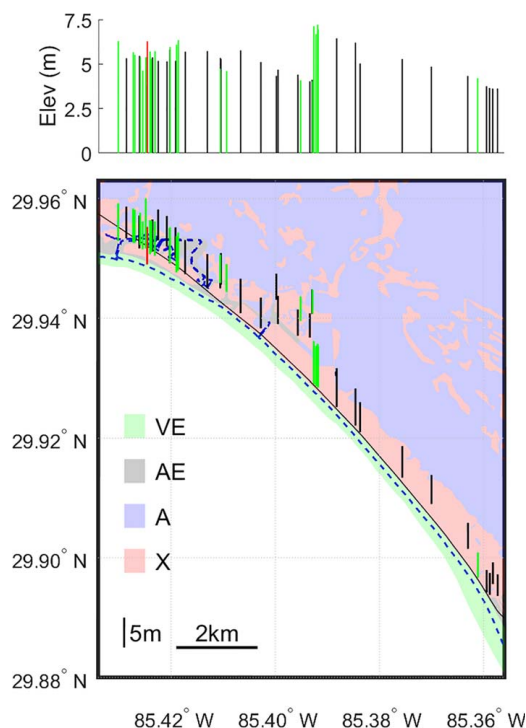
**Fig. 3.** (Color) HWMs in the vicinity of Mexico Beach: green represents measurements; black represents USGS; and red represents peak elevation from USGS sensor at pier. FEMA flood zones are as shown in the legend. Highway US98 is the solid black line close to the coast, and the NOAA shoreline is shown as a dashed line. Elevations are given in NAVD88 datum.

The HWM elevations shown in Fig. 3 demonstrates both their changes in space and overall consistency. In the northwestern area of Mexico Beach, flow depths were large from the beach to US98, with many measurements of 5–6 m NAVD88. All of these HWMs were identified on surviving structures; no HWMs were found anywhere near the original shoreline, where waves were almost certainly larger. Moving southeast along the coastline, HWMs become significantly lower at around 85.4°W, at approximately 4–5 m NAVD88. This is probably because measurements here were quite far inland. However, HWM elevations increase strongly at approximately 85.393°W, where the beach is very narrow, and there are high ground elevations just across US98. Runup here exceeded 7 m in several locations as evidenced by undisturbed runup debris, with a maximum measured elevation of 7.2 m NAVD88 [Fig. 3(b)]. Moving further southeast along the coast, HWM elevations decreased almost monotonically, with all HWMs east of

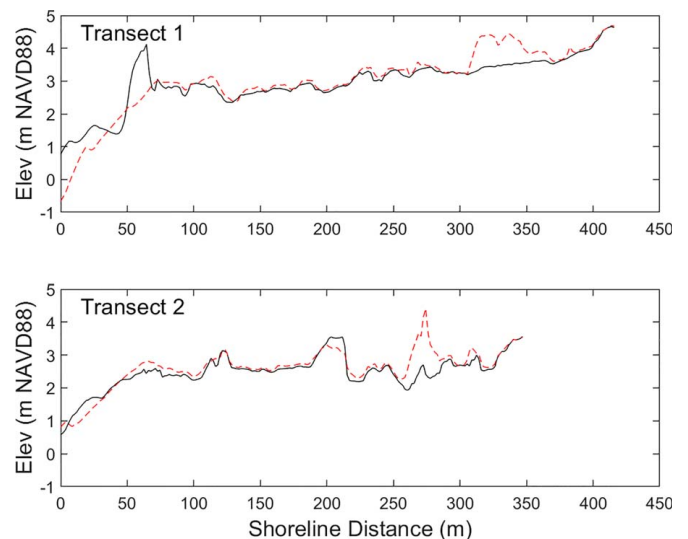
The major difference in prestorm and poststorm onshore data arises from the complete erosion of the coastal dune system, with up to several meters of elevation loss. Areas of deposition are seen landward in some locations and represent debris piles generated from more seaward houses and other moveable objects. Fig. 6 shows the two transects identified in Fig. 5 before and

**Fig. 6.** (Color) Before storm (-) and poststorm (- -) bare earth elevation transects in NW Mexico Beach from the nominal shoreline to HWY98. Locations for Transects 1–2 are shown in Fig. 5.

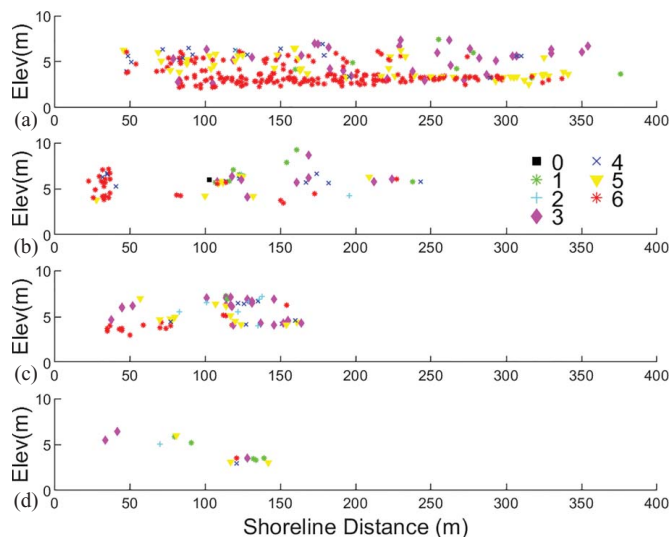
The damage state was found to be a strong function of structural elevation as shown in Fig. 11, in particular, close to the shoreline. This is not at all surprising, because structures at higher elevations may encounter waves and surge for a shorter length of time, or not at all if they are sufficiently elevated. Structures built at-grade were almost universally destroyed in the most severe conditions near the shoreline (DS6) and were largely older single family houses. Structures at higher elevations demonstrated much higher survivability,

although many of them still sustained significant damage. Further inland, structures experienced an increased chance of survival both from the higher ground elevations and the dissipating wave heights, but damage still tended to be severe. Very few structures surveyed had damage states less than DS2. Subregions (c–d) (SE Mexico Beach) showed lower damage states inland of US98, which will be explored in more detail in the following sections.

**Fig. 11.** (Color) Damage state versus elevation of LHMs in m NAVD88, and distance from shoreline in the subregions (a–d) as shown in Fig. 9.

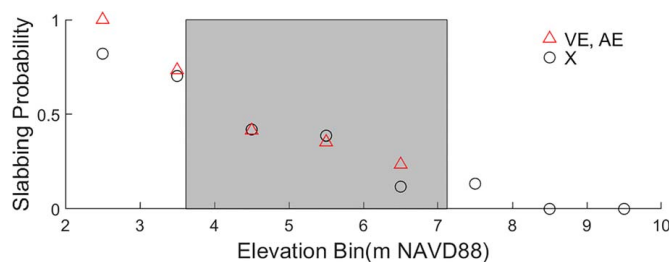
The immediate survival or destruction of a structure is an important safety consideration. In this study, destruction is defined by damage category DS6, where the structure is slabbed; that is to say, it is completely removed from its foundations. Fig. 12 shows the probability of slabbing during Michael for aggregated VE–AE zones and X zones. Unsurprisingly, the probability of survival increases strongly

**Fig. 12.** (Color) Slabbing probabilities as a function of elevation over the Mexico Beach region for combined VE and AE zones (triangle); X zone (circle). The shaded region shows the range of observed HWMs.

with increasing building elevation. Somewhat surprisingly, the probabilities for VE–AE and X zones are almost identical, indicating that structural elevation was the overwhelming factor for survival. Because there was a range of inundation over the Mexico Beach region, this is reflected in the slabbing probabilities. Because Michael so greatly exceeded the 100-year event, the near coast DFIRM zones behaved like one. We note that this study looks almost exclusively at structures in the first few hundred meters from the shore, and slabbing behavior would certainly be different further inland.

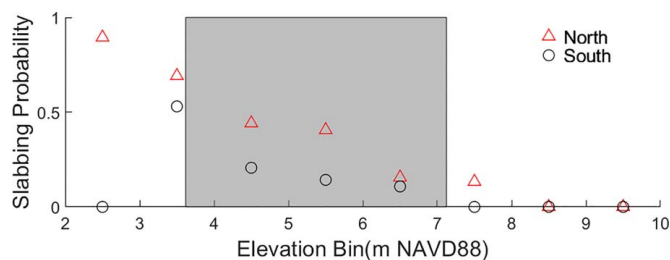
**Fig. 13.** (Color) Slabbing probabilities for all flood zones combined as a function of location. North Mexico Beach (triangle); South Mexico Beach (circle). The shaded region shows the range of observed high watermarks.

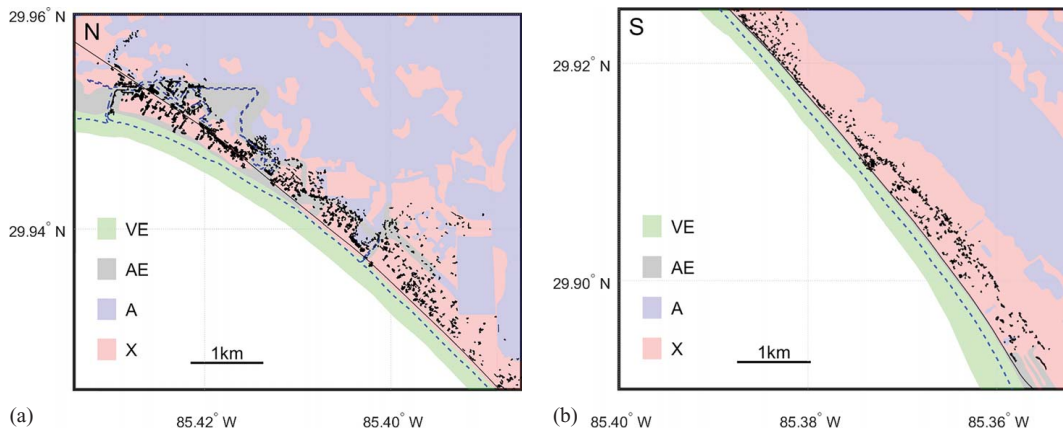
**Fig. 15.** (Color) Debris clusters in (a) North Mexico Beach area; and (b) South Mexico Beach area.

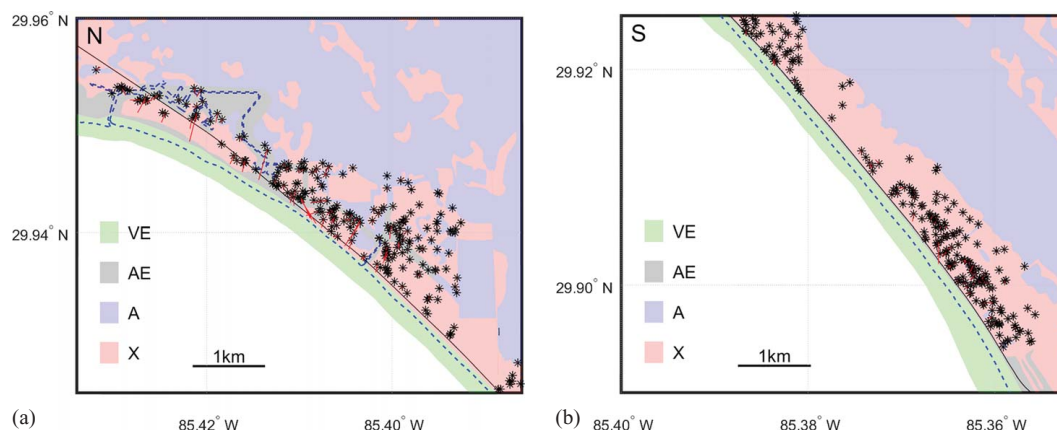
**Fig. 16.** (Color) Resting places for distinct LDOs identified in Mexico Beach post Michael: (a) North Mexico Beach; and (b) South Mexico Beach. Red lines indicate transport paths from original locations, where identified.

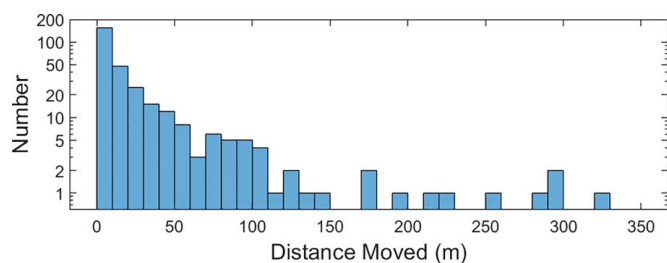
**Fig. 17.** (Color) Distance moved for LDOs in cases where original locations could be determined.
