1. Introduction

2. Objectives

1. To devise a methodology for residential wood deck and balcony inspection for conventional dimension lumber (2x_ material) construction that is accessible to a building inspector or consultant.
2. To complete a draft manual for possible publication that will contain methods for wood deck and balcony inspection.
3. To collect information that can be subsequently used to prepare articles for appropriate magazines and trade journals to increase awareness about the potential problem of wood deck and balcony failure.

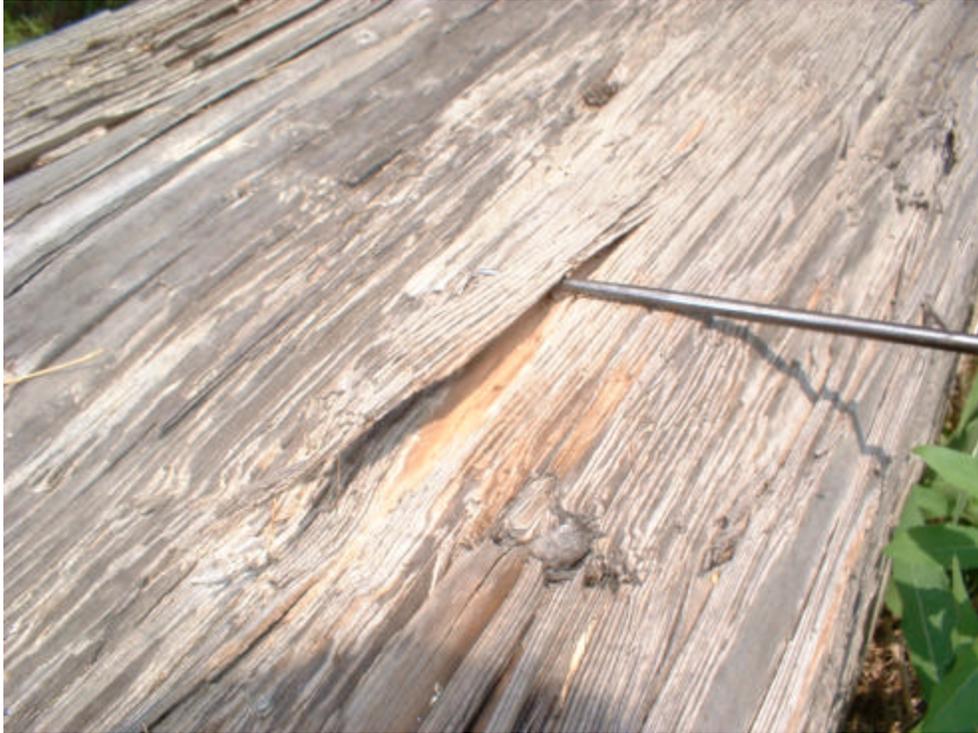
Wilcox (1983) identified three distinct modes of failure for decayed and non-decayed wood. Non-decayed wood will generally fail with either a fibrous failure or a splintering break as shown in Figure 4.9 and 4.11. Decayed wood will have a brash, brittle failure with breaks directly over the tool. Very few splinters, if any, will appear and the break will be across the grain as shown in Figures 4.10 and 4.12. Figure 4.9 and 4.10 were taken in a salvaged Douglas Fir log yard. In the Figure 4.9 and 4.10 examples, the wood is weathered, and to the inexperienced eye they look the same.

Figure 4.9. The sound wood broke in a solid piece, and far from the tool. It was difficult to penetrate deeply. One end did not break at all. The wood under the splinter is intact and looks new.

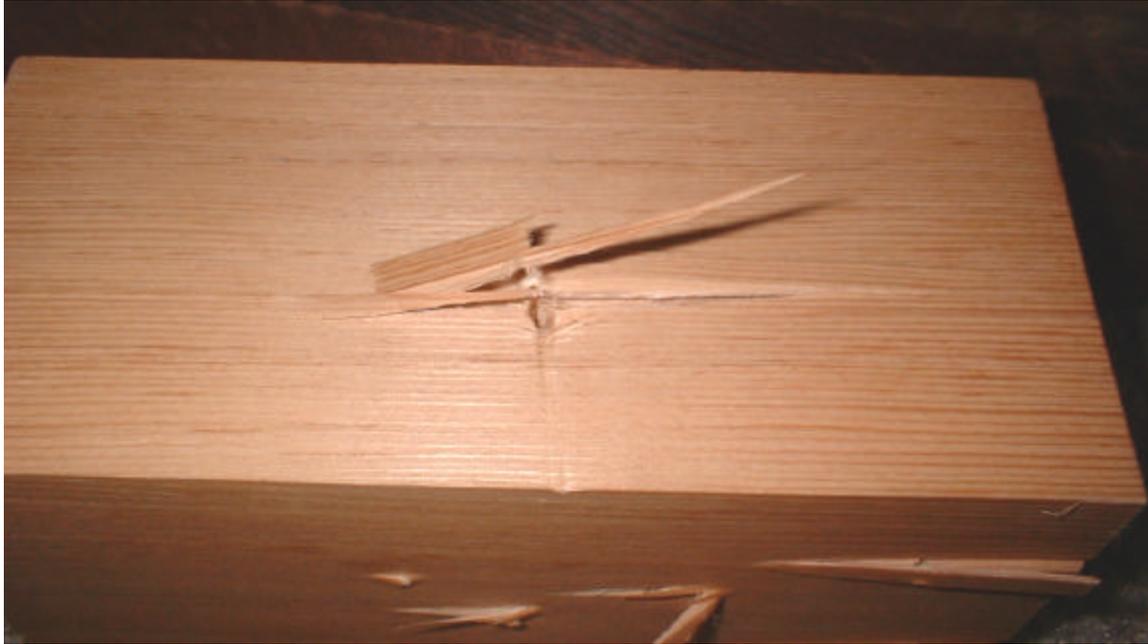
In a fibrous failure, the splinters are long and separate out of the surface far from the tool as shown in Figure 4.11 (Virgin Douglas Fir). A splintering break typically occurs directly over the tool with numerous splinters. It is possible that the wood is very dense and in such good condition that penetration is difficult. Also noticeable with sound wood is the noise associated with the break. In non-decayed wood, the sound will be as expected when wood breaks. However, with decayed wood, the breaking noise will not be as loud, or there may be almost no audible sound.

Figure 4.11. This example is a block of virgin Douglas Fir with no decay. It shows a splintered break that begins far from the penetration.

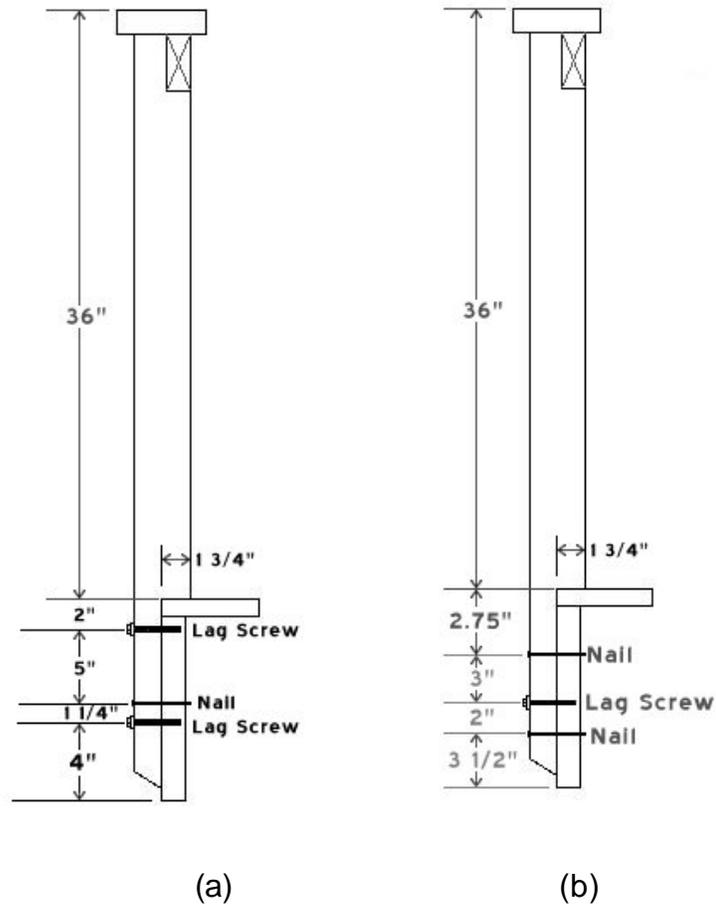
Figure 5.1. Section views of the rail post attachment to the deck: (a) Connection type A is two 1/4"x3" lag screws and one 16d annular threaded nail (b) Connection type B is one two nails and one lag screw.

One lag screw was removed and it had a 0.234 in. shank diameter and 0.175 in. root diameter. The effective length of the lag screw was 2.75 in. Discoloration was seen in the shear plane. The nail was 16d annular threaded with a shank diameter of 0.150 in. The root diameter was 0.140 in. at the unaffected areas and 0.139 in. at the discolored area. Photographs of the nail and lag screw are shown in Figures 5.2 and 5.3.

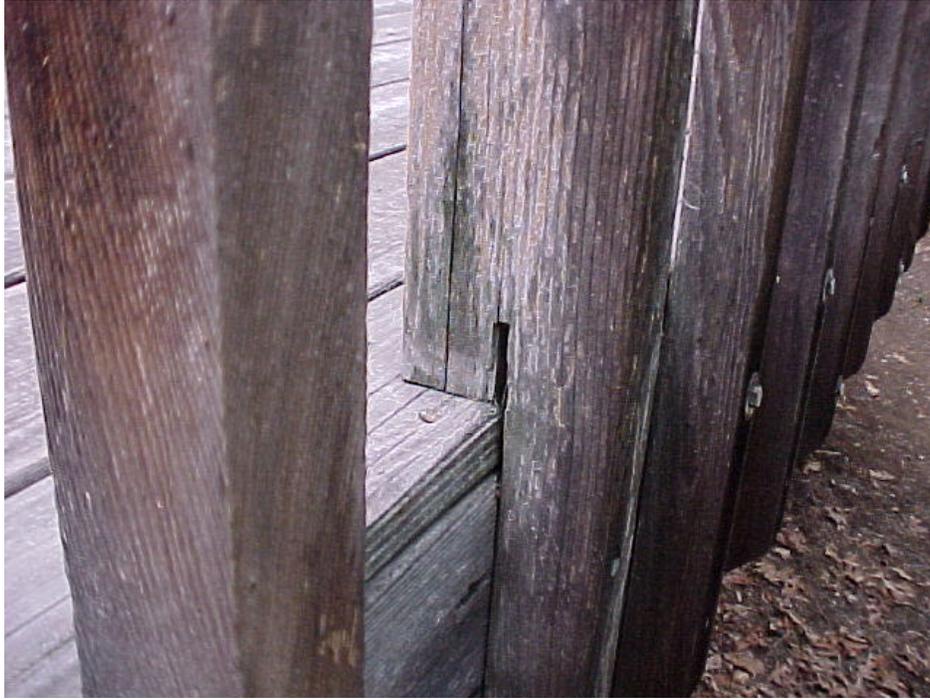
Tables 5.1 and 5.2 give the results of the inspection process on the rail posts and infill sections. The type of connection is identified as A or B with A being two lag screws and one nail, and B being two nails and one lag screw. The NDS-01 specifies allowable notch depth in bending members at the bearing as less than one-quarter of the depth of the member. The notch depth in the rail posts is one-half of the depth, and the rail posts are not in conformance with the NDS-01. Splits at the notches were a concern and were measured. Splits and kerfs are shown in Figure 5.4.

Figure 5.4. (a) The kerf on railpost #12 (b) The split in railpost #14 and the lag screw added by the homeowner.

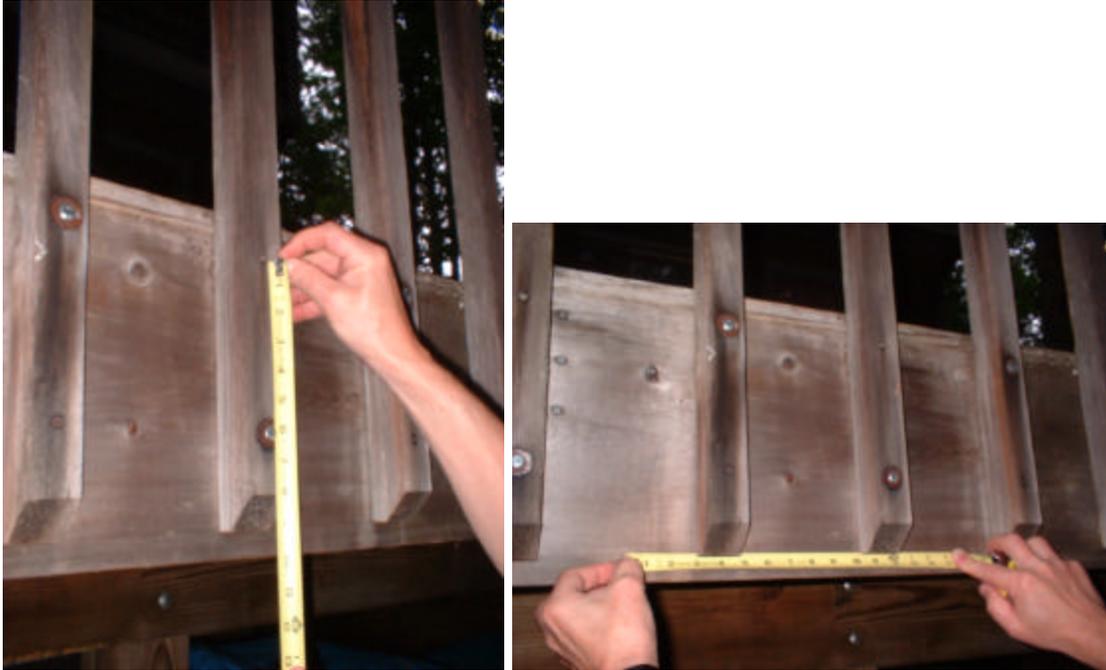
The section of railing selected for the structural analysis unit was 16 in. in width and included two infill posts as shown in Figure 5.5. Calculations (shown in Section 9.1.2.2) were performed to determine the strength of the railing in this area. The IRC-2000 states that a railing must withstand a concentrated load of 200 lbs in any direction along the top of the rail. Other building codes required that the railing resist a distributed force of 50 lb/ft and the infill must be able to carry a 50 lb load over 1 ft².

Figure 5.5. The rail analysis unit was two typical infill posts.

Using the NDS-01, a lag screw in the picket safely resists 115 lb in withdrawal and 95 lb in shear. The allowable withdrawal strength of the nail (assuming hardened steel) is 28 lb and the allowable lateral resistance value (shear) is 99 lb.

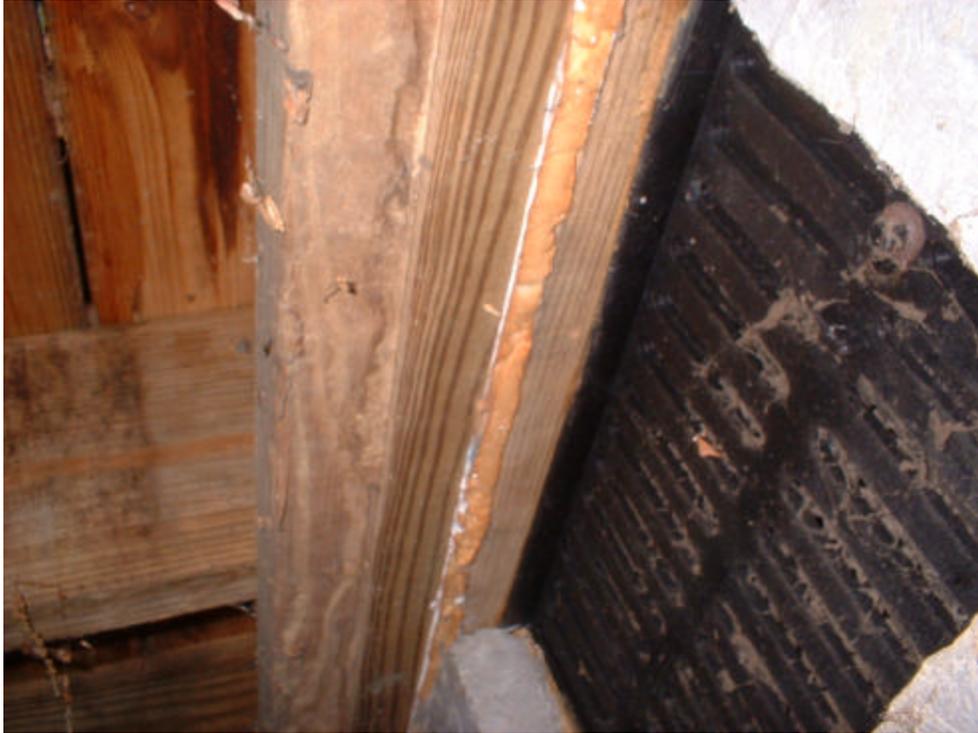
The ledger board was a PPT 2x10 No. 2 Southern Pine. It was attached to the house framing with 1/2"x4" nominal lag screws placed 24 in. on center. At the ends and butt joints, two lag screws were present. In all other places the lag screws were placed alternating top and bottom. Aluminum flashing and 1/2 in. insulation were placed between the ledger and the band joist, as shown in Figure 5.10. From the inside of the house, the lag screws were found to penetrate fully into the band joist with the pointed end coming completely through the joist. The band joist was untreated Spruce-Pine-Fir.

Figure 5.10. Material between the ledger and the band joist was observed at a vent. From right to left the materials are the band joist, 1/2" insulation, ledger and 2x2 support for joists.

One lag screw was removed and measured. The shank diameter was 0.481 in. and the root diameter was 0.372 in. The lag screw and the surrounding wood were in excellent condition. The ledger board could not be removed and, as a result, the condition of the aluminum flashing is unknown.

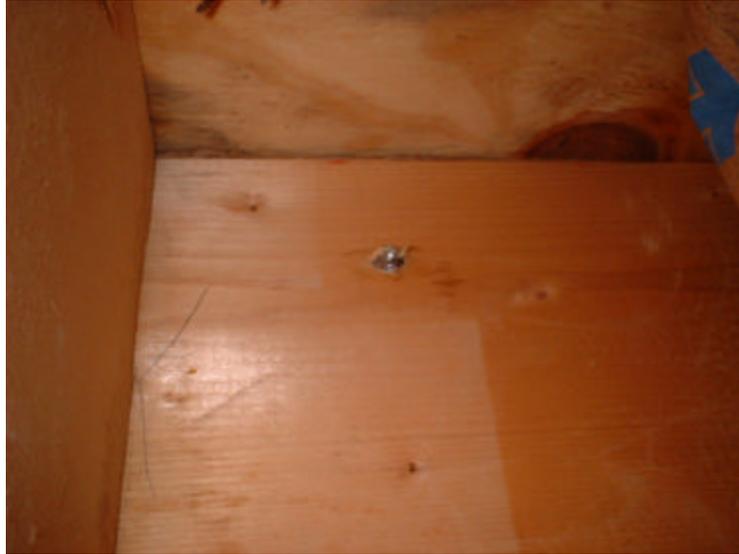
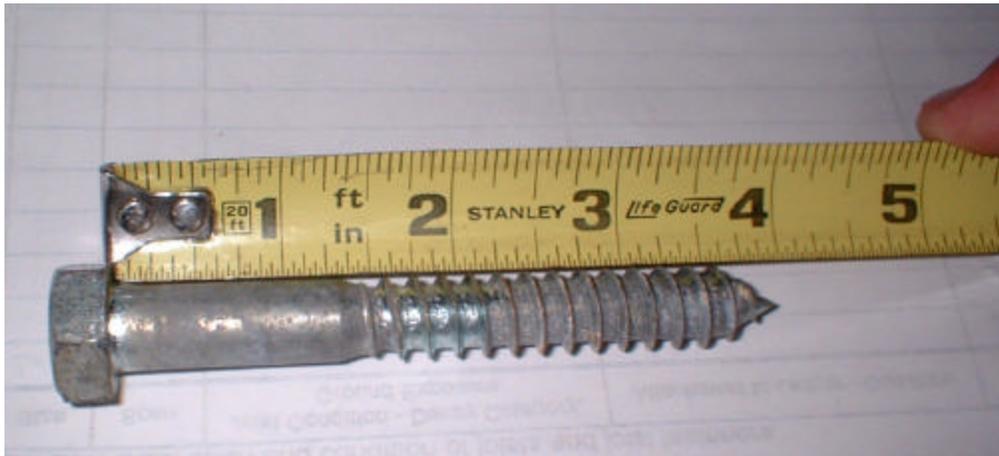
Figure 5.11. (a) The ledger screw (nominal 1/2"x4") was long enough for the pointed end to stick out of the band joist. (b) The shiny area on the ledger screw is where it penetrated the insulation.

As constructed, each lag screw must support 480 lb in shear or lateral loading. The penetration of the lag screw into the band joist was the full 1.5 in., which exceeds the 4D minimum ($4 \times 0.372 \text{ in.} = 1.49 \text{ in.}$) required for the use of the NDS-01 tables. The lateral strength of the lag screw was found using the yield equations in TR-12 (AF&PA, 1999). The analysis included the 1/2 in. gap (for insulation) between the ledger and the band joist. The design value for a 1/2 in. lag screw in this case was 120 lbs.

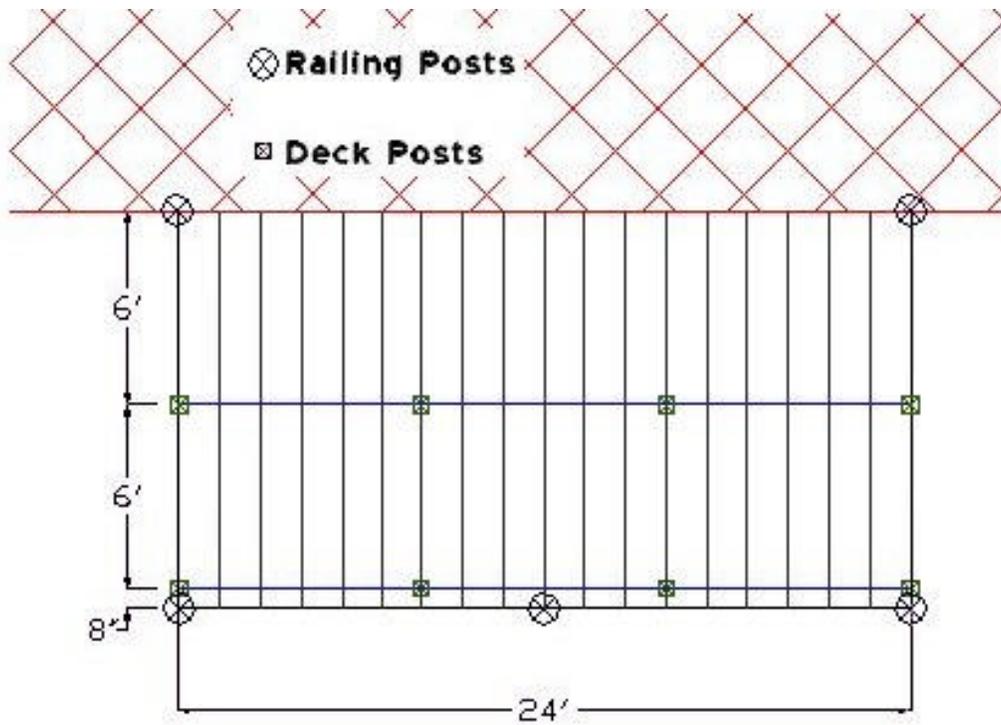
Figure 6.1. Plan view of Deck B showing the locations of joists, beams, rail posts and deck posts.

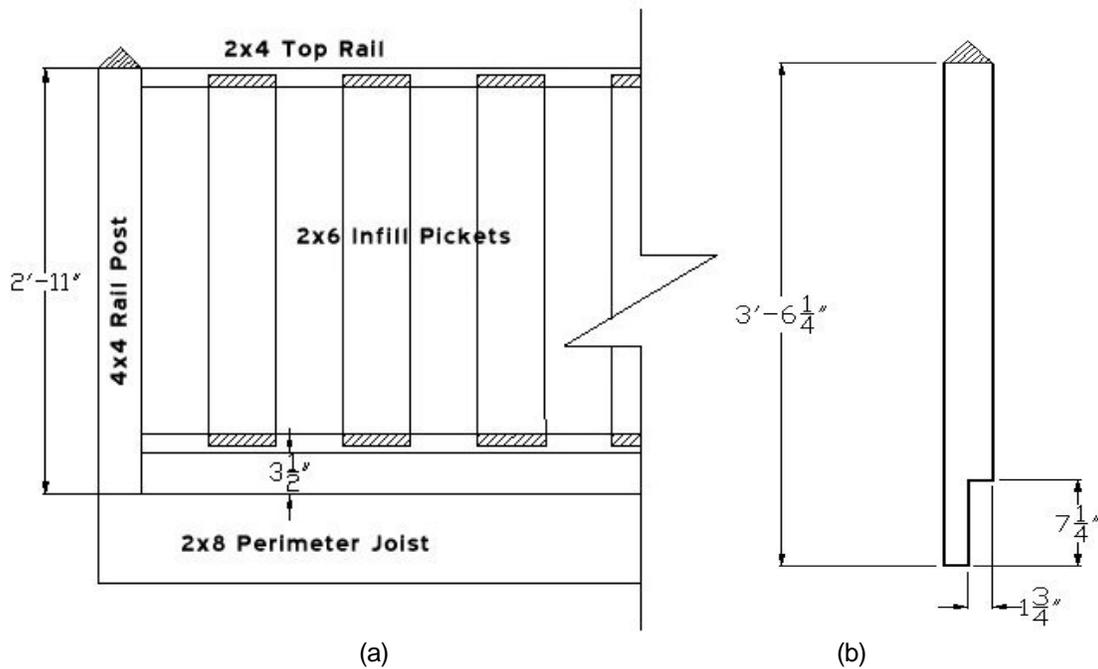
Figure 6.2. (a) A typical railing section. The 2x6 infill pickets were staggered on either side of a 2x4 cap rail. (b) A typical 4x4 rail post.

notches on the rail posts were too large. The assumed lag screws are not adequate to carry the design load. The IRC-2000 requirements on railings were not checked, as the railing is in need of a complete replacement. The railing was only 35 in. above the deck boards, 1 in. shorter than required by the IRC-2000.

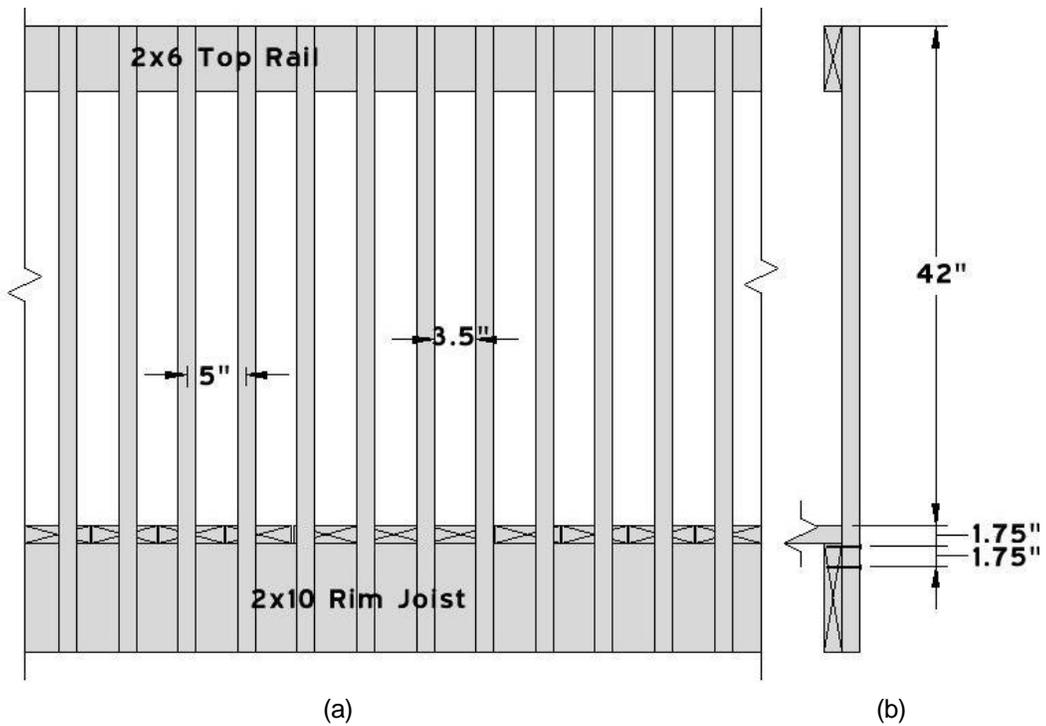
Figure 6.18. (a) A typical section of the railing on Deck F and (b) A typical picket from the railing on Deck F.

The railing pickets of Deck F were 2x2 Southern Pine. They were spaced 5 in. on-center, leaving a 3.5 in. open space between pickets. The pickets were anchored to the rim joist with two threaded nails of unknown length as shown in Figure 6.18(b). Building codes require the pickets to resist a 50 lb load distributed over a 1 ft² area. This loading was checked under the assumption of proper support at the top rail and at the attachment to the deck. Assuming the pickets were No. 2 grade, the results were that the pickets were adequate (Table 6.19.).

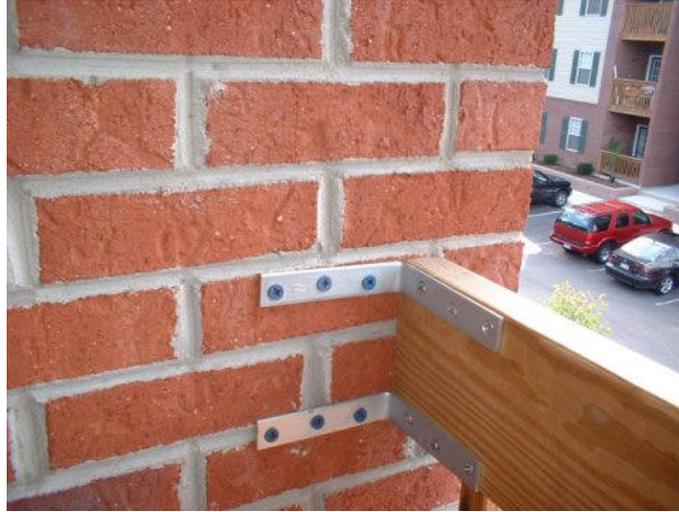
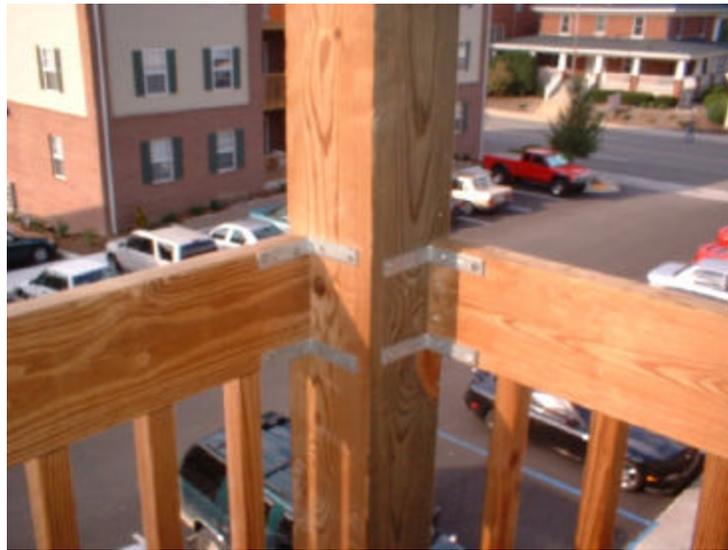
The top rail of the deck was attached to the brick siding of the building with L-brackets and six Tap-con screws, as shown in Figure 6.20(a) and to the post with L-brackets and four screws (Figure 6.20(b)). The thickness of the brackets was measured to be between 1/8 in. and 3/16 in. Using the actual dimensions in the NDS-01 for steel side plates (NDS-01, Table 11M), the brackets were determined to be 10 gage (0.134 in. thick). When the 50 lb/ft distributed load is applied outward, the screws would have to resist 177 lb total in shear. This is approximately 30 lb each for the Tapcon screws and 44 lb each for the screws at the post. As discussed in Section 6.5.4, the sample Tapcon screws were able to hold 180 lb each in shear when used to connect Southern Pine to Brick. With steel side members, this value would be greater. The smallest diameter wood screws with a steel side plate in Southern Pine (assuming ASTM A653, Grade 33 as used in NDS-01, Table 11M) would be able to resist 100 lb in shear. For this inspection, both the Tapcon screws and the screws into the post are adequate. In a professional inspection, the fasteners would be temporarily removed to find their actual dimensions and condition.

Figure 6.20. The top rail of Deck F was attached (a) to the building with six Tapcon screws and (b) to the post with four screws.

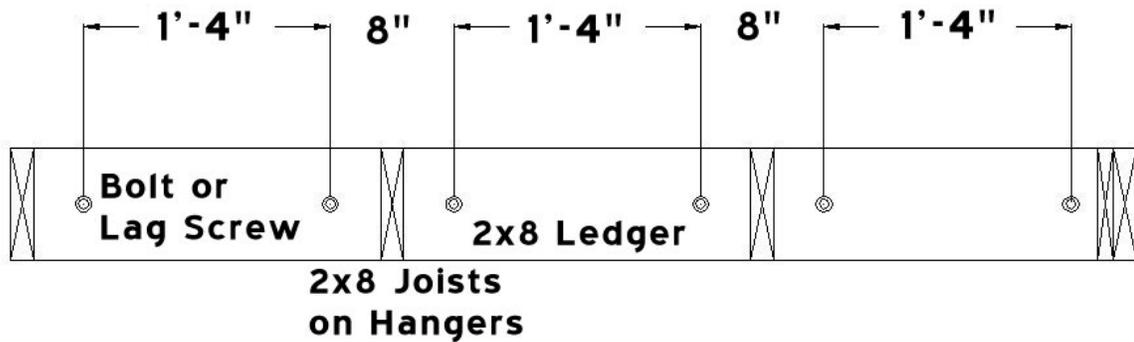
Figure 6.23. The fastener pattern of the ledger board of Balcony G.

Each fastener had a 5/8 in. head, which, assuming a lag screw, is a 7/16 in. lag screw (according to Appendix L of the NDS-01). For an actual inspection, the size and type of connector should be determined. The material between the ledger and the framing of the building could not be determined without removing the ledger boards. Table 6.26 shows the allowable design loads and the actual loads on the fasteners. The allowable design loads were based on the assumption that the ledger and the rim joist of the building were in contact. This assumption was not verified and the actual connection details are unknown.

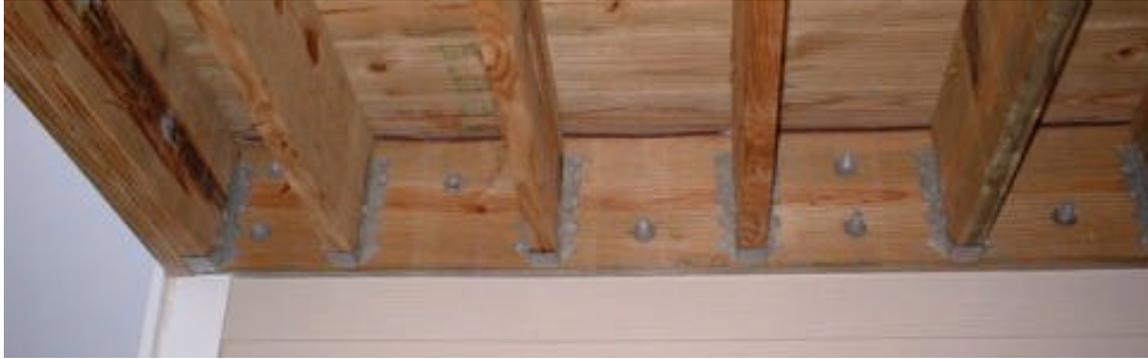
The ledgers for Balcony H were 2x10 Durapine (Southern Pine) boards attached to the building with 1/2 in. bolts with washers. The placement of the bolts is shown in Figure 6.28. The bolts are spaced approximately 12 in. on-center with two bolts in the center of the span and at the ledger ends.

Figure 6.28. One of the ledger boards on Balcony C showing the spacing of the 1/2 in. thru bolts used to hold the ledger onto the building.

Using the yield mode equations in the NDS-01 and assuming the ledger is attached to a 2x_ Spruce-Pine-Fir (SPF) band joist with nothing in between them, each bolt can carry 132 lb in shear. In the configuration shown in Figure 6.28, each bolt must carry 330 lb. Where there are two bolts, each must carry 165 lb.
