Bulletin 83-4

# Structural Development and Evaluation of a Modular House

Homer T. Hurst, P.E. and Research Professor Department of Agricultural Engineering

June 1983

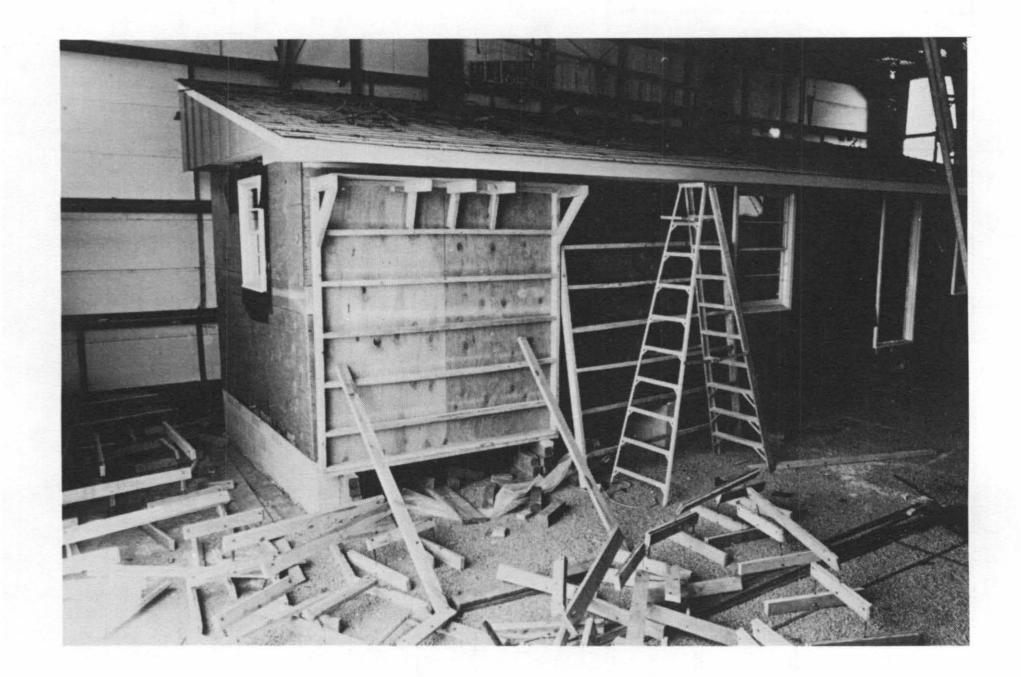
#### Fig. 3. THE MODULE

This 12' x 44' test specimen is framed entirely with one-inch S2S, sized two sides, No. 2 Southern Pine lumber. It is being rigged for simulated wind-load testing by (a) inflating an air bag between the front wall and a "reactor" wall which is under construction, and (b) up-lift forces on the roof by hydraulic cylinders (See Figures 5 and 6).

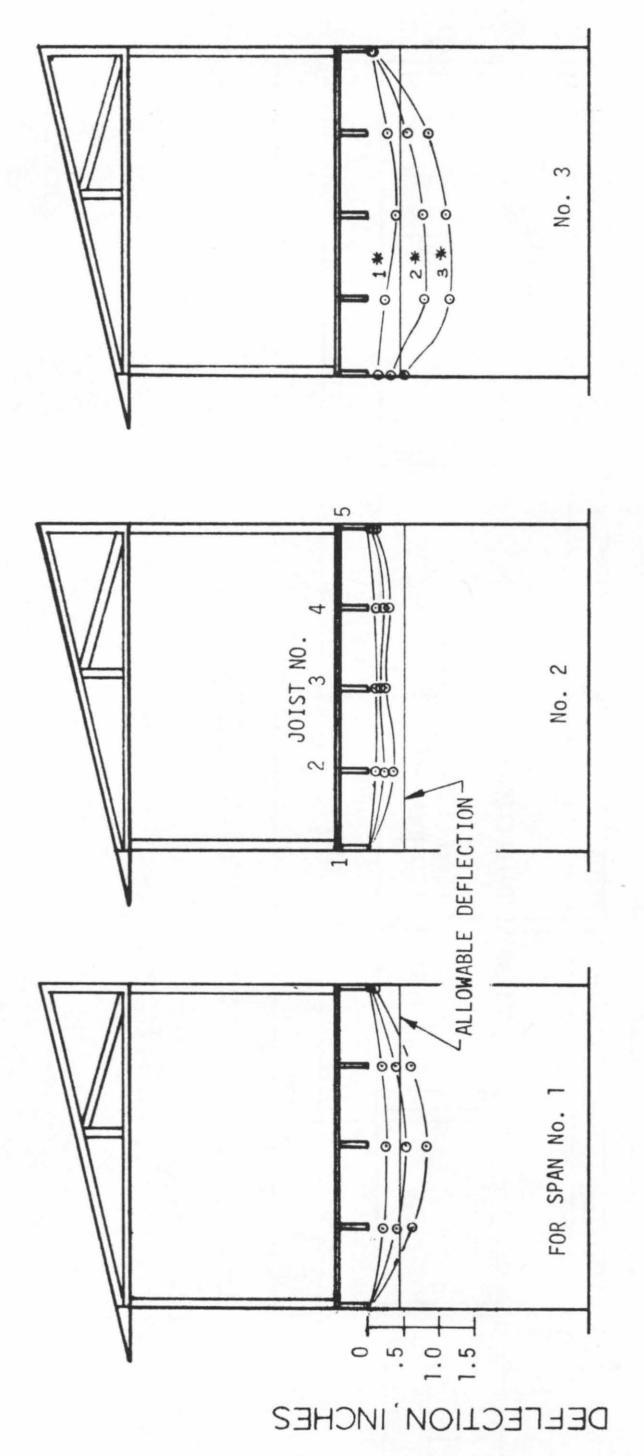
FLOOR SYSTEM DEFLECTIONS FOR INDIVIDUAL JOISTS OF EACH SPAN Fig. 9.

Deflection data for the floor-load tests up to 145.6 psf are presented in Table I. Graphical presentations of the floor performance are shown in Figures 8 and 9. Spans No. 1 and No. 3 are the same, and the loading was distributed as nearly uniformly as possible with air bags in all rooms and hydraulic cylinders under the closet area. Span No. I was obviously much more rigid than span No. 3. The difference in rigidity is attributable to composite action between the floor structure, and such elements as exterior walls of 3/8 inch plywood stapleglued to I x 4 studs with 1/2 inch gypsum board glue-nailed. These elements were very effective in stiffening the floor below. This is well illustrated in Figure 9 in that joist No. I deflected only about 10 percent as much as in span No. 3. Also, the exterior wall over joist No. I of span No. I has a double window over the center of the span and a door almost over the interior support (Fig. 8). The door opening probably weakens the wall most because it is so near the support. These open-

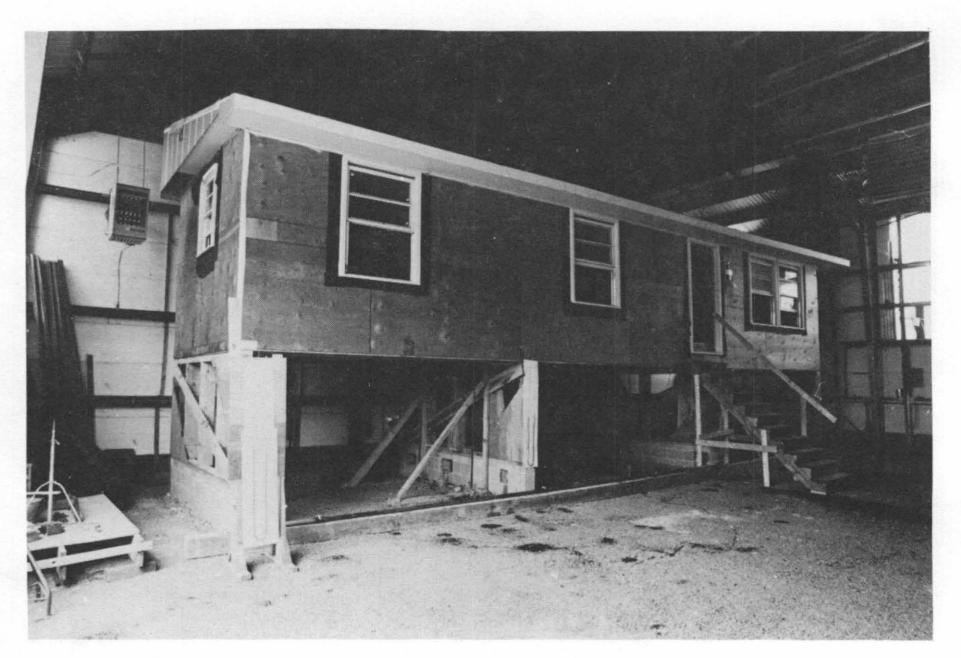
Fig. 11. MODULE ELEVATED FOR FLOOR LOAD-TESTING

In order to rig and instrument the module for floor testing, it was necessary to elevate it from normal foundation height (Fig. 3) to that height shown in Figure II. Each joist was instrumented with a continuous deflection recorder at all supports and at or near midspan where deflection was expected to be greatest. Corrected net deflection of each span was obtained by subtracting support settlement from the total recorded deflection.
