LOAD TESTING DETERIORATED SPANS OF THE HAMPTON ROADS BRIDGE-TUNNEL FOR LOAD RATING RECOMMENDATIONS

Masters of Science
In
Civil Engineering

November 29, 2016
Blacksburg, Virginia

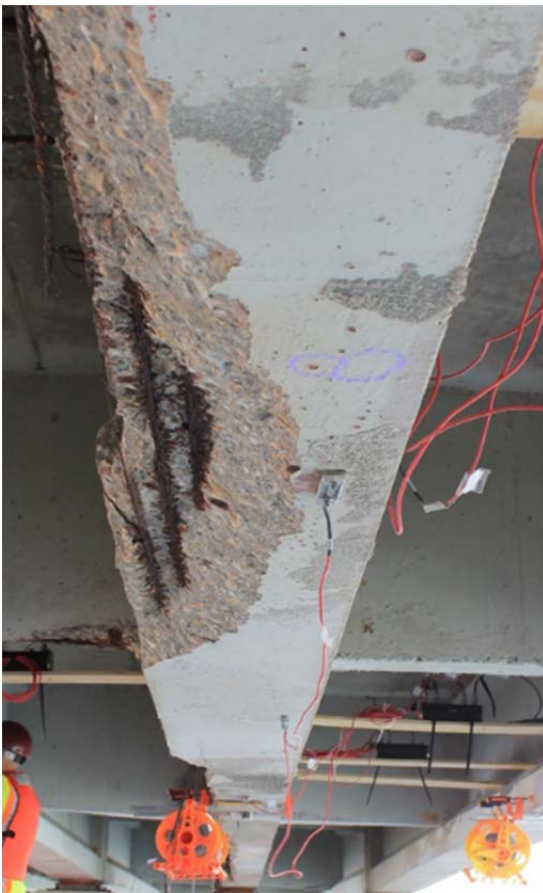
b) Girder 8 Bottom Flange Soffit

Span 31 was designated as the “bad span” for the westbound tests. Girders 7 and 8 exhibited the most damage in their flexural region as shown in Figure 23. Girder 8 had four layers of prestressing strands exposed along the side of the bottom flange for approximately 70% of the span length. The strands showed heavy corrosion while some strands were completely severed. In Figure 23b, the orange reel is at midspan of girder 8 and the purple “8” chalk mark is 8 ft – 4 in. from the pier cap face ($\sim L/5$). Girder 7 had only three layers of strands exposed on the side of the bottom flange, but also had strands exposed on the soffit of the bottom flange (Figure 23c). The deterioration mapping diagrams from the Clark Nexsen inspection report dated June 2015 were accurate for all spans. Figures from this report of the damage mapping are presented in Appendix A.

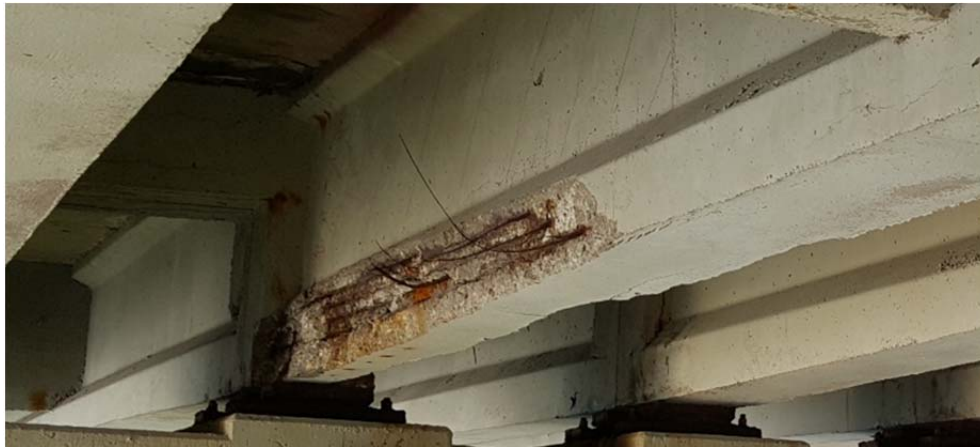
a) Girder 4 Bottom Flange at Support

Span 34 was also defined as a “bad span”, with damage primarily located in the shear critical region of the span. Near the bearing point, girder 4 exhibited significant damage on the bottom flange. This included heavy corrosion and a number of deteriorated strands within the primary three layers of flexural reinforcement. Figure 24 provides an illustration of this damage within the shear zone. It should also be noted that this girder had delamination and strand corrosion at midspan (see Figure 24b).

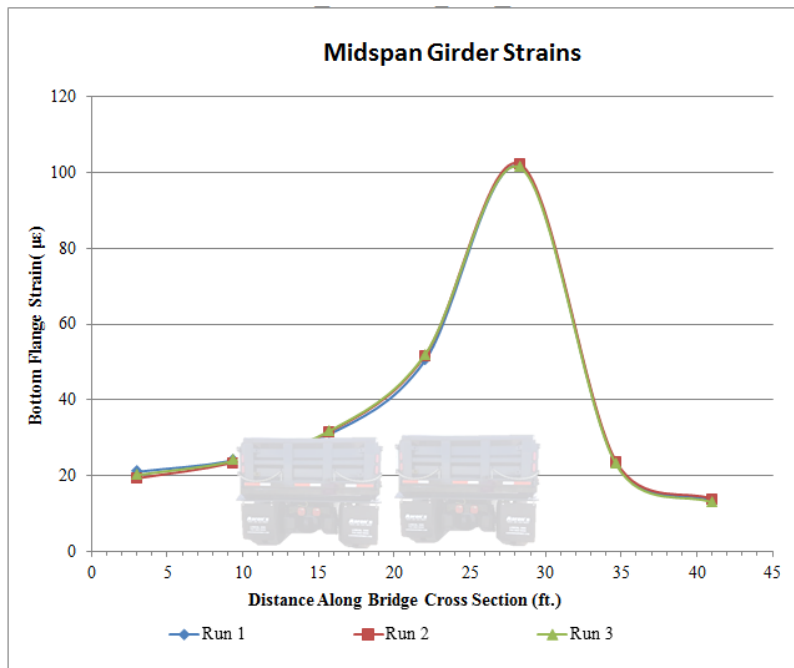
Figure 48: Eastbound Span 56 Midspan Strain Distribution

The BDI system performed extremely well during the first round of testing, yielding a large amount of usable data. The midspan strains are plotted along the cross section for truck configuration 5 in Figure 48.

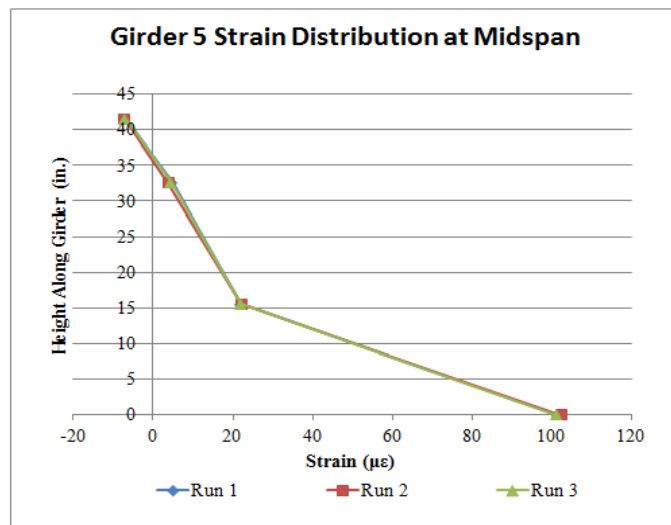
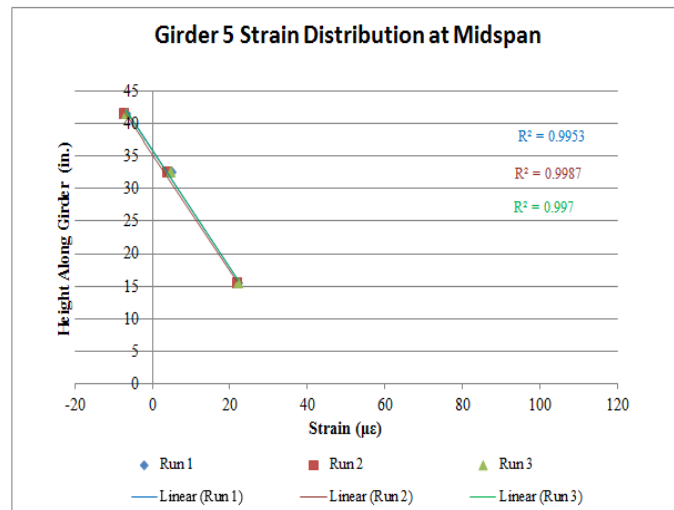
Figure 49: Eastbound Span 56 Midspan Vertical Strain Distribution

The strain values in Girder 5 were extremely elevated due to the deterioration to the girder. This was consistent through all of the truck configurations, even if the truck was on the

opposite side of the cross section. The vertical strain distribution of this girder at midspan, shown in Figure 49, illustrates this behavior.

The strain distribution was still linear in the undamaged portion of the girder cross section. Overall, the strain distribution exhibited bilinear behavior due to the damage causing the strain distribution slope to change. Since this data was post-processed prior to the westbound test, another strain transducer was added between the bottom two transducers on the westbound girders so a better understanding of the strain distribution could be obtained during the westbound testing. The bilinear distribution was not representative of the entire girder. The

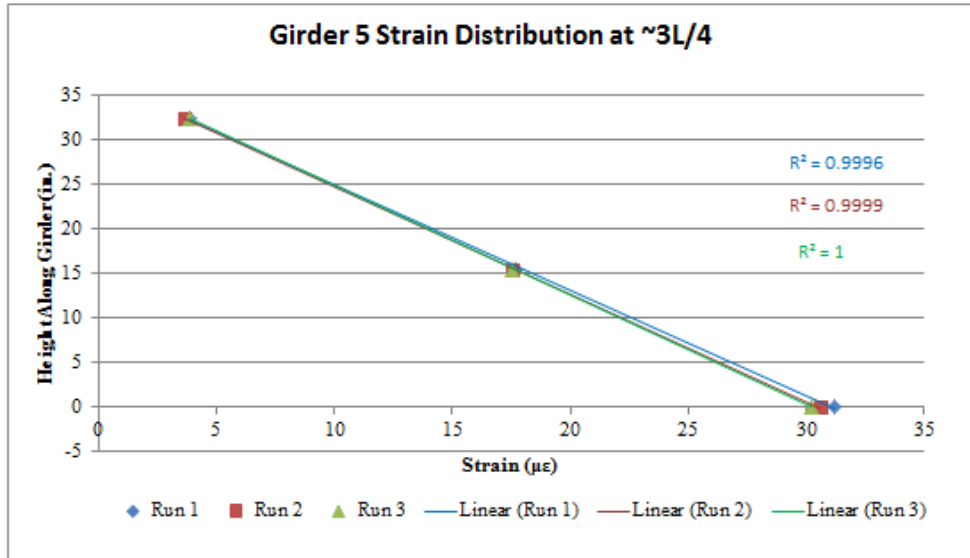
Figure 50: Eastbound Span 56 Girder 5 3L/4 Strain Distribution

instrumentation at the 3L/4 location showed extremely linear strain distributions as shown in Figure 50. This proves that the strain distribution only changes in the locally damaged areas, not over the entire length of the girder.

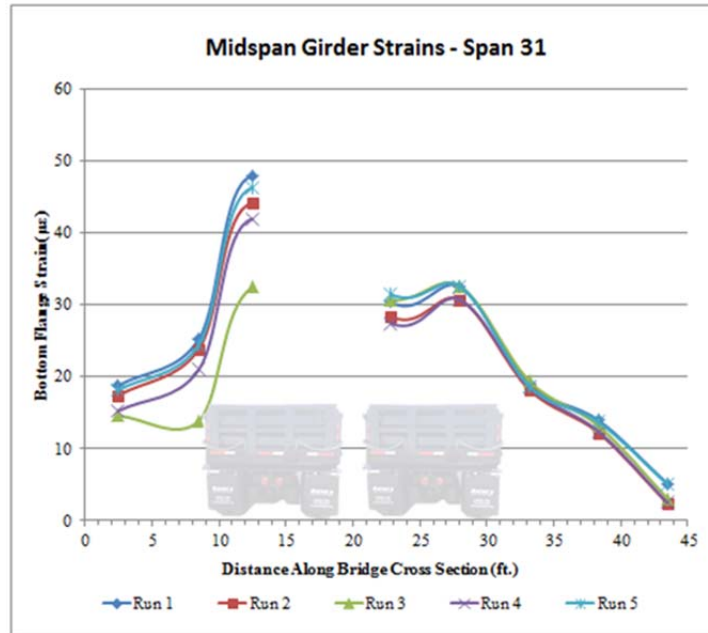
Figure 55: Span 31 Midspan Girder Strains

The strains in westbound span 31 resulting from truck configuration 5 (one truck in each the travel lane) are shown in Figure 55. As expected, the bottom flange soffit strains in girder 7 were relatively high because of the extensive damage. The strains (girder 6 omitted) were plotted across the width of the bridge to show a load distribution. The distribution is looking in the direction of traffic, hence the back of the trucks being seen in Figure 55, so girders are plotted 9-1 from left to right to keep the same numbering convention from VDOT inspection reports. The strain values recorded from girder 6 appeared abnormally low and did not show much variance in magnitude between different truck configurations so this data was considered faulty and was therefore omitted. The faulty data could have been from bad contact between the strain transducer and the concrete if the contact adhesive didn't fully adhere. It could also be from gauge placement. If the gauge was adjacent to a microcrack, the crack opening and closing would cause low strain values adjacent to the crack and much higher strains if the gauge bridged over the microcracks. It is also possible that the gauge was fastened to delaminated concrete/shotcrete which would cause minimal change in strain readings. Regardless, the data

was omitted as shown in Figure 55 where the trendlines are not continuous between girders 5 and 7.

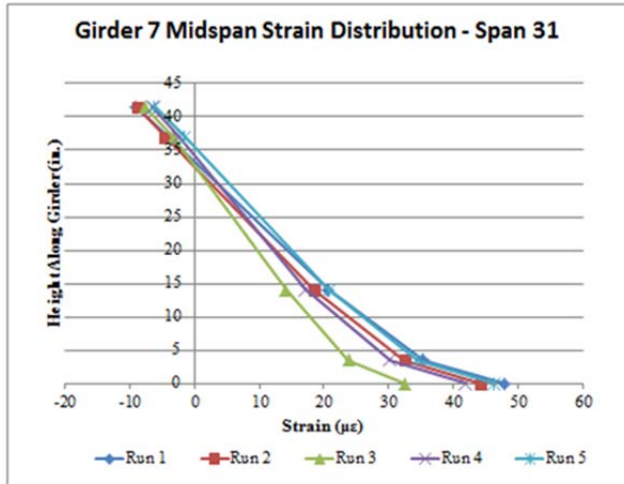
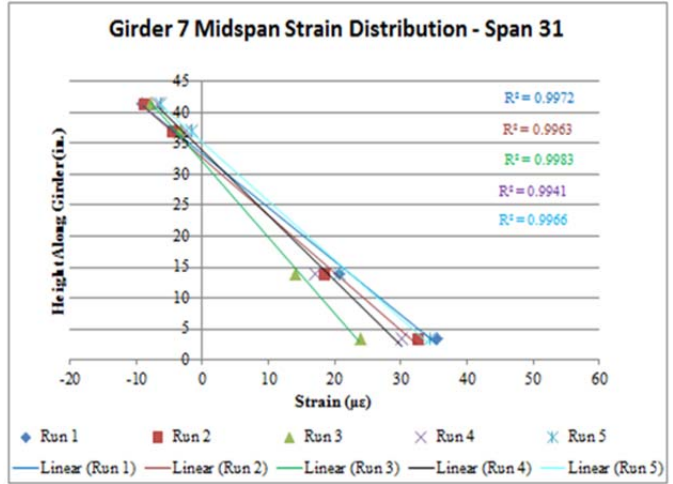
Figure 57: Span 31 Girder 7 Midspan Strain Distribution

The vertical strain distribution data illustrates that the undamaged sections of the girders exhibited a linear strain distribution. However, the localized damaged region of the girders illustrated a nonlinear strain distribution (see Figure 57a). The strain distribution was linear above the damaged section as illustrated by the R^2 values in Figure 57b.

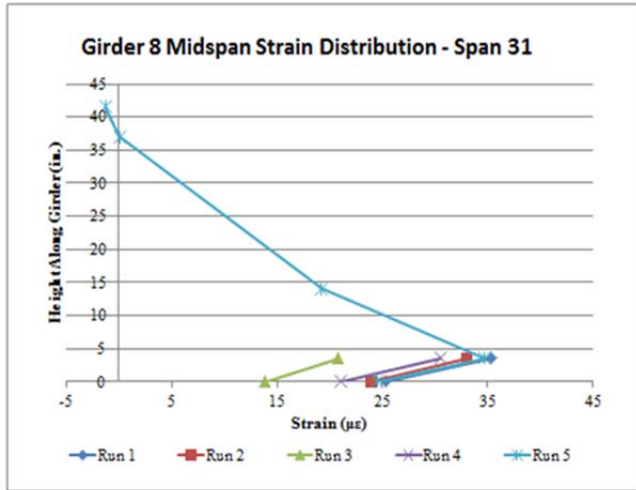
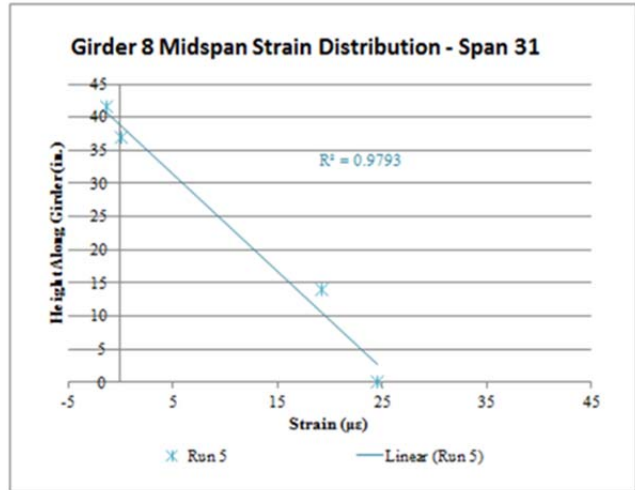
Figure 58: Span 31 Girder 8 Midspan Strain Distribution

The damage in girder 7 was mostly to the soffit of the bottom flange whereas girder 8 had damage near the mid-height of the bottom flange. Again, a strain increase was captured within the damage region as shown in Figure 58a. The data again illustrated that the strain distribution was linear above the damaged section with an R^2 of roughly 0.98 (see Figure 58b). The minimal amount of data in these plots is attributed to the node communication problems during the load tests. Only Run 5 was able to capture data for all of the transducers along the depth of the girder cross section. Runs 1 through 4 only captured data for the bottom two transducers which were working off a different node than the other three gauges. Overall, the data from the first four runs still correlated very well with Run 5.

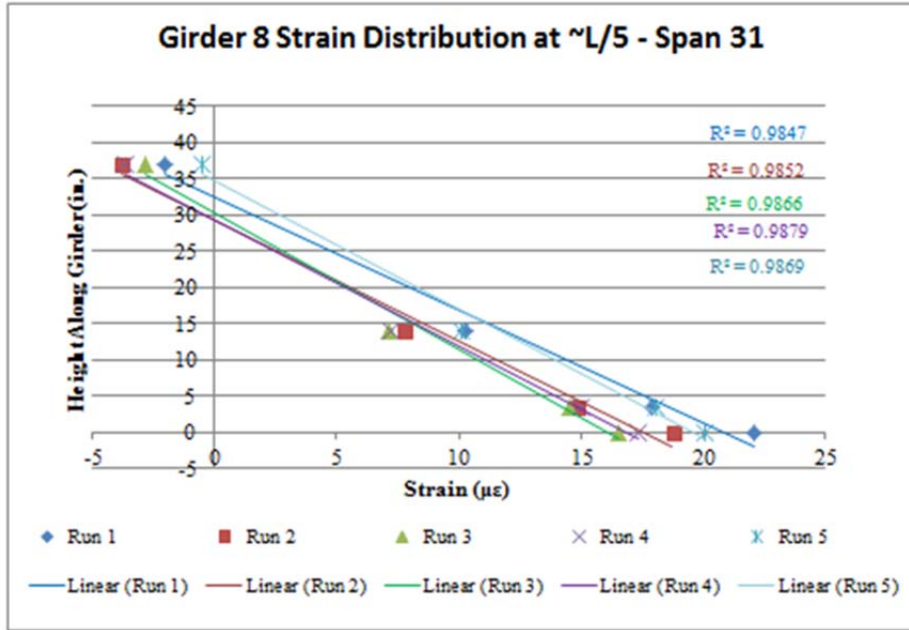
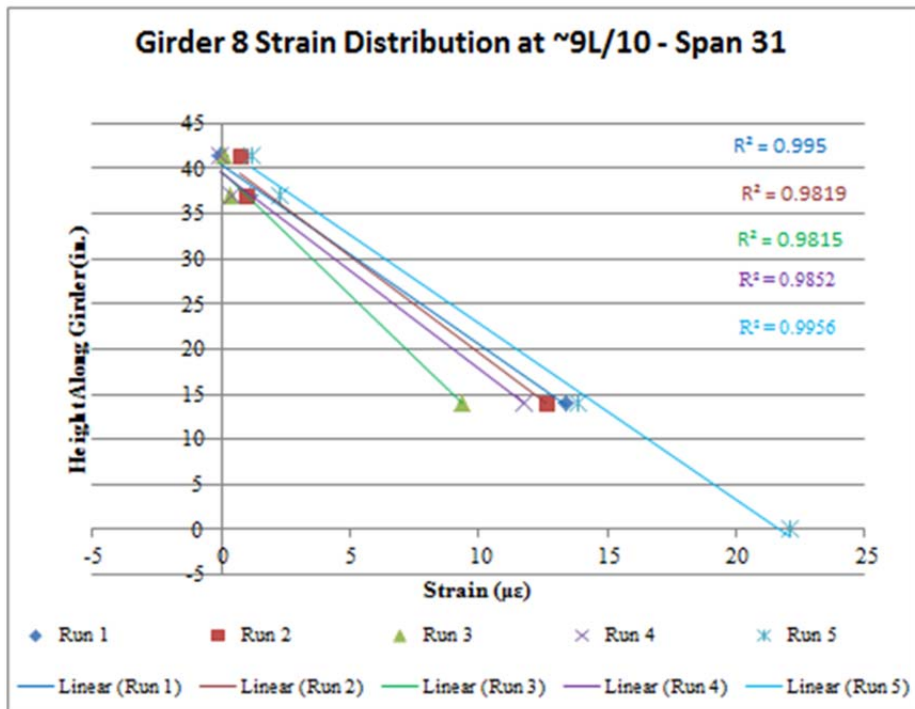
Figure 59: Span 31 Girder 8 Shear Location Strain Distributions

Data was also collected at two locations of shear damage on girder 8, L/5 and 9L/10. Both of these locations showed linear strain distributions with R^2 values of 0.98-0.99 as shown in Figure 59a and b.

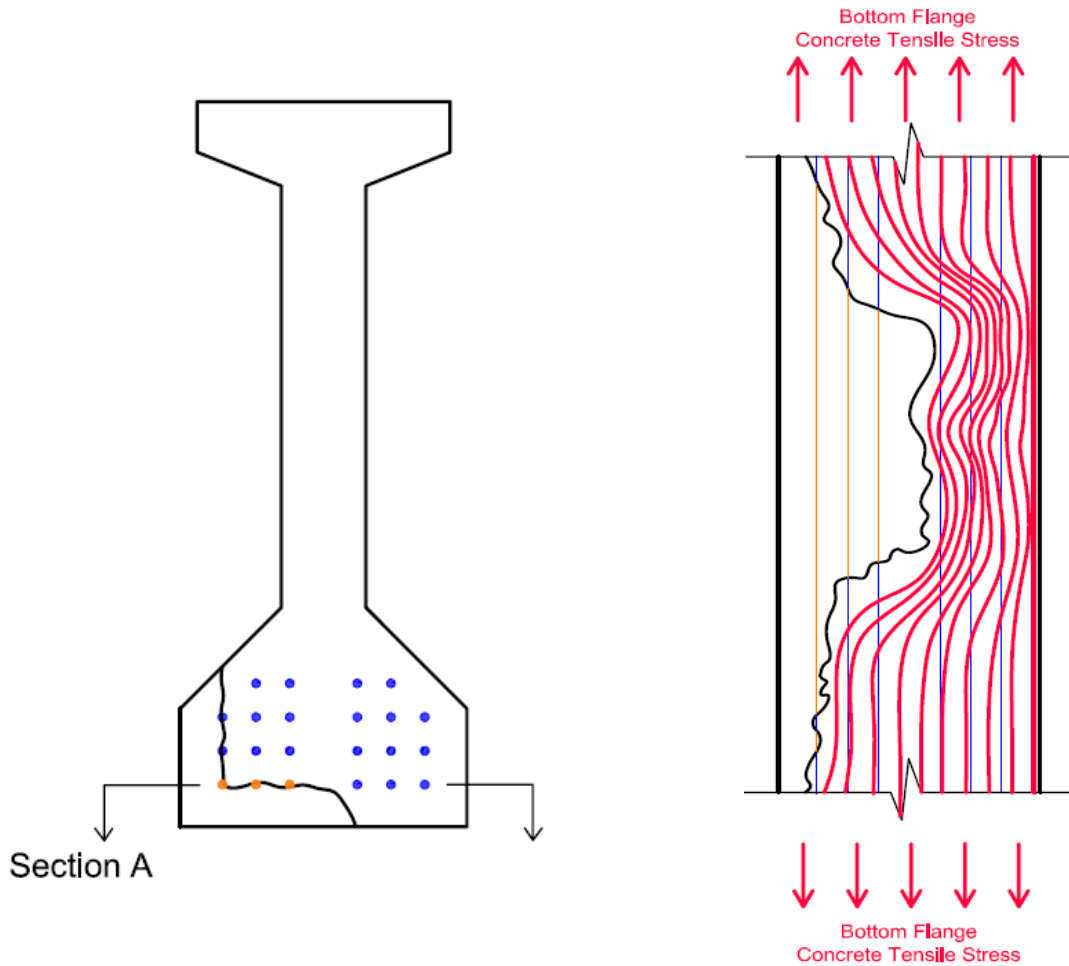
Westbound Span 31 Girder 7 Midspan
Cross Section

The second hypothesis explains the strain increase using stress redistribution within the damaged bottom flange. For example, in girder 7 of westbound span 31, only a portion of the flange was damaged. It has already been proven that no load shedding occurred between adjacent girders so the damaged girder would have to carry a full load through its damaged and undamaged cross sections. More specifically, the tensile stress being carried by the bottom flange would have to transition from a full width flange to a smaller width flange. The smaller flange would represent the portion of the flange that was not deteriorated within the damaged cross section. This is illustrated in Figure 70. Since the same stress would have to pass through

the damaged cross section as the undamaged cross section, a stress concentration would be formed since there is less area to carry the same load. It is possible that the strain transducer was capturing this stress redistribution which would explain the elevated strain values in the test results.

Figure 70: Damaged Cross Section Stress Redistribution

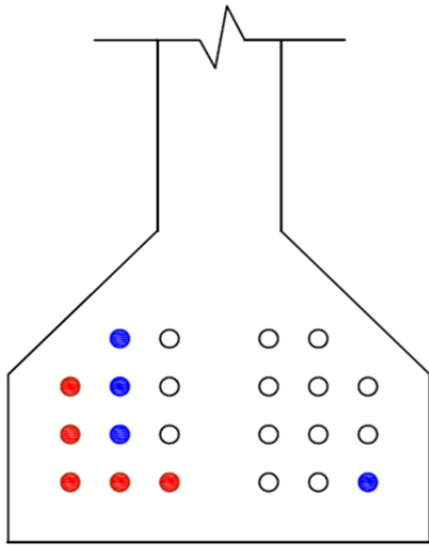
a) Span 31 Girder 7 Midspan

Figure 74: Midspan Girder Strand Deterioration

Some girders exhibited damage over their entire length, such as girder 5 in eastbound span 56. In cases such as this, it is recommended to neglect all prestressing strands in the lowest layer due to extensive spalling of the concrete. Engineering judgement should be used for prestressing strands that are not yet exposed in the damaged regions. For example, on girders 7 and 8 in span 31, the concrete showed signs of longitudinal cracking suggesting that the strands that are currently still enveloped in concrete are undergoing corrosion to an unknown extent. It is recommended to use a minimum of 25% reduction in cross sectional area for these strands showing signs of longitudinal cracking and neighboring damaged areas (Naito et. al, 2010). If the above recommendations are implemented, Figure 74 indicates the strand layout that should be used when calculating the flexural strength of the damaged girders in the load rating. In addition, the Lehigh ATLSS report has a load rating example for an adjacent box girder bridge with corroded strands that may be helpful during the load rating process of the HRBT damaged spans.

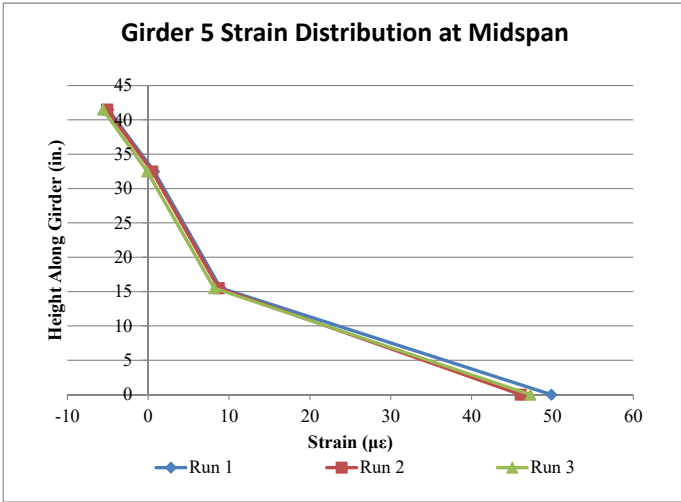
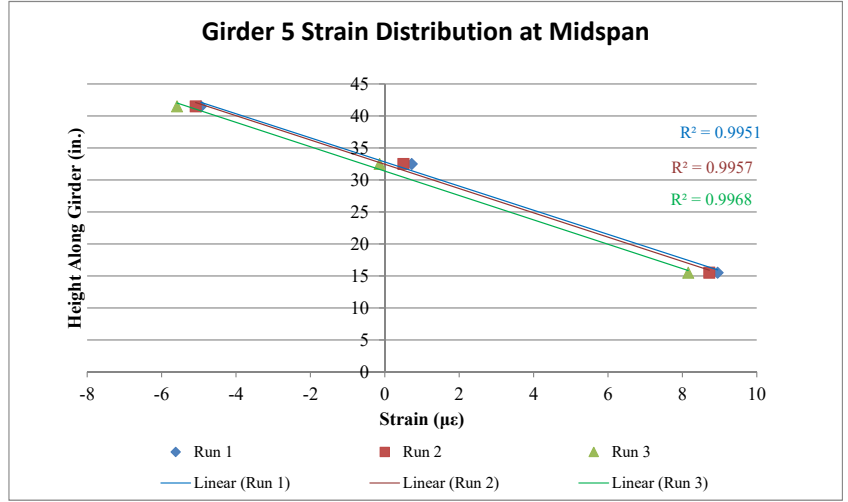
2. Girder 5 Strain Distribution at Midspan

Based on the observed data, there is a bilinear strain distribution caused by the damage to the bottom of the girder flange. The concrete is experiencing much higher strains than it would for an undamaged section. Due to the lack of sound P/S strands, the concrete is forced to carry higher strains.

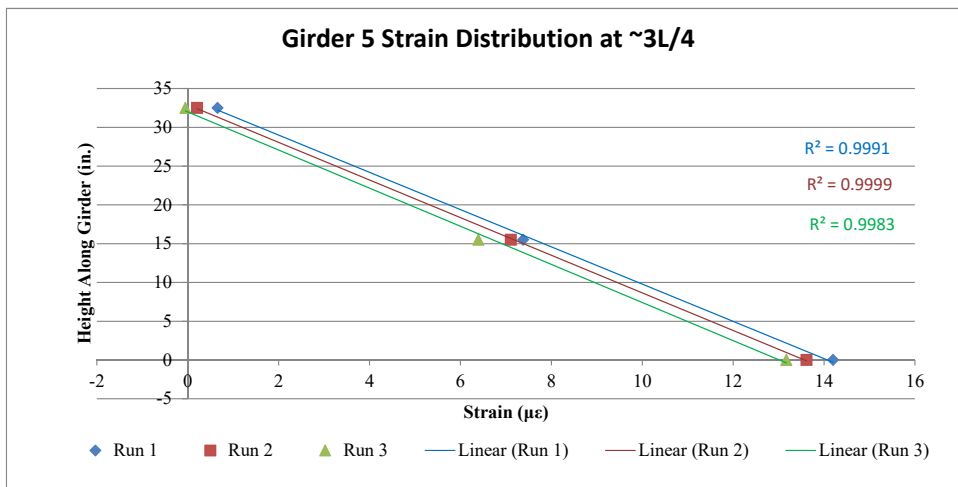
3. Girder 5 Strain Distribution at ~3L/4

** Based on the observed data, it is evident that the top flange strain transducer was not adhered to the flange fully. This led to faulty values.

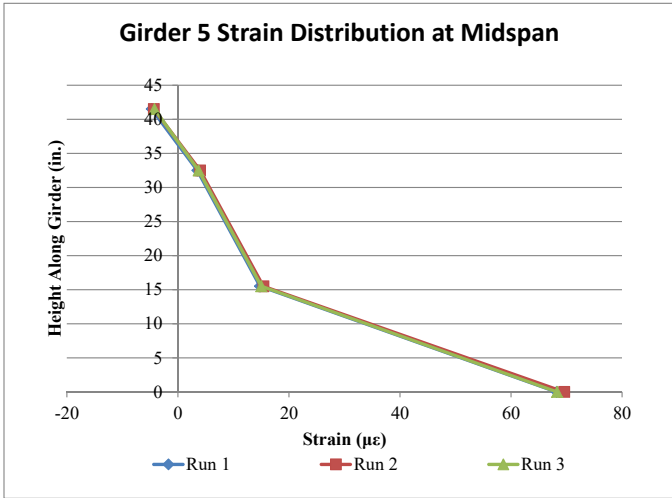
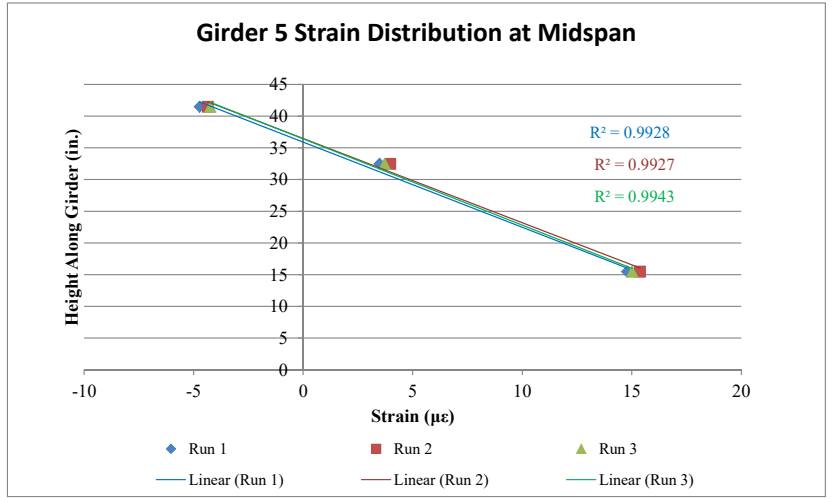
2. Girder 5 Strain Distribution at Midspan

Based on the observed data, there is a bilinear strain distribution caused by the damage to the bottom of the girder flange. The concrete is experiencing much higher strains than it would for an undamaged section. Due to the lack of sound P/S strands, the concrete is forced to carry higher strains.

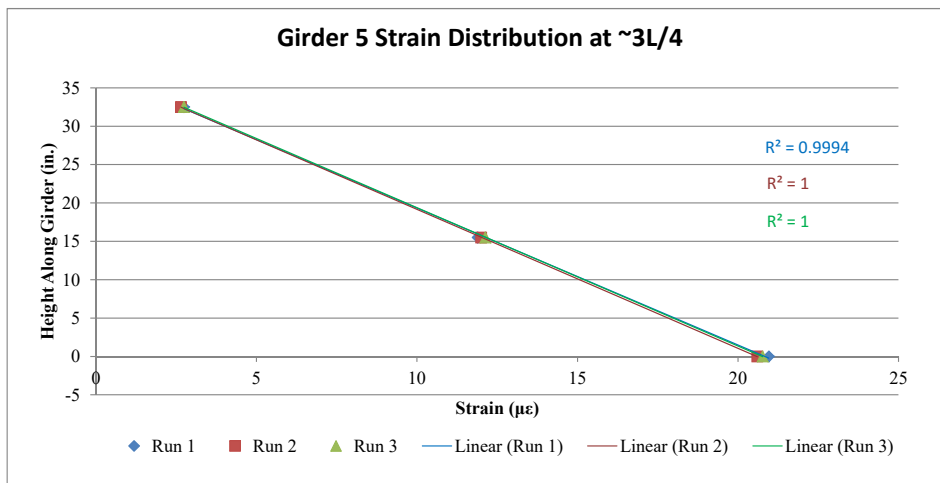
3. Girder 5 Strain Distribution at $\sim 3L/4$

** Based on the observed data, it is evident that the top flange strain transducer was not adhered to the flange fully. This lead to faulty values.

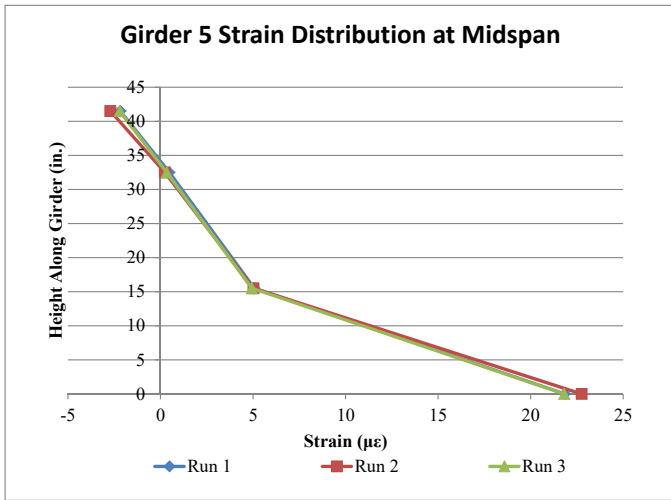
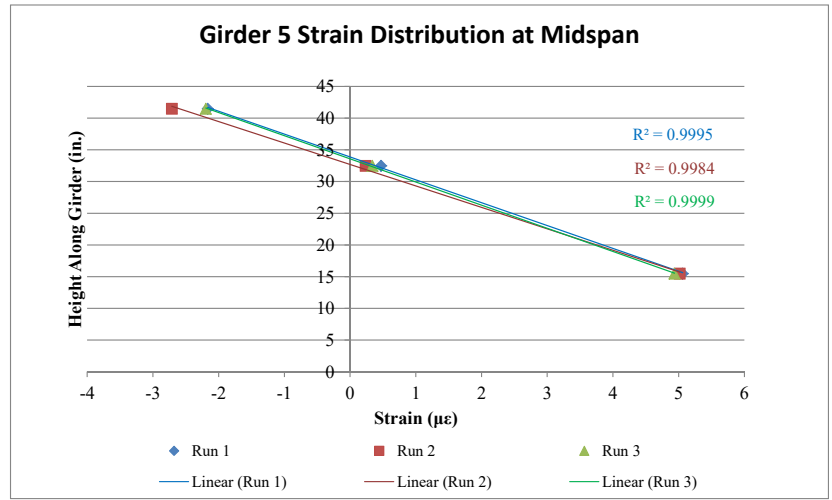
2. Girder 5 Strain Distribution at Midspan

Based on the observed data, there is a bilinear strain distribution caused by the damage to the bottom of the girder flange. The concrete is experiencing much higher strains than it would for an undamaged section. Due to the lack of sound P/S strands, the concrete is forced to carry higher strains.

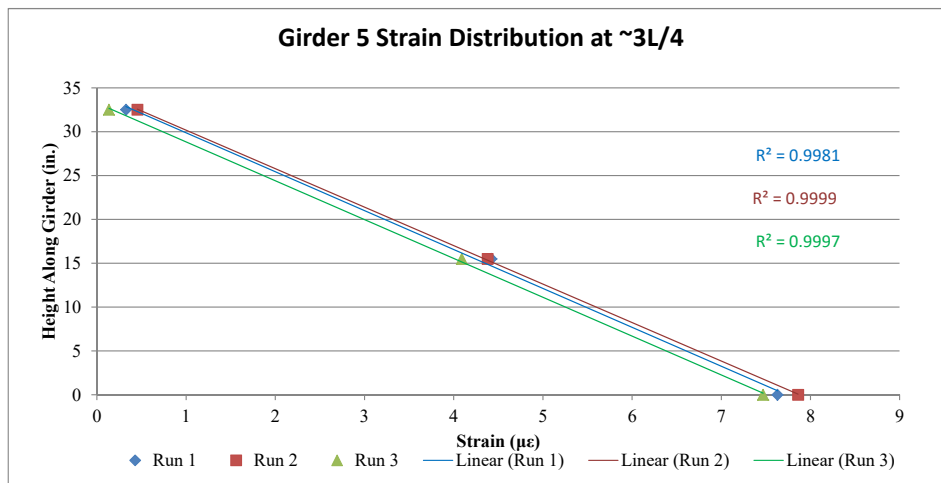
3. Girder 5 Strain Distribution at $\sim 3L/4$

** Based on the observed data, it is evident that the top flange strain transducer was not adhered to the flange fully. This lead to faulty values.

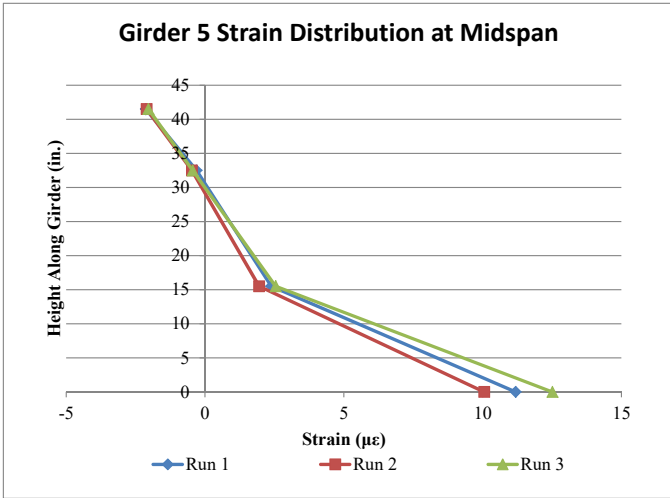
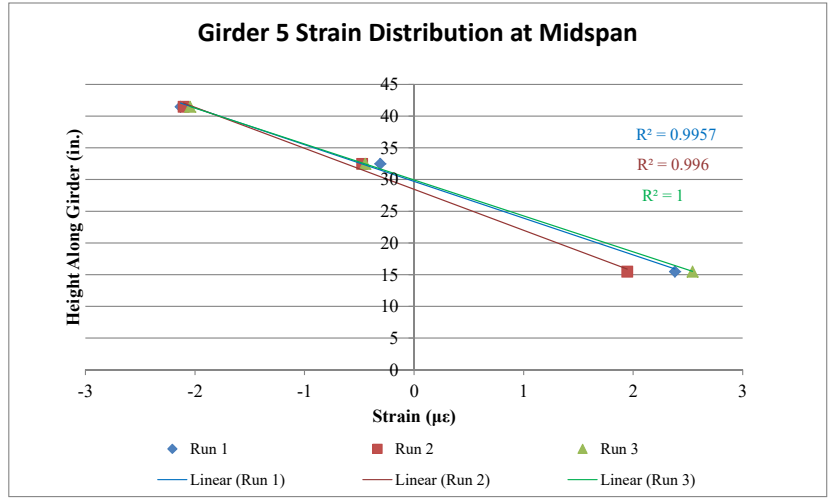
2. Girder 5 Strain Distribution at Midspan

Based on the observed data, there is a bilinear strain distribution caused by the damage to the bottom of the girder flange. The concrete is experiencing much higher strains than it would for an undamaged section. Due to the lack of sound P/S strands, the concrete is forced to carry higher strains.

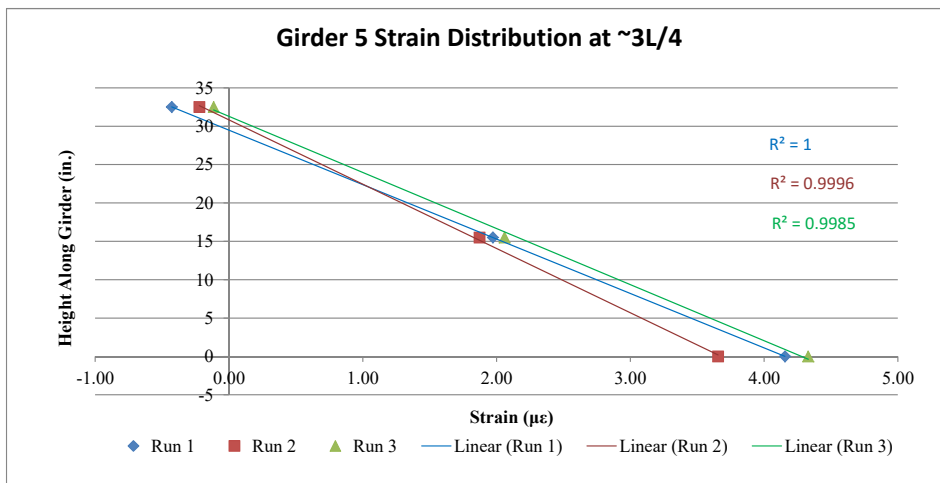
3. Girder 5 Strain Distribution at ~3L/4

** Based on the observed data, it is evident that the top flange strain transducer was not adhered to the flange fully. This lead to faulty values.

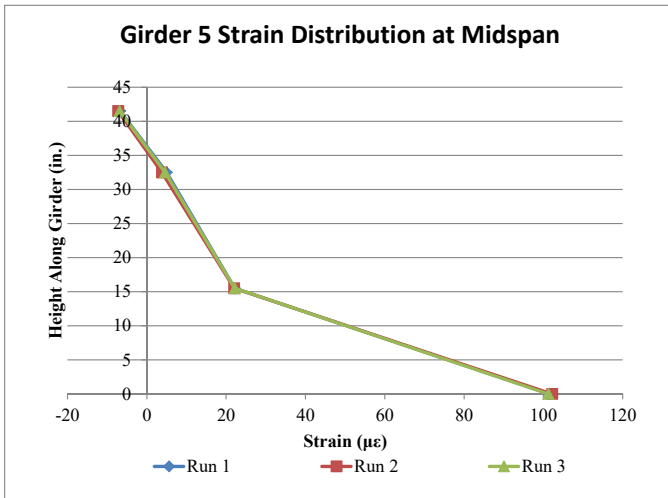
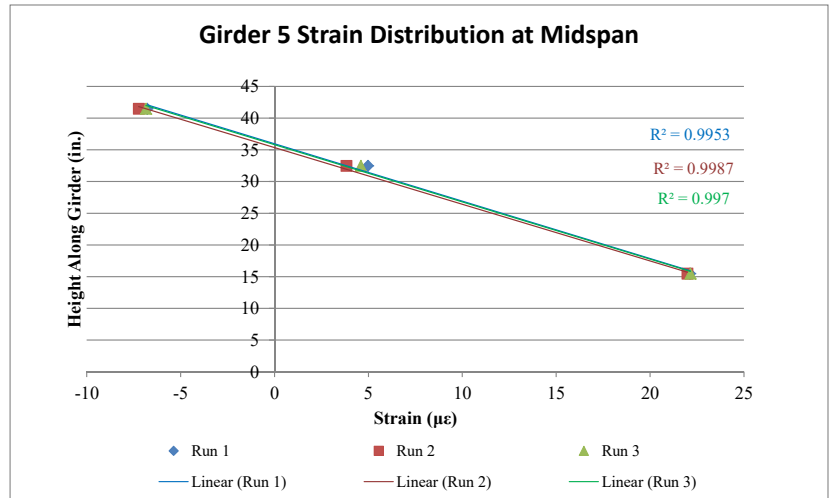
2. Girder 5 Strain Distribution at Midspan

Based on the observed data, there is a bilinear strain distribution caused by the damage to the bottom of the girder flange. The concrete is experiencing much higher strains than it would for an undamaged section. Due to the lack of sound P/S strands, the concrete is forced to carry higher strains.

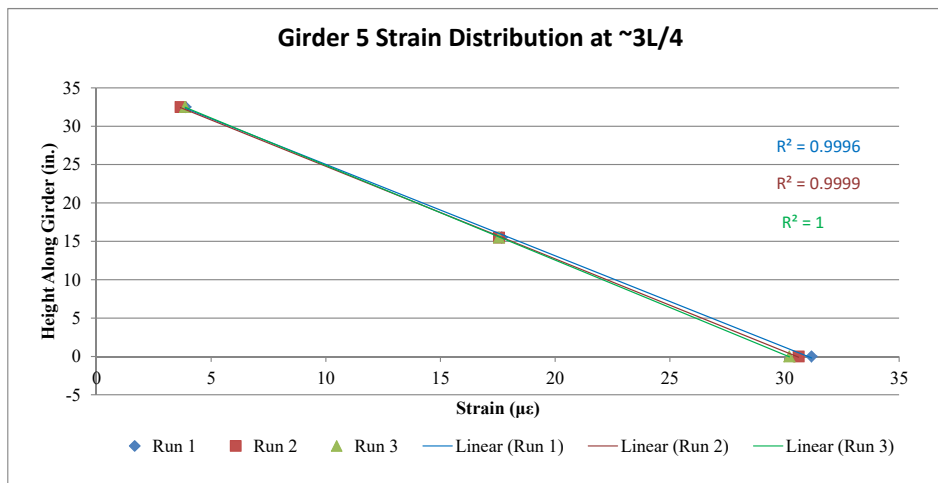
3. Girder 5 Strain Distribution at ~3L/4

** Based on the observed data, it is evident that the top flange strain transducer was not adhered to the flange fully. This lead to faulty values.

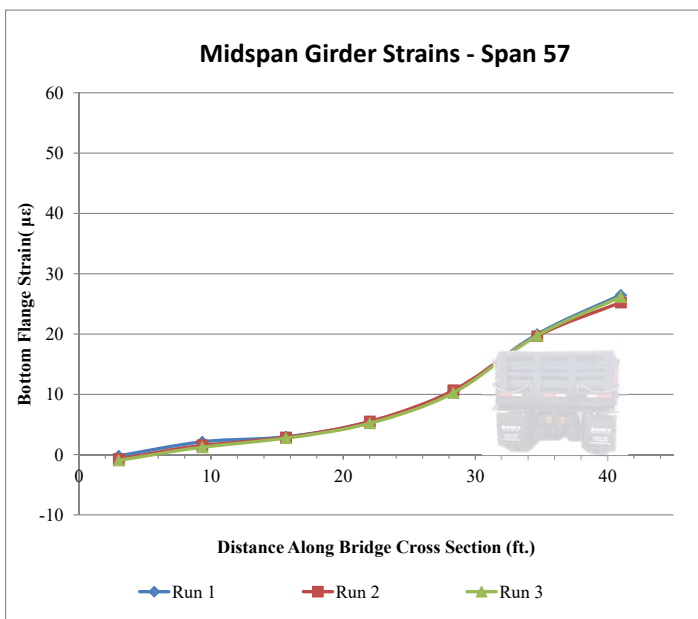
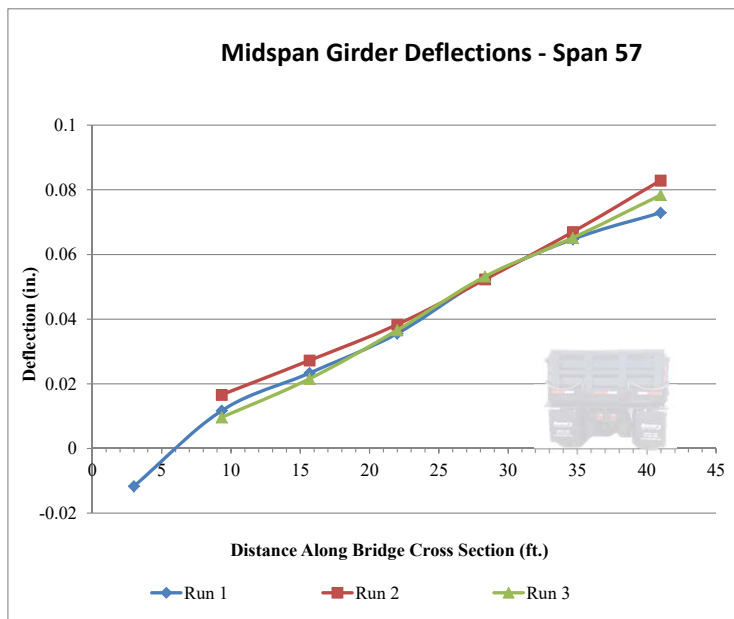
Note: The midspan deflection of Girder 1 was not captured for Runs 2 and 3 due to low quality (excessively dark) images acquired during testing.

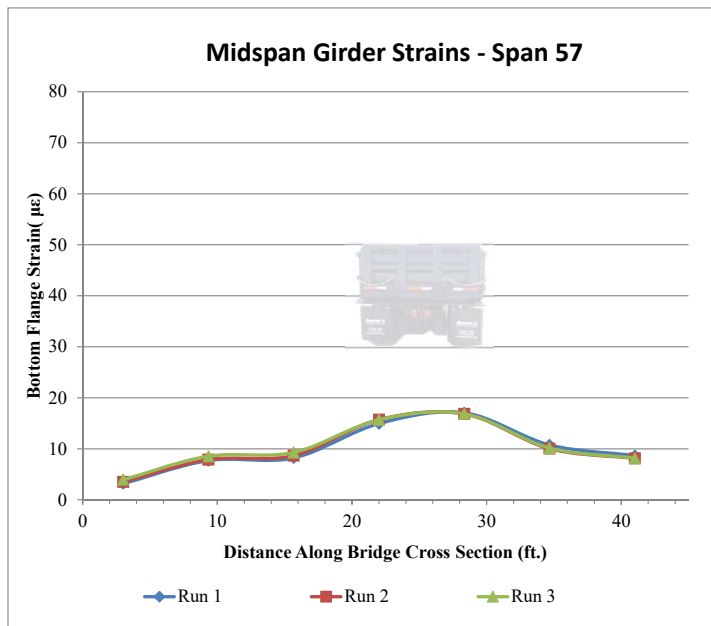
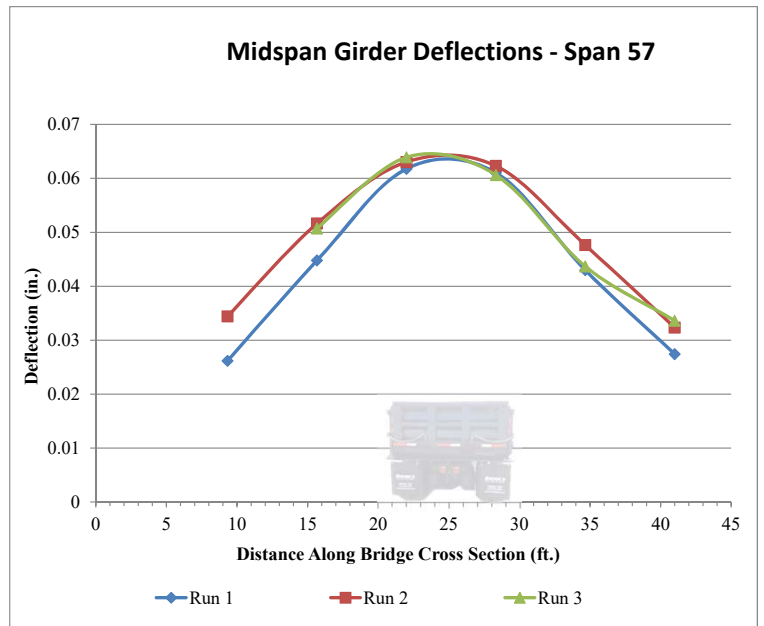
Note: No signs of obvious damage were present in Girder 2, but the peak response (or response not decreasing at a proportional rate for this load case) may be indicative of potential damage that is not observable.

Note: The midspan deflection of Girder 1 was not captured in any of the Runs (1-3) and for Girder 2 in Run 3 due to low quality (excessively dark) images acquired during testing.

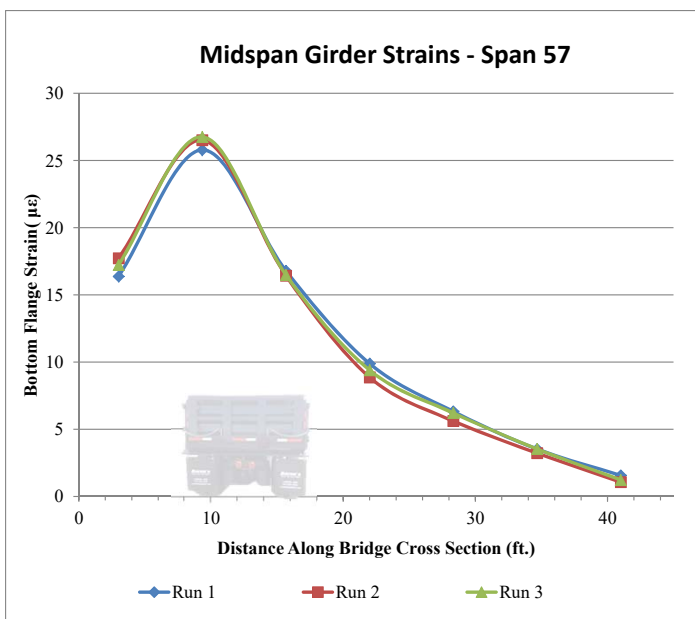
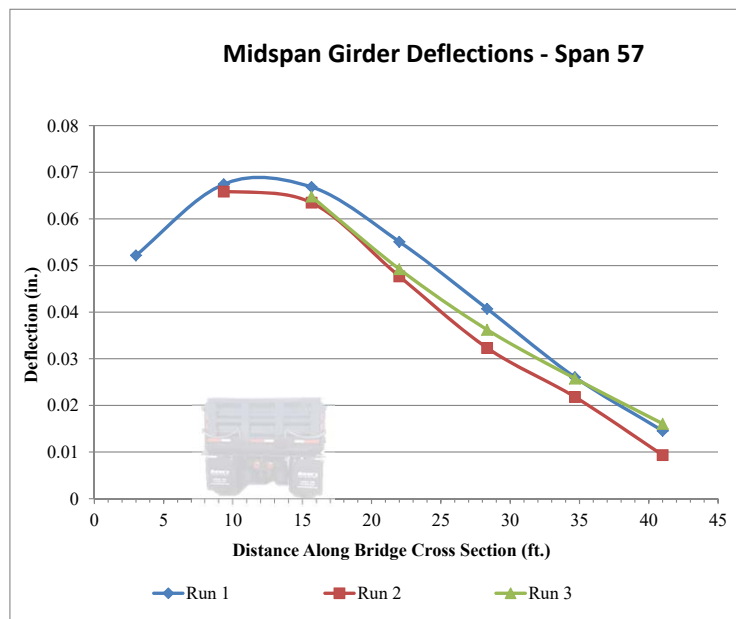
Note: No signs of obvious damage were present in Girder 2, but the peak response may be indicative of potential damage that is not observable.

Note: The midspan deflection of Girder 1 was not captured in any of the Runs (1-3) and for Girder 2 in Run 3 due to low quality (excessively dark) images acquired during testing.

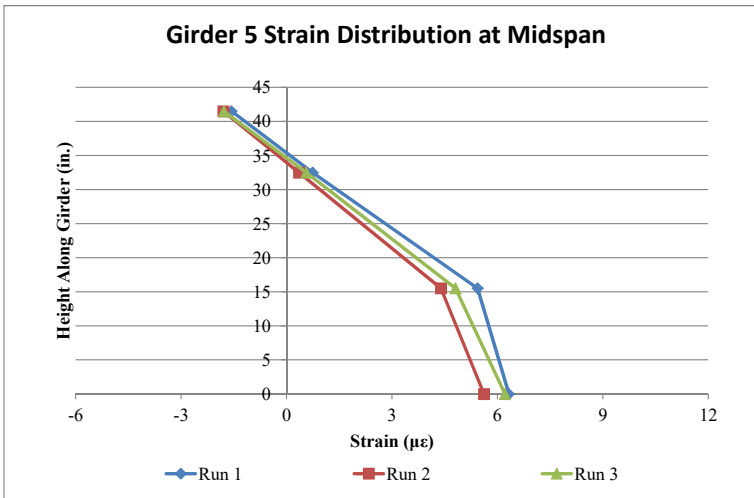
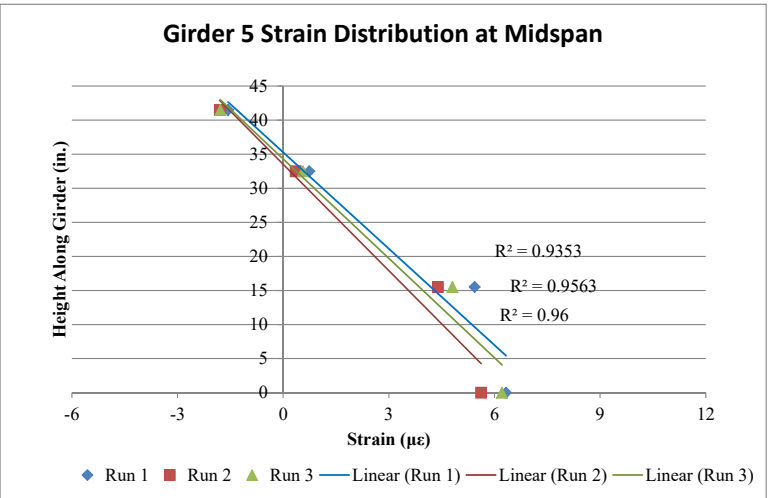
2. Girder 5 Strain Distribution at Midspan

* Based on the observed data, there is not a linear strain distribution at the low level of strains. The concrete is experiencing lower strains, and strands are forced to carry more strains.

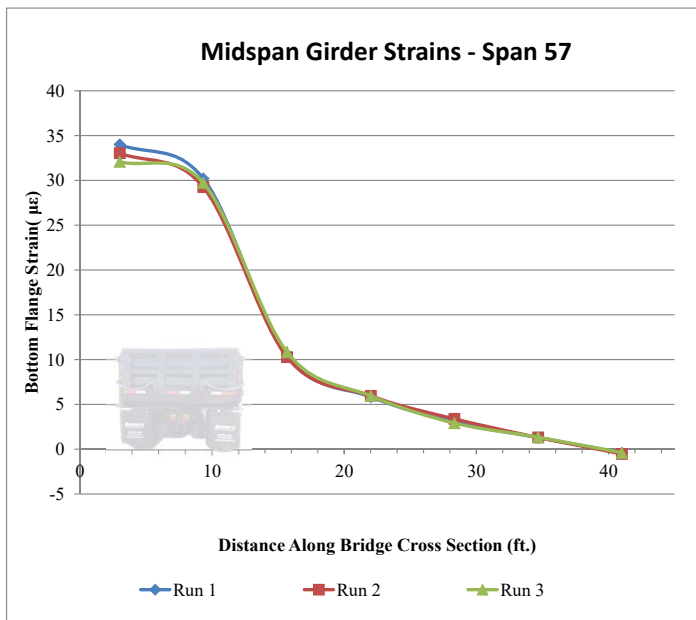
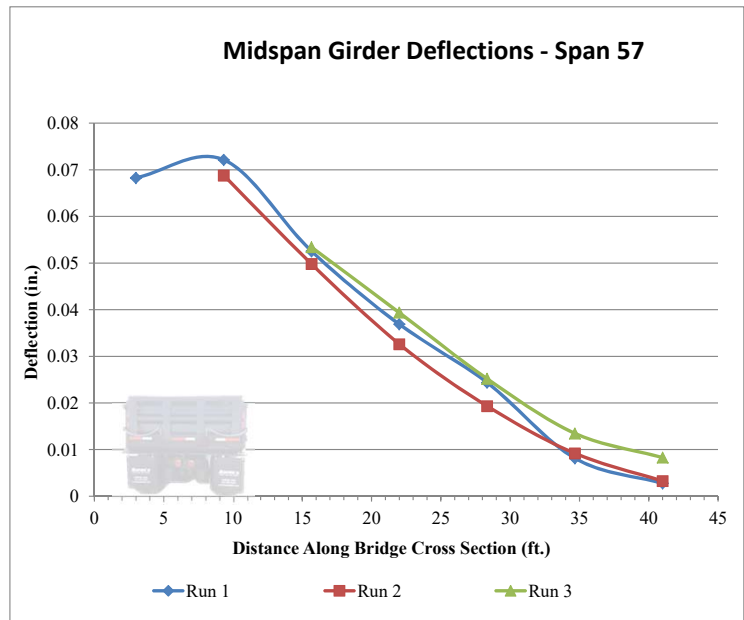
Note: No signs of obvious damage were present in Girder 2, but the peak response (or response not decreasing at a proportional rate for this load case) may be indicative of potential damage that is not observable.

Note: The midspan deflection of Girder 1 was not captured in any of the Runs (1-3) and for Girder 2 in Run 3 due to low quality (excessively dark) images acquired during testing.

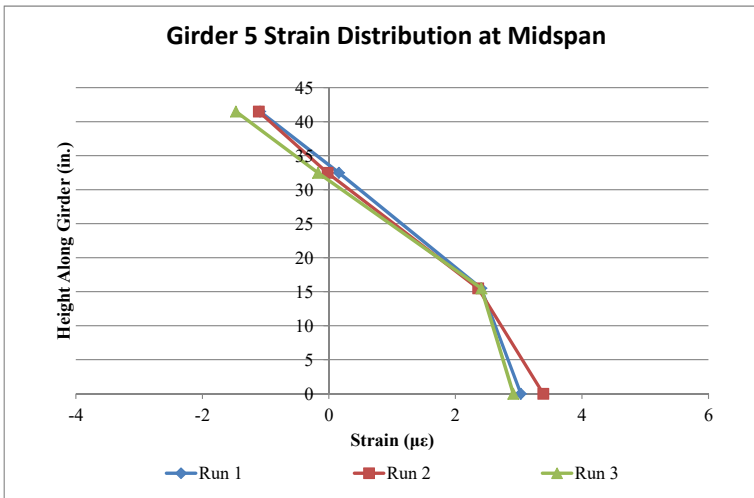
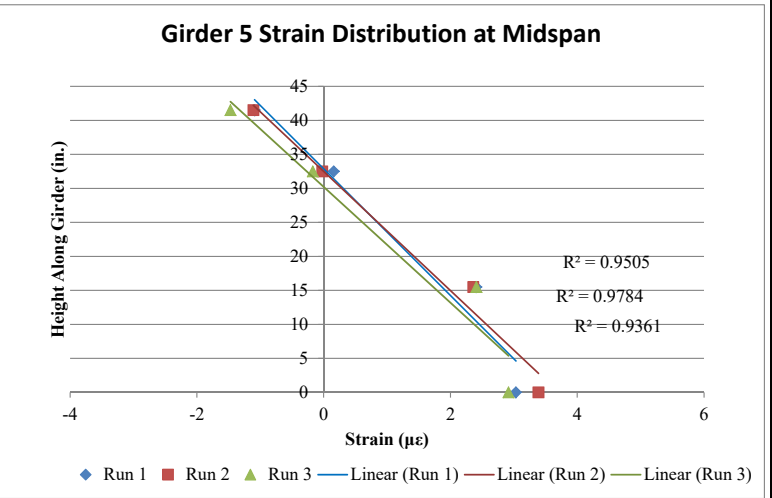
2. Girder 5 Strain Distribution at Midspan

* Based on the observed data, there is not a linear strain distribution at the low level of strains. The concrete is experiencing lower strains, and strands are forced to carry more strains.

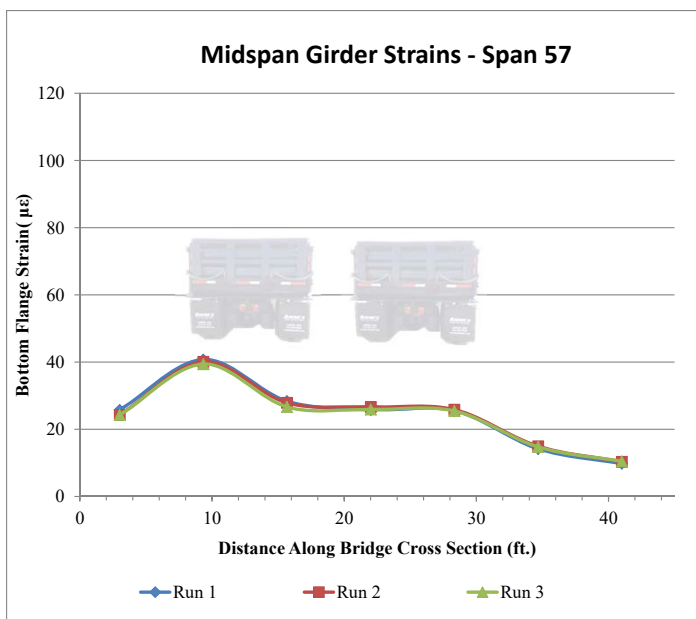
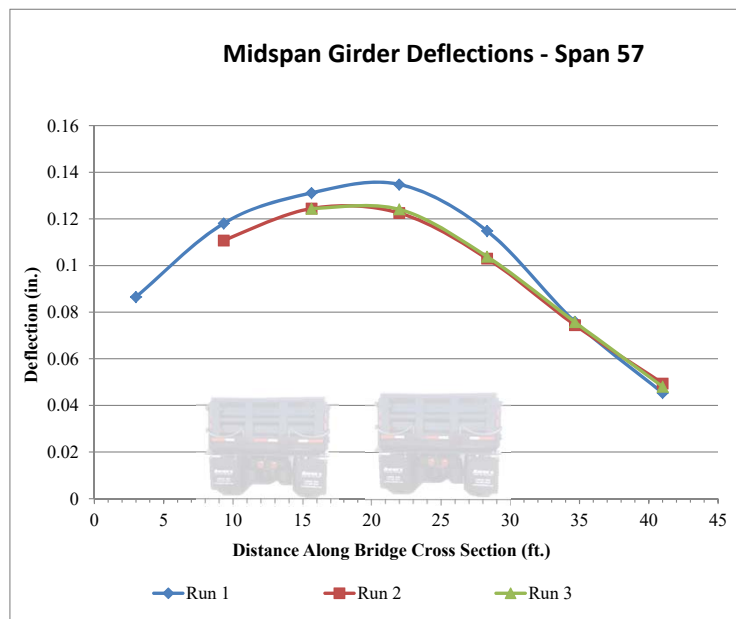
Note: No signs of obvious damage were present in Girder 2, but the peak response may be indicative of potential damage that is not observable.

Note: The midspan deflection of Girder 1 was not captured in any of the Runs (1-3) and for Girder 2 in Run 3 due to low quality (excessively dark) images acquired during testing.
