LOAD TESTING DETERIORATED SPANS OF THE HAMPTON ROADS BRIDGE-TUNNEL FOR LOAD RATING RECOMMENDATIONS

Masters of Science
In
Civil Engineering

November 29, 2016
Blacksburg, Virginia

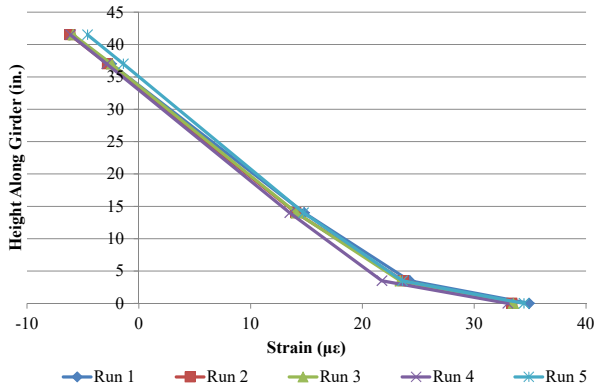
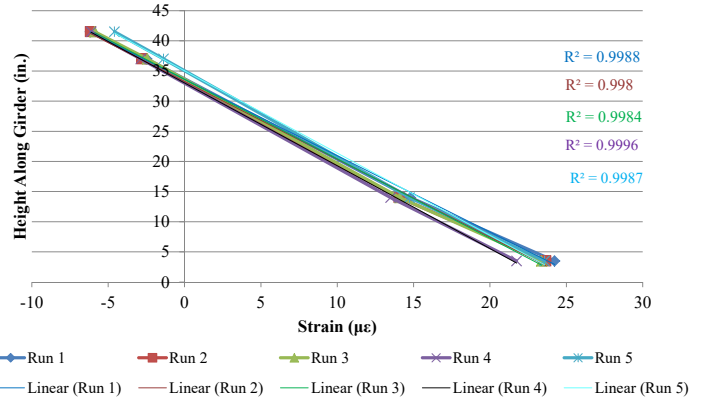
Girder 7 Midspan Strain Distribution - Span 31

The damaged strands at the bottom of Girder 7 cause a bilinear strain distribution. The concrete is forced to carry higher strains because of the damaged strands at the same height in the cross section. The plot to the right shows the top 4 strain readings to prove a linear strain distribution in the undamaged area of the cross section.

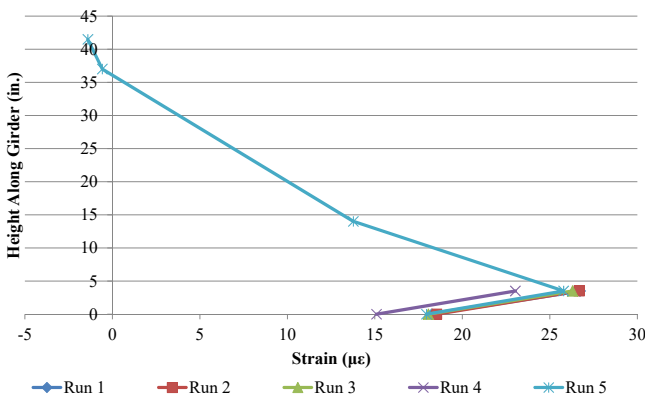
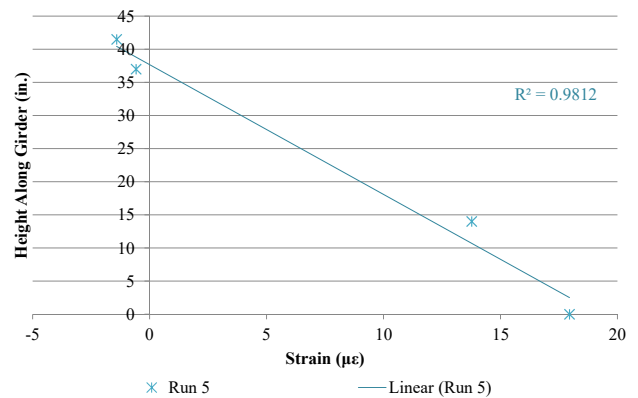
3. Girder 8 Strain Distribution at Midspan - Span 31

Similar to Girder 7, the damaged strands in Girder 8 are causing the forces to redistribute to the intact strands and the surrounding concrete. In girder 8, layers 2-4 are most damaged causing the concrete strains at this location to be higher than at the bottom face of the flange. The plot on the right excludes the strain value at midheight of the

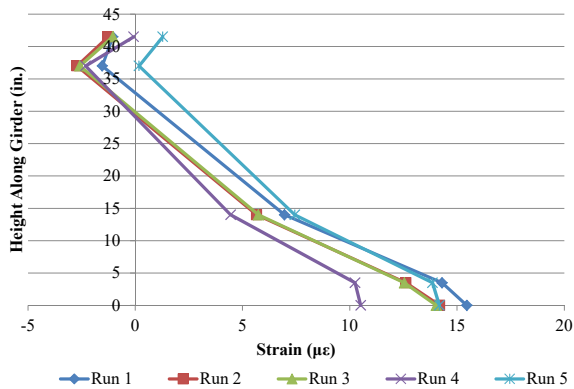
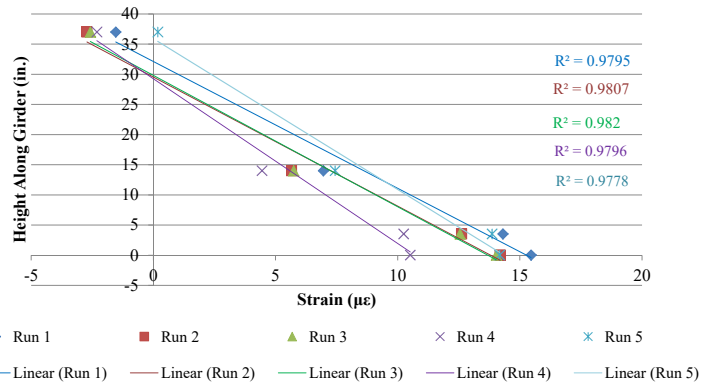
Girder 8 Strain Distribution at ~L/5 - Span 31

The plot on the right only includes the bottom four strain readings for each run in an attempt to prove a linear strain distribution. Due to the damage at this location, there is some strain redistribution between neighboring strands and the concrete causing the distribution to stray from being exactly linear.

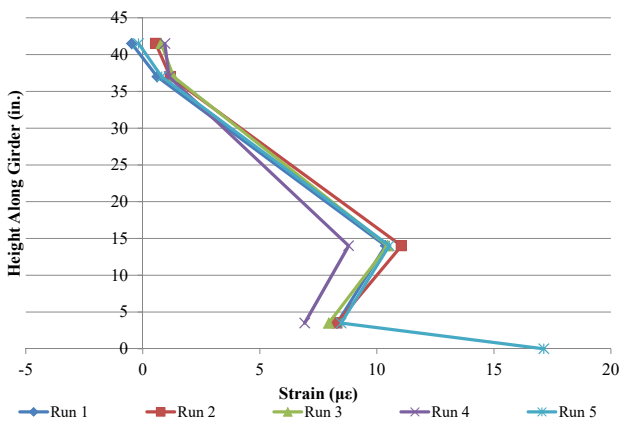
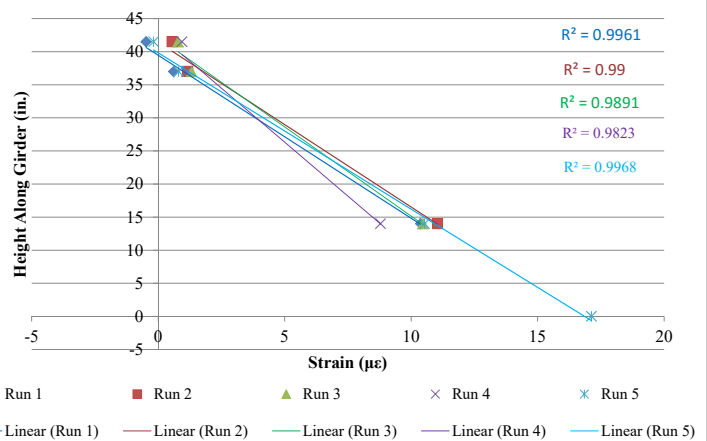
5. Girder 8 Strain Distribution at ~9L/10 - Span 31

**The plot on the right doesn't include the strain readings at the mid height of the bottom flange. This gauge wasn't attached fully.

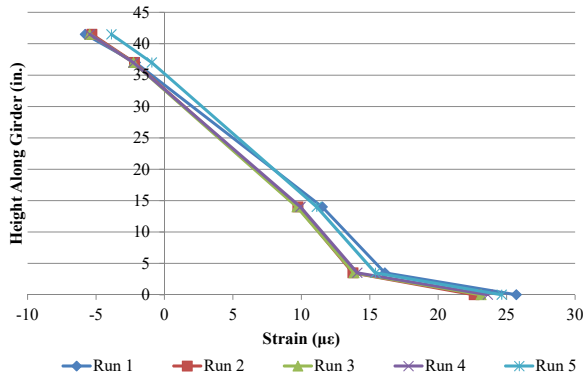
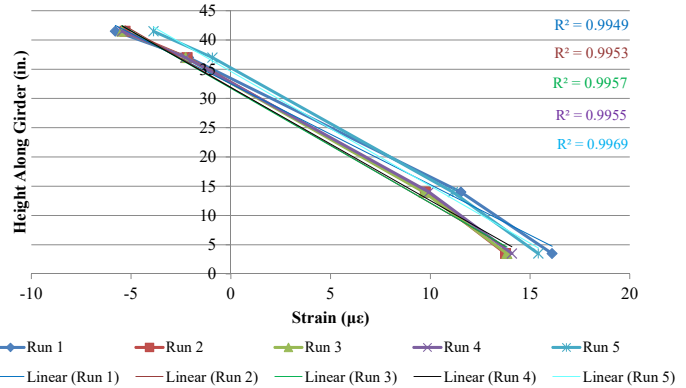
Girder 7 Midspan Strain Distribution - Span 31

The damaged strands at the bottom of Girder 7 cause a bilinear strain distribution. The concrete is forced to carry higher strains because of the damaged strands at the same height in the cross section. The plot to the right shows the top 4 strain readings to prove a linear strain distribution in the undamaged area of the cross section.

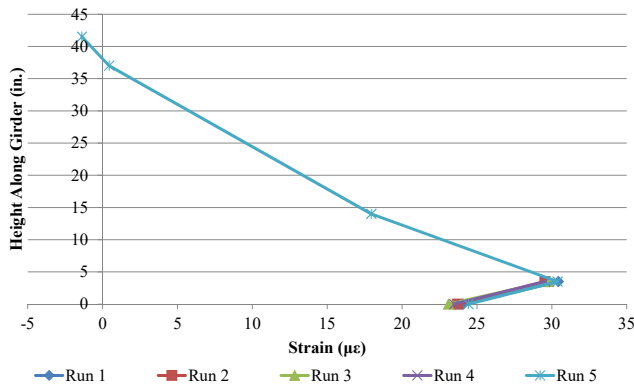
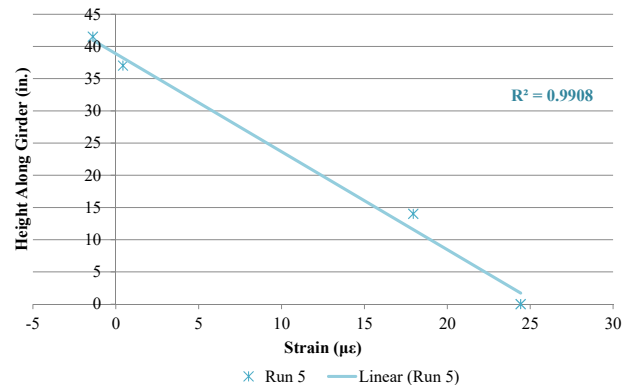
3. Girder 8 Strain Distribution at Midspan - Span 31

Similar to Girder 7, the damaged strands in Girder 8 are causing the forces to redistribute to the intact strands and the surrounding concrete. In girder 8, layers 2-4 are most damaged causing the the concrete strains at this location to be higher than at the bottom face of the flange. The plot to the right excludes the strain value at midheight of the bottom flange

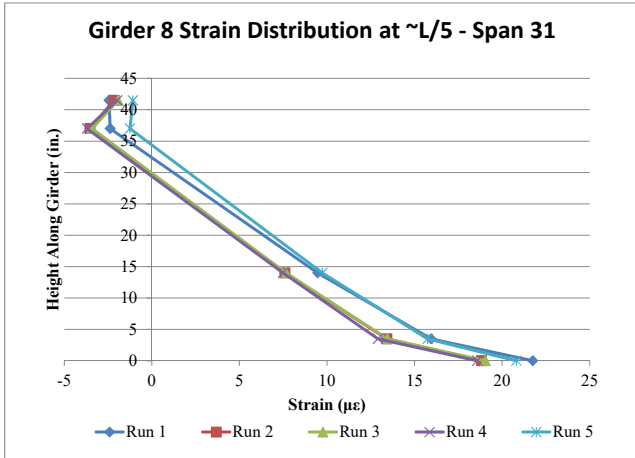
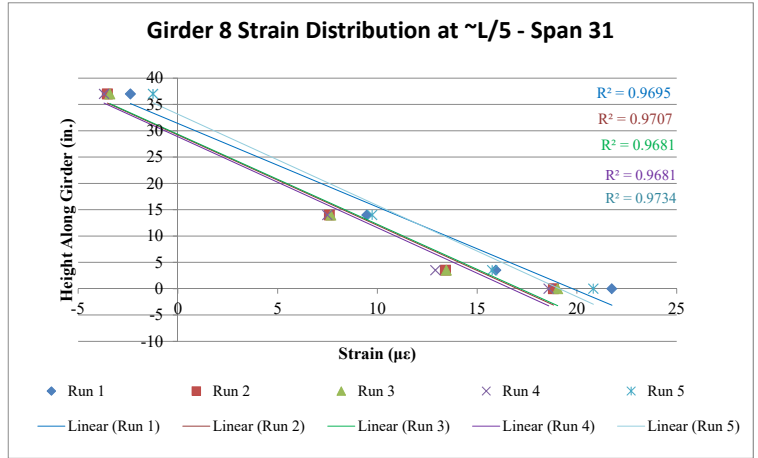
4. Girder 8 Strain Distribution at ~L/5 - Span 31

The plot on the right only includes the bottom four strain readings for each run in an attempt to prove a linear strain distribution. Due to the damage at this location, there is some strain redistribution between neighboring strands and the concrete causing the distribution to stray from being exactly linear.

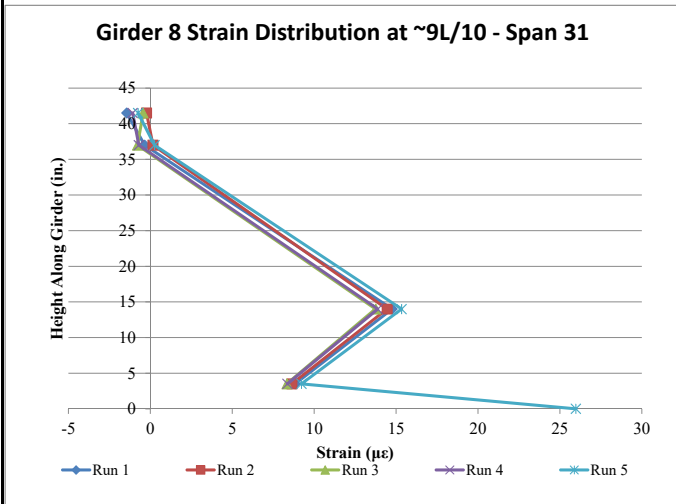
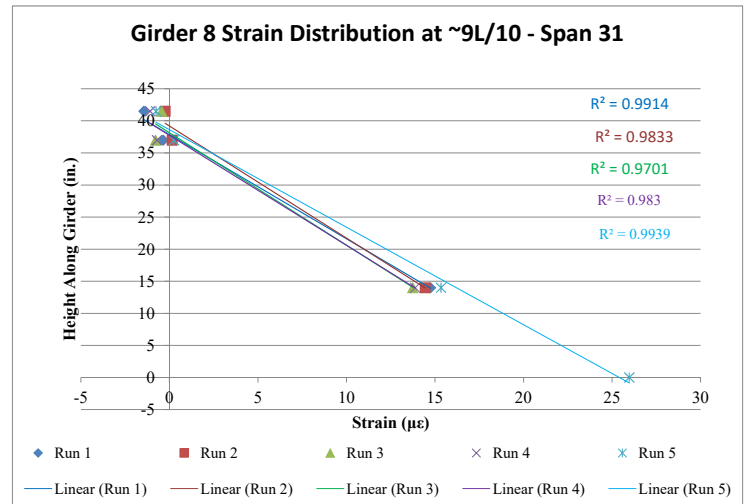
5. Girder 8 Strain Distribution at ~9L/10 - Span 31

**The plot on the right doesn't include the strain readings at the mid height of the bottom flange. This gauge wasn't attached fully.

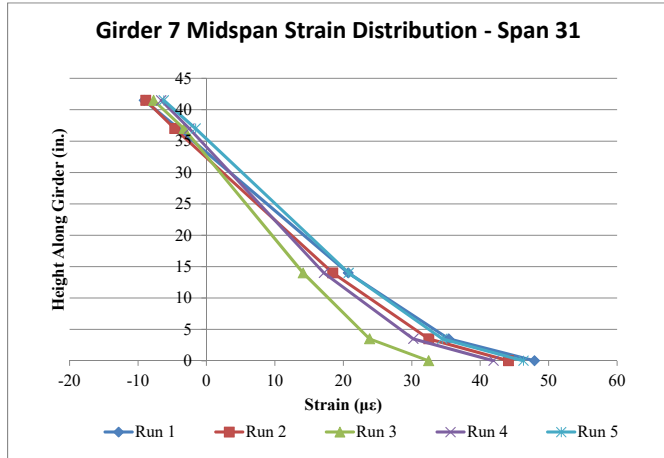
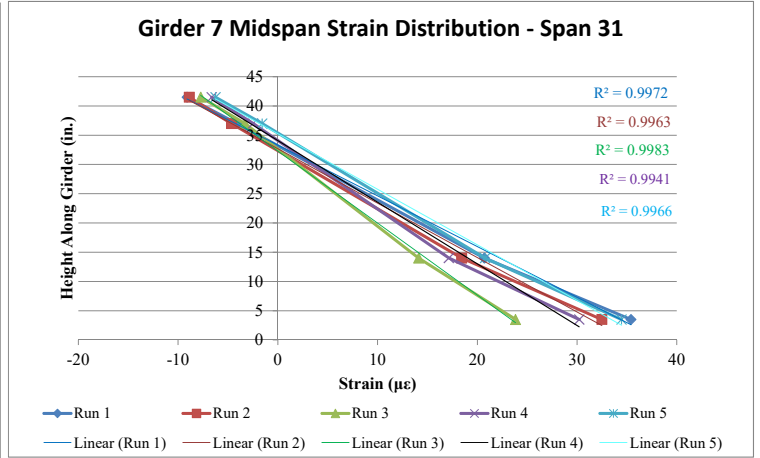
2. Girder 7 Strain Distribution at Midspan - Span 31

The damaged strands at the bottom of Girder 7 cause a bilinear strain distribution. The concrete is forced to carry higher strains because of the damaged strands at the same height in the cross section. The plot to the right shows the top 4 strain readings to prove a linear strain distribution in the undamaged area of the cross section.

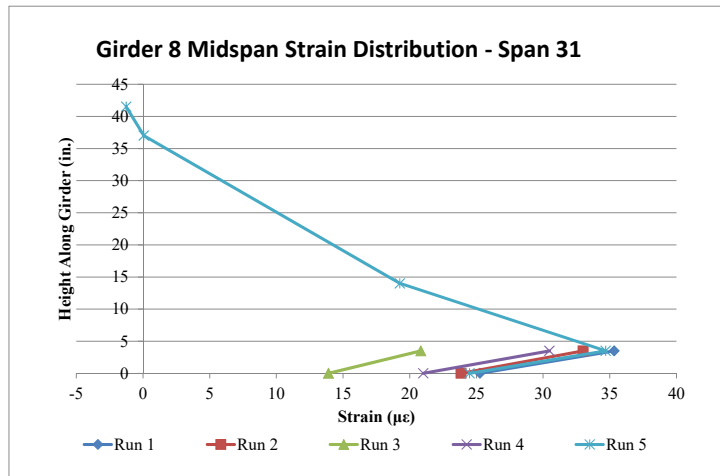
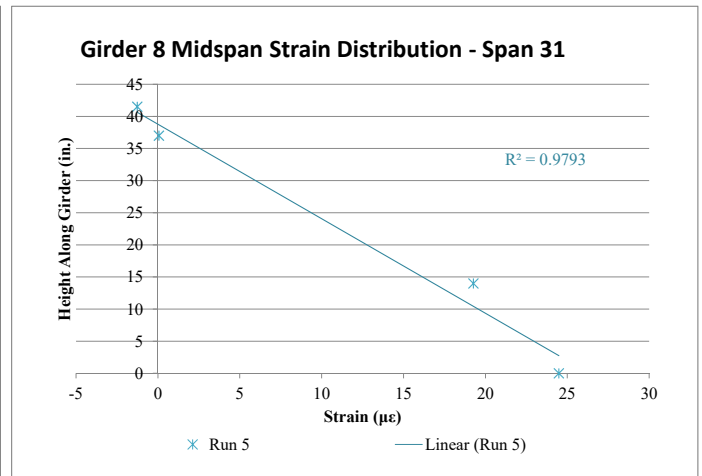
3. Girder 8 Strain Distribution at Midspan - Span 31

Similar to Girder 7, the damaged strands in Girder 8 are causing the forces to redistribute to the intact strands and the surrounding concrete. In girder 8, layers 2-4 are most damaged causing the the concrete strains at this location to be higher than at the bottom face of the flange. The plot on the right excludes the strain value at midheight of the

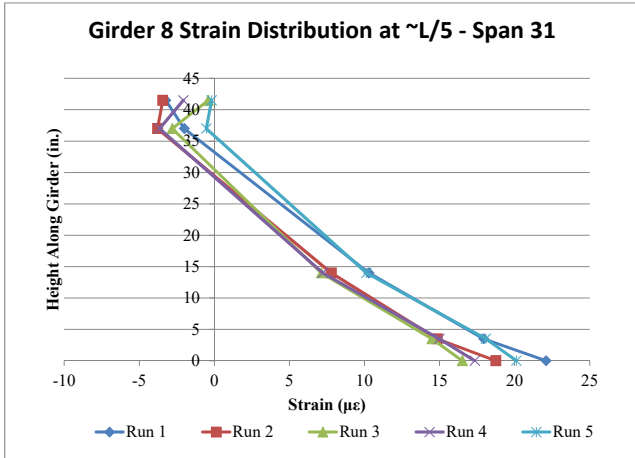
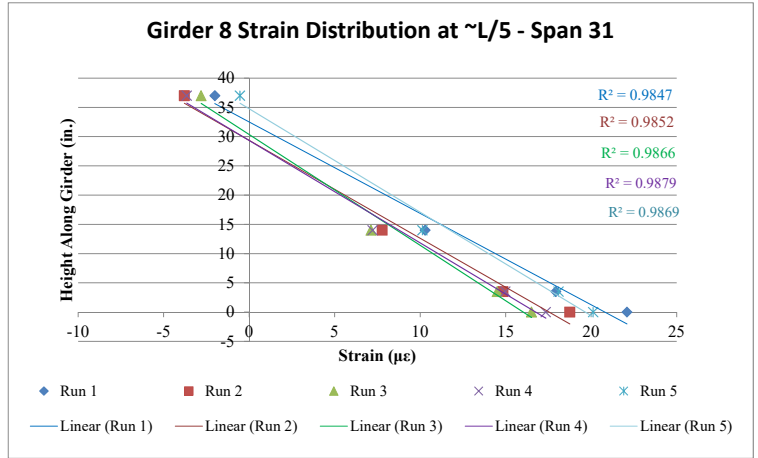
4. Girder 8 Strain Distribution at ~L/5 - Span 31

The plot on the right only includes the bottom four strain readings for each run in an attempt to prove a linear strain distribution. Due to the damage at this location, there is some strain redistribution between neighboring strands and the concrete causing the distribution to stray from being exactly linear.

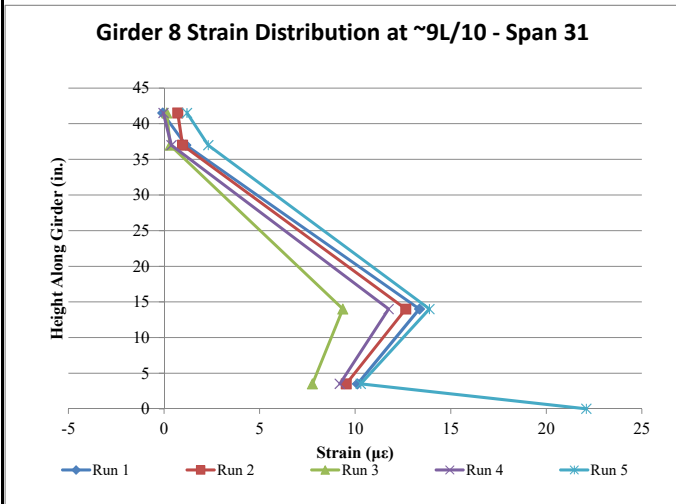
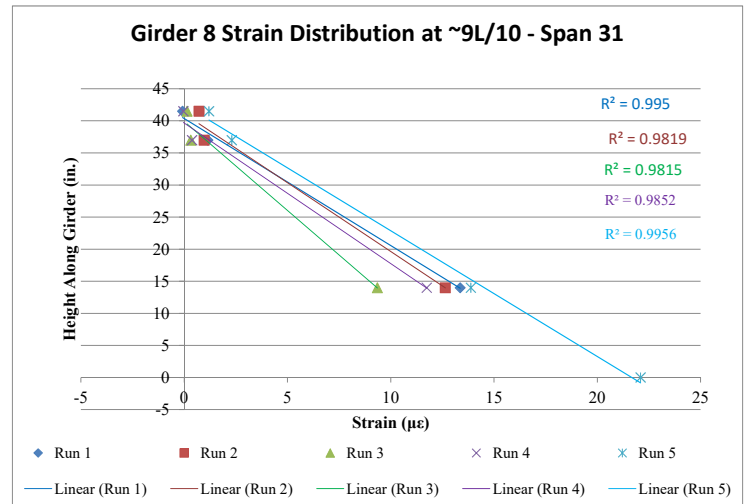
5. Girder 8 Strain Distribution at ~9L/10 - Span 31

** The plot on the right doesn't include the strain readings at the mid height of the bottom flange. This gauge wasn't attached fully.

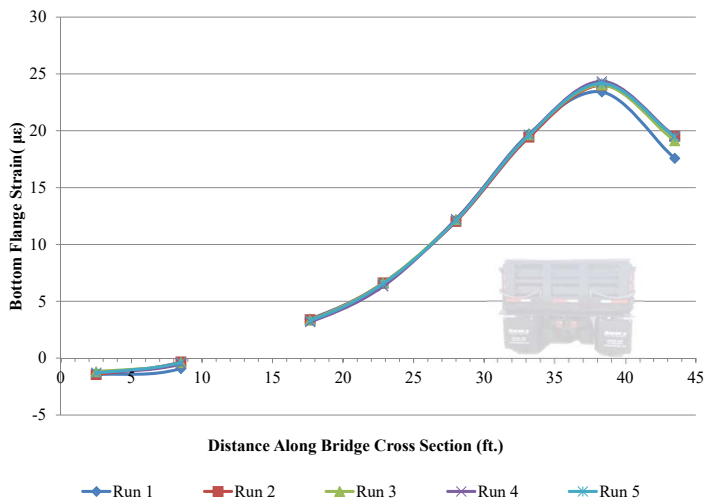
Midspan Girder Strains - Span 32

* Girder 7 strain values are low for each configuration. The contact adhesive most likely was not fully adhered. These values are excluded from the girder strain plot.

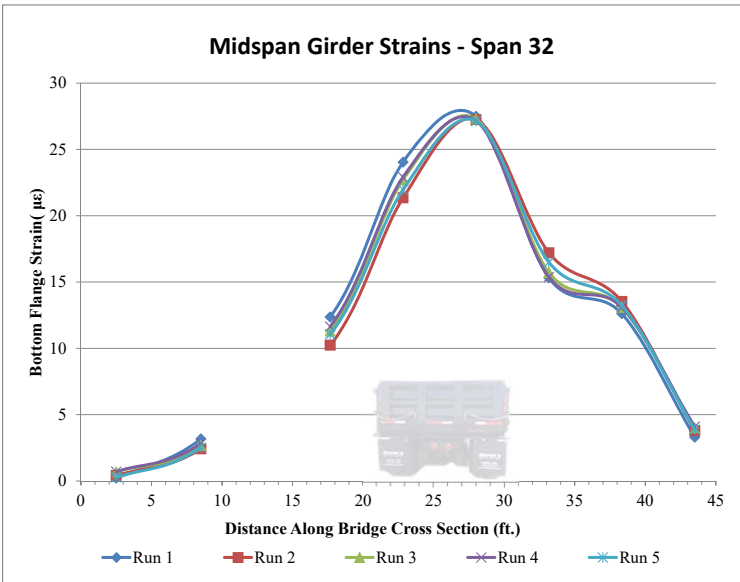
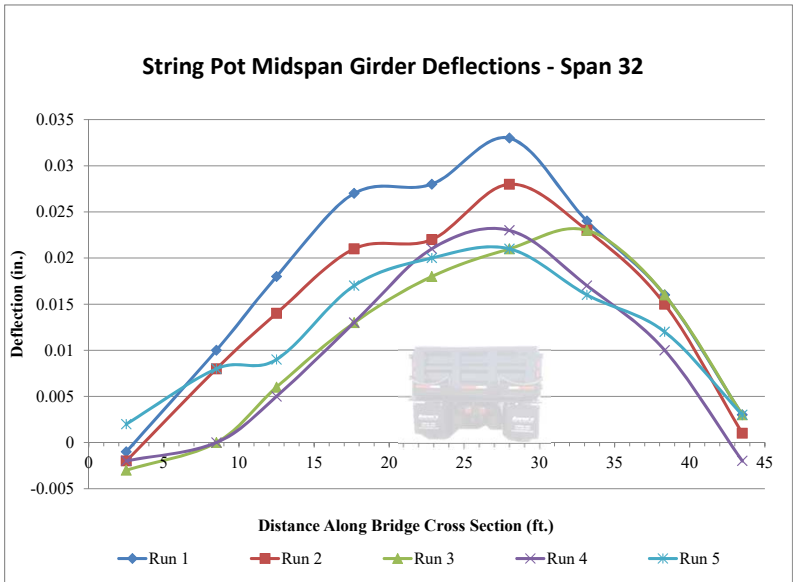
* Girder 7 strain values are low for each configuration. The contact adhesive most likely was not fully adhered. These values are excluded from the girder strain plot.

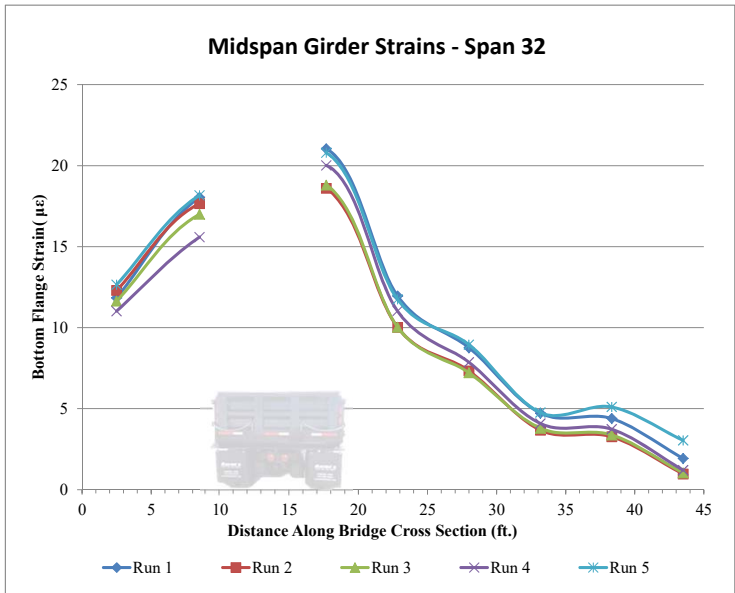
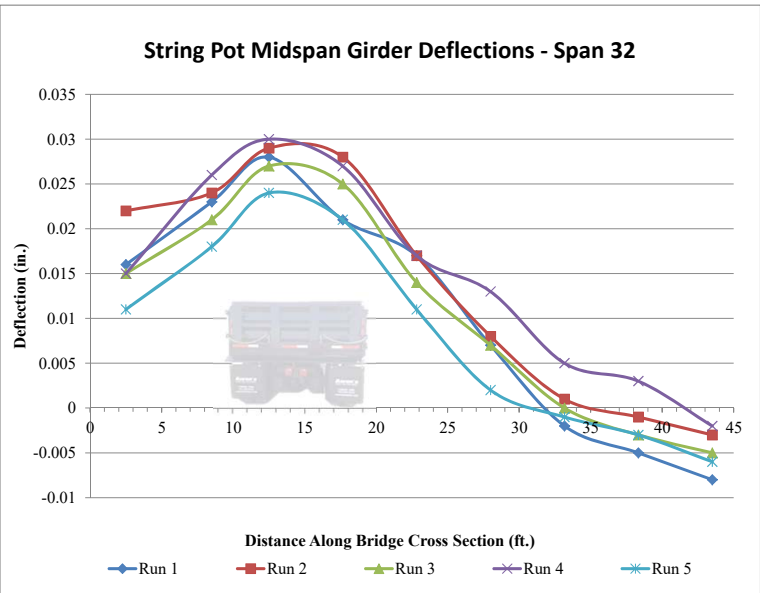
* Girder 7 strain values are low for each configuration. The contact adhesive most likely was not fully adhered. These values are excluded from the girder strain plot.

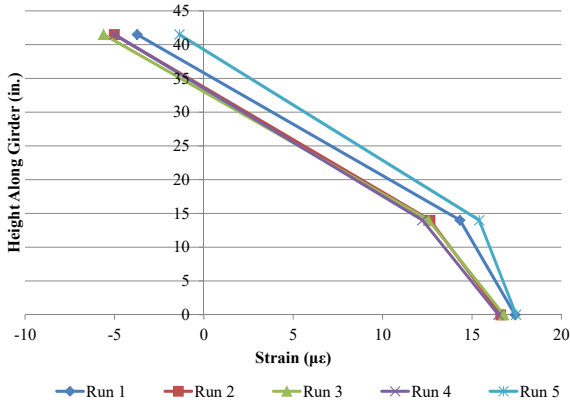
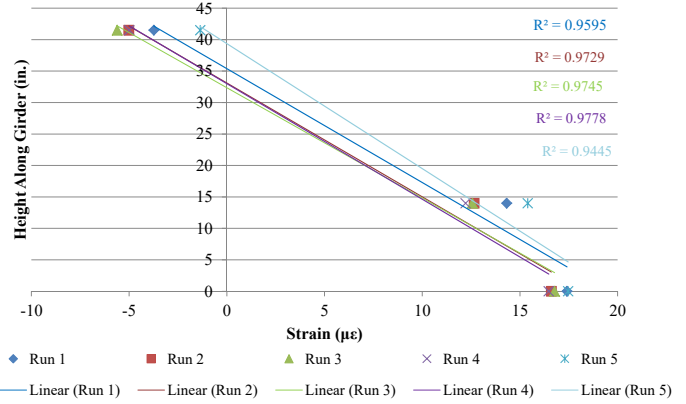
Girder 7 Midspan Strain Distribution - Span 32

** This is the same problematic gauge from the previous page. The contact adhesive most likely was not fully adhered making the strain values "softened" and not fully capturing

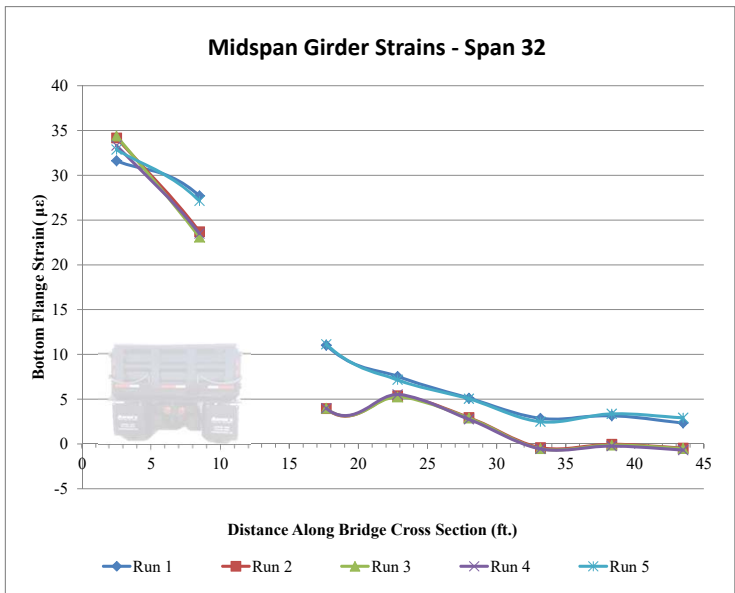
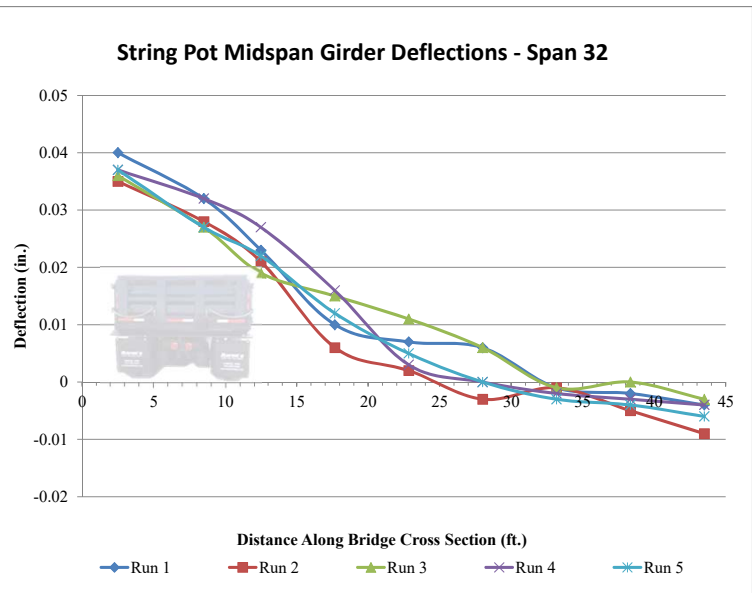
* Girder 7 strain values are low for each configuration. The contact adhesive most likely was not fully adhered. These values are excluded from the girder strain plot.

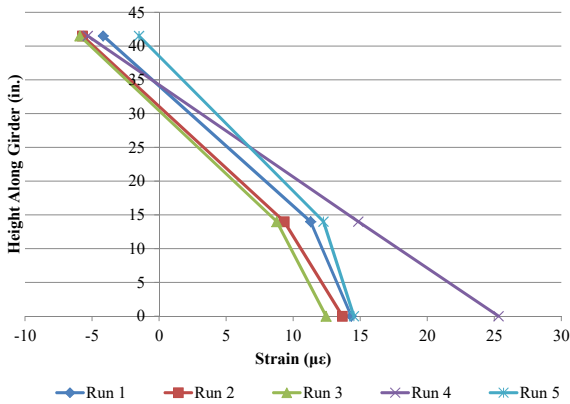
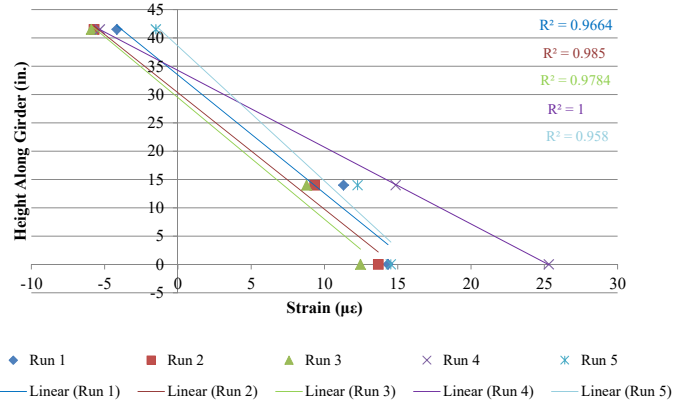
Girder 7 Midspan Strain Distribution - Span 32

** This is the same problematic gauge from the previous page. The contact adhesive most likely was not fully adhered making the strain values "softened" and not fully capturing

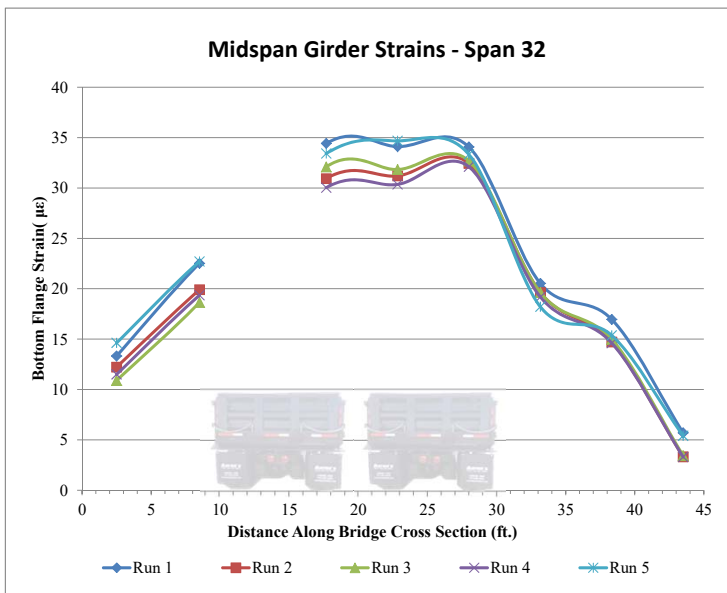
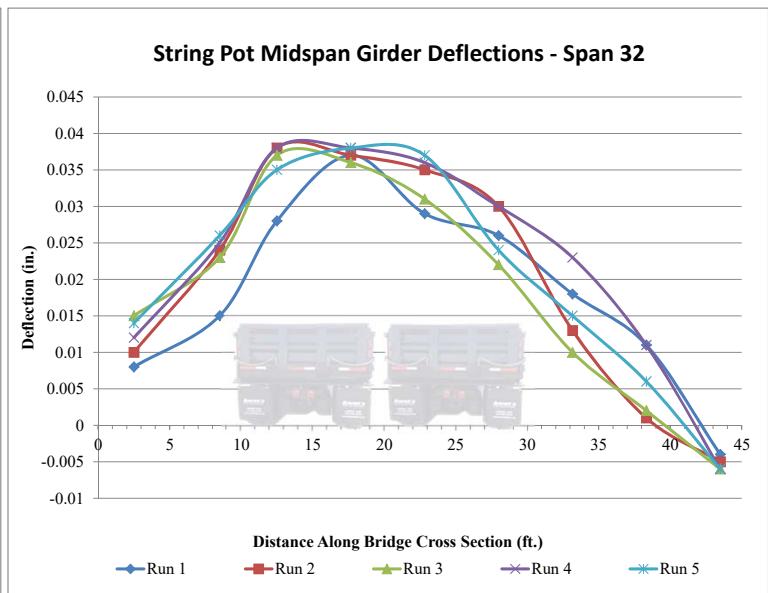
* Girder 7 strain values are low for each configuration. The contact adhesive most likely was not fully adhered. These values are excluded from the girder strain plot.

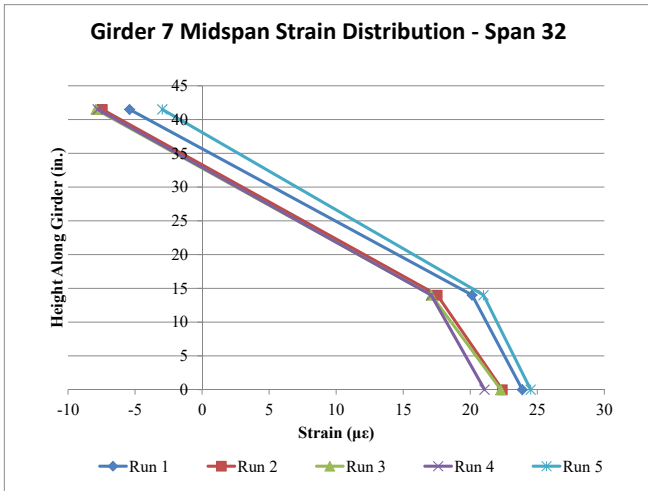
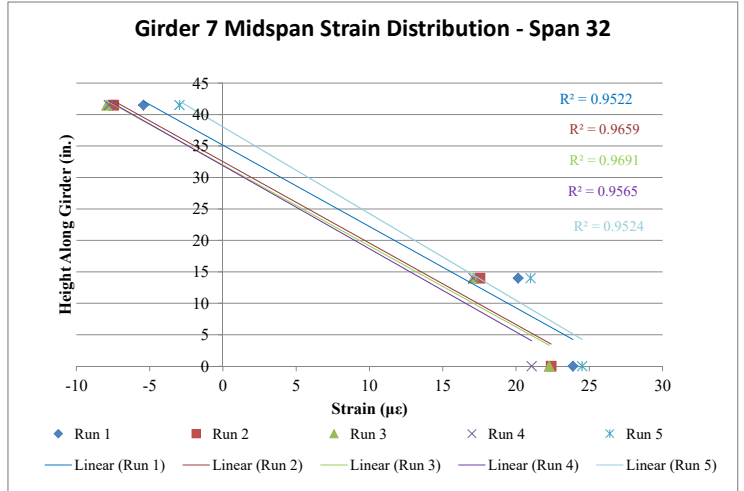
** This is the same problematic gauge from the previous page. The contact adhesive most likely was not fully adhered making the strain values "softened" and not fully capturing

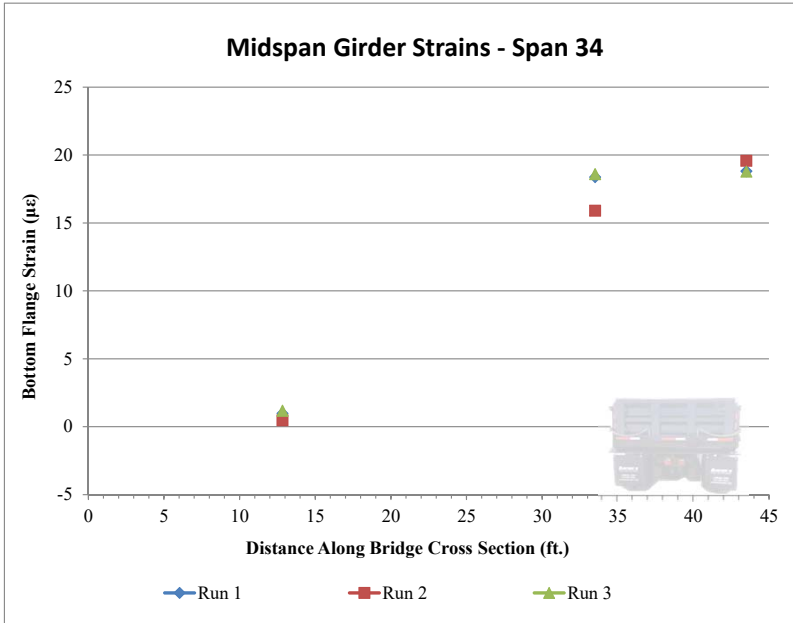
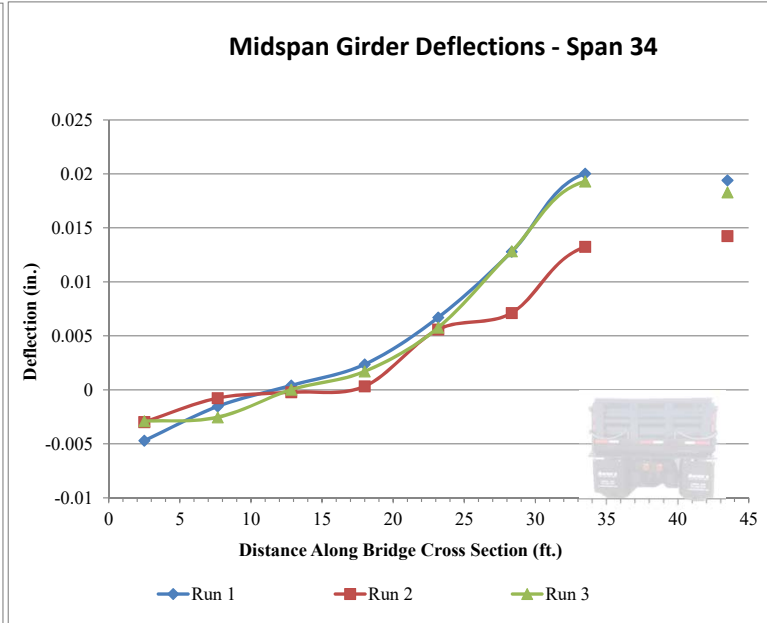
1. Midspan Measurements

Note: Strain measurements for girder locations 2, 4, 5, 6, 8, and 9 (G2, G4, G5, G6, G8, and G9) not included in figures due to uncertainty surrounding the validity. It was noted during installation of gauges on G8 and G9 that adhesion was difficult; however, the cause of the inconsistency in the other gauges is uncertain and may be attributed to poor calibration.

Note: The midspan deflection of girder 2 is not included in the plots due to low quality images acquired during testing, which could not be resolved.
