**DETERMINATION OF REMAINING FATIGUE LIFE OF WELDED STUD DETAILS
ON OVERHEAD ALUMINUM SIGN PANELS IN VIRGINIA**

Contract Research Sponsored by
Virginia Transportation Research Council

March 2005
VTRC 05-CR10

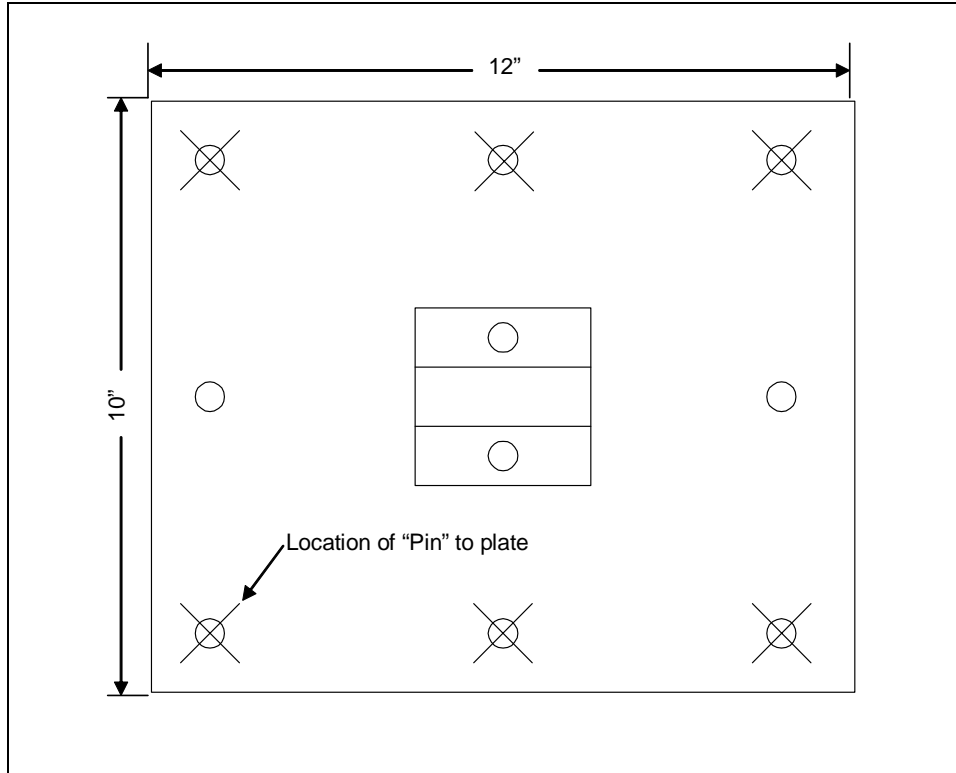
Figure 18. "Interior" Connection.

The sign specimen was first pinned on all four sides, as seen in Figure 18, to simulate an interior connection. The nuts were hand tightened on the studs. Repetitive pseudo-static tests were first performed on the interior test specimen to determine the stress distribution between the forces in the two studs. This was done by loading and unloading the specimen to 200 lb force. Bolt gages were installed in the threaded studs for these tests to determine the force distribution between the two studs during loading. Once this relationship was established, multiple pseudo-static tests at loading rates of 2-3 lb/sec were run to failure to determine the ultimate pseudo-static strength of a connection. Figure 19 shows a specimen during a pseudo-static test. Fatigue tests were then run at stress ranges starting at half of ultimate pseudo-static strength based on the pseudo-static test results. Table 1 shows the type of tests run and how many specimens were run at each load.

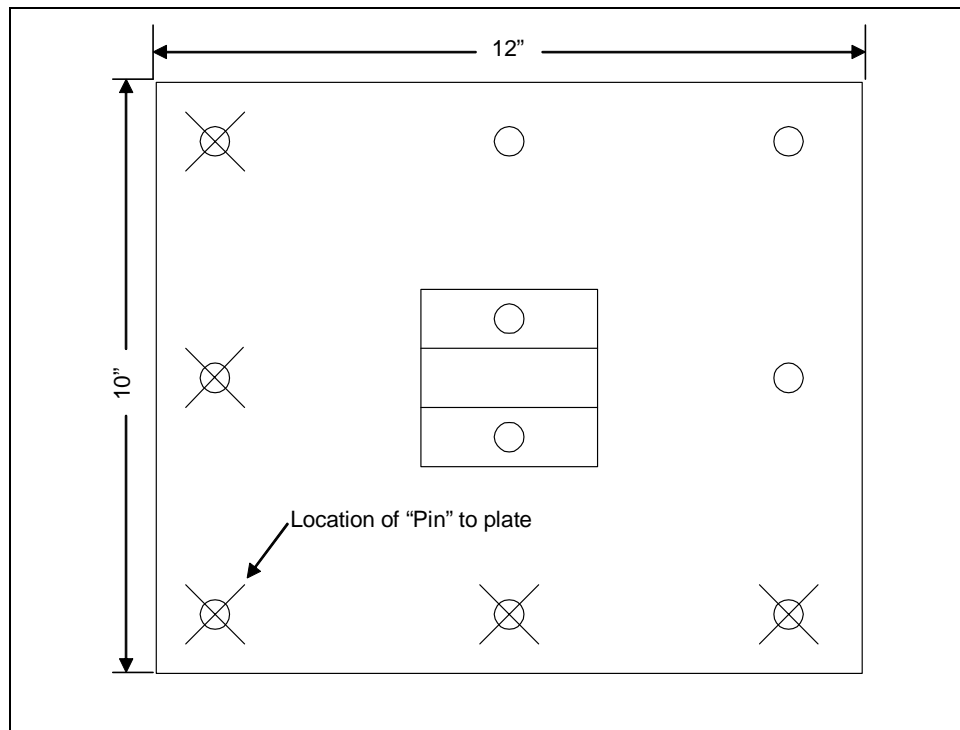
Figure 20. “Exterior” Connection.

To simulate an exterior connection, the specimen was pinned on two sides, as seen in Figure 20, with the nuts hand tightened on the studs. Pseudo-static tests to failure were first run to determine the maximum static strength. The first fatigue tests were then performed at the same levels as the interior connections. Fatigue tests were also run at other stress levels as seen in Table 2.

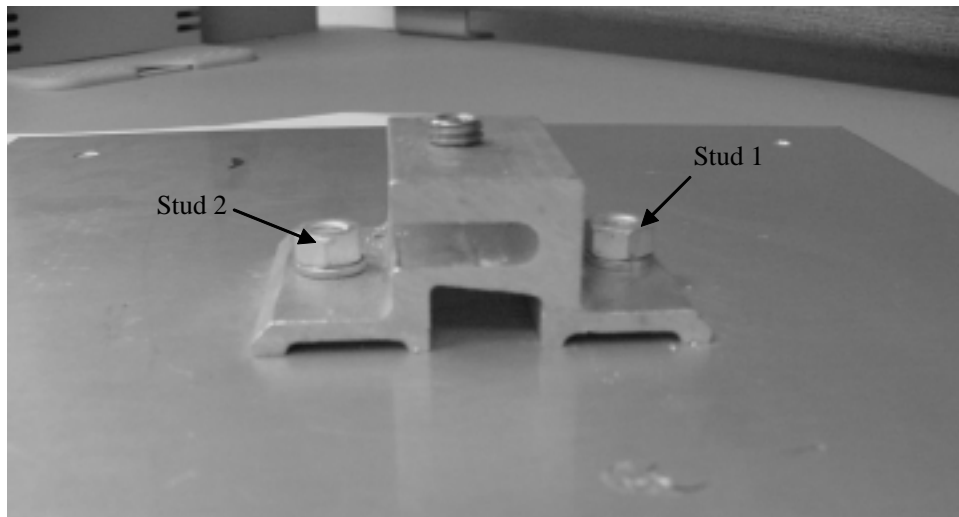
Figure 21. Stud Orientation.

The interior connection was first tested to determine the stress distribution between the two studs. Figure 21 shows the orientation of stud 1 and stud 2 with respect to the clip orientation. From low load pseudo-static tests, it was approximated that stud 2 carries about 90% of the tension force that which stud 1 will carry. Figure 22 shows a plot of the stresses in stud 2 with comparison to what stud 1 carries. The difference between the forces in the two studs can be attributed to the stiffness of the clip.
