## Chapter 2

### Characterization of Dry Etching Damaged Layer

A study on dry etching damaged layer and elimination method is described in this chapter. This section was published in Applied Physics Letters Vol.75, No.3, p.334, July 1999 under the title “*Characterization and Elimination of Dry Etching Damaged Layer in Pt/Pb(Zr<sub>0.53</sub>Ti<sub>0.47</sub>)O<sub>3</sub>/Pt Ferroelectric Capacitor*”. The authors are June Key Lee, Tae-Young Kim, Ilsub Chung and Seshu B. Desu.

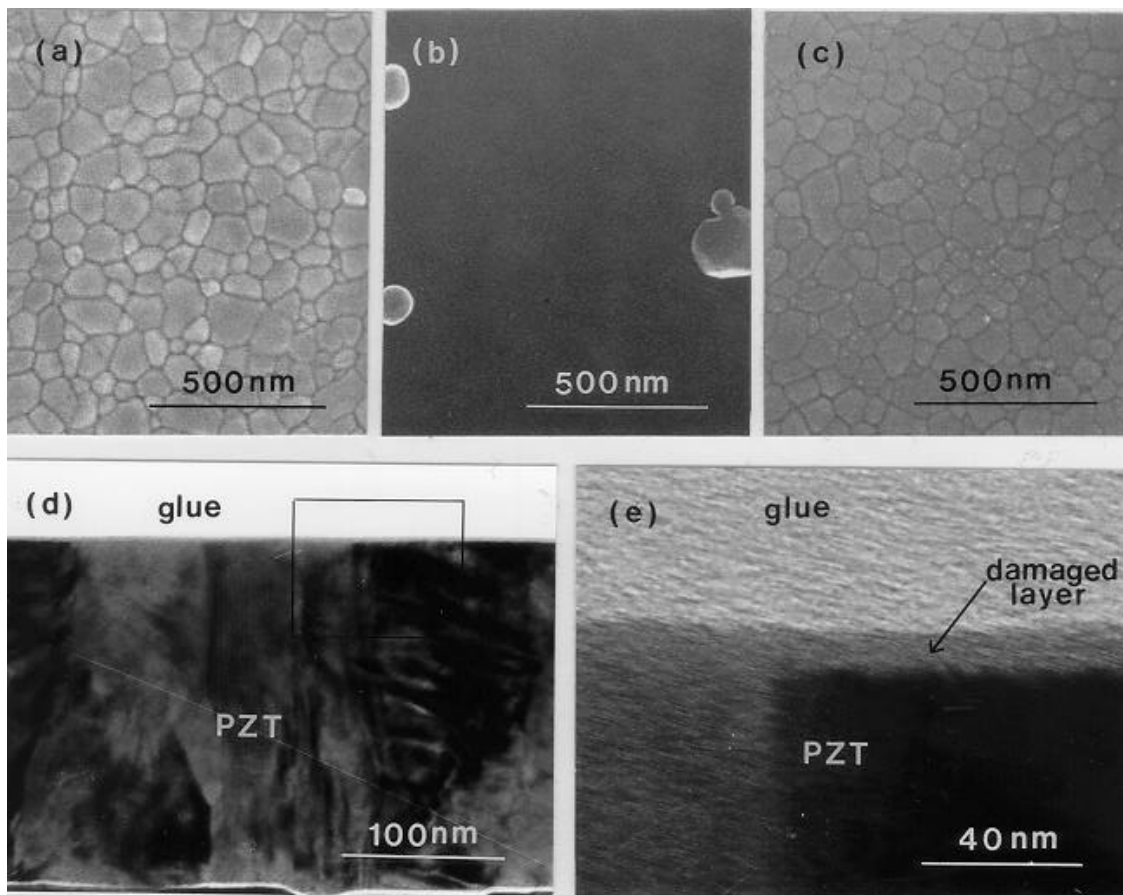
Figure 2-1. (a) SEM pictures of as-deposited PZT thin film, (b) after dry etching process, (c) surface wet cleaned PZT. The etching damaged layer is completely removed by the cleaning solution treatment. (d) Cross-sectional TEM images of dry etched PZT, (e) magnified image of inset region in (d).

Figure 2-1(a) shows the surface morphology of as-deposited PZT thin film, and figure 2-1(b) shows the surface morphology of PZT film after about 50 nm of PZT was etched off. The figures clearly illustrate the fact that well-defined perovskite grains are destroyed during dry etching process. Similarly, the cross-sectional TEM picture of figure 2-1(d) reveals that the surface of PZT film had a different contrast compared with that of perovskite grains. Moreover, the magnified image shown in the figure 2-1(e) gives that the thickness of the damaged surface layer is about 10 nm. X-ray diffraction patterns with glance mode given in figure 2-2 clearly indicate that dry etching damaged layer does not have a crystallinity. Hysteresis loops obtained from the capacitors fabricated on PZT/Pt, where the surface of PZT film was damaged by the plasma, are given in the figure 2-3(a). As shown in the figure, the distinct difference in the hysteresis loop is the coercive voltages ( $V_c$ ). Capacitors that have the damaged layers on the PZT surface give higher coercive voltages compare to that of the damage free PZT film. The increase of the coercive voltage is attributed to the existence of the layer which cause the voltage drop, that is, the dry etching damaged layer. Up to the 550 °C annealing, which is considered as a typical temperature to recover dry etching damage, the shape of hysteresis loop was changed insignificantly. Even though it is annealed above the formation temperature, namely 650 °C, the coercive voltage is still 0.3V higher than that of as-deposited PZT. SEM and X-ray diffraction analysis indicate that the annealing at 650 °C yields only a partial re-crystallization of the damaged

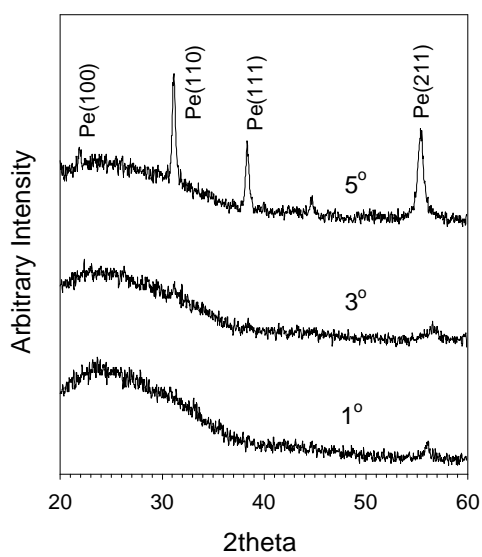
Figure 2-2. X-ray diffraction spectra of the dry etched PZT film with the glance angle of 1°, 3° and 5°.

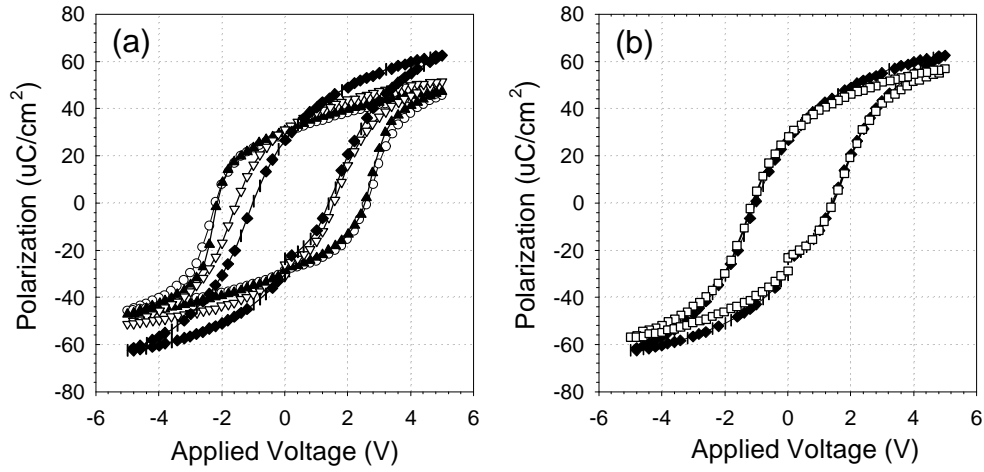
Figure 2-3. (a) Hysteresis loops of Pt/PZT/Pt capacitors;  $\circ$  with the etching damaged layer on the PZT film surface,  $\blacktriangle$  550 °C annealed,  $\nabla$  650 °C annealed,  $\blacklozenge$  as-deposited PZT. (b) Hysteresis loops of Pt/PZT/Pt capacitors;  $\blacklozenge$  as-deposited PZT,  $\square$  after cleaning solution treatment.

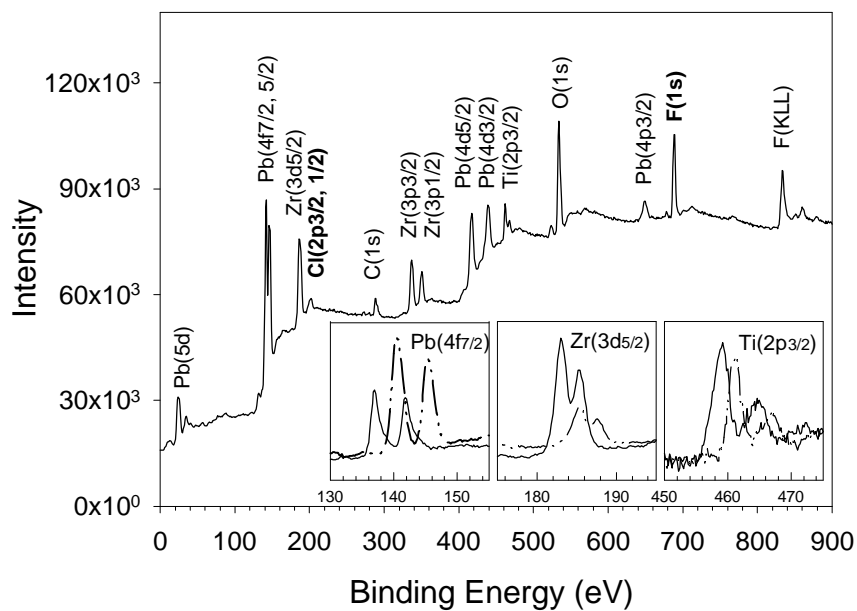
Figure 2-4. X-ray photoelectron spectrum of the etching damaged layer. Solid lines: perovskite PZT, dashed lines: etching damaged layer.

The chemical composition of the dry etching damaged layer was evaluated by using XPS analysis. As shown in figure 2-4, fluorine and chlorine atoms were detected in XPS survey spectrum. The atomic percentage of fluorine and chlorine were 23.0% and 4.3%, respectively. Furthermore the insets of figure 2-4 obviously show shifts of binding energy, such as lead (Pb 4f<sub>7/2</sub>), zirconium (Zr 3d<sub>5/2</sub>) and titanium (Ti 2p<sub>3/2</sub>) peaks. That is to say, in the etching damaged layer, Pb, Zr, and Ti peaks were shifted 2 ~ 4 eV toward higher binding energy compared to those obtained from the pure perovskite phase. Due to strongly electronegative fluorine atom, the peaks of metal components seems to be shifted to higher binding energy. This implies that metal components would make chemical bonds with halide atoms (Cl, F) as the result of the chemical reaction between reactive etching gas (Cl<sub>2</sub>-C<sub>2</sub>F<sub>6</sub>) and PZT film. It is generally known that metal halides are hard to change into metal oxide below 800 °C. This is a main reason why 650 °C annealing could not completely revert the damaged layer to the crystallized perovskite layer. Since the thermal treatment was not sufficient to completely remove the dry etching damage, the approach utilizing the wet cleaning treatment was attempted. We prepared a specially designed cleaning solution, in which acetic acids, hydrofluoric acid and ethanol were mixed with 10/5/85 volumetric ratio. The solution shows about 20Å/min of etching rate to the dry etching damaged PZT thin film [8]. Figure 2-1(c) clearly shows that the damaged layer was fully removed by the wet cleaning treatment. In addition, as shown in figure 2-3(b), the shape of hysteresis loop obtained from the wet cleaned PZT is quite similar to that obtained from the damage free PZT except a minor difference in the slopes of the non-switching cycles. This implies that the characteristic of Schottky contact would be changed by the cleaning of PZT surface. In fact, the etching damaged layer would be formed in the sidewall of Pt/PZT/Pt capacitor during the fabrication of Pt/PZT/Pt capacitor. Thus, the effectiveness of the wet cleaning in patterned capacitors was evaluated by measuring the leakage current with TDDB mode. The TDDB characteristics given in figure 2-5 reveal that about one order (from 1x10<sup>-6</sup> A/cm<sup>2</sup> to 1x10<sup>-7</sup> A/cm<sup>2</sup>) improvement is achievable after the wet cleaning treatment. Such an improvement seems to be come from the elimination of the parasitic path that would be

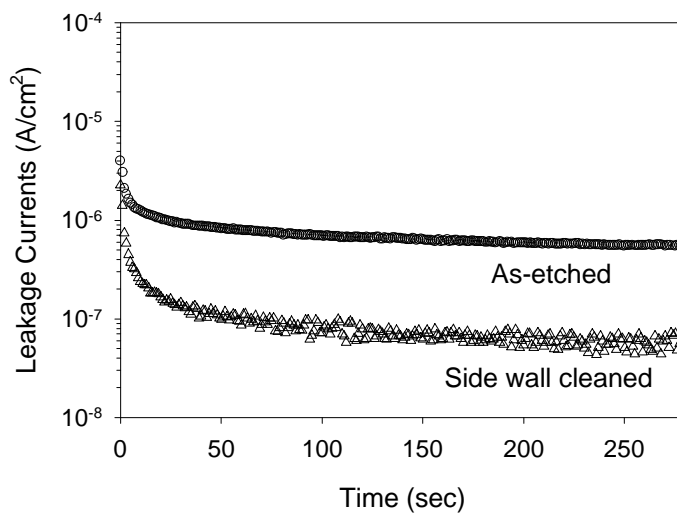
Figure 2-5. Leakage current properties of Pt/PZT/Pt capacitors before and after cleaning solution treatment. Applied voltage: 5V
