Chapter 4: Evaluation of the Power Add-On Unit Performance on a Wheelchair

Objective

The objective of the wheelchair performance evaluation with the PAU was to determine the characteristics which define its level of operation. The intended use for the information collected is to identify the weak performance areas of the power assist. These areas can be addressed in future design iterations. The following characteristics of the power assist device were evaluated in this section:

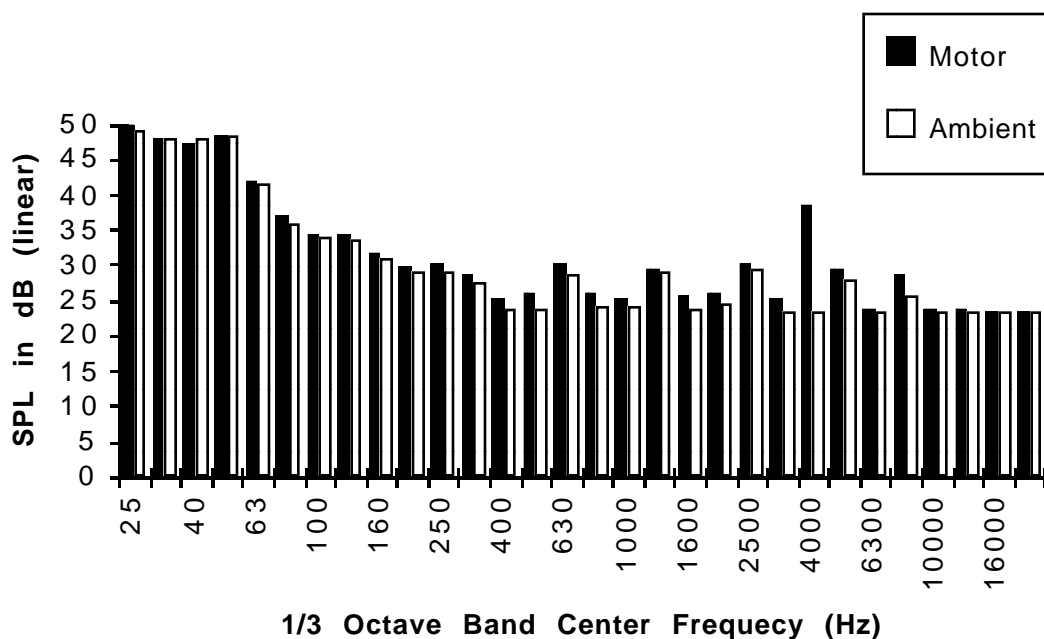
The motor one-third octave band noise spectrum was contrasted with the laboratory ambient noise spectrum. Figure 12 shows the decibel levels for the one-third octave band center frequencies of the two sets of measurements.

Figure 12. Wheelchair motor spectrum compared to the ambient noise spectrum.

Sound Pressure Level Measurements. The sound pressure level of the motor whine was measured in an attempt to compare the sound to common noise sources. Voltage to the motor was adjusted to consistently produce the whine and a Rion model SA-27 one-third octave band real-time analyzer was used to measure the one-third octave band 30-second Leq (level average over a 30-second period). The microphone was placed at the height, angle, and position of the wheelchair operator's ear. A 30-second measurement, taken in the Auditory Systems Laboratory at Virginia Tech, produced a broadband sound pressure level of 42.4 dBA. The broadband ambient noise level in the laboratory was measured and calculated to be 38.2 dBA (sound pressure level calculations are shown in Appendix I: Motor Sound Level Measurements). This was very close to the motor whine level of 42.4 dBA which was below the sound pressure level of voice conversation (Berger, Ward, Morrill, and Royster, 1986).

The figure illustrates the predominant differences between the motor and ambient sound spectrums at the center frequencies of 4000 Hz and 8000 Hz. The spike at 4000 Hz represents a 15.1 dB (linear) difference between the motor and ambient sound pressure levels (38.6 dB for the motor noise versus 23.5 dB for the ambient noise). The broadband sound pressure level of the motor whine was quite low at 42.4 dbA (below voice conversation). The tonal nature of the motor whine, predominantly at 4000 Hz, probably contributed to the annoyance factor of the noise.
