**Durability of Chopped Fiber-Reinforced Polymeric Composites for use in  
Experimental Automotive Fuel Cells**

Thesis submitted to the Faculty of the  
Virginia Polytechnic Institute and State University  
in partial fulfillment of the requirements for the degree of

Master of Science  
in  
Engineering Mechanics

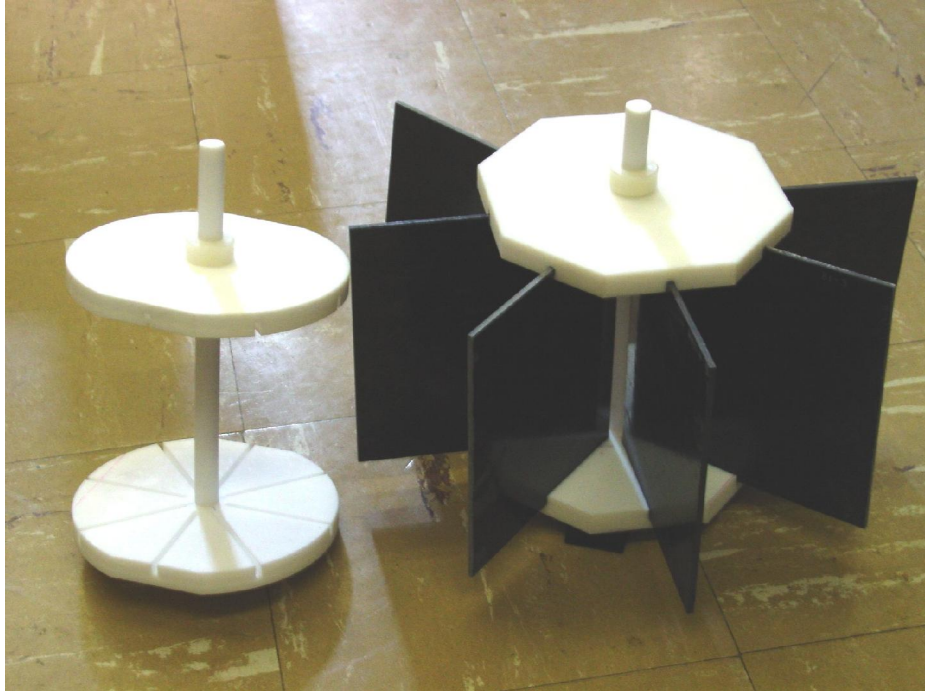
Figure 3: Radial Specimen Holders

Composite panels manufactured by Quantum Composites measuring 12-inches x 12-inches x 1/8-inches were cut using a wet diamond saw to panels 5-inches wide by 6-inches long for aging. Each panel was labeled using a hand engraver in the top right corner. A random sample of panels were selected and used for the moisture uptake study. These specimens were individually weighed before insertion into the aging containers. Specimens were arranged radially using custom designed 15 cm clamping in PTFE (Teflon®) racks, fabricated from 1/2 inch thick Teflon® sheets, rods and nylon set screw collars, to ensure sufficient and equal access to moisture on all sides (Figure 3). The panels were then aged at 85° C in air, deionized water, and a 50/50 mixture of deionized water and ethylene glycol antifreeze for 1, 2, 4, 16, 32, or 83 days. A photo of the specimens in the water aging system is shown in Figure 4.

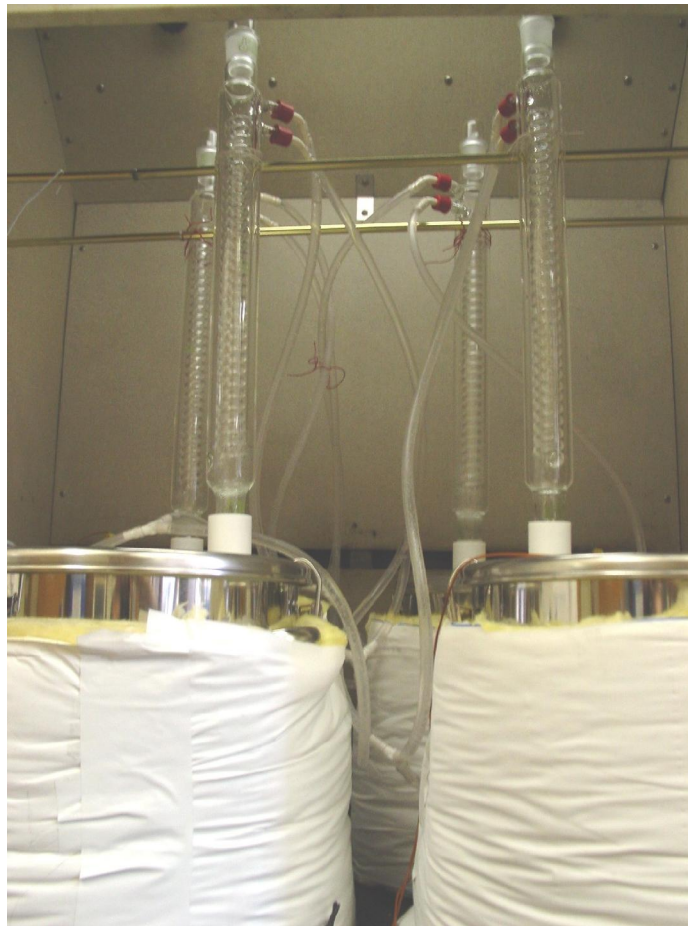
Figure 5: Vapor Condensers with cooling water tubes

(15 Ra electro-polished). The containers were heated using 76 cm long flexible silicone rubber fiberglass insulated heater with a watt density of  $5 \text{ W/in}^2$  from Omega Engineering, Inc. model number SRFG-1030/5. The heaters were attached using two wrappings of  $\frac{1}{2}$  inch hanger iron. A modified water heater blanket utilizing fiberglass insulation (R-19) was used as insulation for each container. Temperature control was performed using an Omega Subminiature quick-disconnect probe, type-K, 0.125" O.D. stainless steel sheath, grounded junction, 6" length (KMQSS-125G-6) thermocouple and Omega Controller. The condensers used were Kuhler 400mm Reflux condensers each having an internal coil that was water jacketed (Figure 5). Vapors are condensed both on the coil and the inner wall of the jacket. The condenser connection to the stainless steel lid of the aging container was made using a machined female, Teflon® tapered joint (29/42) attached to the container lid using 316 SS sheet metal screws (Figure 6). The condensers were supported using tension rods placed between the walls of the fume hood. The above described system can be seen in Figure 7. Air aging was conducted in an Espec ESX-4CA hygro-thermal cycling chamber (Figure 8).

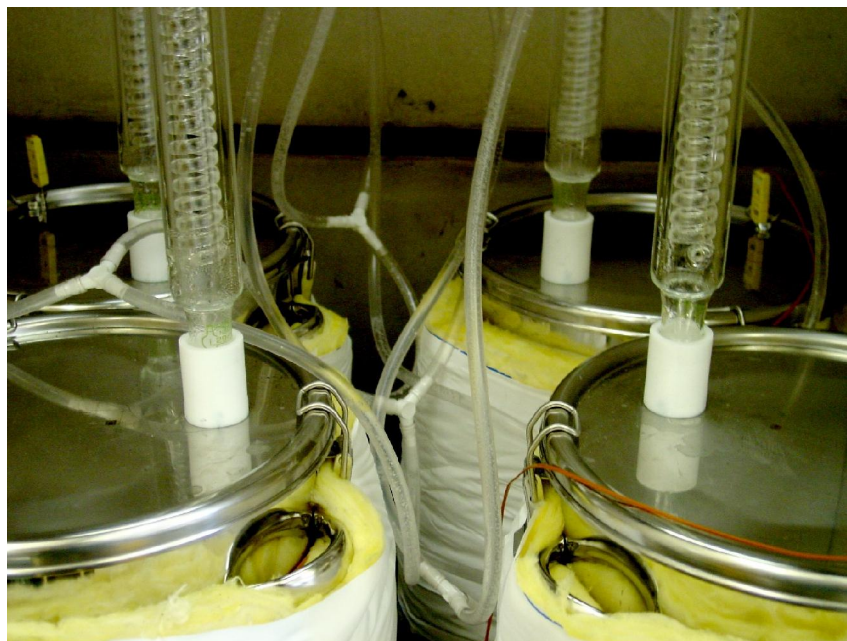
Figure 6: Teflon® connects for vapor condensers

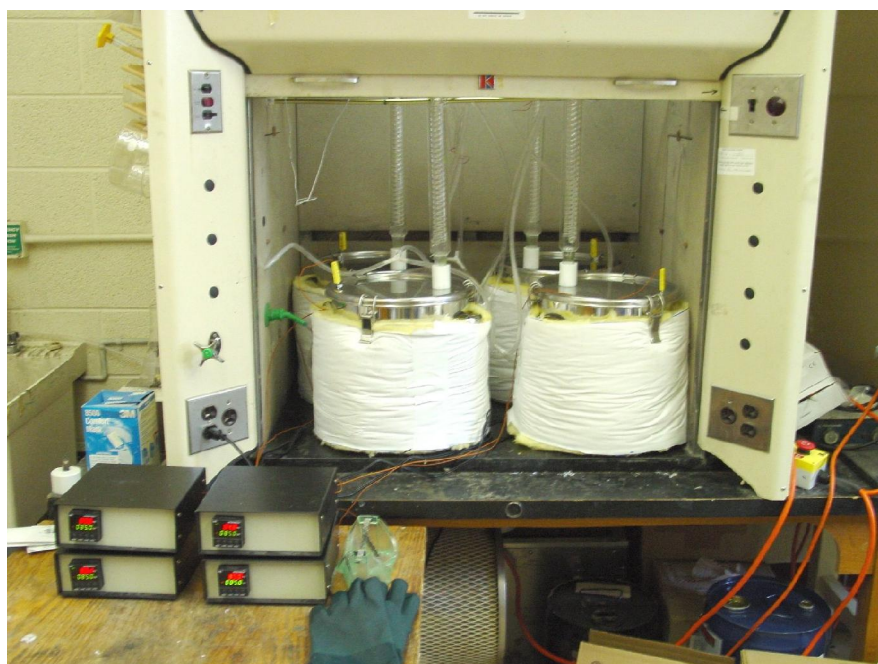
Figure 7: Liquid aging system

The aging system containers are Eagle Stainless Container CTH-30 made of 316L Stainless Steel with a Platinum Cured Silicone rubber gasket and a 24 Ra standard finish

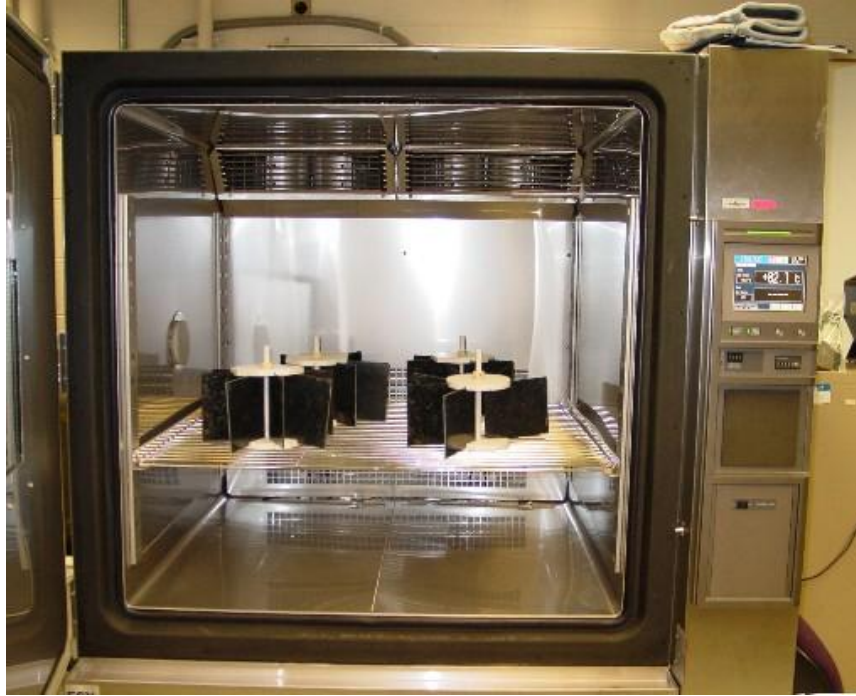
Figure 8: Espec ESX-4CA hydro-thermal cycling chamber

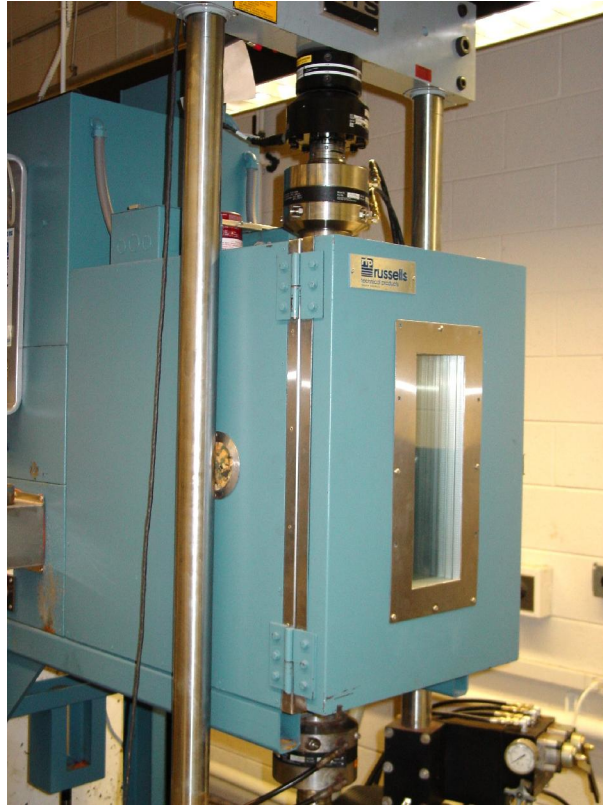
Figure 10: Environmental Chamber encased MTS test machine

Quasi-static compression tests were conducted using a hydraulic driven, load driven MTS machine (20 kip capacity) controlled using a MTS 407 controller. The test machine was encased within a custom Russell self-controlled hygro-thermal environmental chamber that provided temperature regulation at 85°C and -20°C (Figure 10). The specimens were loaded at a rate of 1000 lbs/min until failure.

Fatigue compression tests were conducted using a hydraulic driven, load controlled MTS machine (20 kip capacity) regulated using a MTS 407 controller. The test machine was encased within a custom Russell self-controlled hygro-thermal environmental chamber that provided temperature regulation at 85°C and -20°C (Figure 10). An S/N curve was created for each material.

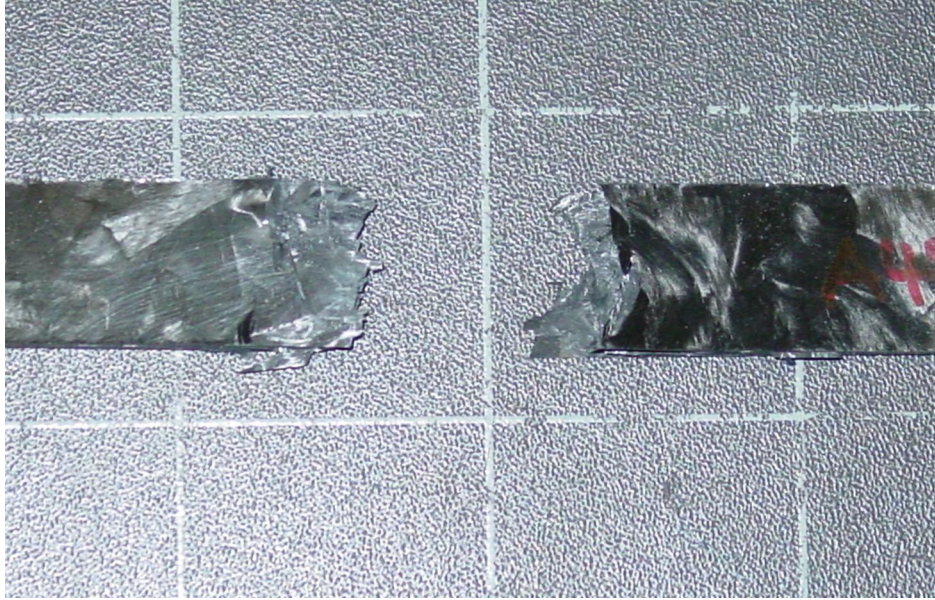
Figure 16: Typical tensile failure for Material A

A set of five replicate quasi-static tensile tests for each aging condition (air, water, 50/50 water/antifreeze mixture) were conducted for each of the composites Materials A and B for the as received, 1, 2, 4, 16, 32, and 83 days aged conditions. A typical tensile failure can be seen in Figure 16. The failures occur perpendicular to the load direction within the 3 inch heated gage section. Figure 17 and Figure 18 show the changes in average tensile strength versus time for the Materials A and B materials respectively.

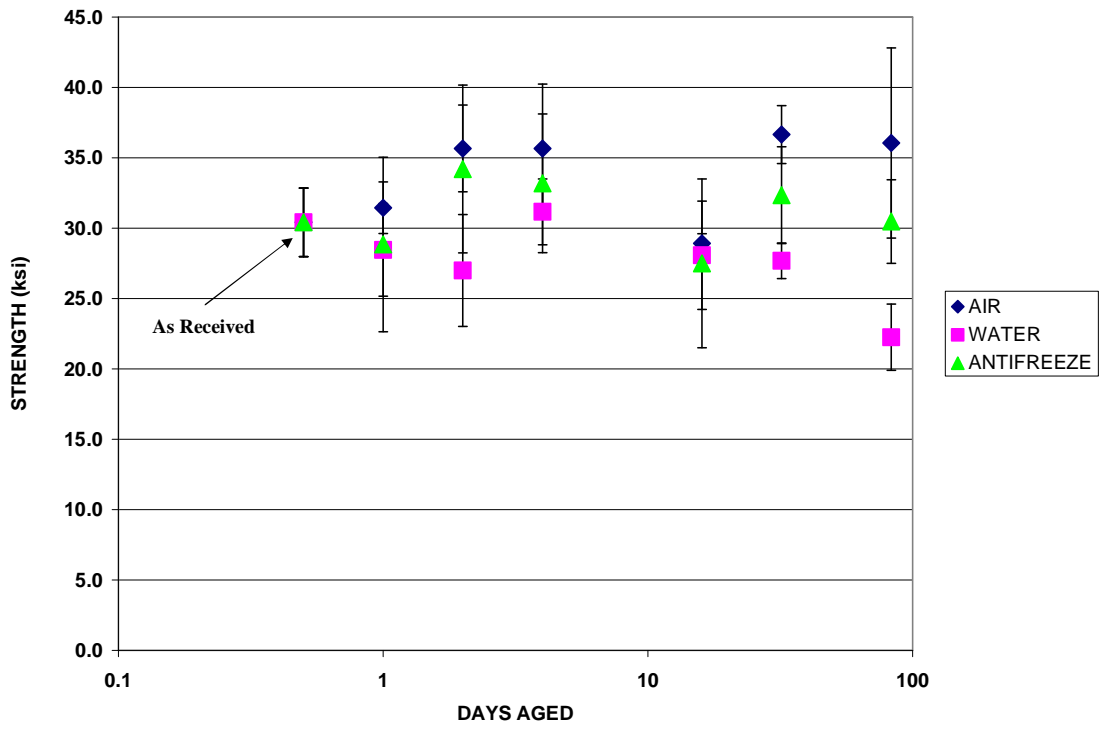
Figure 17: Materials A Tensile Strength vs. Aging Time

The increase in strength between the as received and 4 day tests are likely due to residual curing of the composite at the 85°C aging conditions. A dynamic mechanical analysis was conducted to determine if there was potential for additional curing and is shown in Figure 19. The increase in storage modulus between scan 1 and scan 2 is due to additional curing of the material. Aging in air at 85°C has little effect on the tensile strength of the Materials A material. This is not surprising considering the fibers and matrix are both very resilient at this temperature in dry conditions.

The loss of strength of the Materials A and B materials aged in water and the 50/50 water/antifreeze mix is due to multiple factors. The first to consider is the likely reduction in the glass transition temperature of the matrix due to absorbed moisture. As stated earlier, moisture absorbed in epoxy acts as a plasticizer and reduces the glass transition temperature. This effect is likely the cause of the delamination and blistering seen in the samples exposed to water. In addition, as the process begins in the early stages of aging, the increased compliance of the material reduces the energy required for the water molecule to be transported into the free volume of the polymer. As the delamination begins, water quickly fills the free space and the damage continues eventually forming a water filled blister in the material. Aiding in the transport of water into these composites is the chopped fiber reinforcement. Composites with chopped fiber reinforcement are known to have greater diffusivities than their woven roving counterparts.

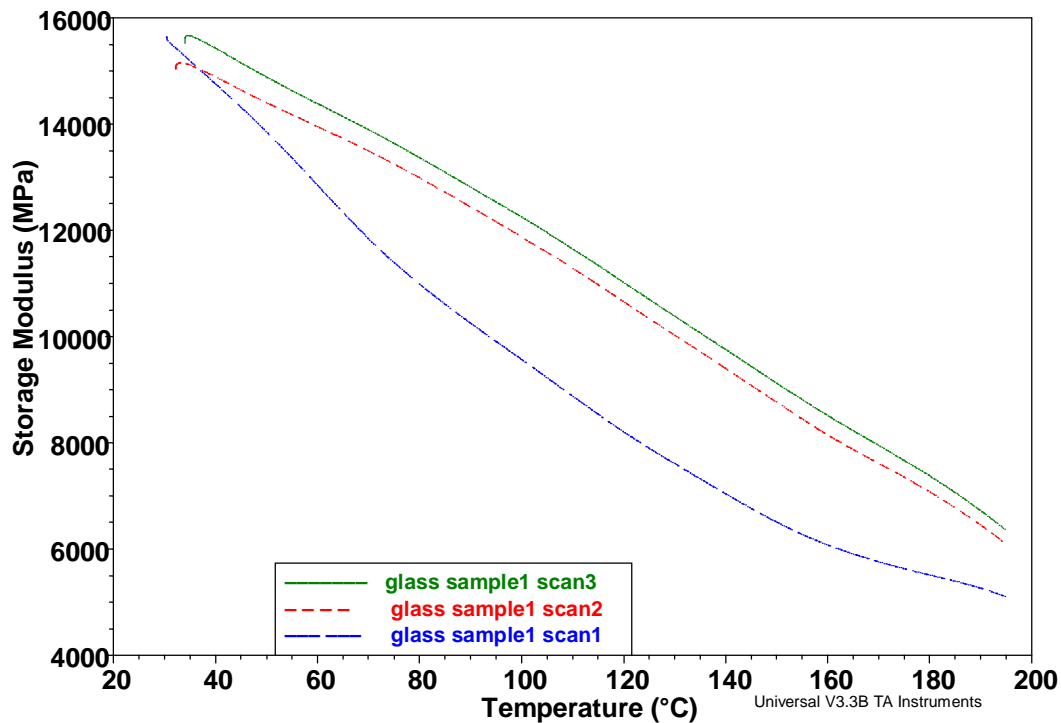
Figure 19: Dynamic Mechanical Analysis of Material B

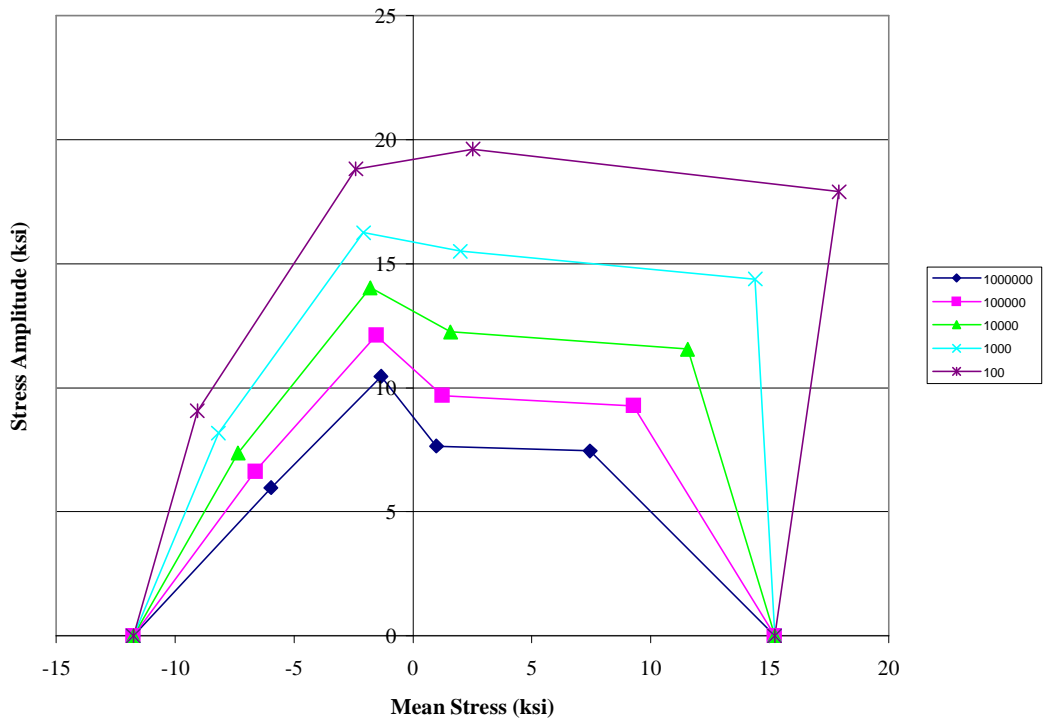
Figure 37: 85°C fatigue lifetime plot for Material A

From the development of the S/N curves, fatigue lifetime plots were constructed. The fatigue lifetime plots compare the life of the material to the mean stress and amplitude stress. The fatigue lifetime plots for Material A and Material B for room temperature are shown in Figure 35 and Figure 36 respectively. The more developed 85°C fatigue lifetime plots are shown in Figure 37 (Material A) and Figure 38 (Material B). Figure 39 and Figure 40 show the fatigue lifetime plots for the -20°C test condition.
