An Innovative Footpath Pavement Management System for Auckland Transport

Abstract: Traditionally footpath inspections are done either on foot which is slow and labour intensive, or from a vehicle driving on the carriageway. Both often give inconsistent and inaccurate results. A mobile footpath inspection vehicle, consisting of a 50cc scooter and an on-board data capture system, has been developed for inspecting and collecting footpath condition data for Auckland Transport. Voice recognition technology is utilised so that the inspector can record type and severity of faults hands-free. All location information (route position, road id#, footpath id#, street address) is captured automatically through GPS tracking technology. The system also automatically calculates the condition grade of each footpath section based on fault types, quantity and severity. This mobile inspection system greatly enhances the efficiency, accuracy and consistency of collecting and managing footpath condition data. Three years of inspections have been completed for over 6,800 km of footpath managed by Auckland Transport. Optimized 3-year and 10-year footpath renewal programmes have been developed based on t

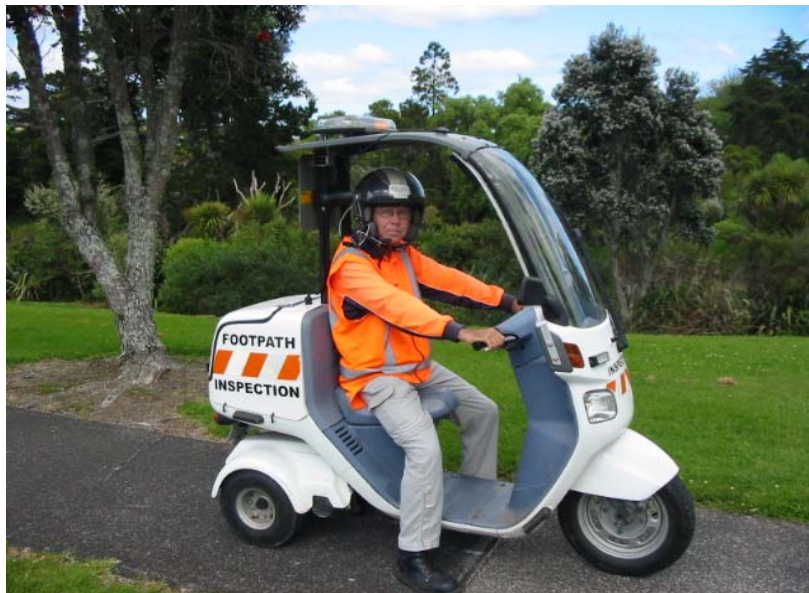
The safety features include high mounted LED orange flashing lights and reflectorized “Footpath Inspection” sign writing visible from all angles. The operator wears orange overalls, safety boots and a helmet.

FIGURE 2 Scooter and Operator

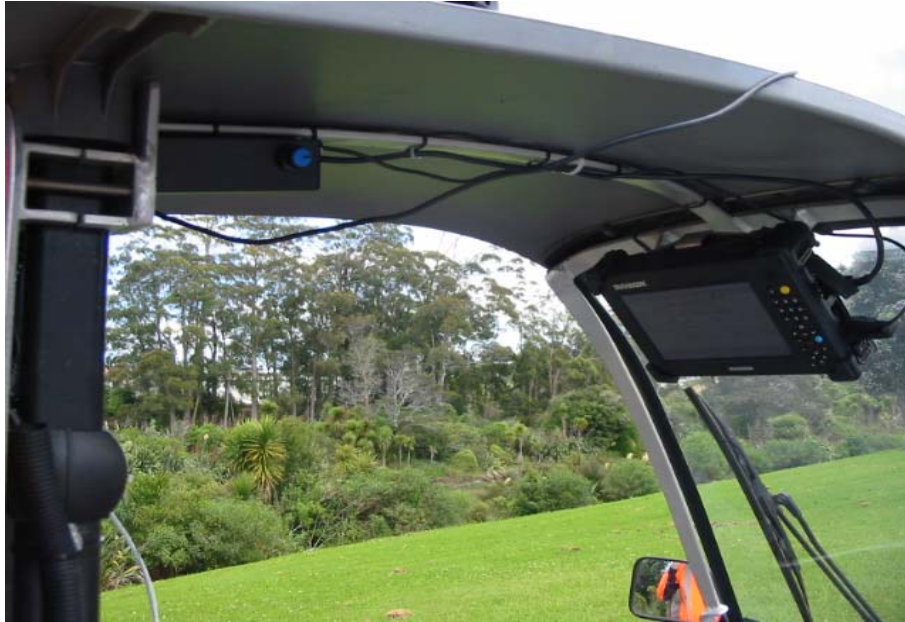
The selected hardware specific to the data collection is a Windows compatible rugged tablet, GMouse GPS receiver, microphone/speakers attached to a helmet and a video camera. A 22ah Lithium-Ion battery located in the scooters storage compartment provides the daily

Custom brackets were required for mounting the tablet and other equipment.

FIGURE 3 Data collection device and mounting brackets
