## Stray Electricity on Dairy Farms

G. M. Jones, Extension Dairy Scientist, Management  
Virginia Tech

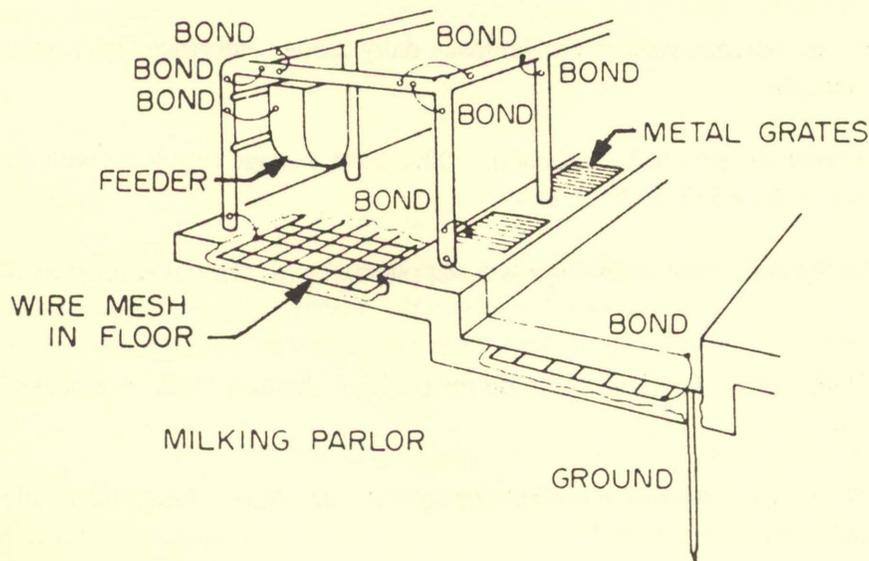
Figure 1

With an *equipotential plane* in the milking parlor, all cow contact points are at the same potential, including stalls, floors, and all equipment (Figure 1). All new milking parlors should be installed with an equipotential plane or grounding mat. Embed a welded wire mesh (6 x 6, 9 or 10 gauge) in the concrete floor for the cow stalls and operator pit. Cover this grid with a layer of concrete which is less than 2 inches thick. Bond the grid to other conductors -- stalls, floor grates, feeders -- by welding to No. 4 copper wire. Connect the copper wire with stainless steel clamps to stainless steel pipelines and bulk tanks. Copper wire in concrete may deteriorate over a short period of years. Use 3/8 rebar and carry it out the side of the building and to service entrance. Ground to the well casing.

To off-set reluctance by cows to enter the milking parlor from the holding area, extend the wire mesh grid through the holding area.
