Alternative Methods for Sealing Overlapping Steel Members with Narrow Gaps During Galvanizing

Thesis submitted to the faculty of the Virginia Polytechnic Institute and State University in partial fulfillment of the requirements for the degree of

Civil Engineering

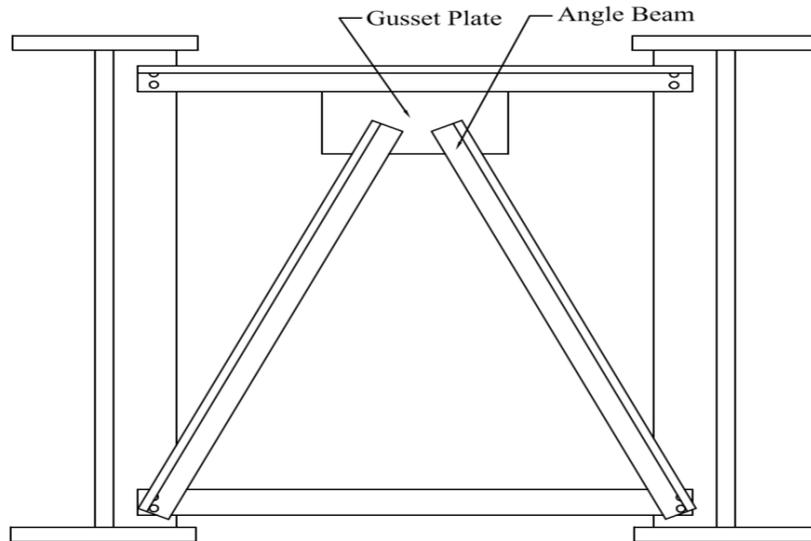
For the purposes of this research, overlapping surfaces are considered simply as two adjacent planar steel surfaces that are either welded or bolted together. They are common in many structural steel applications. For this project, the focus is highway bridges; specifically, lateral bracing systems (cross frames). Cross frames are used for stability and stiffness needs. For steel bridges, they often consist of angles (surface 1) fabricated and attached diagonally to gusset plates (surface 2), as shown in Figure 1. This geometrical configuration between the two surfaces causes an overlapping surface.

Figure 1: Overlapping Surfaces Between the Angle Beam and the Gusset Plate

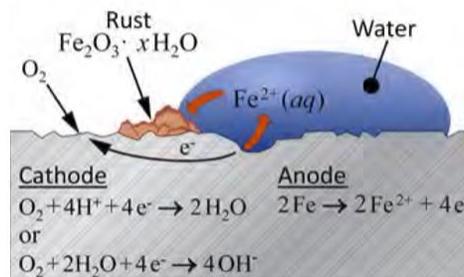
Corrosion is the natural deterioration process of a metal due to an electrochemical reaction between the metal and the environment. The electrochemical reaction occurs when the metal surface undergoes oxidation reaction. An oxidation reaction is the process of losing electrons of the metal from the contribution of oxidizing agents, typically oxygen. For steel specifically, when encountering such a loss of electrons, ferrous ions are formed, which is the actual metal loss. The ferrous ions can potentially react and combine with hydroxyl ions, which are formed from the reaction of oxygen from the environment with the electrons from the metal, creating a reddish to brown rust (Young, Mindess, J. Gray, & Bentur, 1997). The schematic picture shown in Figure 2 illustrates the process of the general corrosion case.

Figure 2: A General Electrochemical Reaction on a Metal Surface (NACE International, 2012)

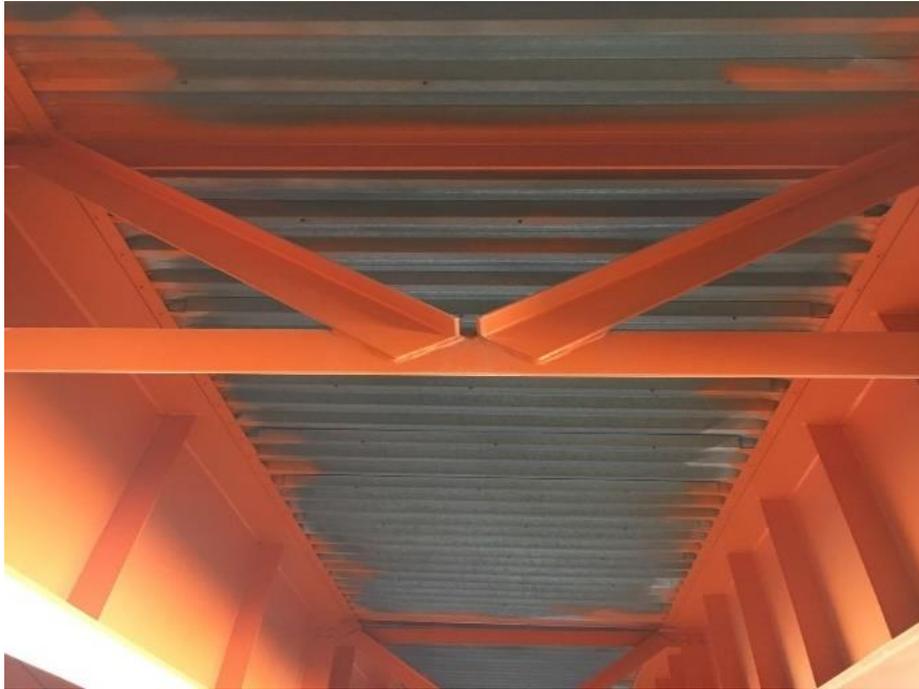
There are several preventative measures to impede or control the corrosion that occurs. The ultimate goal for these measures is to provide a layer on top of the steel that acts as a first line of defense against the corrosive attack. For example, one of the commonly applied methods is painting, as shown in Figure 3. Painting provides a protective barrier between the steel and the surrounding environmental factors, such as moisture, oxygen, and chlorides or salts. This

Figure 3: Painted Girders and Bracings in a Bridge (Highway 460, Blacksburg VA)

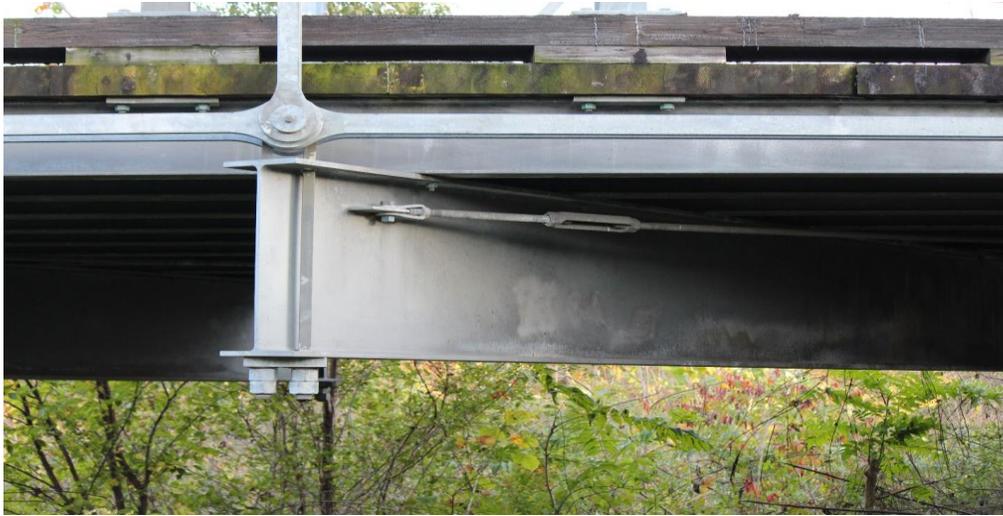
Another common example is galvanizing the steel. Hot-dip galvanizing is one of the most common methods of galvanizing steel and is explained in detail in the next section. Galvanizing the steel provides a gray looking thin zinc coating layer as shown in Figure 4. Zinc acts as the anode and, when coated on steel, corrodes first, impeding the corroding of steel. Lastly, one preventative measure, which differs from coating methods, is having corrosion-resistant steels. These steels are self-resistant. The method to achieve such resistance is by changing some of the composition of alloying elements of the steelmaking. Some elements, such as copper, phosphorus, and aluminum, are known for their corrosion resistance (Young et al., 1997).

Figure 4: Galvanized Bridge Components (Goshen Land Company Bridge, VA)

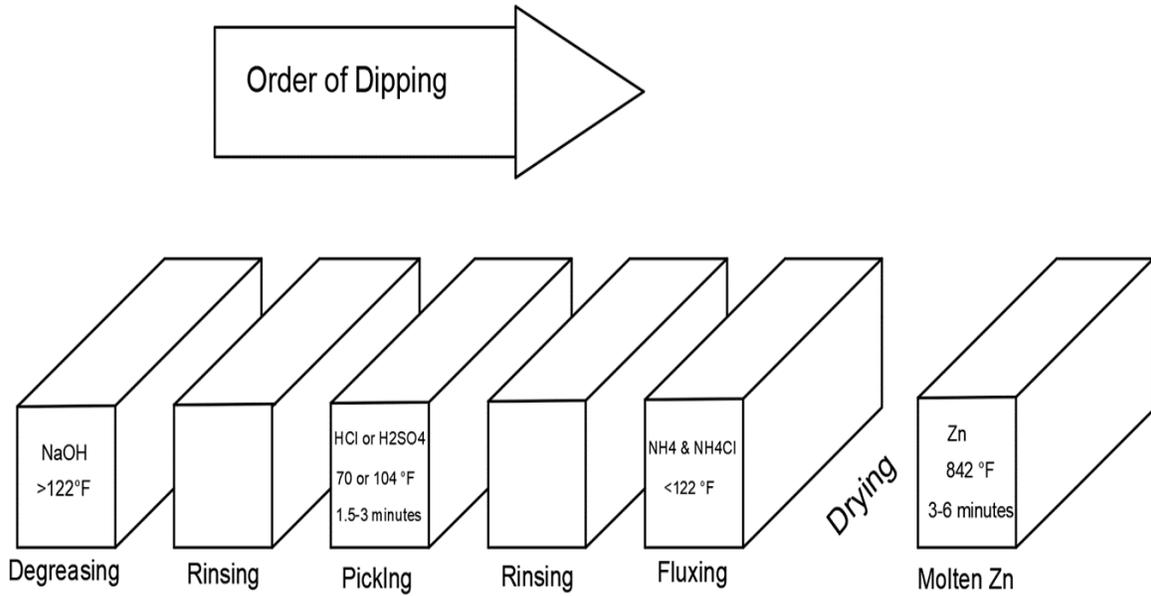
In general, HDG is a dipping process where steel is immersed into multiple baths in a sequential order. Each bath has a different chemical formula that provides the appropriate need for steel preparation and protection. The key to having a uniform and efficient zinc coating is to provide a proper surface cleaning. The steel preparation has three stages: caustic cleaning/degreasing, pickling, and fluxing. Figure 5 illustrates the HDG process and shows each bath with the cleaning solution chemicals and temperatures.

Starting with the degreasing process, the steel is immersed in an alkaline solution bath (typically NaOH) that helps remove soil contaminants such as dirt and oil. Degreasing improves the efficiency of the pickling bath. It is recommended that the degreasing bath maintain a temperature of 122°F or higher (Kuklík & Kudláček, 2016). Second is the pickling bath, which is an acid solution bath (typically HCl) that removes the corrosive products such as stains, rust, and scale (oxidation surface). The efficiency of pickling is a function of the temperature of the pickling bath, the concentration of the HCl, and whether or not the steel has been degreased. A study has shown that the optimum pickling time changes when these parameters change, it was also found that the optimum pickling time occurs around 1.5-3 minutes for HCl that is 10% concentrated at room temperature or around 104°F (S. Sarhan, 2000). The last cleaning stage is the fluxing bath. It contains salty aqueous solutions such as zinc chloride and ammonium chloride. These chemical solutions are responsible for having a prepared steel surface to get the proper metallurgical reaction with the molten zinc bath. Also, the bath prevents any oxidation to the steel that might occur before galvanizing it with the molten zinc. The temperature of this bath is recommended to be below 122°F (Kuklík & Kudláček, 2016).

Figure 5: Hot-Dip Galvanizing Typical Process

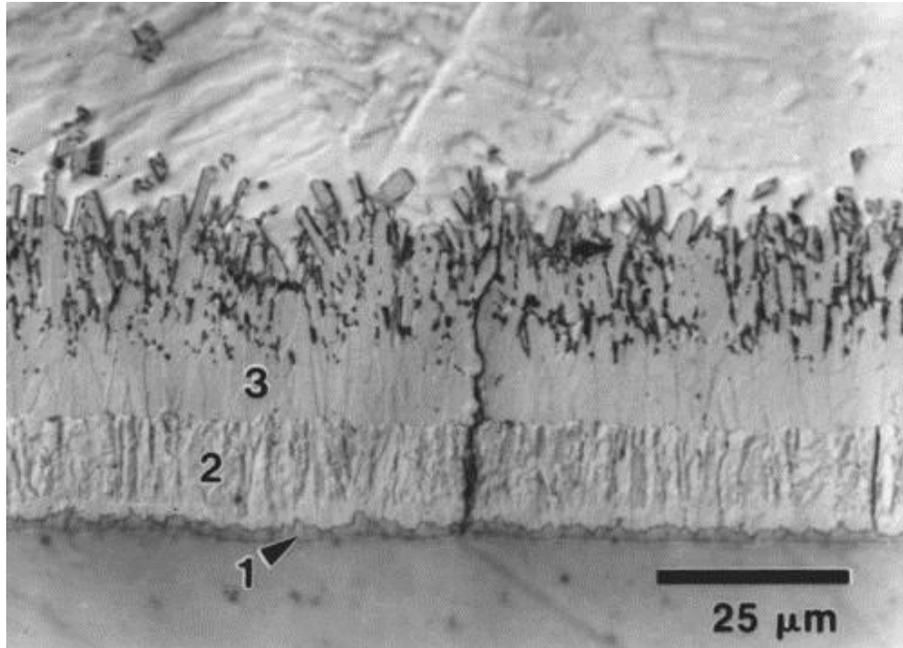
The final bath of the process is the molten zinc bath. It has a temperature of around 850°F and a purity of zinc of at least 98% (ASTM B6, 2013). Many factors affect the immersion time such as the thickness of the steel, the bath's temperature, and the zinc content. The molten zinc reacts with the steel and provides the protective coating layer. A typical microscopic metallurgical reaction layer between the steel and the molten zinc is shown in Figure 6. Each phase has a different crystal structure and different zinc weight percentages. In Phase 1, gamma, the closest to the base steel, has approximately 75% zinc and 25% iron. In Phase 2, delta, has around 90% zinc and 10% iron. In Phase 3, zeta, has around 94% zinc and 6% iron. The layer above 3 is a pure zinc (Marder, 2000).

Figure 6: Typical Layers Of (1) Gamma, (2) Delta, (3) Zeta Found After HDG (Marder, 2000)

After obtaining the cuts, two areas were investigated as indicated in Figure 33 which shows a drawing of the cross section of a plate with the indications of the investigated areas. The first area is indicated by the top circle of the cross section and the second area is indicated by the bottom circle. The objective of investigating the top area was to determine the zinc quality adjacent to the gap. As stated, some of the configurations were sealed with silicone, and some of them had a minimum gap of $3/32$ in.; thus, the zinc interface between the area adjacent to the gap and the surface of the gap was a question of reliability. To the left, the bottom investigated area of the overlapping surface was near the welds, as shown in the same figure. The motivation behind this spot was to determine if the zinc coating or cleaning solutions reached to the bottom given the small gap and, additionally, to determine the detailing of the interface between the weld and the zinc. After cutting the specimen, a microscope was used to determine the bond quality of the indicated areas. A typical metallurgical reaction layer was shown in Figure 6.

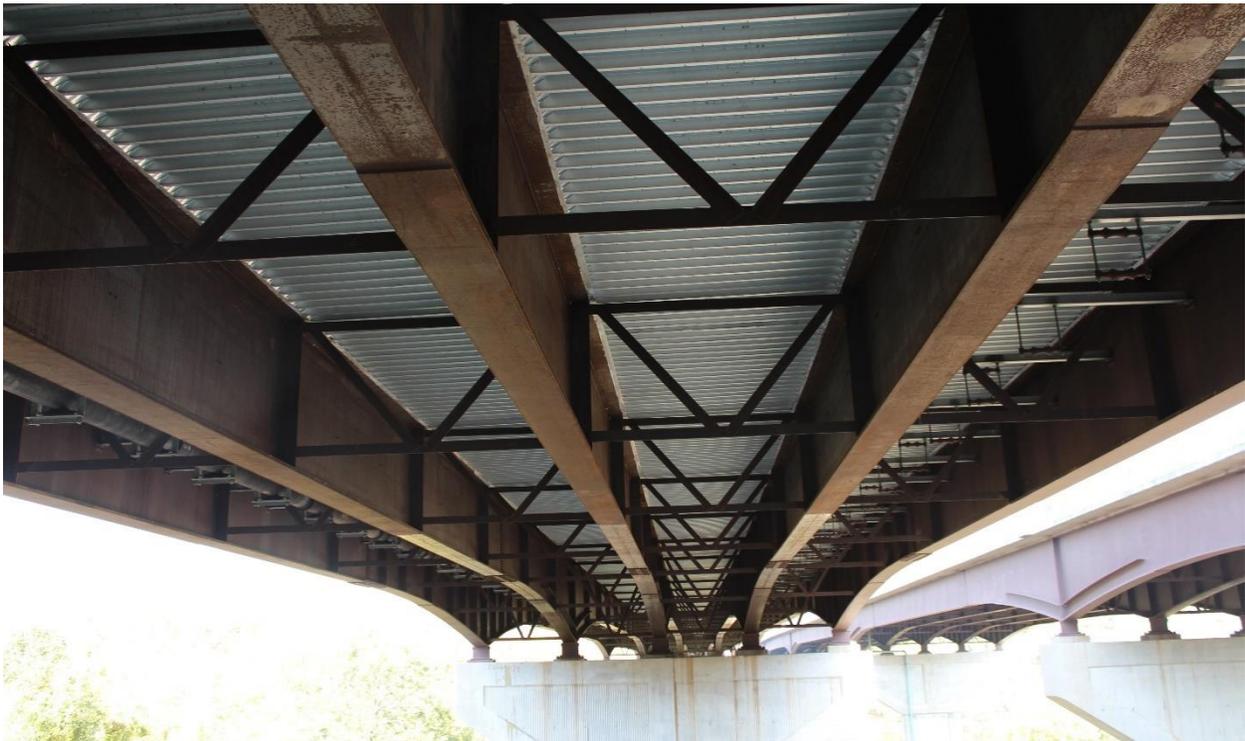
Many steel highway bridges in the United States use bracing systems to achieve stability and transfer lateral loads. Figure 7 shows several K-bracings of one span of the Lee Highway Bridge in Radford, VA. These systems are usually composed of bracing angles or steel bars connected to gusset plates by welding or bolting. This configuration creates an overlapping surface as shown in Figure 8. These overlapped surfaces create a very small gap between surfaces. When galvanizing, this gap can cause interior corrosion that can lead to rust bleeding and stains.

Figure 7: K-Bracing Systems Welded to Gusset Plates (Lee Highway Bridge, Radford)

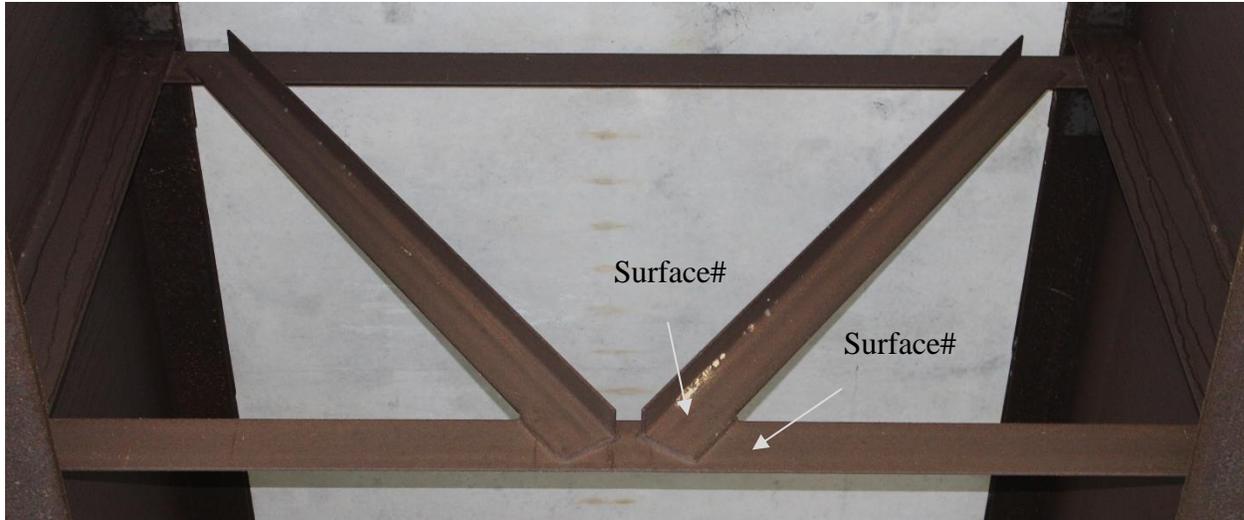
Figure 8: Angle Beam (Surface 1) Overlapping with a Steel Bar (Surface 2) (I-81 Bridge, Blacksburg VA)

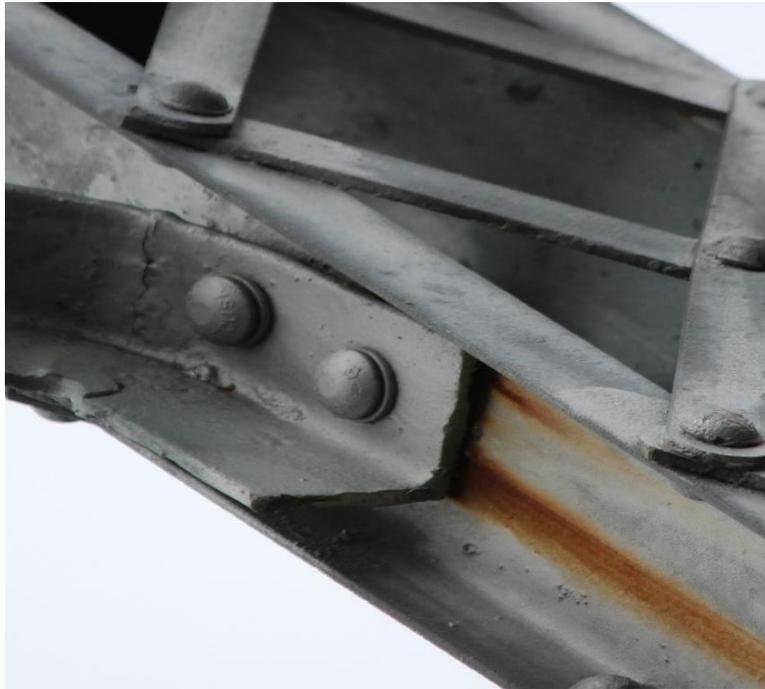
- The trapped cleaning solutions turn to steam, causing high pressure between the contacting surfaces which in turn may lead a burst of escaping steam, sending molten zinc into the air and creating safety issues as well as damage to the zinc coating nearby (ASTM A385, 2010)
- Because of moisture, the trapped cleaning solutions may cause corrosion issues later due to the leaching or ‘bleeding’ of the chemicals within the cleaning solutions when exposed to the atmosphere (ASTM A385, 2010). Figure 9 shows a typical ‘rust bleeding’ that was caused by the interior corrosion of the overlapped surface due to the trapped cleaning

solutions. Although the member shown is riveted, which is not the focus of this research, it illustrates the concept of the potential problems with overlapping surfaces.

Figure 9: Rust Bleeding (Goshen Land Company Bridge)

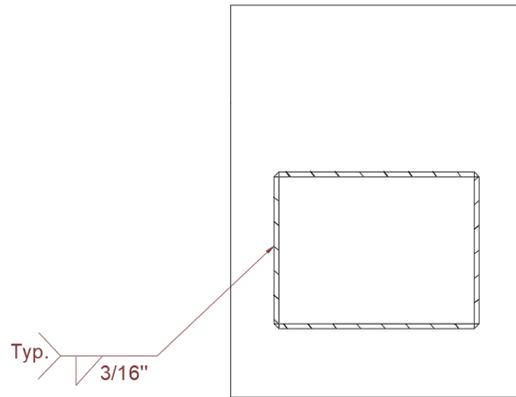
surfaces by eliminating the existence of the gap. Figure 10 shows an example of a typical seal-weld between two plates in which the weld continues to the edges. When the research team visited several bridges around the area of Montgomery County, such as Route 460, Interstate 81, and Lee Highway, it was found that most of the bracings were seal-welded. Figure 11 shows an example of a seal-welded bracing. Although seal-welding is proven to be an effective method to prevent the penetration of cleaning solutions, it requires time and excessive welding when used in cross frames.

Figure 10: Typical Seal-Weld Example

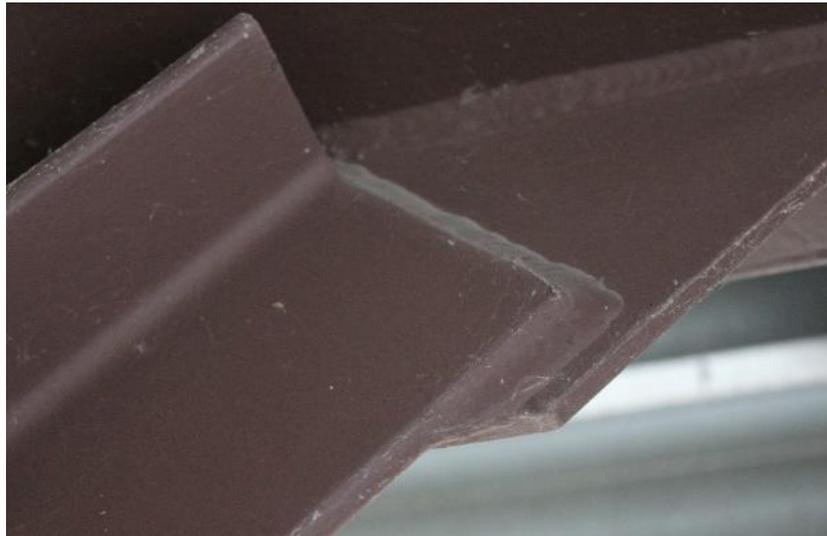
Figure 11: Seal-Welded Bracing to a Gusset Plate (Lee Highway Bridge)

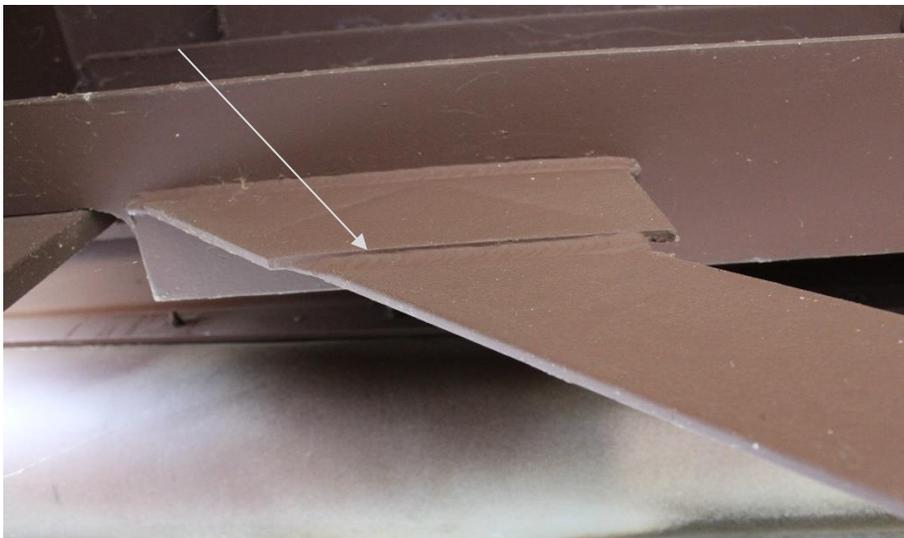
Since cross frame angles are extended beyond the gusset plate, a fillet weld is typically required on the back-side of the frame. An example in Figure 12 shows the back of bracings welded to a plate as indicated by the arrow. Since the transverse weld is in the other side of the overlapping surface, it requires flipping and rotating of the cross frame by cranes in the fabrication shops to account for it. From a fabrication standpoint, omitting the back weld can reduce the handling and lifting of cross frames during the fabrication. To reemphasize, for instance, according to the California Department of Transportation, it was stated in their design guidelines for cross frames that "...all welding during fabrication should be done from one side to minimize handling costs." (Duan, Saleh, & Kim, 2015), this is to eliminate the transverse weld.

Figure 12: Transverse Weld (Lee Highway Bridge)

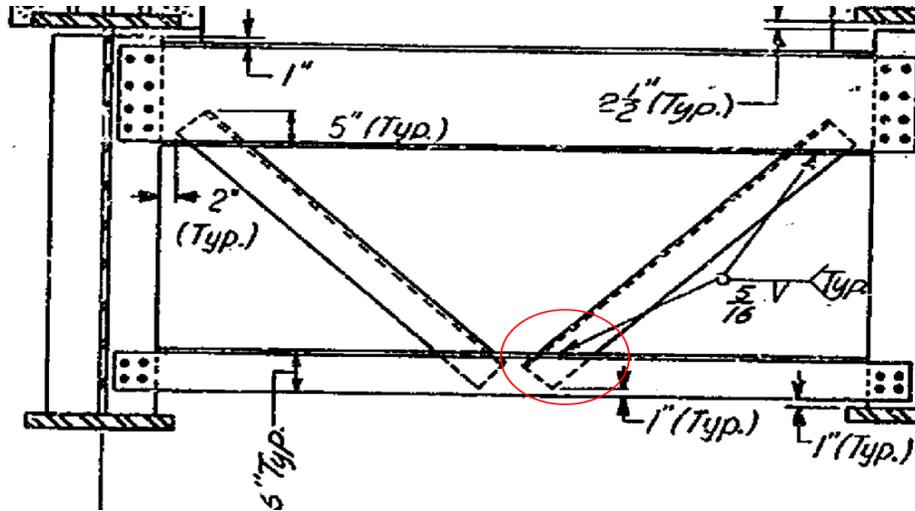
The study was done for the Prices Fork bridge over the State Highway 460, located in Blacksburg. Plans and drawings were obtained from VDOT. The plans showed that there is a total of 164 K-cross frames in the nearly 250 ft long bridge. Figure 13 shows the drawing of the cross frames. The red circle represents the angle beam, which is L5x3x3/8 in. according to the plans, welded to the steel bar. As can be seen from the figure, the transverse weld indicated at the back of the beam to be 5/16 in.. Although there is no indication of welds in the other three edges as seen from the figure, a VDOT representative verified that the contacting lengths between the two frame members were welded in the fabrication shop. Figure 3 shows the cross frames same bridge, where it can be seen clearly that the contacting surfaces were welded.

Figure 13: Prices Fork Bridge (460 highway, VA) (Sutherland-VDOT, 1977)

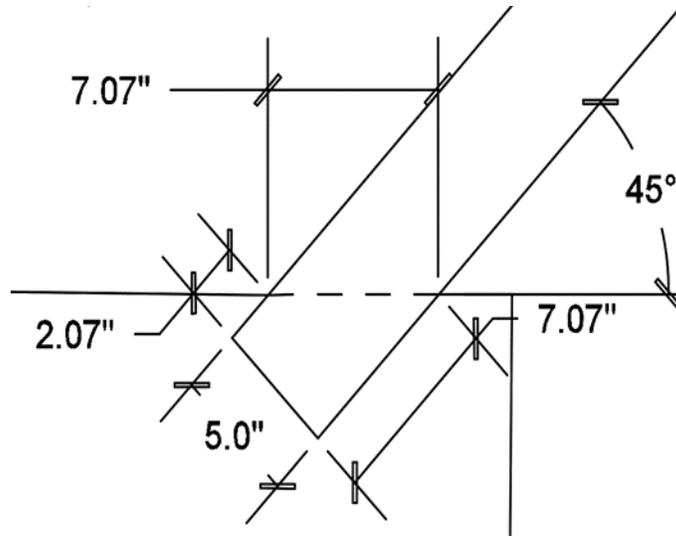
The weld material deposited (volume of welds) and the time utilized for the welding can be estimated given the rate of weld application and the length of the contacting surfaces. According to a journal from the American Welding Society, it requires 99 seconds for a 5/16 in. fillet weld that is 1 ft long (Barckhoff, Kerluke, & Lynn, 2010). The weld length for the given K-frames were estimated using simple geometry obtained from the plans. Figure 14, which is a simplification of the red circle from the previous figure, shows each side and the estimated lengths. The only assumption made for determining the lengths is the angle of the oriented angle beam to the horizontal, which is 45° . Given the dimensions, the total length of the weld length is 21.2 in. for four edges, 14.1 in. for three edges, and 9.1 in. for two edges, for one overlapping surface. Note that three edges means omitting the 7.07 in. back weld, and the two edges is omitting the back and the top (7.07 in. and 5 in.) leaving the two sides only.

Figure 14: Lengths of the Contacting Surfaces.

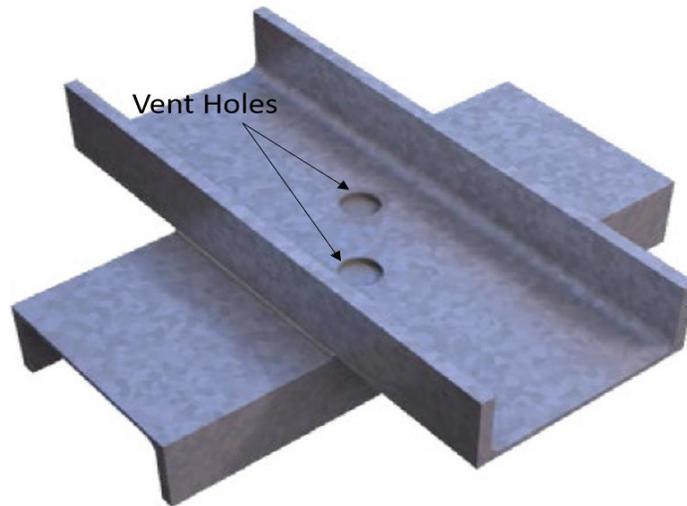
The other solution that was investigated to overcome the previously mentioned issues with galvanizing overlapping surfaces is to have holes in the overlapping surfaces when their contacting area is large, as shown in Figure 15. The purpose of these holes is to smooth the flow of the cleaning solutions, the rinsing water, and the molten zinc. This in return drains out the

cleaning solutions, which prevents a high-pressure liquid collecting inside the contacting surface. The vent hole size(s) are a function of the overlapping surface area. To illustrate, as the overlapping surface area or the contacting surface increases, the diameter of the hole increases as well. ASTM A385 and many other technical practical design reports from the galvanizing industry have standards for the hole's dimension, as shown in Table 2.

Figure 15: Typical Vent Holes for Overlapping Surfaces (GAA)

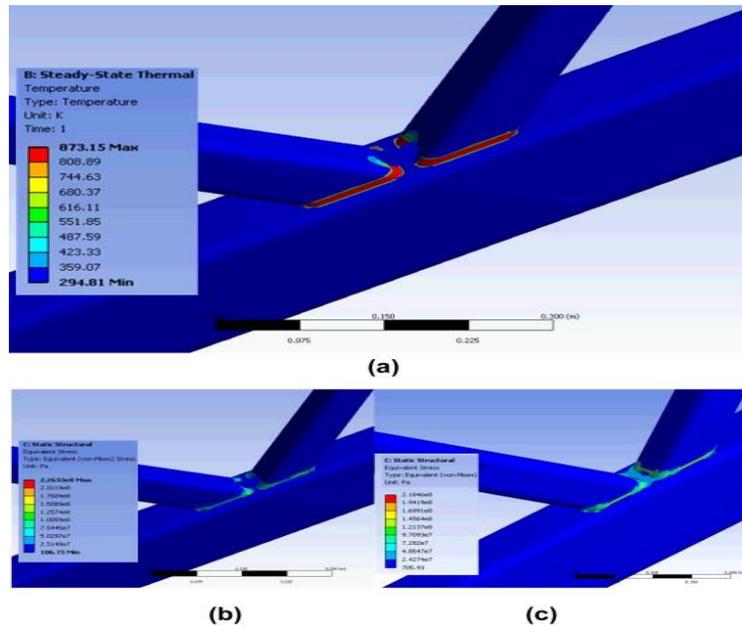
Holes, however, may introduce new potentials for failure. Although a numerical study published the effect of circular, semicircular and V-notched holes of K-joints, as shown in Figure 16, it was concluded that these small holes do not have a significant influence to the strength of the member (Serrano-López, López-Colina, Díaz-Gómez, López-Gayarre, & Iglesias-Toquero, 2015), the study did not consider the fatigue limit state, which is a significant factor in the bridge

Figure 16: K-joint Test Study (Serrano-López et al., 2015)

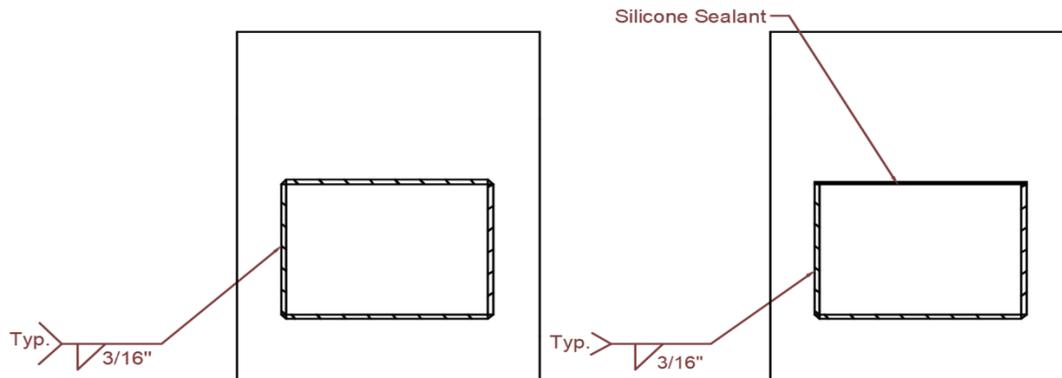
and the fabrication of cross frames, commercial silicone caulk sealants were thought to be the best alternatives to replace the welds. Figure 17 shows where the bead of the sealant is applied instead of the weld on the top edge. Silicone sealants are easily and quickly applied, no prior experience is needed, and they are ultimately more economical than welding. These advantages favored using silicone sealants instead of other materials.

Figure 17: Comparison of Welding and Caulking Overleaped Surfaces

in Figure 17. Therefore, the silicone was applied only to these configurations and not the others. As can be seen from the table, some of the specimens were only degreased, some were degreased and pickled, and some were degreased, pickled, and fluxed. This is to determine at which stage the silicone failed.

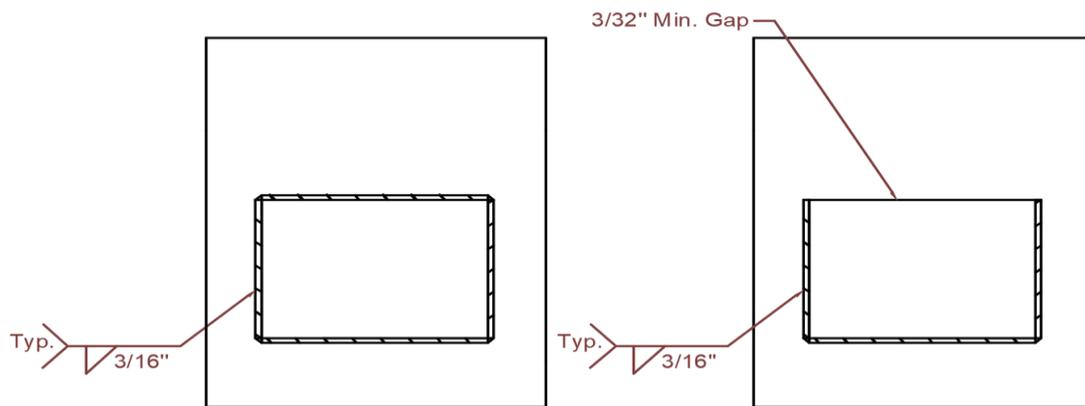
Figure 18: Comparison of Welding and Wide Gap Overlapped Surfaces

In addition to the recommended use of silicone by the fabricators, galvanizers, on the other hand, recommend using a minimum of $\frac{3}{32}$ in. gap between the overlapping surfaces, as shown in Figure 18. The main purpose of this gap is to allow the thick zinc leach through the gap to galvanize the surface. Additionally, it allows adequate cleaning and rinsing of the cleaning solutions between the overlapping surfaces as well as letting them escape easily. Thus, preventing the existence of bare spots, internal corrosion and splashes of the molten zinc. The gap is simply constructed using a shim between the overlapping surfaces when welding them together.

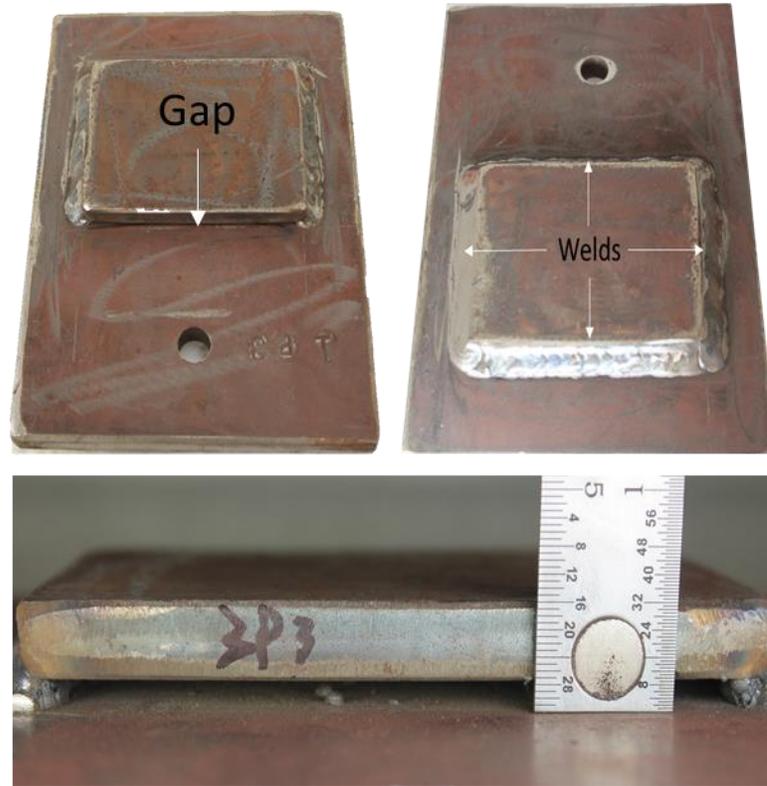
Figure 19: Sample Plate Specimens

The materials and fabrications determined for this research were targeted to be similar to the lateral bracing systems of bridges. Therefore, overlapped surfaces of steel plates were the best representatives of cross frames. A sample of the specimens is shown in Figure 19. The bigger plate (6x8x1/2 in.) is the gusset plate, and the smaller plate (4x3x3/8 in.) represents the bracing bar. In addition, there is a 1/2 in. diameter hole on top to help galvanize the specimens by having steel hooked through the hole. The overlapped surface area was chosen to prevent any vent holes as required by ASTM A385, in which any overlapped surface areas that are 16 in² or less do not require vent holes (ASTM A385, 2010). A 1/2 in. thickness of the bigger plate was preferred to prevent any warping during galvanizing, as recommended by the galvanizers. Lastly, a typical fillet weld of 3/16 in. was chosen as it is common in bracing systems in highway bridges. The steel plates were donated and fabricated by Hirschfeld.

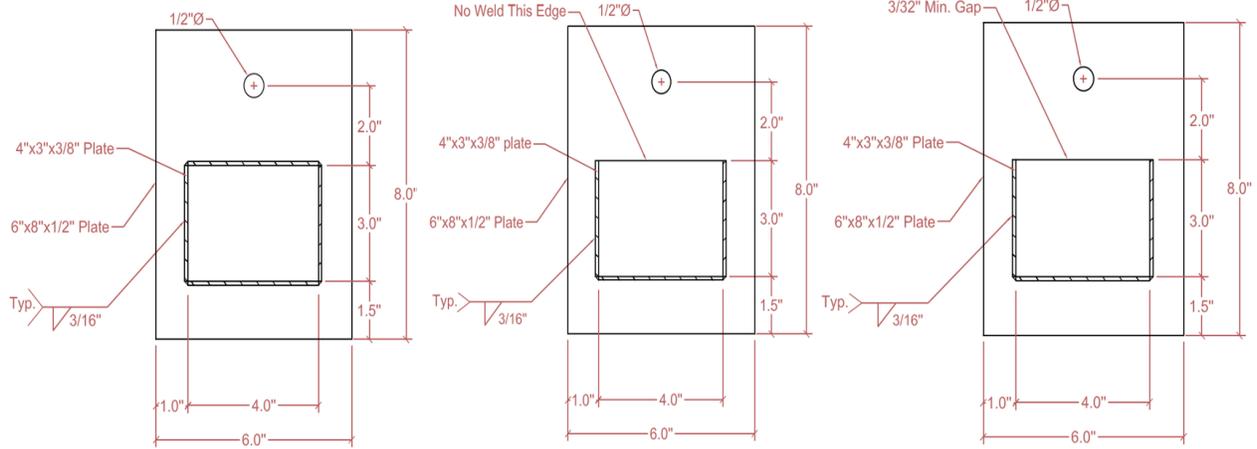
Figure 20: Steel Plates (configuration 1, 2 & 3, respectively from left to right)

There were a total 45 steel plates, all of which had the same dimensions but different configurations. There were six different configurations, as seen in Figure 20 and Figure 21. Each configuration was fabricated to achieve a specific purpose. The main difference between each configuration was the existence of the gap, the width of the gap and the location of the gap. Given the nature of this study, the configuration type, quantity, mark of each specimen, and the tasks, all can be found and summarized as a guide in Table 7 in Appendix A.

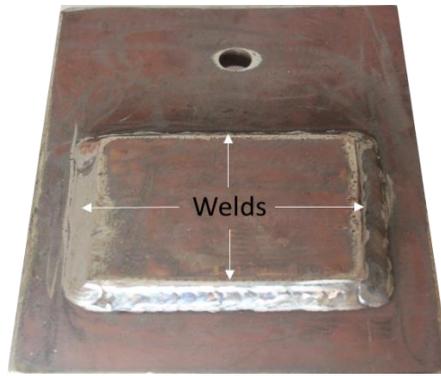
Figure 22: Configuration 1 (welded in all sides)

This was the control configuration, to which the other proposed specimens were compared with. This configuration is what was seen in the bridges that the researcher visited where the bracing bar is welded on all of the sides (four sides). Figure 22 shows one specimen of Configuration 1.

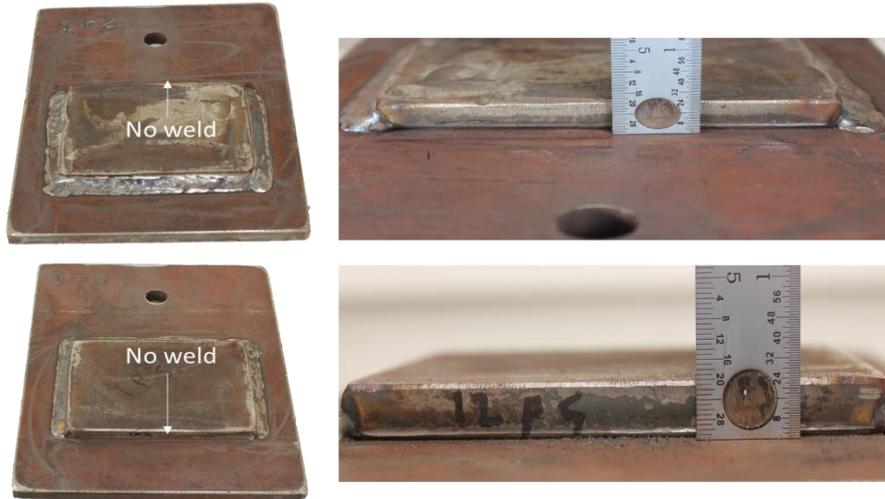
Figure 23: Configuration 2 (top) and Configuration 5 (bottom)

Configurations 2 and 5 were almost identical except that the open edge in 2 was on top relative to the immersion path while it was on the bottom in 5, as shown in Figure 23. In both configurations, the remaining three sides were welded. The reason behind having different location of the gaps was to determine if the orientation of dipping plays any factor in the coating quality of the galvanizing of overlapping surfaces. Figure 24 shows where the circular holes were attached to the hook cranes to immerse the specimens vertically. As seen, the open edge of the left specimen is facing upward whereas the open edge of the right specimen is facing downward. By analogy, an open pocket is used to collect and keep articles whereas an upside open pocket cannot hold items. In this case, Configuration 2 represents the open pocket whereas Configuration 5 represents the upside down open pocket.

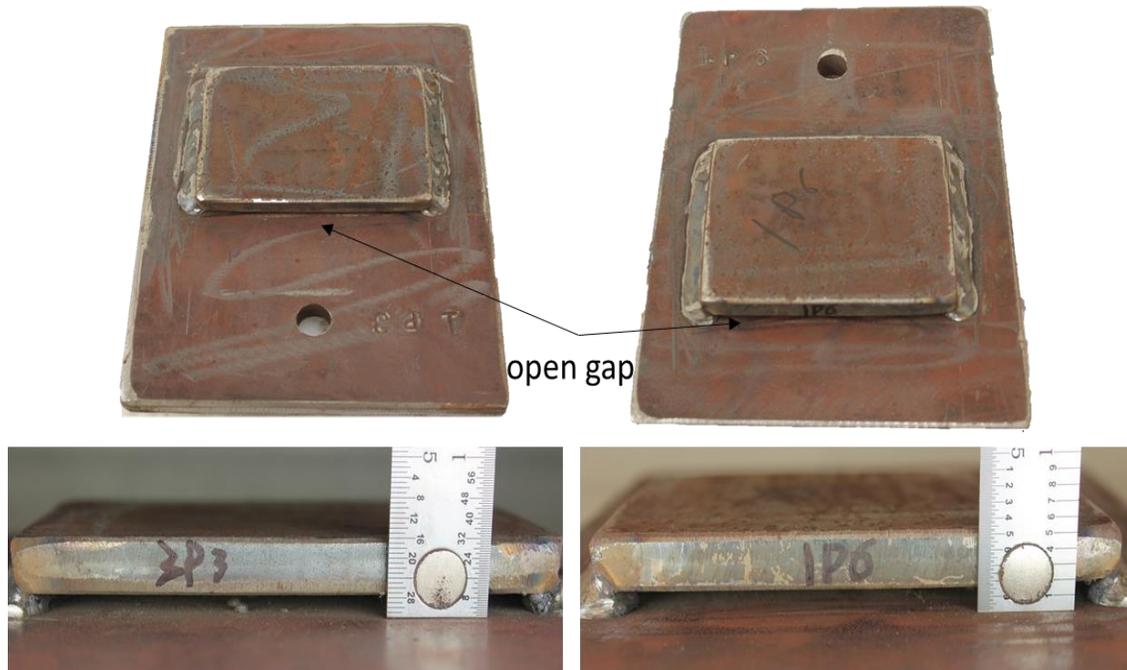
Figure 25: Configuration 3 (left) and Configuration 6 (right)

Similarly, Configurations 3 and 6 were almost identical to the analogy of Configurations 2 and 5, except that the gap was fabricated to be 3/32 in. or more, as shown in Figure 25. This gap width

is recommended by galvanizers in the industry. This was to allow not only the cleaning solutions to penetrate between the gap, but also the relatively thick zinc to flow inside and coat the interior surface.

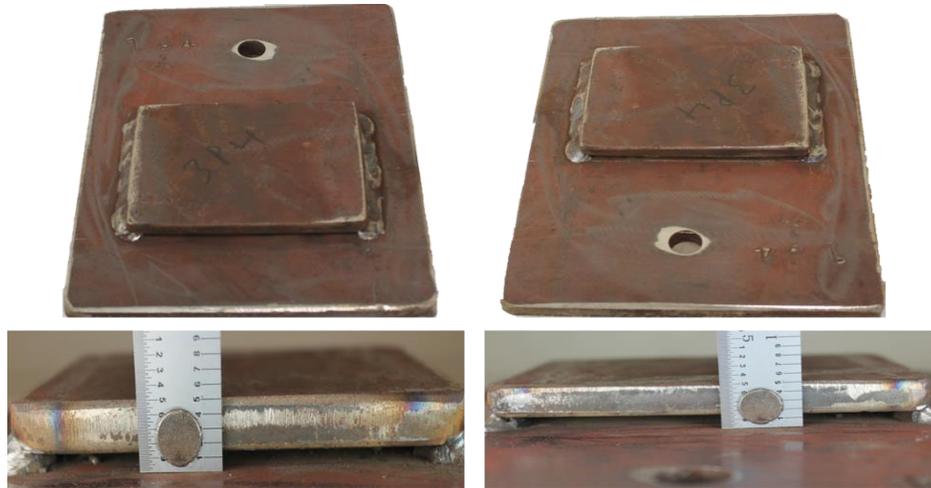
Figure 26: Configuration 4 (top and bottom views)

Unlike the others, Configuration 4 had only two welds on the side, with a minimum gap of $3/32$ in., as shown in Figure 26. The motivation behind this geometry was to have the cleaning solutions as well as the zinc flow between the overlapping surfaces.

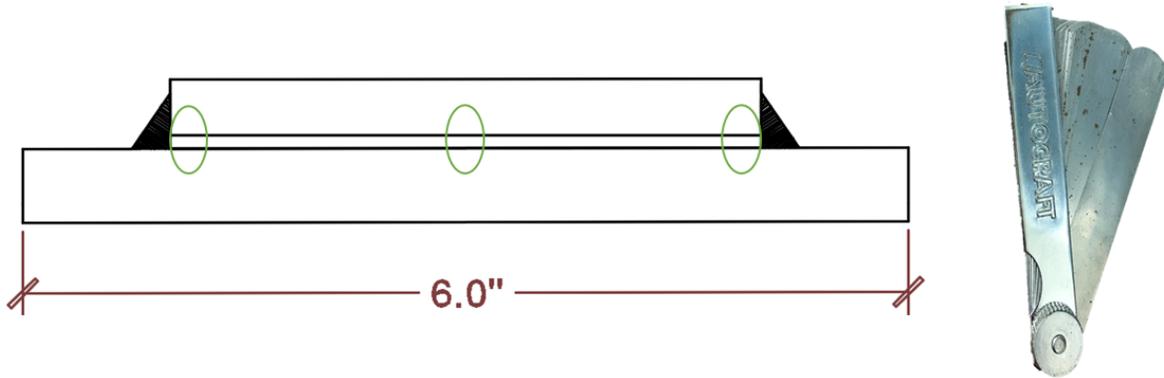
Figure 27: Three Circles Representing Location of Measurements (top view of a specimen (left) and feeler gauge (right))

The measurements were taken in three separate locations using a feeler gauge, as shown in Figure 27. The reason for having these three locations was to determine if the gap measurement could be related to performance of the specimens in the HDG process. Configurations 3, 4, and 6 were verified to be more than $3/32$ in. (0.09375 in.) as required, except one specimen from Configuration 3 where the gap measured was 0.0930 in., which is almost equal to the required $3/32$ in.. Most of the gaps in Configurations 2 and 5 could not be measured by the least unit of the feeler gauge, which is 0.0015 in., due to the gap tightness. In other words, there were no gaps between the overlapping surfaces in these configurations. Some difficulties arose when measuring some of the specimens, due to the slags and spatter of the welds stuck between the overlapping surfaces, preventing the movement of the feeler gauges. All of the measurements for

the 45 specimens can be found in Table 8 in Appendix A. Note that from the table, edge 1 refers to the left circle, edge 2 refers to the middle, and edge 3 refers to the right circle.

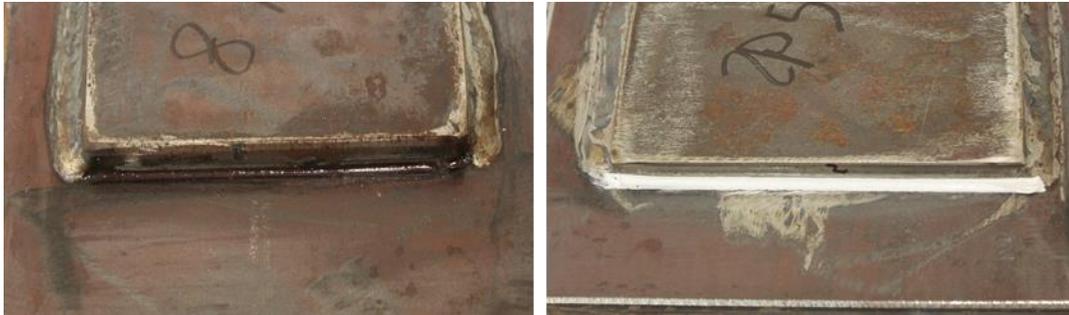
Figure 28: Configuration 2 Sealed with DAP Silicone (left) and Configuration 5 Sealed with GE Silicone (right)

The goal of applying the silicone was to seal the open edge specimens. The application was initially a bit challenging. With the aid of a caulk gun, silicone was applied as thinly and

sparingly as possible, as shown in Figure 28. To achieve this, tape was used adjacent to the gap, so that the silicone would not stick to or touch the steel surface other than the gap. However, the first attempted application of the silicone was done without the tape, which resulted in the removal and reapplication of the caulk for some of the specimens. Before application, the area adjacent to the gap had to be cleaned to improve the adhesion between the silicone and the steel surface. Figure 29 shows the sealants used along with the cleaner.

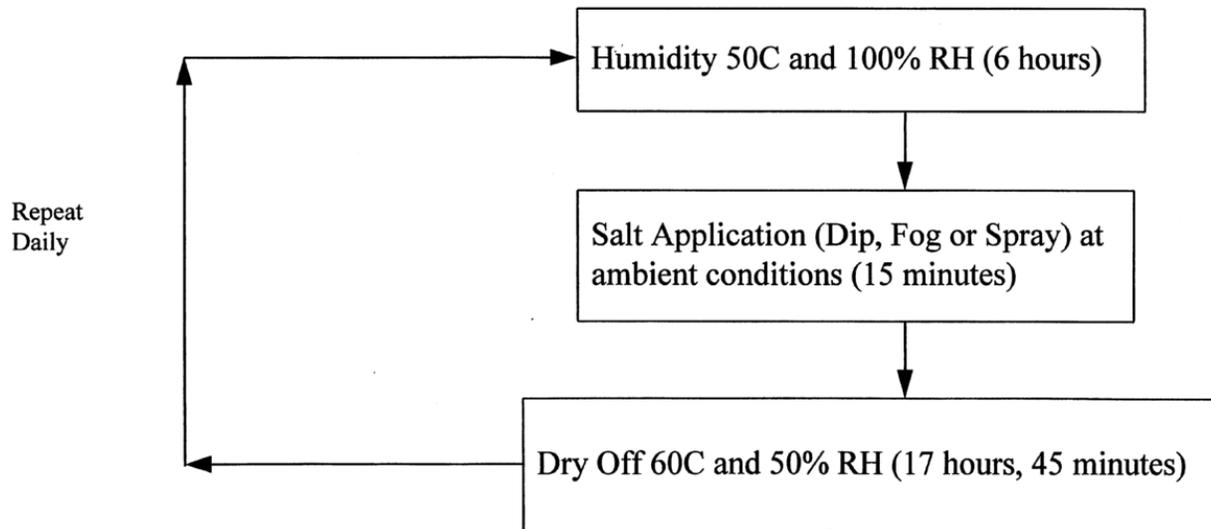
Figure 30: Corrosion Lab Cycles (SAE International, 2016)

The SAE J2334 provides a clear laboratory procedure to process the accelerated test. The steel specimens must undergo a process referred to as test cycles. The cycles are a 24-hour test. In these 24 hours, the specimens were exposed to three main stages: the humidity stage, the salt application stage, and the dry stage. Figure 30 shows the repeated daily cycles with the time and temperature for each stage.

As shown in Figure 30, the salt application stage can be completed using either of three different methods: dipping, fogging, or spraying. Since the chamber does not have the feature of spraying or fogging, dipping was chosen. The process simply required a daily immersion of the specimens into the salt solution for fifteen minutes.

The process of accelerating the corrosion was done in 40 cycles. The steel specimens were first placed in the humidity chamber. At exactly 3:45 am, the chamber was automated to start producing a 100% RH for 6 hours in the humidity stage with a temperature of 122° Fahrenheit. Although the requirement is to have 100% RH, the chamber is unable to produce such a high percentage as it causes sensor reading issues. The chamber can provide 98% to 99% RH. Then, at 9:45 am, the specimens were withdrawn from the chamber and dipped into the salt soaking containers for 15 minutes. Before dipping the specimens, however, for the first 10 cycles and at intervals of 20, 30, and 40 cycles, pictures were taken of the specimens to document the corrosion process. Next, the specimens were returned to the chamber for the drying stage, which is a temperature of 140° Fahrenheit for 17 hours and 45 minutes with 50% RH, thus completing one cycle.

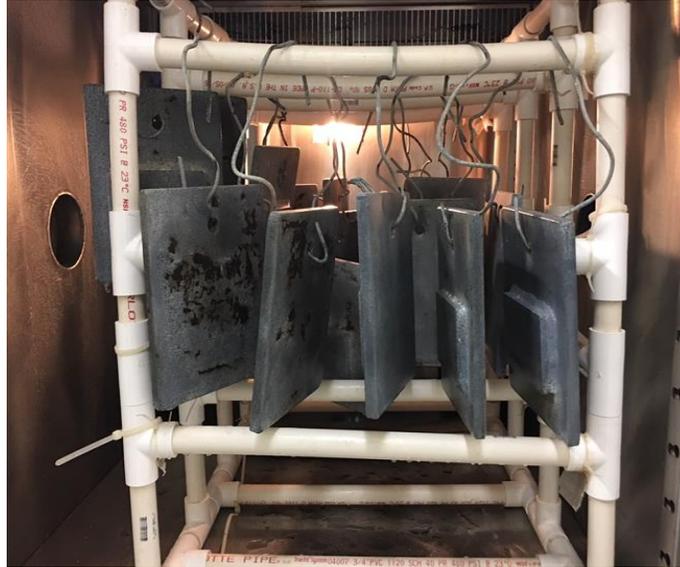
Figure 31: Steel Specimens Hung on PVC Pipes Inside the Chamber

The specimens were hung vertically inside the chamber through the 1/2 in. hole. This was done by inserting steel bendable wires through the 1/2 in. hole to be hooked to PVC plastic pipes inside the chamber, as shown in Figure 31. The reason for choosing this setup was to allow leaching or bleeding of rust, and additionally, to prevent any runoff from the moisture or the salt solution that might occur between specimens if the specimens had been placed on top of each other.

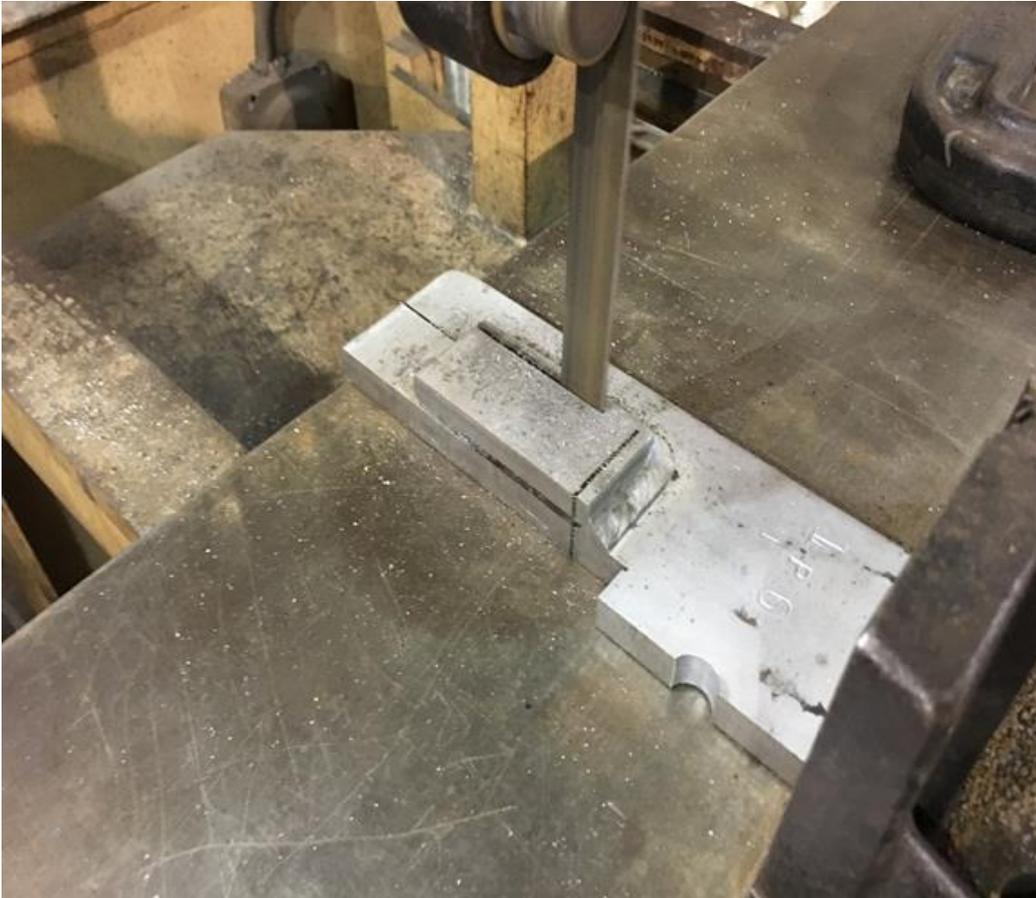
Figure 32: Bandsaw Saw Cutting a Specimen

The third task was a head-to-head comparison between different configurations in certain locations in terms of bond quality between the zinc and the steel after hot-dip galvanizing the specimens. The specimens were cut in half using a band saw from the Virginia Tech Structural Lab, as shown in Figure 32.

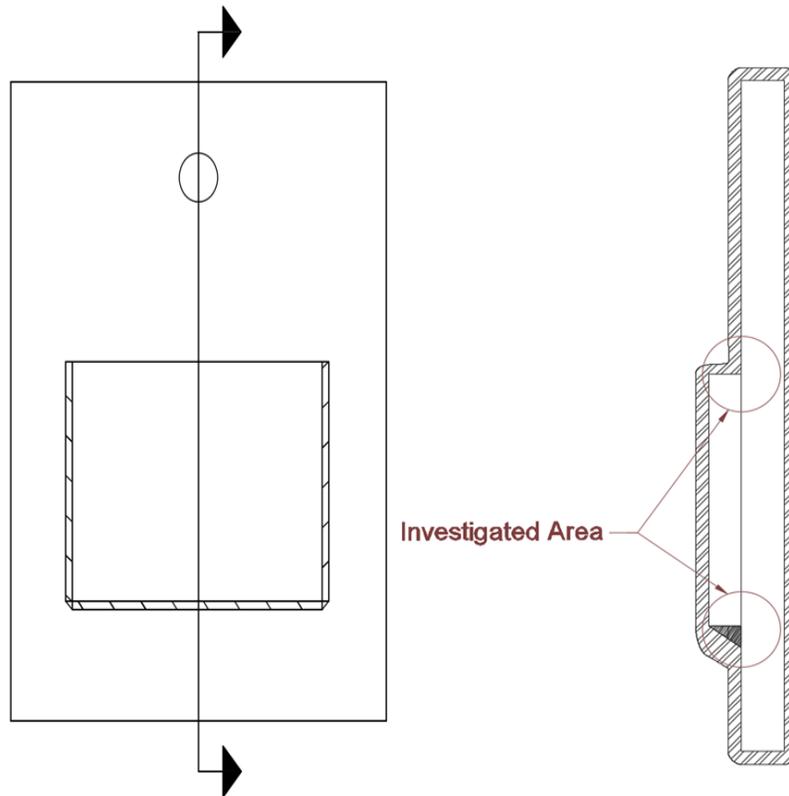
Figure 33: Steel Plate Cross-section Investigation Areas (all configurations except 4)

Furthermore, in addition to the two investigated areas, Configuration 3, 4 and 6 were cut in the edges to remove the smaller plate from the bigger plate, in other words, removing the overlapping surface, to view the zinc profile of the overlapping surfaces.

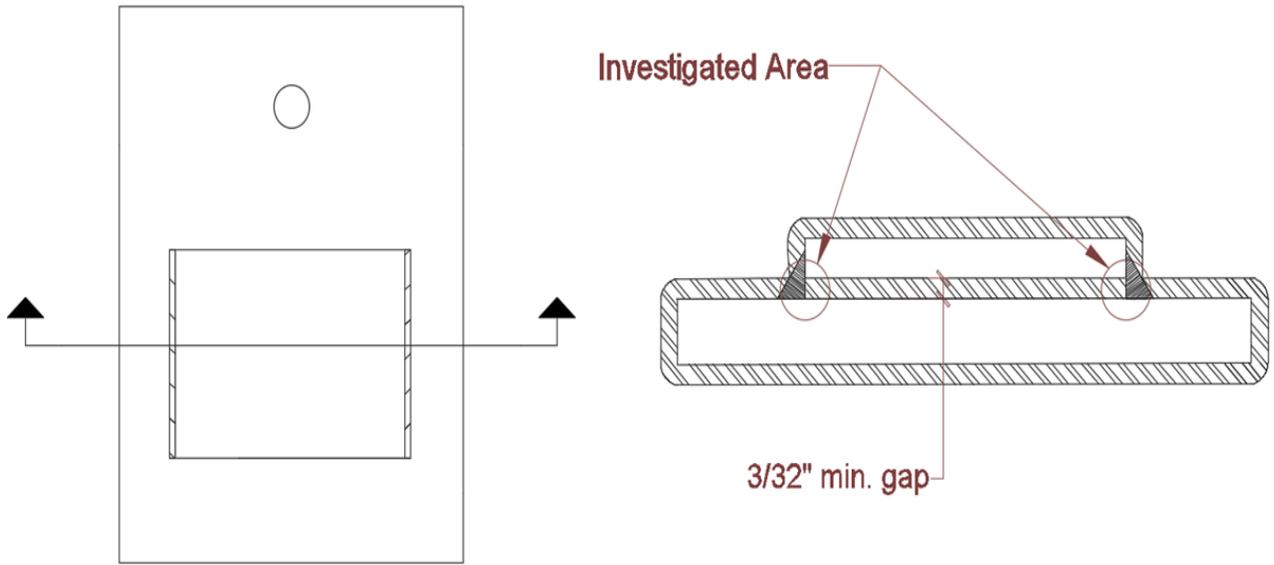
Figure 34: Configuration 4 Cross-section

Since Configuration 4 had welds on two sides, the cut runs in the opposite direction of the previous figure, as shown in Figure 34. The purpose of this cut was to determine the quality of the zinc around the weld of this configuration.
