Alternative Methods for Sealing Overlapping Steel Members with Narrow Gaps During Galvanizing

Thesis submitted to the faculty of the Virginia Polytechnic Institute and State University in partial fulfillment of the requirements for the degree of

Civil Engineering

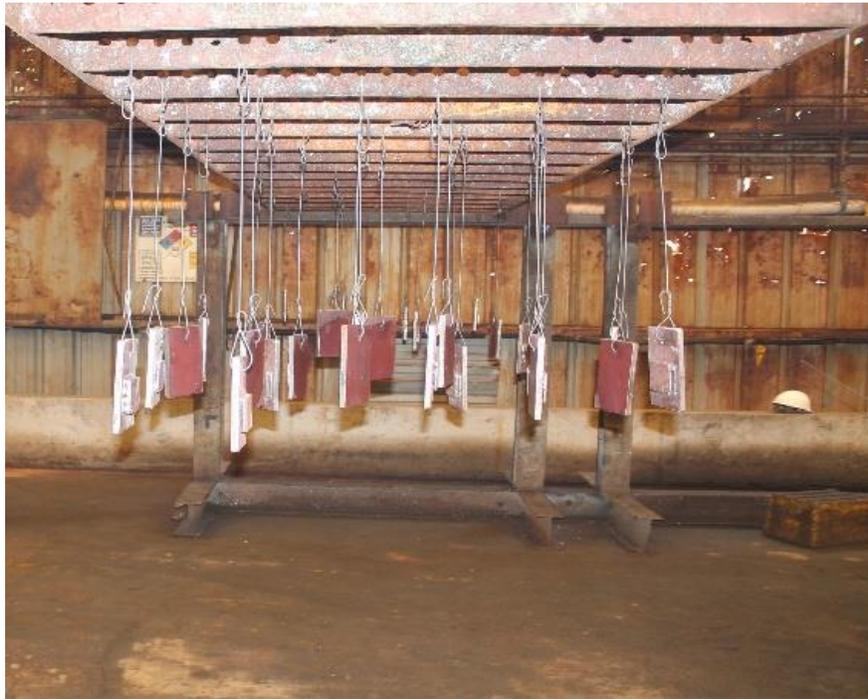
Figure 35: Steel Specimens Hung with a Moveable Crane

The steel specimens were hung on a large moveable crane using steel bendable wire hangers, as shown in Figure 35. The crane was used to dip the specimens into different baths. Since some of the specimens were to be degreased only, some to be degreased and pickled only, some to be degreased, pickled and fluxed only, and some to be fully galvanized, the specimens were spaced into four different batches in the crane for identification.

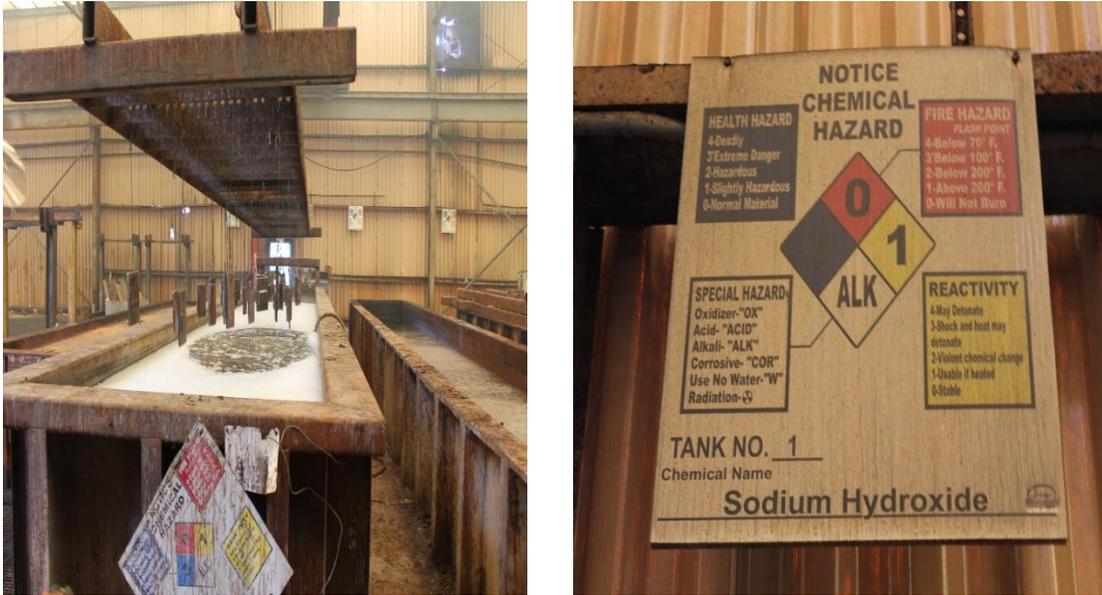
Figure 36: Degreasing Bath with the Chemical Composition

The first stage was the degreasing bath, as shown in Figure 36. Sodium hydroxide was used at a concentration of around 12-25%. The specimens were submerged for approximately five

minutes. The temperature of the bath was about 160-180°F. After five minutes of immersion, the crane lifted the specimens and four specimens were withdrawn from the bath as specified for task 1, these specimens did not continue the HDG process. The four specimens were rinsed with water from a hose. Figure 37 shows the four specimens which were from Configurations 2 and 5 and were sealed with GE or DAP Silicone.

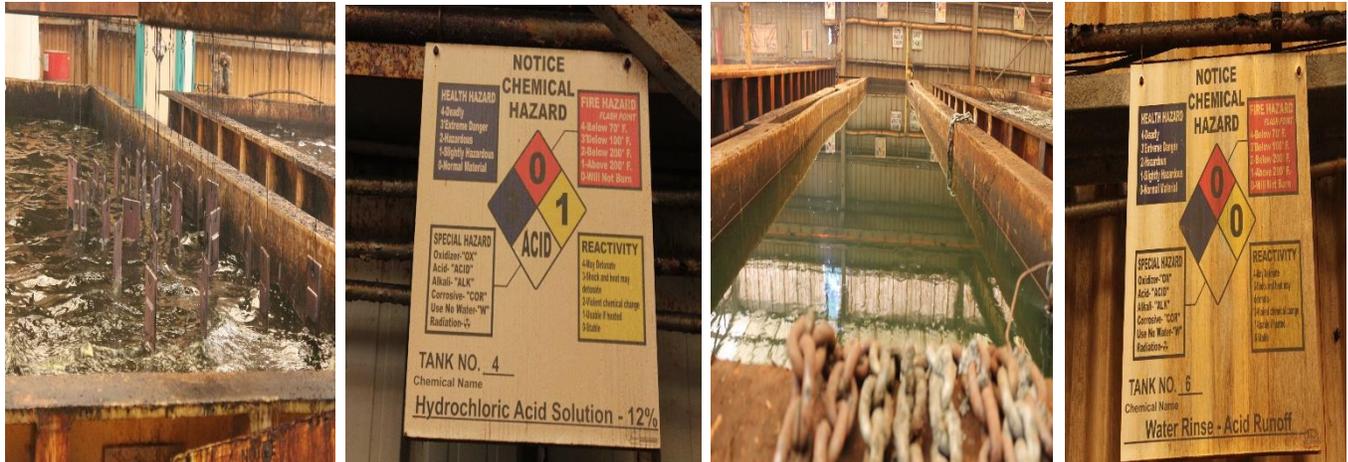
Figure 38: Pickling Bath (Bristol, VA)

The second bath was the pickling bath, as shown in Figure 38. The bath had the same ambient temperature with a 12% concentration of HCl. The dipping time initially took about 20 minutes. Then the specimens were checked, and it was determined that they were not cleaned enough.

They were dipped again in the same bath for around 12 minutes. After checking, they still were not cleaned enough so they had to be degreased again for about 2 minutes. After that, they were pickled a third time for 5 minutes. Next, they were rinsed with a water bath with an ambient temperature. After that, similar to the degreasing bath, four specimens were withdrawn from the bath. Similarly, two specimens from Configurations 2 and two specimens from Configuration 5 were withdrawn.

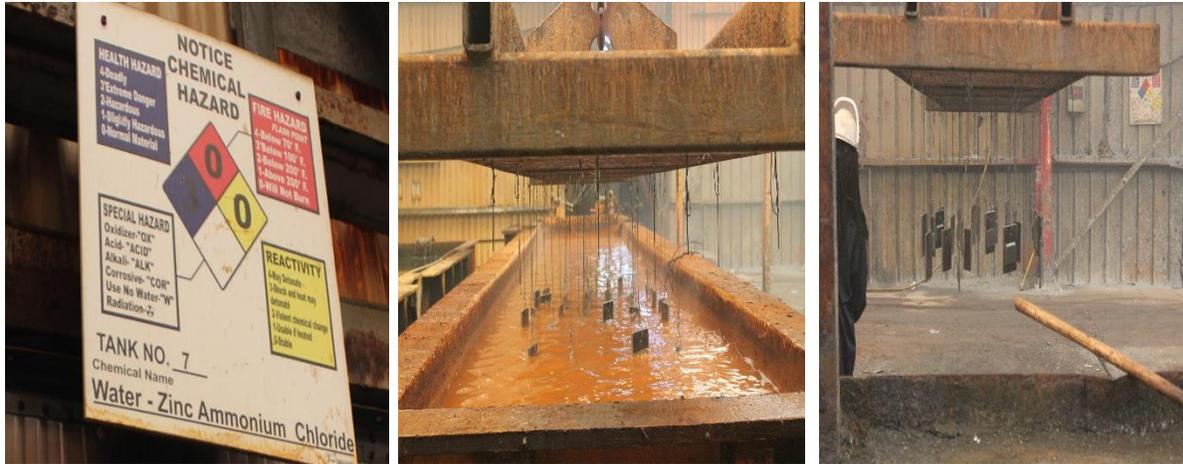
Figure 39: Fluxing Bath (Bristol, VA)

The last bath of the cleaning solutions was the flux bath, which contained zinc ammonium as shown in Figure 39. The temperature of the bath was around 160-180°F. The dipping took 1-2 minutes, but it was done by multiple dippings, not a constant dipping as was the case for the other baths. Next, again, four specimens—two specimens from Configuration 2 and two specimens from Configuration 5, with each specimen either having silicone (GE or DAP), were withdrawn from the bath and rinsed by a water hose. After the fluxing bath, the specimens were dried and hung for about 3-4 minutes. The drying was crucial to prevent any splashing that result from dipping the specimens into the hot zinc later.

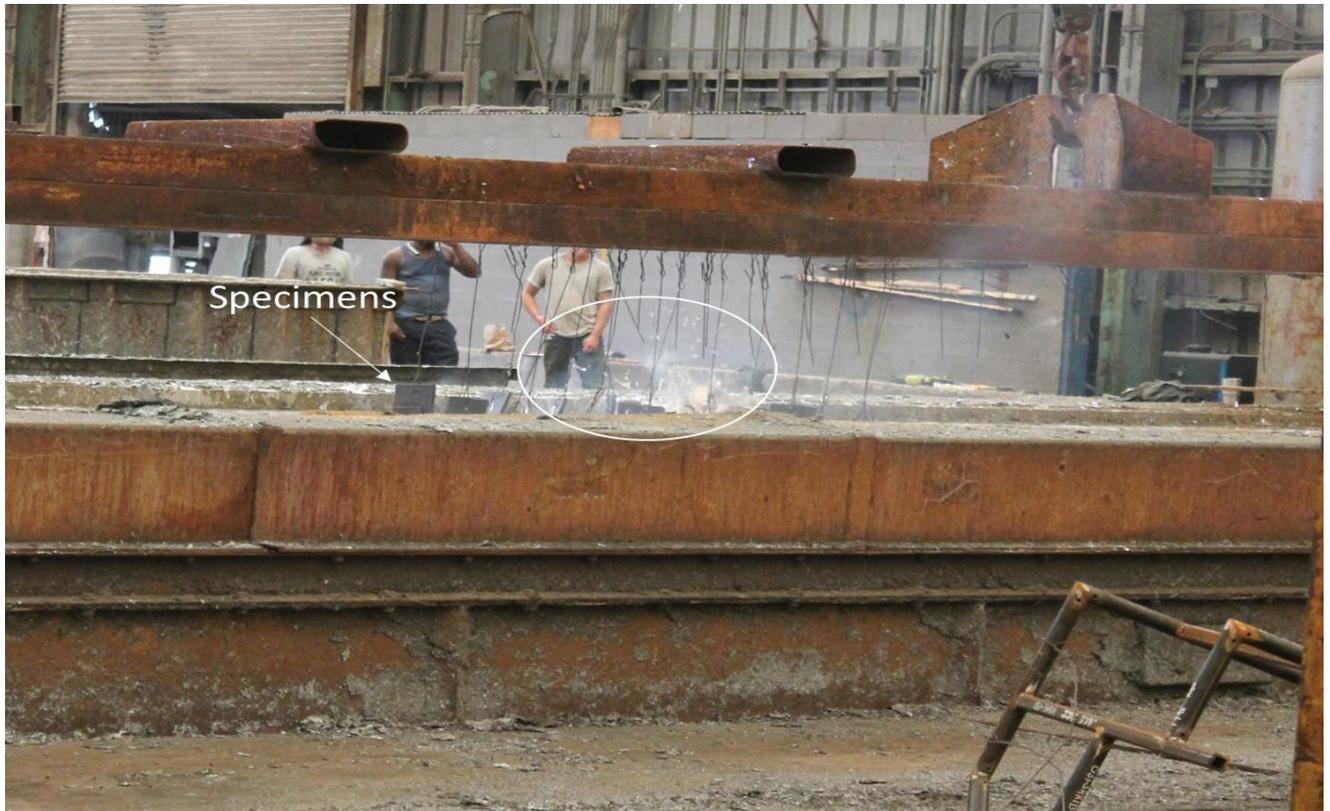
Figure 40: Zinc (left) and Water (right) Baths

Lastly, the molten zinc with a temperature of about 835°F was the final bath. After taking 12 specimens out at the previous stages from the cleaning solutions for task 1, only 29 specimens were fully galvanized. The galvanizing took around 2-3 minutes. As expected, high pressure was developed for the specimens with small to no gaps, which damaged some of the plates. Once the specimens were lifted by the crane, they were poorly galvanized. Therefore, it was decided to re-galvanize some of the specimens. The specimens that were chosen to be re-galvanized were the ones with no sealants on them since galvanizing the sealant specimens twice could affect the caulks, which could risk changing the results. The specimens that were taken out were rinsed in a water tank. The primary purpose of the water was to cool down the specimens from the hot molten zinc. Figure 40 shows the zinc bath. Note the previously mentioned high pressure between contacting surface causing zinc splash as shown in the white circle.

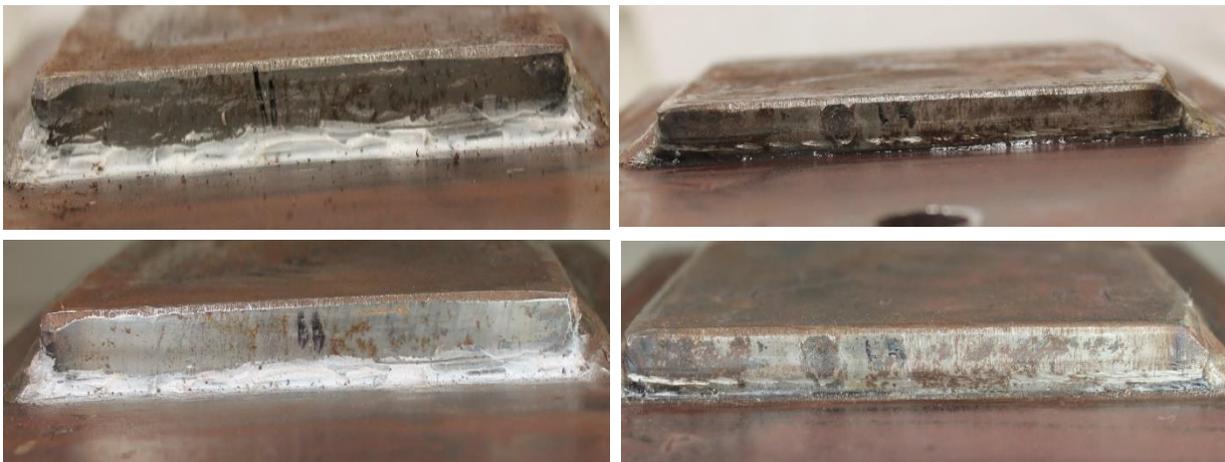
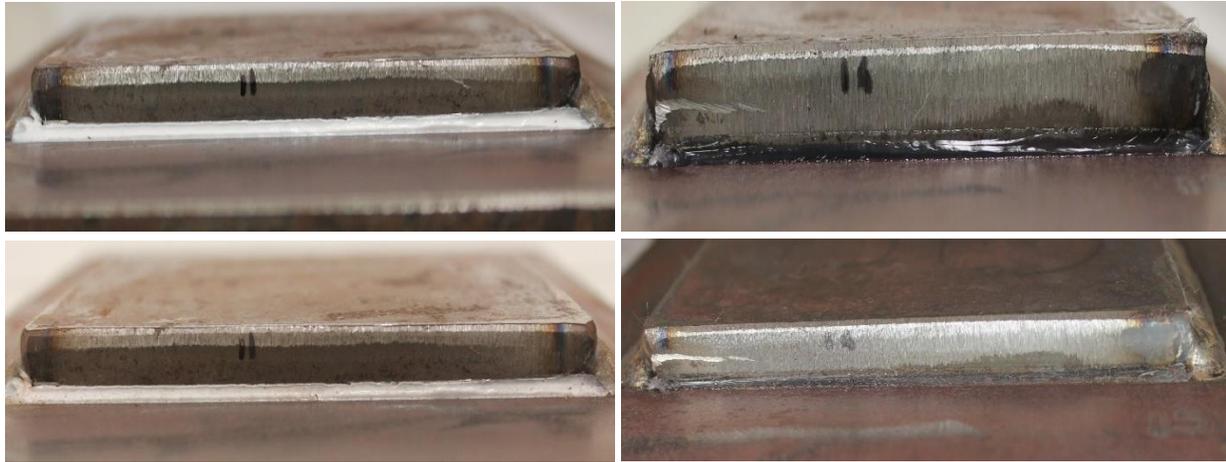
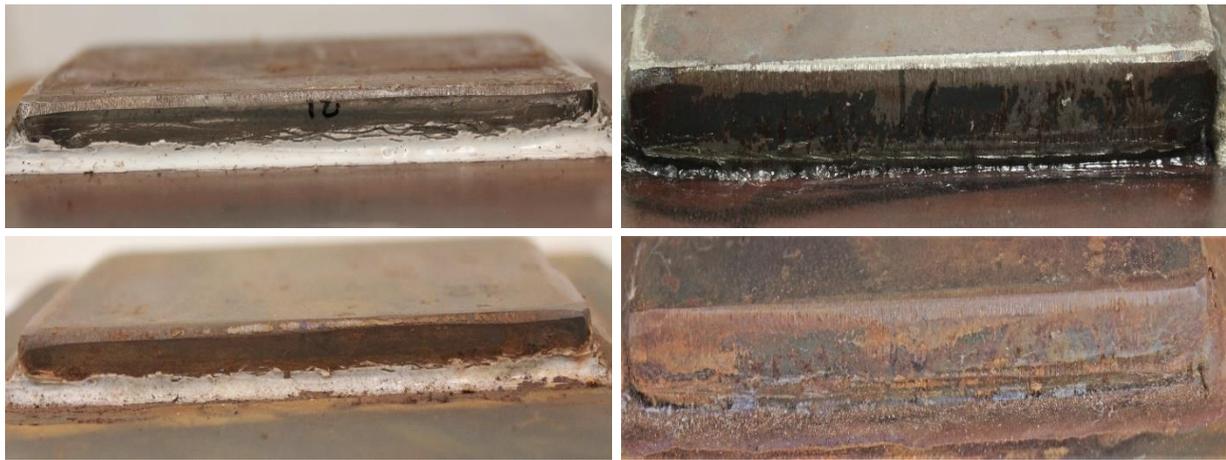
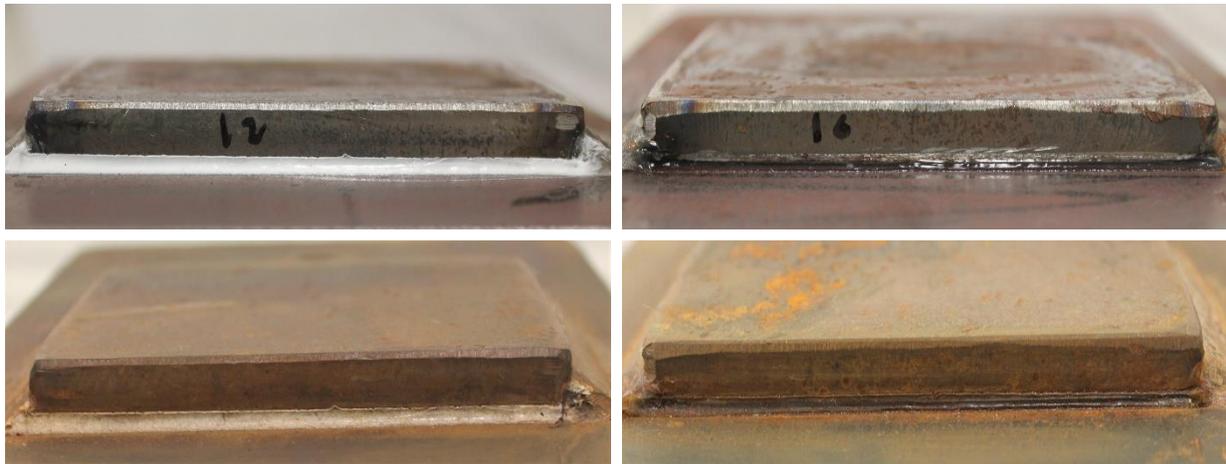
Figure 41: Before (top pictures) and After (bottom pictures) Degreasing for GE Silicone (left column) and DAP Silicone (right column) of Configuration 2

Figure 42: Before (top pictures) and After (bottom pictures) Degreasing for GE Silicone (left column) and DAP Silicone (right column) of Configuration 5

Figure 43: Before (top pictures) and After (bottom pictures) Pickling for GE Silicone (left column) and DAP Silicone (right column) of Configuration 2

Figure 44: Before (top pictures) and After (bottom pictures) Pickling for GE Silicone (left column) and DAP Silicone (right column) of Configuration 5

Silicone was shown to pass the degreasing, pickling, and fluxing baths without any apparent issues, for both Configurations 2 and 5. Figure 41 through Figure 46 show four plates of Configurations 2 or 5, where the plates of the left column of the figures were sealed with GE Silicone and the right column were sealed with DAP Silicone. The top pictures are the ones before the cleaning baths while the ones on the bottom are after cleaning baths. It was apparent that, in general, the sealants were not negatively affected by the cleaning baths.

On a separate note, although the time which had elapsed between taking photographs before and after cleaning the specimen in the plant was short (2 to 3 days), the specimens corroded very quickly, especially the specimens that were tested in the pickling and fluxing baths, as shown below. This was due to the saltiness of the cleaning solutions that accelerated the corrosion of the specimens.

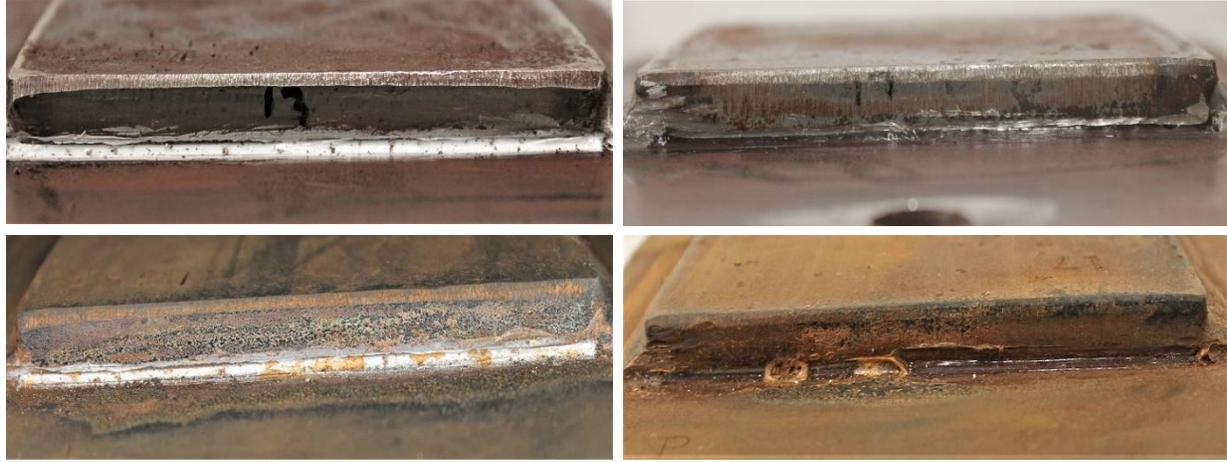
Figure 45: Before (top pictures) and After (bottom pictures) Fluxing for GE Silicone (left column) and DAP Silicone (right column) of Configuration 2

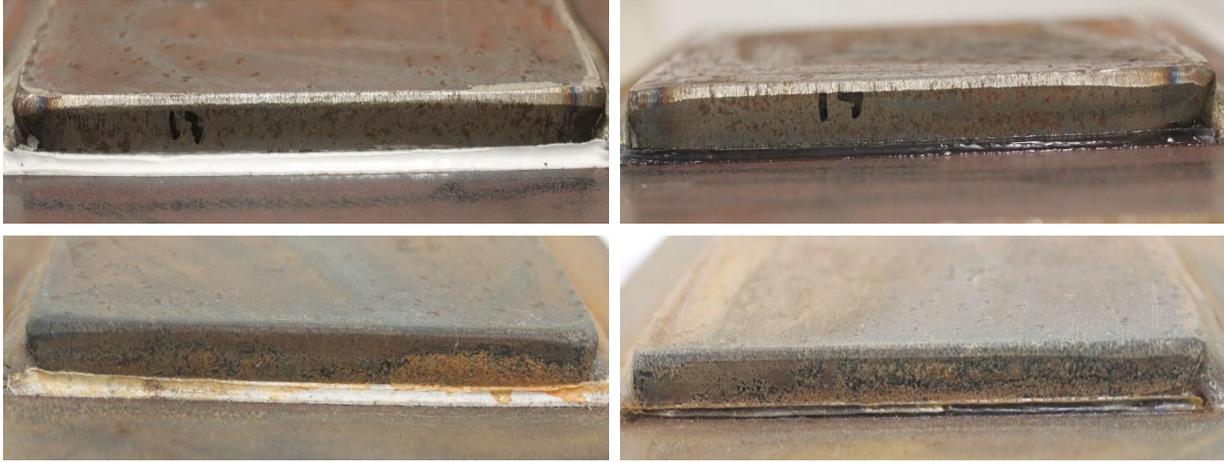
Figure 46: Before (top pictures) and After (bottom pictures) Fluxing for GE Silicone (left column) and DAP Silicone (right column) of Configuration 5

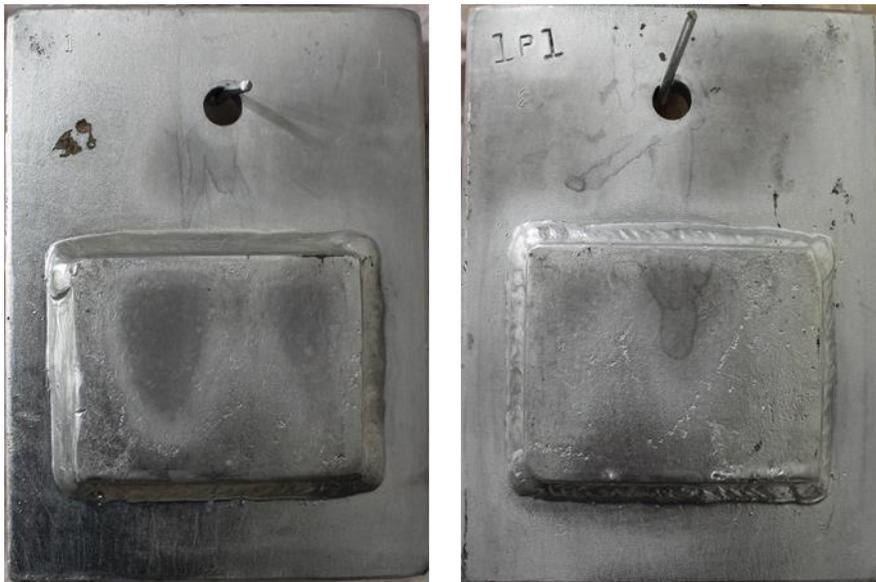
Figure 47: Configuration 1 Specimens After Galvanizing

This was the control specimen as shown in Figure 47, and it is also the configuration that is currently being designed in the industry. The two specimens from Configuration 1 yielded relatively satisfactory results compared to the other configurations. This was due to the fact that there was no gap at any of the edges. This prevented any collection of moisture or fluids between

the overlapping surfaces. However, note the bare spot in the same figure (upper left of the left specimen), this indicates that the specimens were not appropriately galvanized, and not, however, a defect that resulted from this configuration. In addition to the bare spot, the difference in color (shiny silvery to matte gray) from within each specimen indicates an insufficient cooling rate of the specimens or probably a difference in the chemistry elements of the steel making (*Inspection of Hot-Dip Galvanized Steel Products*, 2016). Although the difference in appearance does not have an impact on the behavior of the coating, it gives evidence of the poor galvanizing that the specimens experienced.

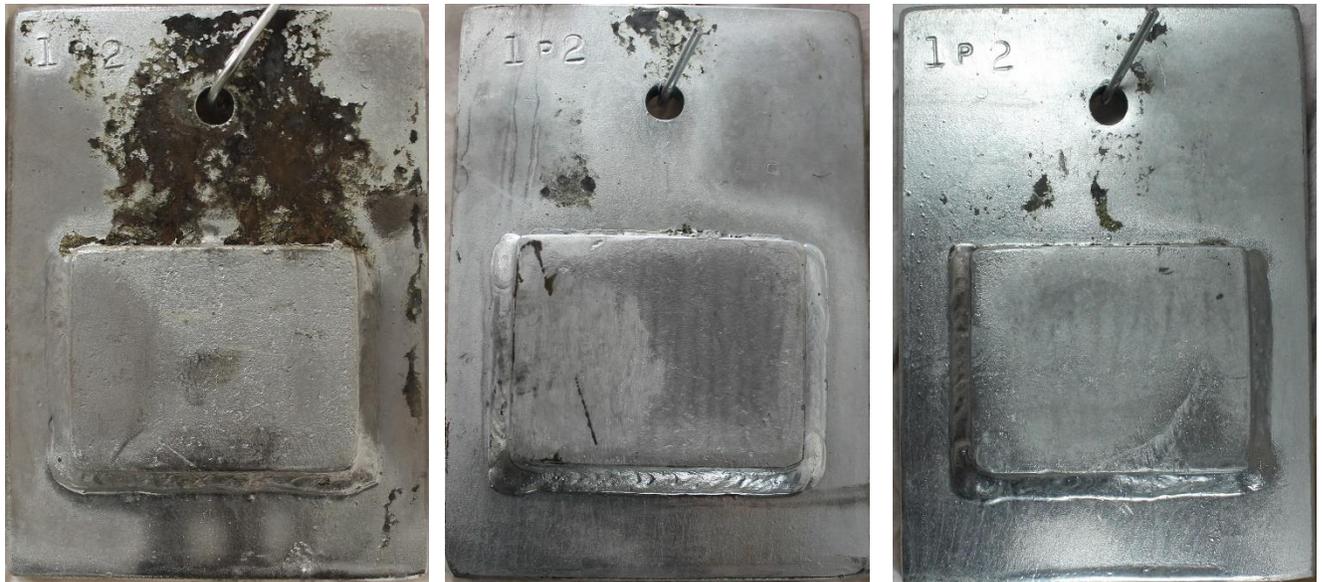
Figure 48: Configuration 2 (open edge on top, no sealants 1p2, 4p2, 5p2)

The results for Configuration 2 are shown from Figure 48 to Figure 51. As can be seen, the sealants did not contribute to having a better dipping performance. In fact, in general, specimens with no sealants performed better than the ones with the sealants as seen from Figure 48 and Figure 49 vs Figure 50 and Figure 51. However, among the three unsealed specimens, 1p2 was severely damaged, which had a small gap on the right edge, indicated by the arrow as seen in Figure 49. This gap was measured to be 0.0015 in., and it is likely that the gap collected some fluids from the cleaning solutions and damaged the coating for this specimen. The gaps for the other two unsealed specimens were less than 0.0015 in. as indicated by Table 8 from appendix

All of the gaps measured for this Configuration were less than 0.0015 in., except in two specimens. The first one, 1p2, was just discussed in the previous paragraph. The second one was sealed with GE Silicone, 2p2. The gap measured for this specimen was 0.07 in. on the left of the overlapping surface (left gap = right side from the front view of the specimen). Remarkably, as seen from , the bare spots were oriented on the right of the specimen, where the gap existed. This indicates that the silicone did not perform well during the HDG in spite of the fact that the silicone task was verified to withstand the cleaning solutions. Furthermore, although the gap in the sealed specimen (0.07 in.) was bigger than the unsealed one (0.0015 in.), this sealed specimen in particular performed relatively better than the unsealed one as shown in Figure 48 and in terms of the distribution and amount of the bare spots.

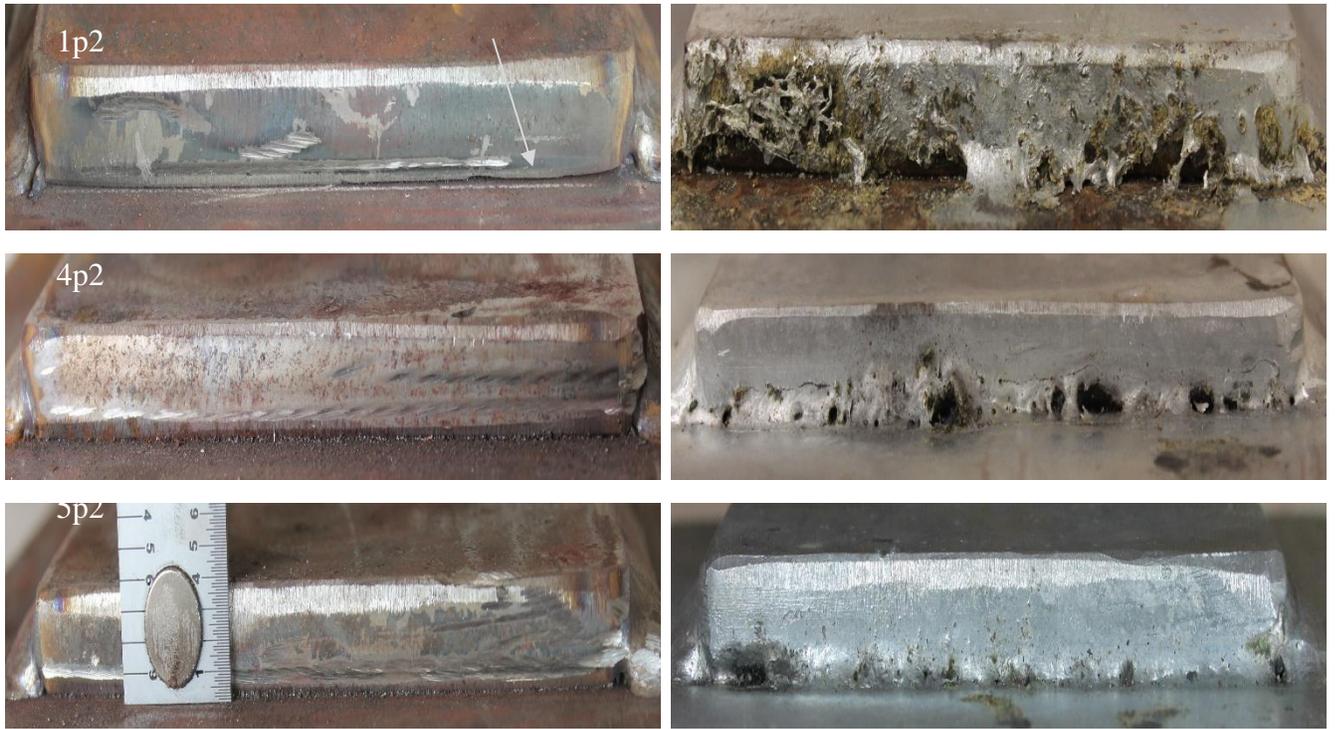
Figure 49: Gap View of Configuration 2 Before (left column) and After (right column) (1p2, 4p2, & 5p2)

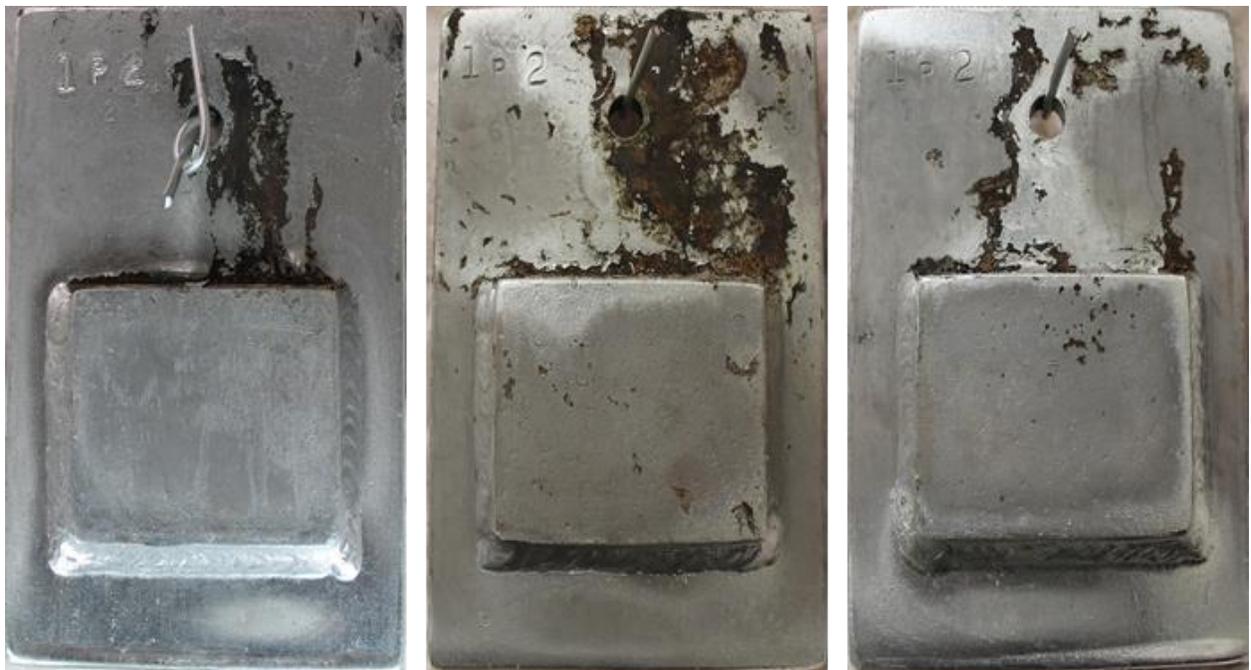
Figure 50: Configuration 2 (GE Silicone Sealant, 2p2, 6p2, 7p2)

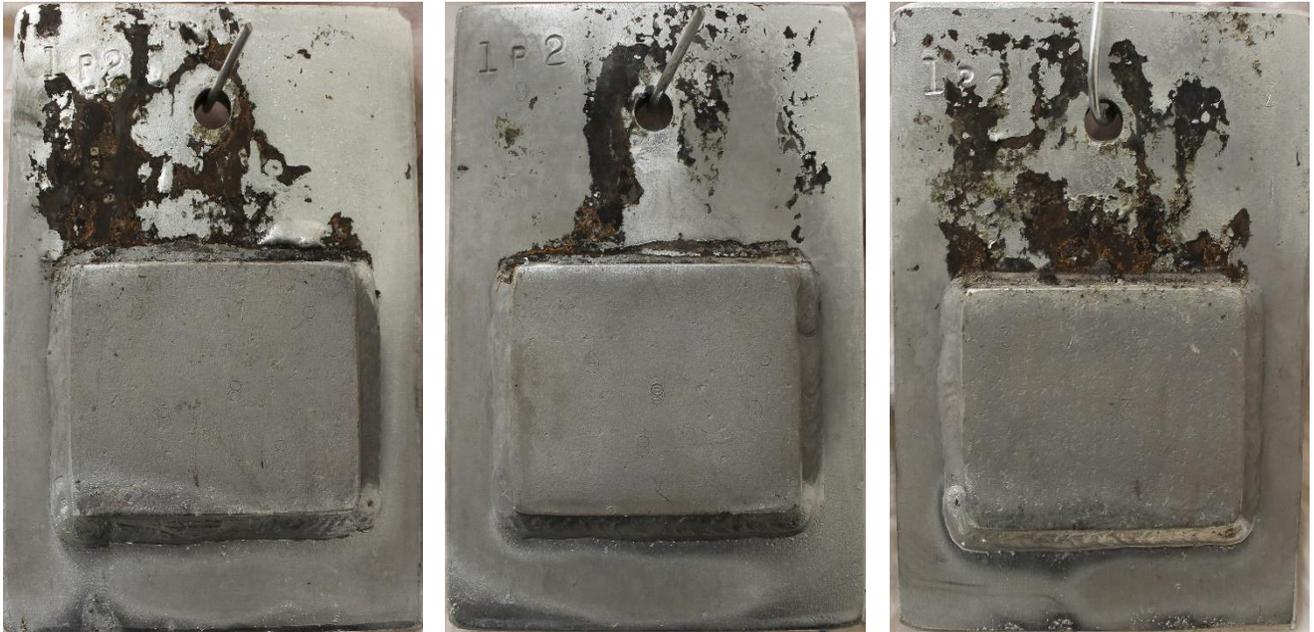
Figure 51: Configuration 2 (DAP Silicone Sealant, 3p2, 8p2, 9p2)

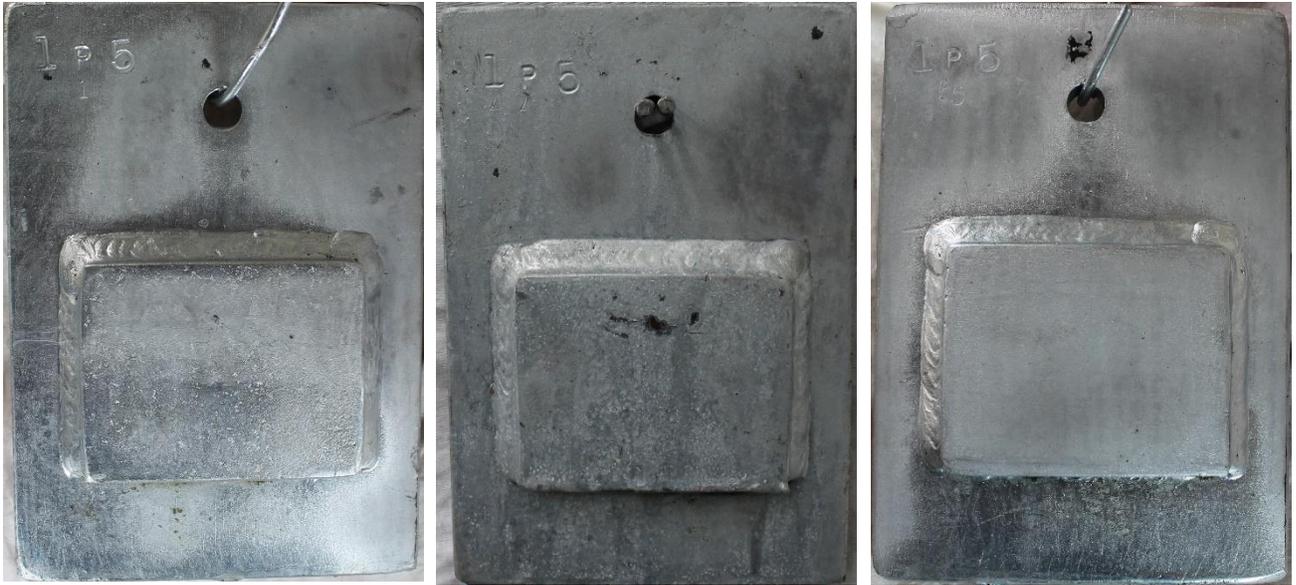
Figure 52: Configuration 5 (open edge on bottom, no sealants 1p5, 4p5, 5p5)

Configuration 5 specimens (Figure 52 through Figure 54) yielded a better outcome than Configuration 2 (Figure 48 through Figure 51), in all three types of specimens (no sealants, GE Silicone, DAP Silicone). As a result, the orientation of the dipping has been determined to be a significant factor in the quality of the zinc on the surface. This is because the cleaning solutions could easily penetrate into the gap if it is on top but faces difficulty when it is at the bottom. An illustrative figure is shown in Figure 55, this was a Configuration 2 specimen in the plant during the HDG process, specifically, after the fluxing bath. As seen when the gap or the open edge is on top, the solutions were collected on top of the overlapping surface as indicated by the arrow. For Configuration 5, at the gaps, similar to Configuration 2, those that were not sealed had less damage, as shown in Figure 56.

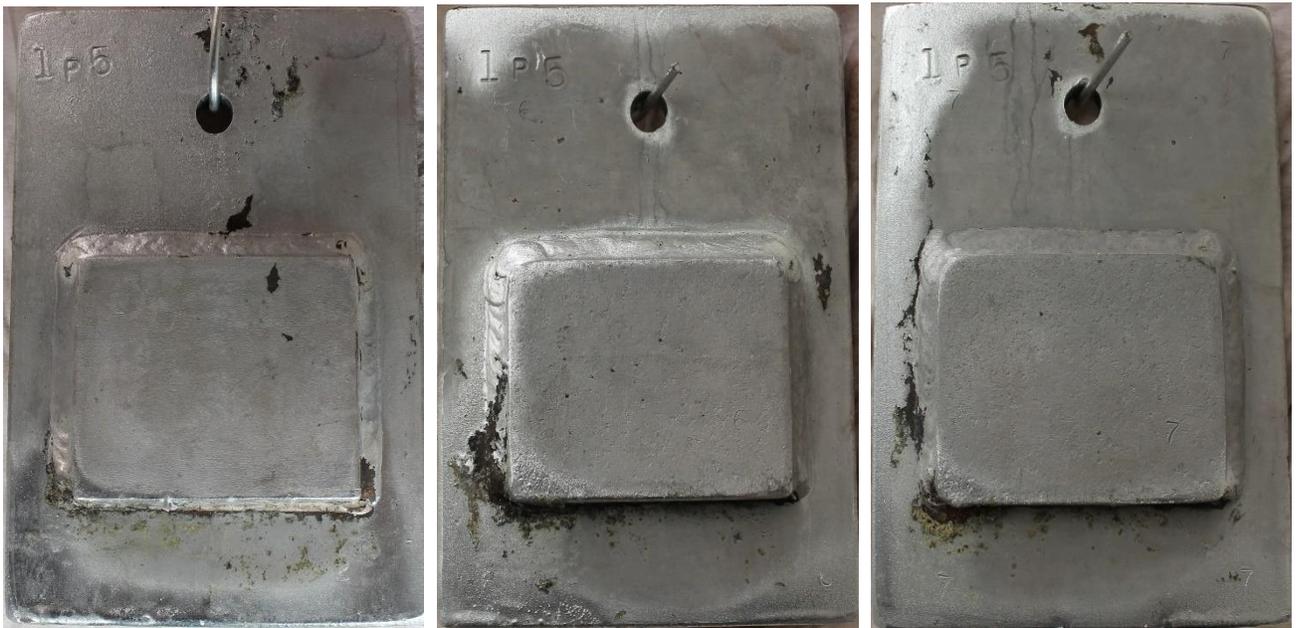
Figure 53: Configuration 5 (open edge on bottom, GE Silicone Sealant 2p5, 6p5, 7p5)

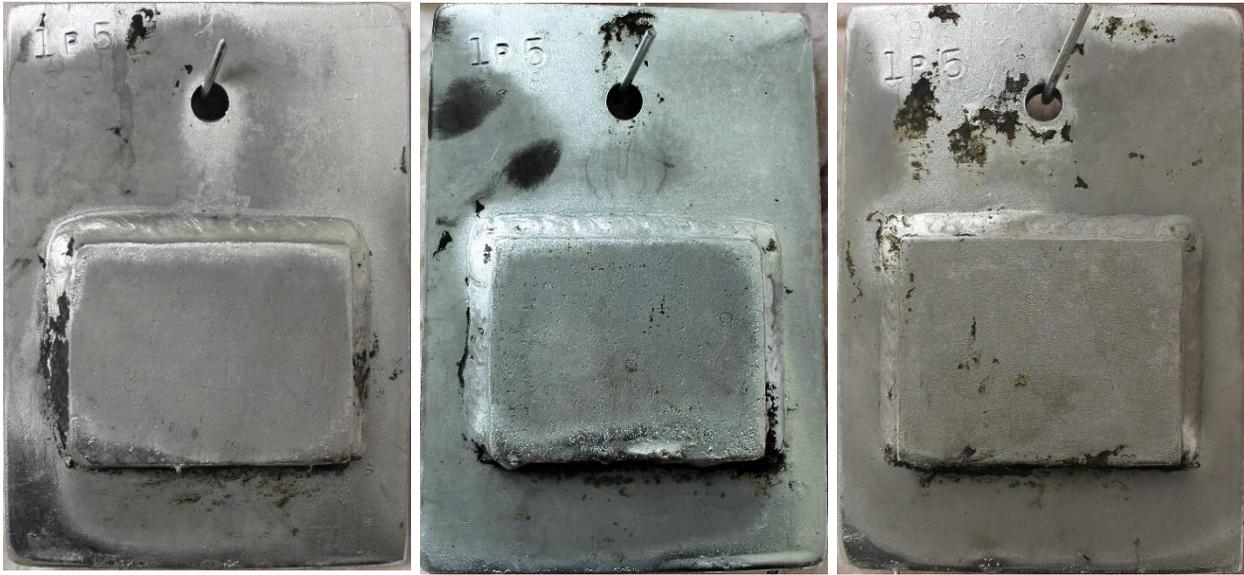
Figure 54: Configuration 5 (open edge on bottom, DAP Silicone Sealant 3p5, 8p5, 9p5)

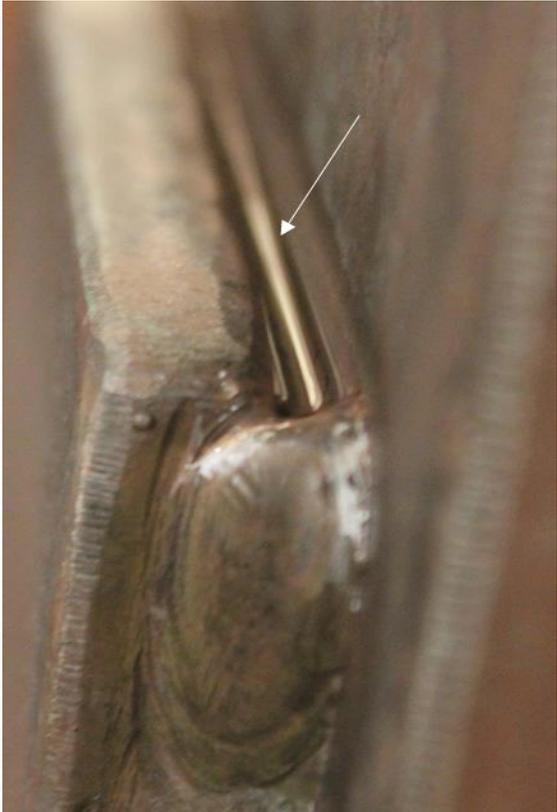
Figure 55: Configuration 2 Specimen Collecting Fluids Between Two Surfaces

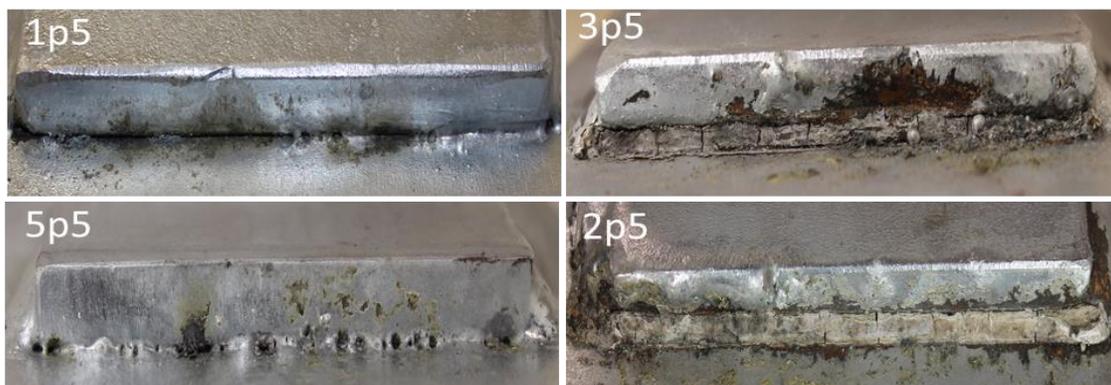
Figure 56: Sealed vs Unsealed Specimens

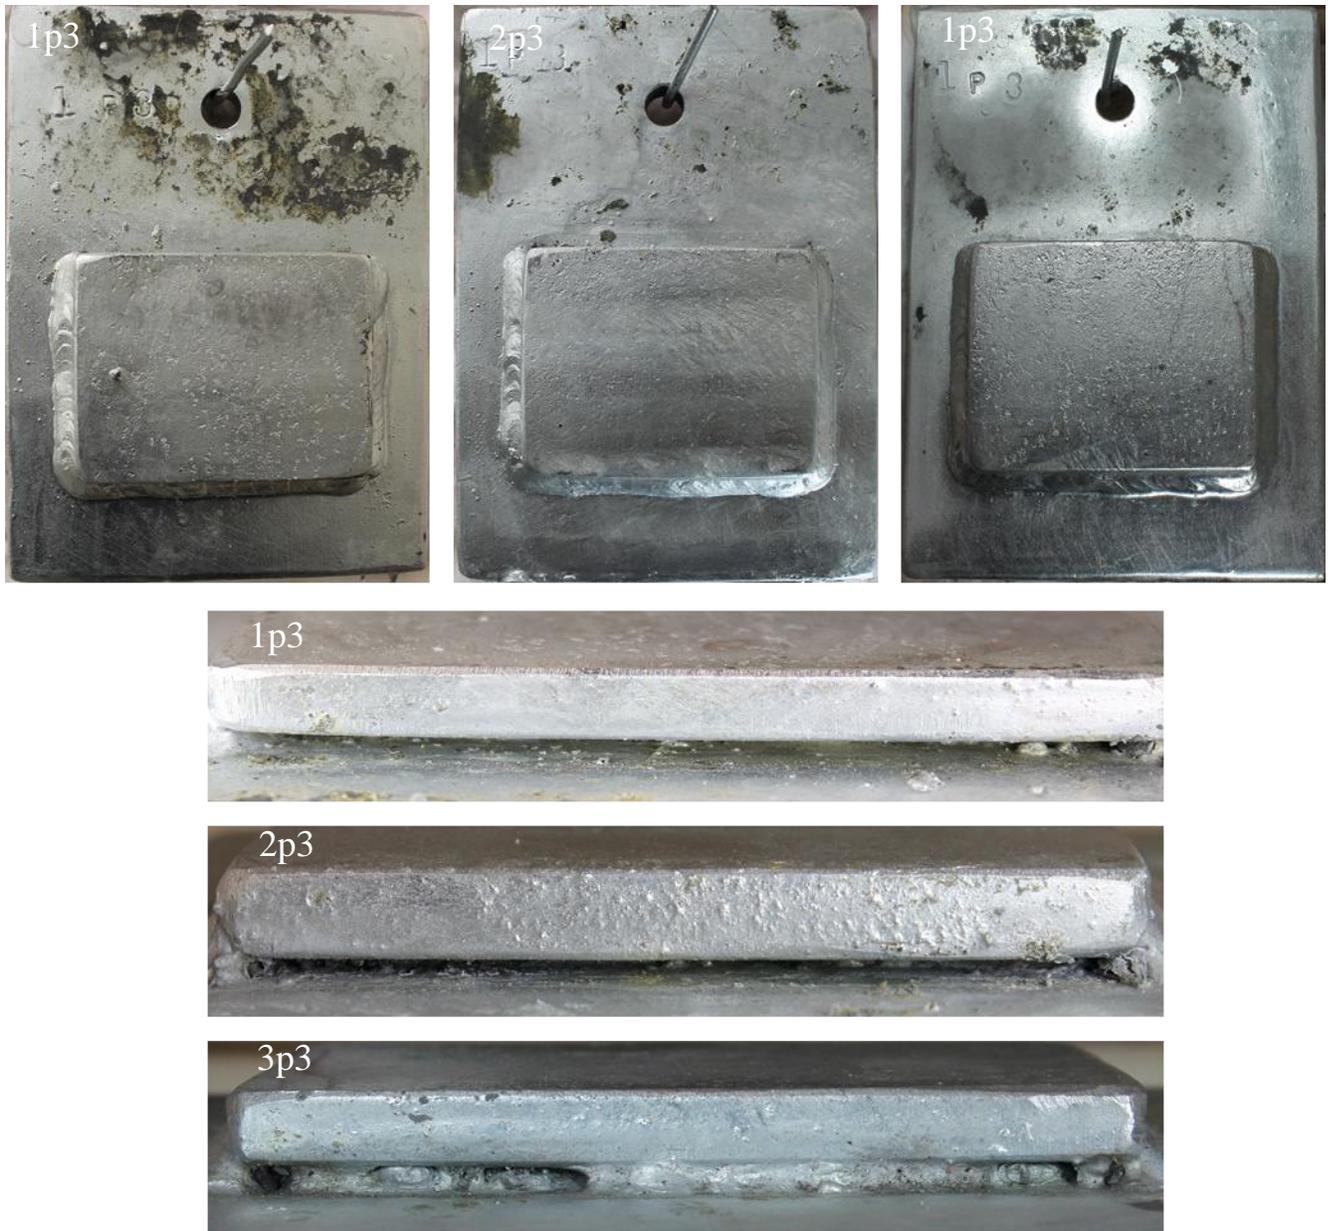
Figure 57: Configuration 3 After Galvanizing

Overall, Configuration 3 did not provide satisfactory results but yielded a better outcome than Configuration 2. There were some damaged areas on the upper side of the plates as seen in Figure 57, but they were not as severe as Configuration 2. It is difficult to conclude that the recommended minimum $3/32$ in. gap was an inadequate solution for overlapping surfaces given that it provided unsatisfactory results for Configuration 3. Again, the bare spots observed in this configuration could be due to the poor HDG process. In fact, the bare spots for Configuration 2 were likely due to the open edge collecting fluids since they were initiated and extended from the open edge up to the upper side of the specimens, however, for Configuration 3, the bare spots were located only at the upper side of the specimens and no bare spots existed near the gaps. This favors the fact that the inferior coating found in Configuration 3 were due to the improper HDG process. In addition to the bare spots, this configuration experienced dots and rough surface, especially near the gaps in 2p3.

The orientation of dipping and the gap width contributed to having a filled zinc between the overlapping surfaces. The gap width can be correlated with the visualized zinc through the gap. The gap, although required to be larger than $3/32$ in. ($0.09375''$), varied between the three specimens. The gaps were measured for the three specimens before galvanizing. They were, on average, 0.125, 0.0950, 0.130 in. for 1p3, 2p3, 3p3 respectively. This is shown in Figure 57, where the zinc in 3p3 can be visualized since this specimen had the widest gap.

There were two specimens of this configuration, namely 2p3 and 3p3. Specimen 3p3 had a considerably larger gap than 2p3. Hence, this led to the visible zinc coating through the gap in specimen 3p3 but not in specimen 2p3 as was seen in Figure 57. As seen in Figure 67, 2p3 had more severe damage than 3p3 even though 2p3 was smaller, especially near the gap where the red rust is clearly visualized in 2p3, meaning the white corrosion products and the zinc were consumed. This can be explained by the difference in the gap. Since 3p3 was filled with zinc, this made the gap shallower into the overlapping surface, allowing only limited air circulation. This limitation slowed down the drying process of the moisture and zinc thus contributed to

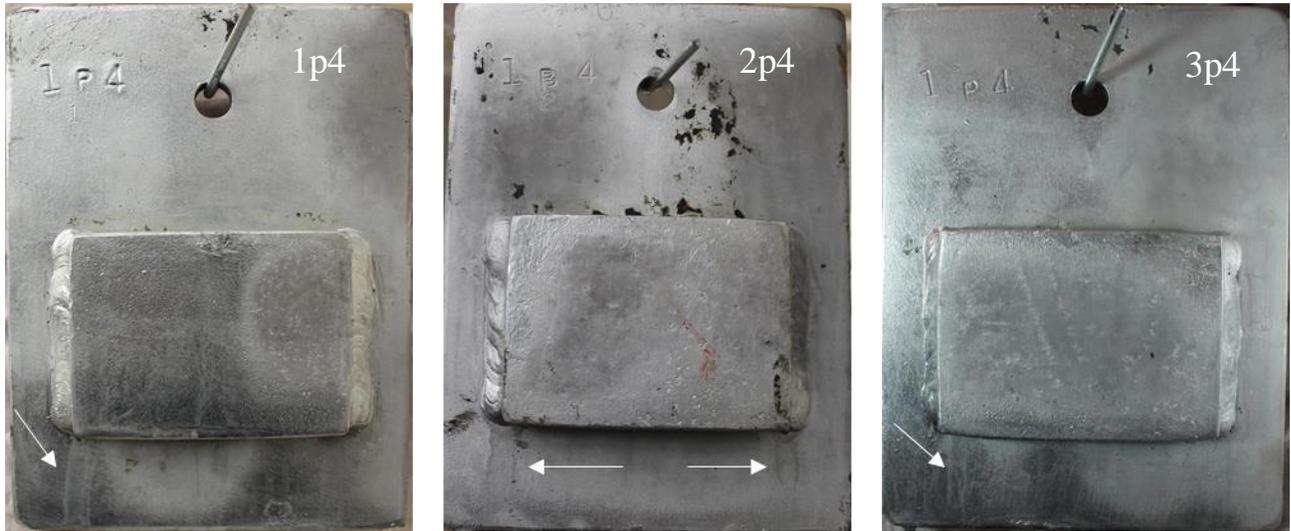
Figure 58: Configuration 4 After Galvanizing

Except for the control configuration, Configuration 4 has yielded the best results in comparison with the other configurations, as shown in Figure 58. This configuration experienced uniform coating, meaning the surface of the specimens was smooth. Additionally, despite some minor bare spots, the surface of the specimens was free from any galvanizing defects such as drainage

spikes and dots which were found in the other configurations. Nonetheless, some fluid leaching was observed along the weld edges as indicated by the white arrows from the same figure, these were likely due to the cleaning solutions not being able to clean the weld edges such as slags and spatters. The tasks implanted for this research, detailed in the next sections, gave more insight into these leaching.

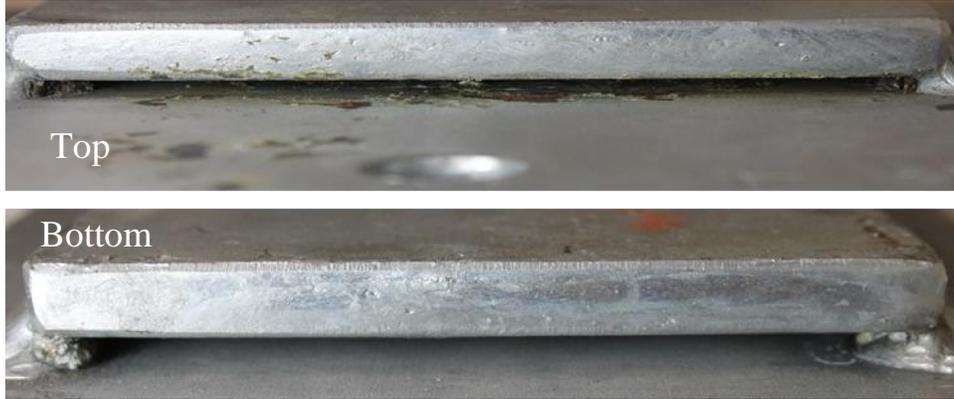
Figure 59: Gap View (top and bottom) of Specimen 2p4 of Configuration 4

The top gaps in this configuration for the three specimens experienced some minor damage while the bottom gaps were uniformly coated, regardless of which gap was larger. Figure 59 shows two gaps of the 2p4 specimen. For this specimen, the difference in behavior between the two gaps can be explained by the width of the gaps. The average gap width was 0.108 in. for the top view, and the average gap width for the bottom gap was 0.184 in.. However, for 1p4, the top gap was considerably larger than the bottom gap when measured. Also, for specimen 3p4, the top and bottom gap measurements were very close to one another. A conclusion can be made that even if the top gap was larger than the back gap, bare spot areas were always present in the top gap.

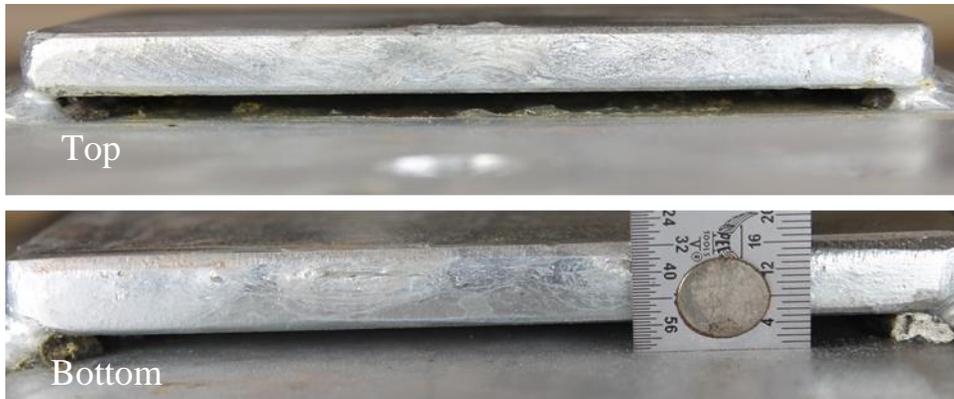
Figure 60: Gap View (top and bottom) of Specimen 1p4 of Configuration 4

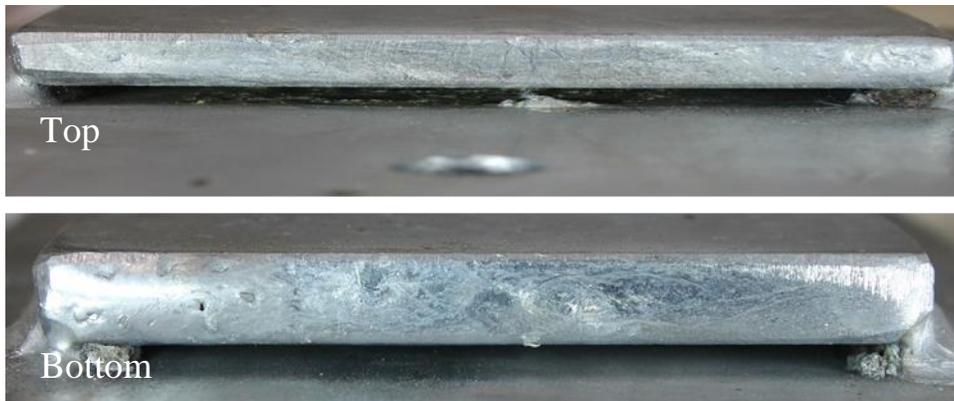
Figure 61: Gap view (top and bottom) of Specimen 3p4 of Configuration 4
