Alternative Methods for Sealing Overlapping Steel Members with Narrow Gaps During Galvanizing

Thesis submitted to the faculty of the Virginia Polytechnic Institute and State University in partial fulfillment of the requirements for the degree of

Civil Engineering

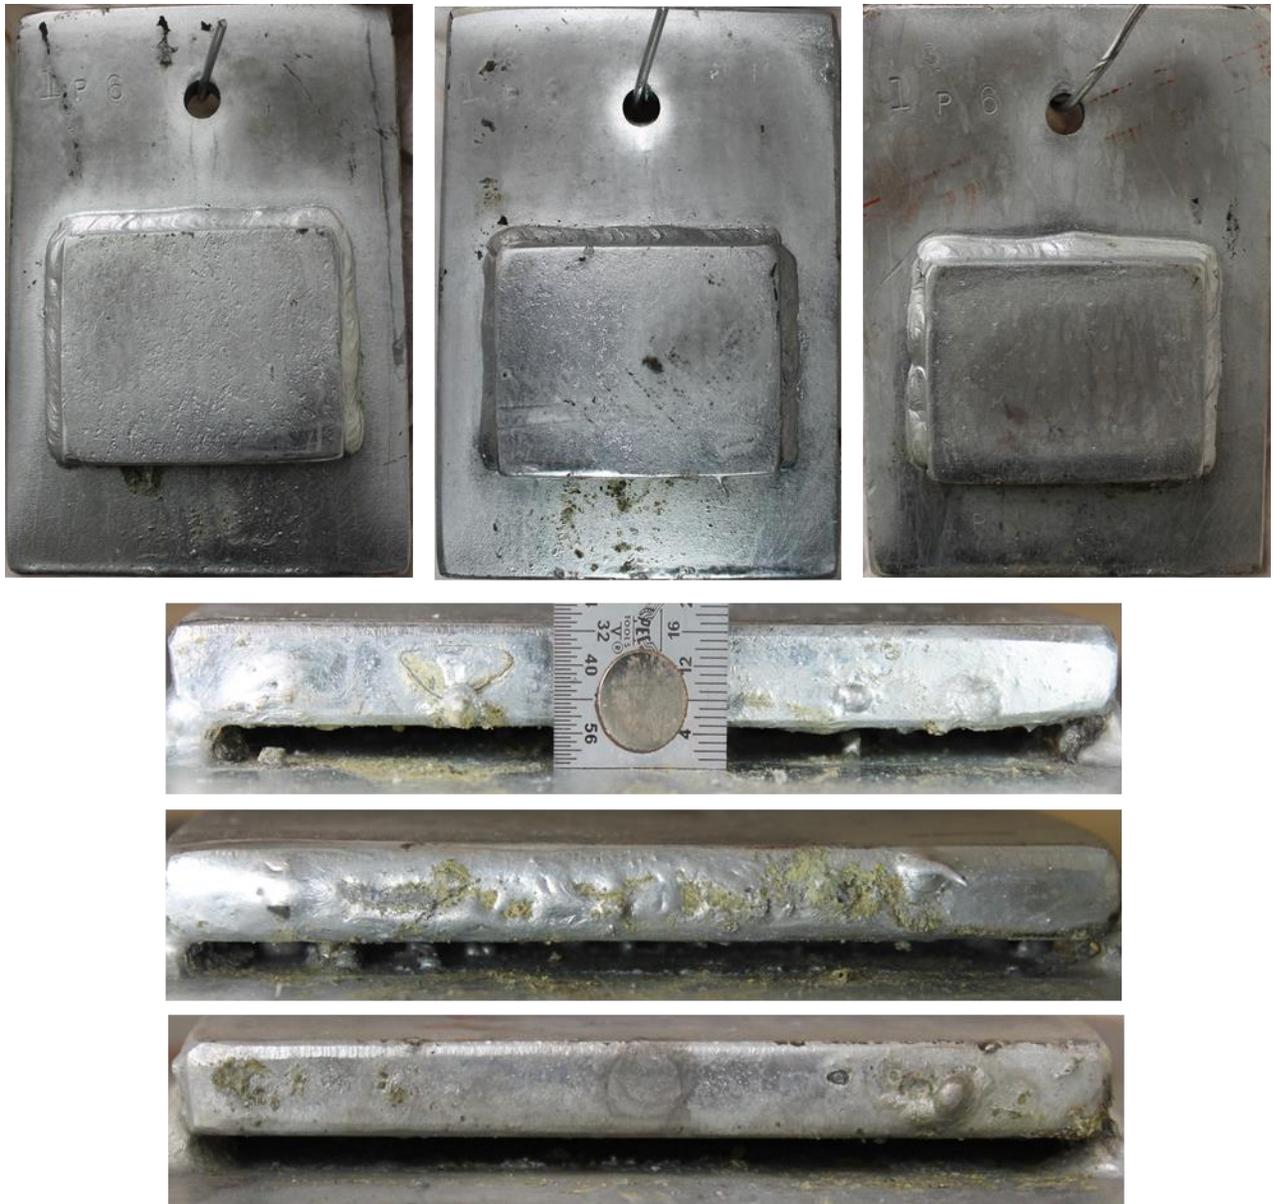
Figure 62: Configuration 6 Specimens (1p6, 2p6 and 3p6 respectively)

The overall coating results for this configuration were not satisfying although it provided better outcomes than Configuration 5, as shown in Figure 62. Two features were observed for this configuration. The first one was the yellow-green deposits near the gaps. These were probably flux deposits. Flux deposits are non-metallic chlorides or oxides deposits that occur when the flux from the HDG process did not release or flow freely from the metal surface (Maass & Peißker, 2011). The second observation was the existence of spikes near the gaps and at the bottom of the specimens. Both observations, zinc being able to solidify to spikes and flux not being able to release, all indicate the surface tension property influence for this geometrical configuration near the gaps since they were oriented on the bottom. Comparing Configuration 6 to Configuration 3, it can be concluded that Configuration 3 yielded better outcomes near the gaps while Configuration 6 had a better overall coating elsewhere.

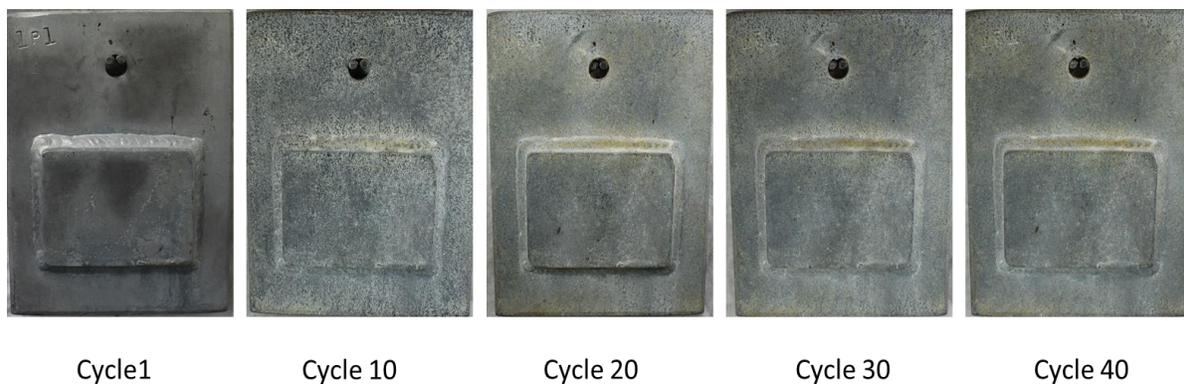
Figure 63: Cyclic Corrosion of Configuration 1

This configuration experienced a good coating behavior over testing, as shown in Figure 63. Except for the top of the overlapped surface where the yellow to red corrosion started to form. This, as mentioned previously, was due to the test set up and not results from the task outcome for this configuration. At cycle 10 as seen from the figure, the white corrosion products were dominated and clear to see. At cycle 40, the white corrosion products were likely carbonated and consumed and thus disappeared. This, again, indicates a healthy corrosion behavior of this configuration.

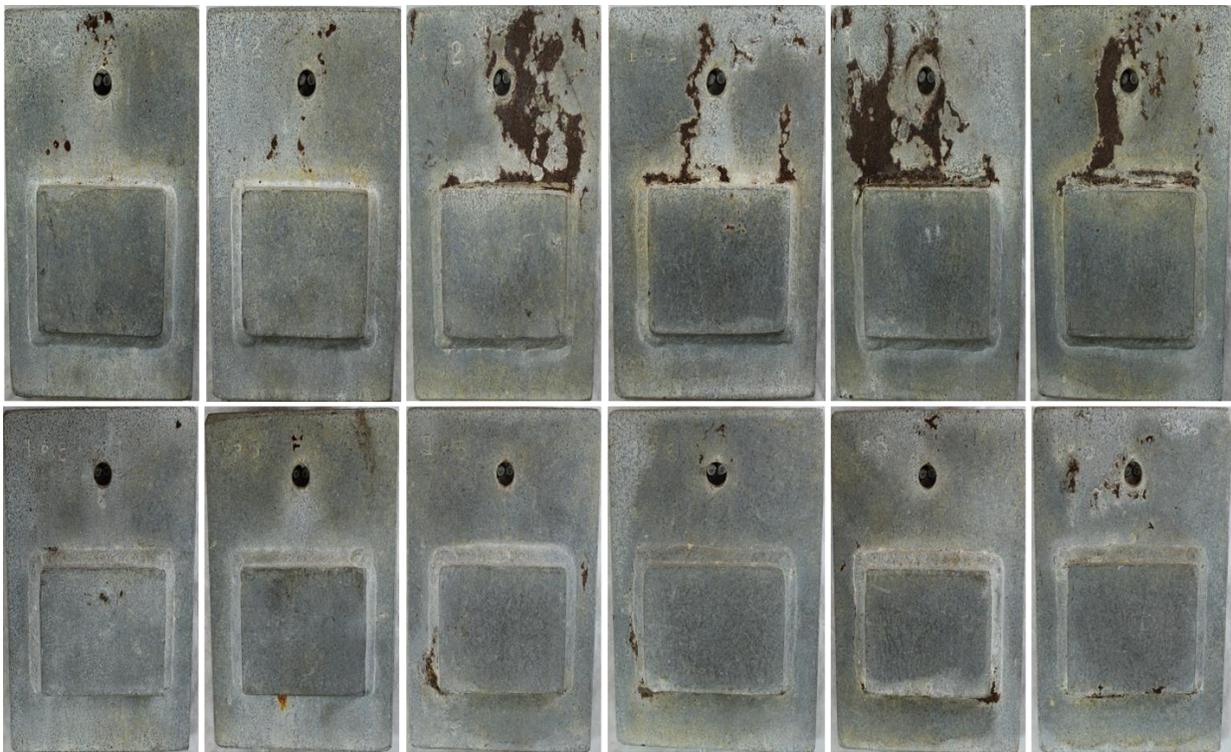
Figure 64: Configuration 2 (upper row) and Configuration 5 (bottom row) After 40 Cycles

Despite the bad coating in the surface of Configuration 2, all of the specimens for both configurations experienced a relatively uniform corrosion except the white rust accumulation along the open edges, which was insignificant compared to the wide gap non-uniformity in configurations 3 and 6 as shown in the next section. Figure 64 shows Configuration 2 (upper row) and Configuration 5 (bottom row) after 40 cycles. The first two specimens for both rows from the left were not sealed, the second two were GE Silicone sealed, and the last two were DAP sealed.

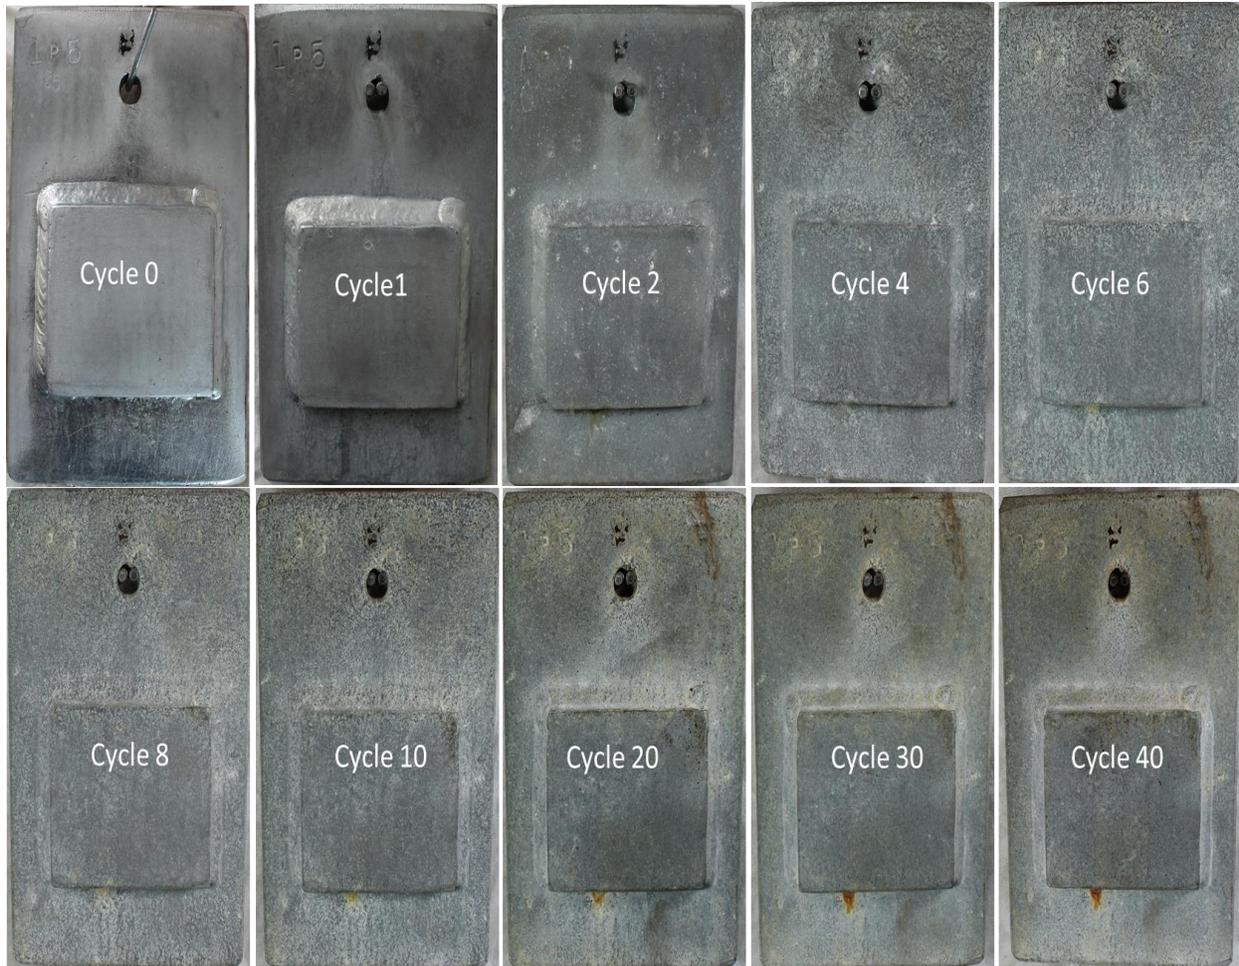
Figure 65: Configuration 5 Specimen 5p5 (not sealed) from 0 to 40 Cycles

Note the formation of a rust bleeding (iron oxide) in one of the specimens of Configuration 5 as shown in Figure 65, this specimen was not sealed with sealants. Although there was another specimen that was not sealed with sealants for the same configuration, this was the only specimen that experienced rust bleeding. The reason can be explained by the gap width. The gap was measured to be .019 in. on the red bleeding specimen, whereas the gap on the other

specimen could not be measured by the feeler gauge, meaning it was less than .0015 in.. Another set of two specimens from Configuration 2 were not sealed with GE Silicone and yet did not experience rust bleeding, this was due to the fact that the orientation of hanging plates through the 1/2 in. gap allowed the open edge to be on top, which was the opposite of the gravitational force. Hence, had the specimens experienced rust stains inside the overlapping surface, it could not leach out or be visualized.

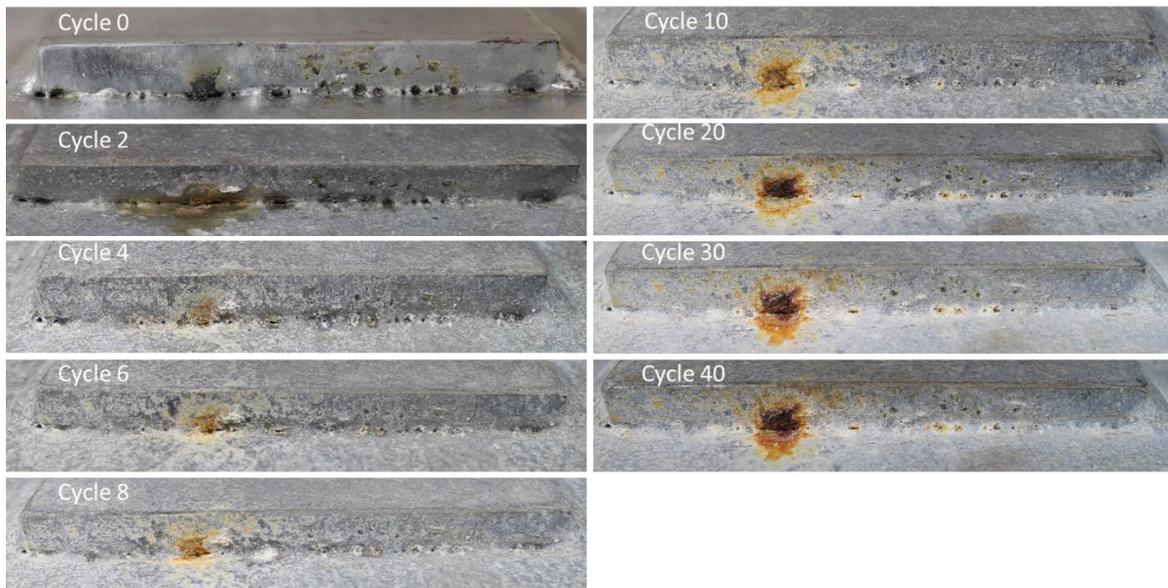
Figure 66: Configuration 5 Specimen 5p5 (not sealed) from 0 to 40 Cycles (gap view)

The rust bleeding was believed to be a corrosion product of the steel substrate, due to a defect that occurred between the overlapping surface, that traveled along the surface of the coated steel. It was not, however, a corrosion or consumption of the zinc coated over the traveled path surface. The reason behind this explanation is that it was observed that the red corrosion was

initiated at early stages of the cycles in this specimen (around 4th cycle), as shown in Figure 66, unlike the other specimens where the red corrosion appeared around the 20 cycles. It can be concluded that, first, the overlapped surface was not cleaned or galvanized properly. Second, as mentioned previously, the coatings along the open edges were probably inhibited due to the white products presence and thus did not function very well as the steel substrate started to corrode and leach out.

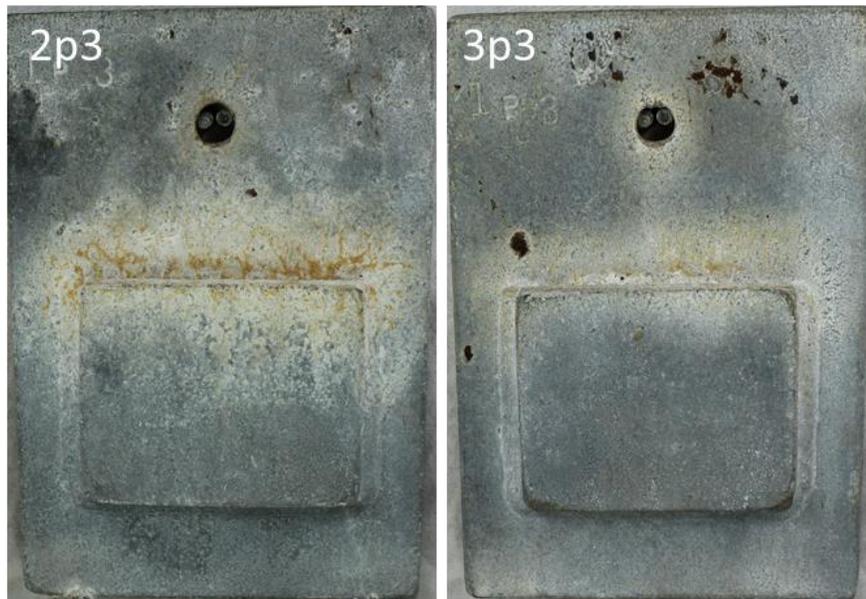
Figure 67: Configuration 3 After 40 Cycles

There were two specimens of this configuration, namely 2p3 and 3p3. Specimen 3p3 had a considerably larger gap than 2p3. Hence, this led to the visible zinc coating through the gap in specimen 3p3 but not in specimen 2p3 as was seen in Figure 57. As seen in Figure 67, 2p3 had more severe damage than 3p3 even though 2p3 was smaller, especially near the gap where the red rust is clearly visualized in 2p3, meaning the white corrosion products and the zinc were consumed. This can be explained by the difference in the gap. Since 3p3 was filled with zinc, this made the gap shallower into the overlapping surface, allowing only limited air circulation. This limitation slowed down the drying process of the moisture and zinc thus contributed to

white rust accumulations. To the left, 2p3 had more damage which indicates a faster drying and corrosion rate, compared to 3p3, due to the wide deep gap.

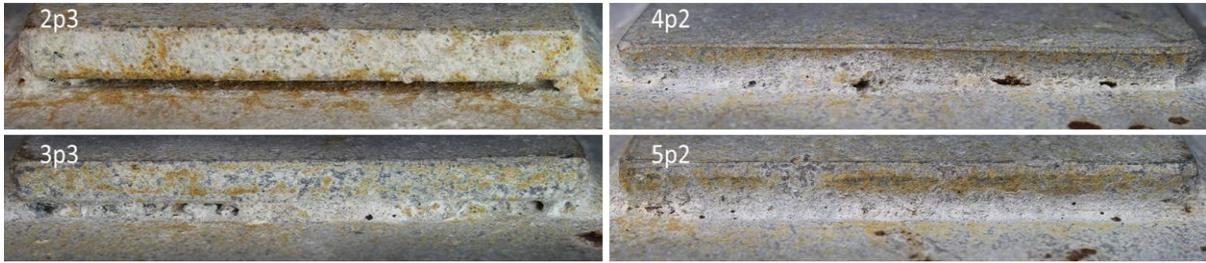
Figure 68: Configuration 3 (left) and Configuration 2 (right) After 40 Cycles

Comparing Configuration 3 with 2, Configuration 3 had more red stains and faster corrosion rate than Configuration 2. This again goes to the existence of the gap. A clear comparison can be seen in Figure 68. The right column shows unsealed specimens from Configuration 2 with Configuration 3 in the left column. Although specimen 3p3 behaved similar to Configuration 2 specimens in terms of the white corrosion products, specimen 2p3 appeared to be worse than Configuration 2. Nonetheless, the red stains and corrosions in 2p3, again, indicate a healthy corrosion process. For Configuration 2, the white products along the edges indicate a poor diffusion of oxygen and slower drying rate since the gaps were too small, which could probably lead to the risk of unforeseen corrosion of the steel substrate. To sum, although Configuration 2 had less severity than Configuration 3, both of them behaved poorly compared to the other configurations.

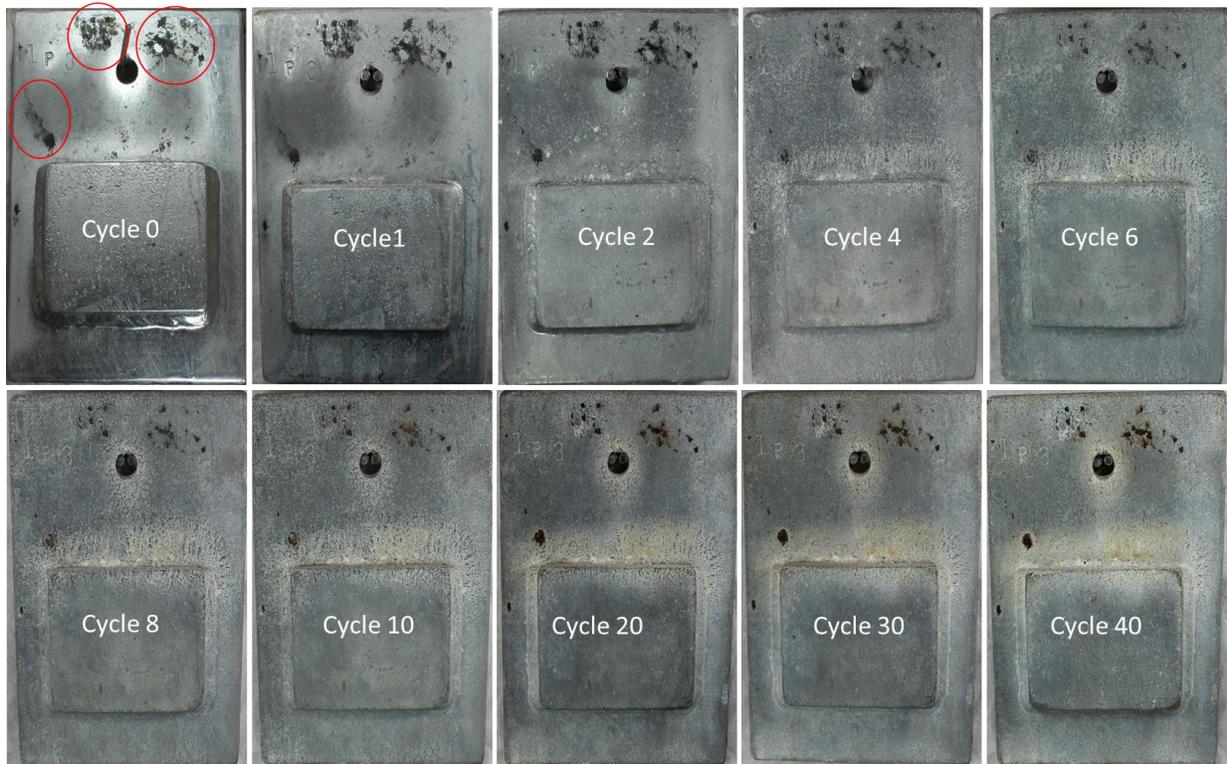
Figure 69: Configuration 3 Specimen for 40 Cycles

One interesting observation was noticed for this task, in Configuration 3 specifically, was the disappearance or the reduction of some of the bare spots as the cycles progress. This is shown in the three circles indicated in Figure 69. The basic premise of this occurrence is that the zinc adjacent to bare spots, steel substrates that did not get galvanized, migrated or sacrificed to them due to the difference of the electro-potential between the two elements. This is one of the powerful benefits of using HDG as a preventative mean for steel against corrosion. More investigations should be done for this phenomenon.

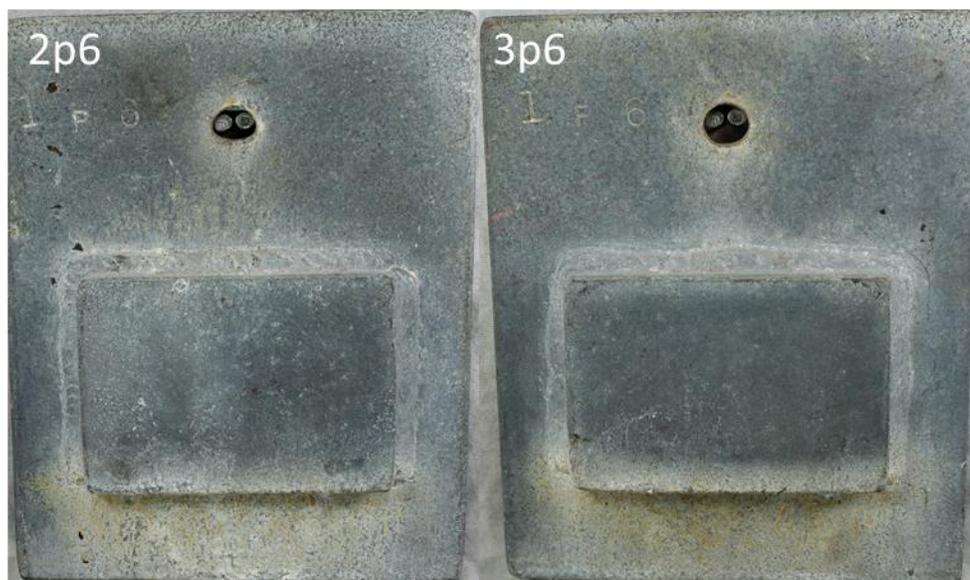
Figure 70: Configuration 6 After 40 Cycles

As can be seen in Figure 70 and Figure 71, the corrosion products were slightly different between the two specimens. White products were dominant in specimen 2p6 whereas 3p6 had more reddish corrosion products. In other words, the white corrosion products in specimen 3p6 had been consumed more than that in 2p6. This can be explained by the gap measurement. Specimen 2p6 has a relatively smaller gap than 3p6. It can be concluded that red corrosion products grow and dominate the area adjacent to the gap as the gap width increases, which can be explained by the fast-drying process in larger gaps.

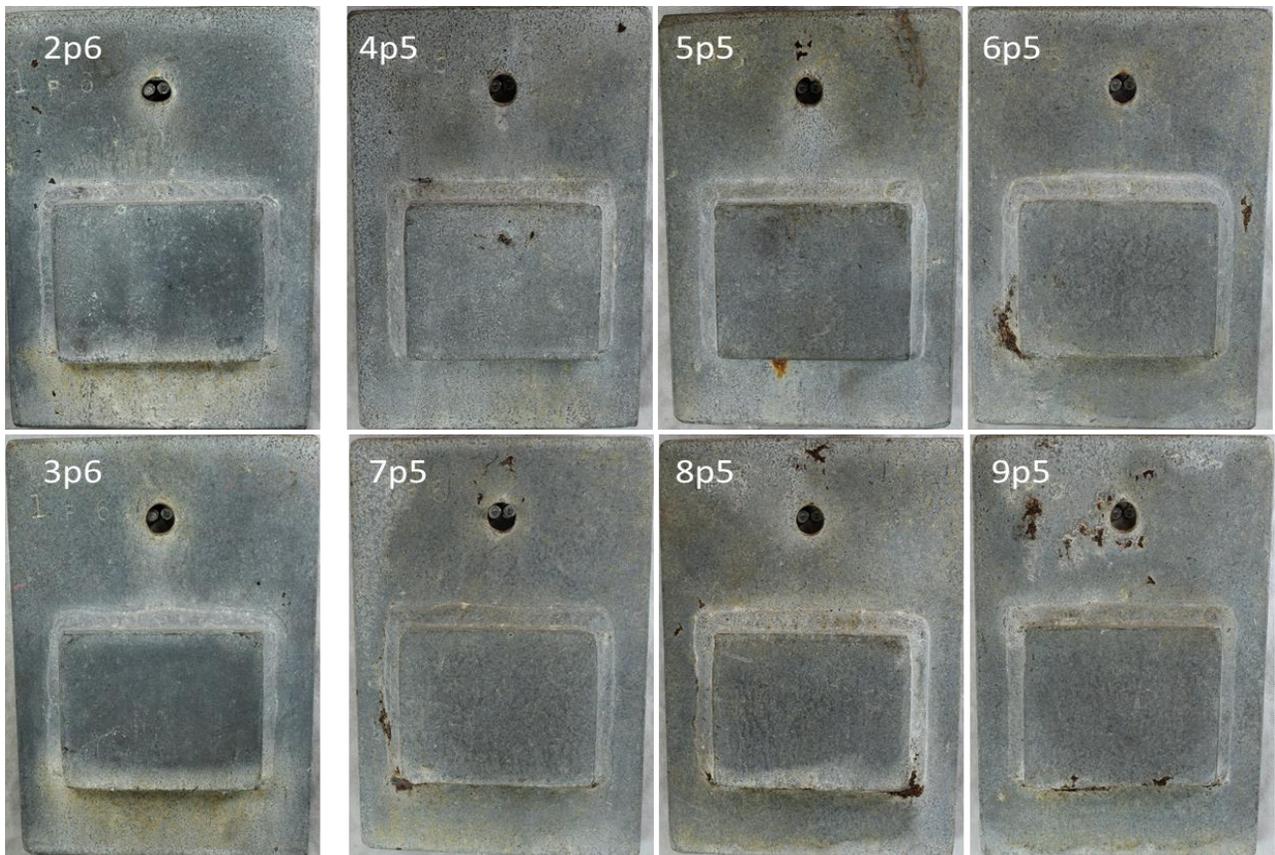
Figure 72: Configuration 6 (left column) and Configuration 5 After 40 Cycles

Similar to the comparison between Configurations 2 and 3, Configurations 5 and 6 experienced the same issue, that is, the localized corrosion adjacent to the gaps was much more severe in Configuration 6 than in Configuration 5 as shown in Figure 72. However, note that Configuration 6 did not experience or show any symptoms of rust bleeding. This formed two

theories: The first one could be that part of the overlapped surface between the two plates had been properly galvanized in Configuration 6 due to the existence of the gap. Thus, more testing cycles could corrode the specimen and thus form rust bleeding. The second theory is that zinc migrated, as was proved in Configuration 3, between the overlapped surfaces towards the bare spots, thus eliminating bare spots and rust bleeding. However, the second theory contradicts 5p5 specimen from Configuration 5 where rust bleeding was observed. Nonetheless, as discussed at the beginning of the results of this task, accumulation of white corrosion products, as was the case for Configurations 2 and 5 near the open edges, probably stopped the functionality of the zinc coating, as a result, allowing steel substrates or bare spots to further corrode. It can be concluded that the existence of the minimum 3/32 in. gap eliminated the rust bleeding phenomenon as in Configuration 6, yet, had a faster corrosion rate and more growing red rust than the open edge/small gap specimens.

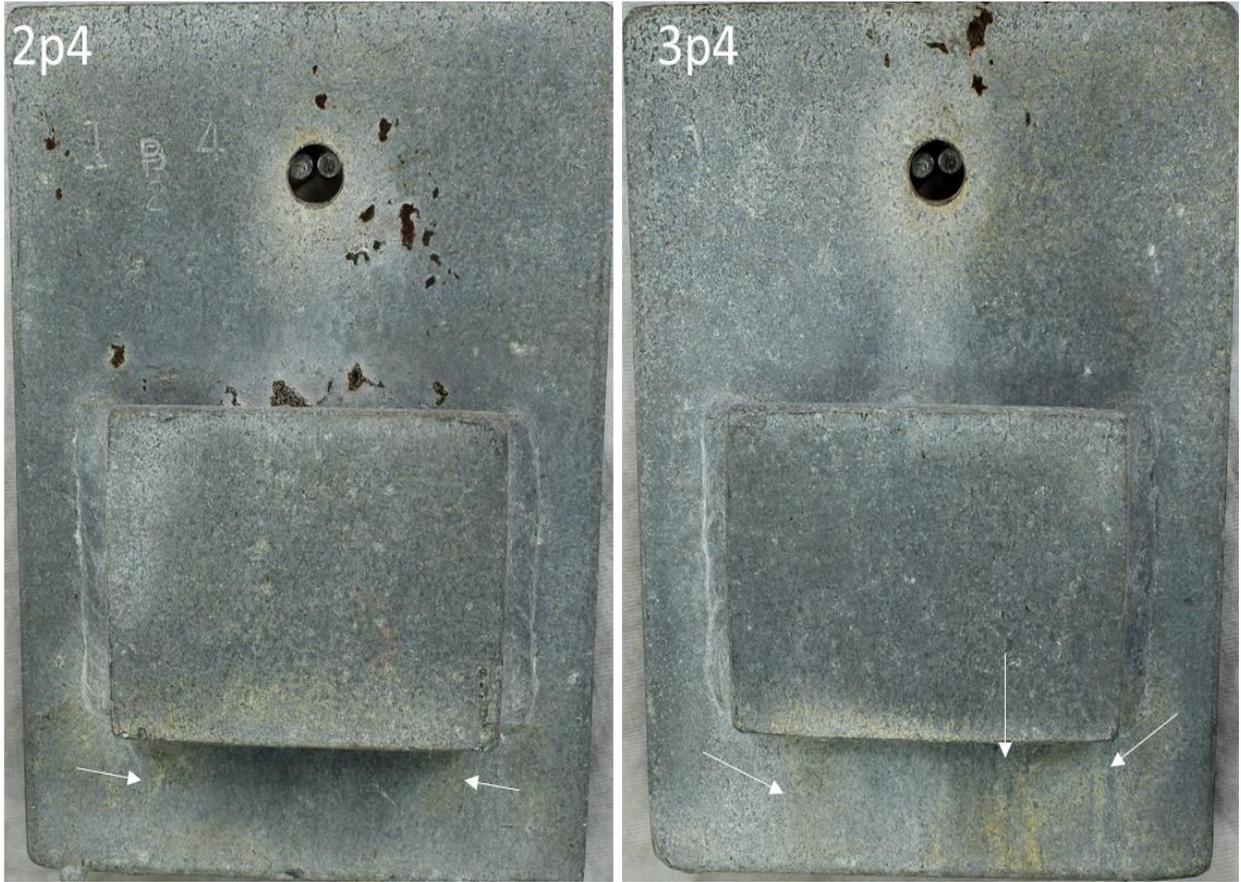
Figure 73: Configuration 4 After 40 Cycles

Configuration 4 had the highest quality corrosion behavior from the accelerated corrosion test when compared with the other configurations, except for the control specimens. This configuration experienced a relatively uniform corrosion. As seen in Figure 73, there was no localized corrosion near the gaps as opposed to what was found in the other configurations. This was due to the open gaps in both edges that allowed air circulation and thus a fast-drying process after the immersion in the salt solution or from the moisture of the chamber. However, in agreement with what was observed in 4.2.2 regarding the leaching along the edges, it can be noted that the damages were slightly distributed or oriented along the edges where leaching occurred as shown in the white arrows of Figure 73. This was believed to be due to improper edge cleaning due to the welds. In addition to the improper cleaning, the salt solution and moisture from the tests were contributing factors to have corrosion products along the edges as they were likely traveled along the edges due to the surface tension property. A comparison between Configurations 3, 4 and 6 is shown below in Figure 74. Configuration 4 corrosion behavior was relatively uniform even near the gaps in contrast to the wide gap configurations where the corrosion products were localized near the gaps, this what favors this configuration to the other configurations.

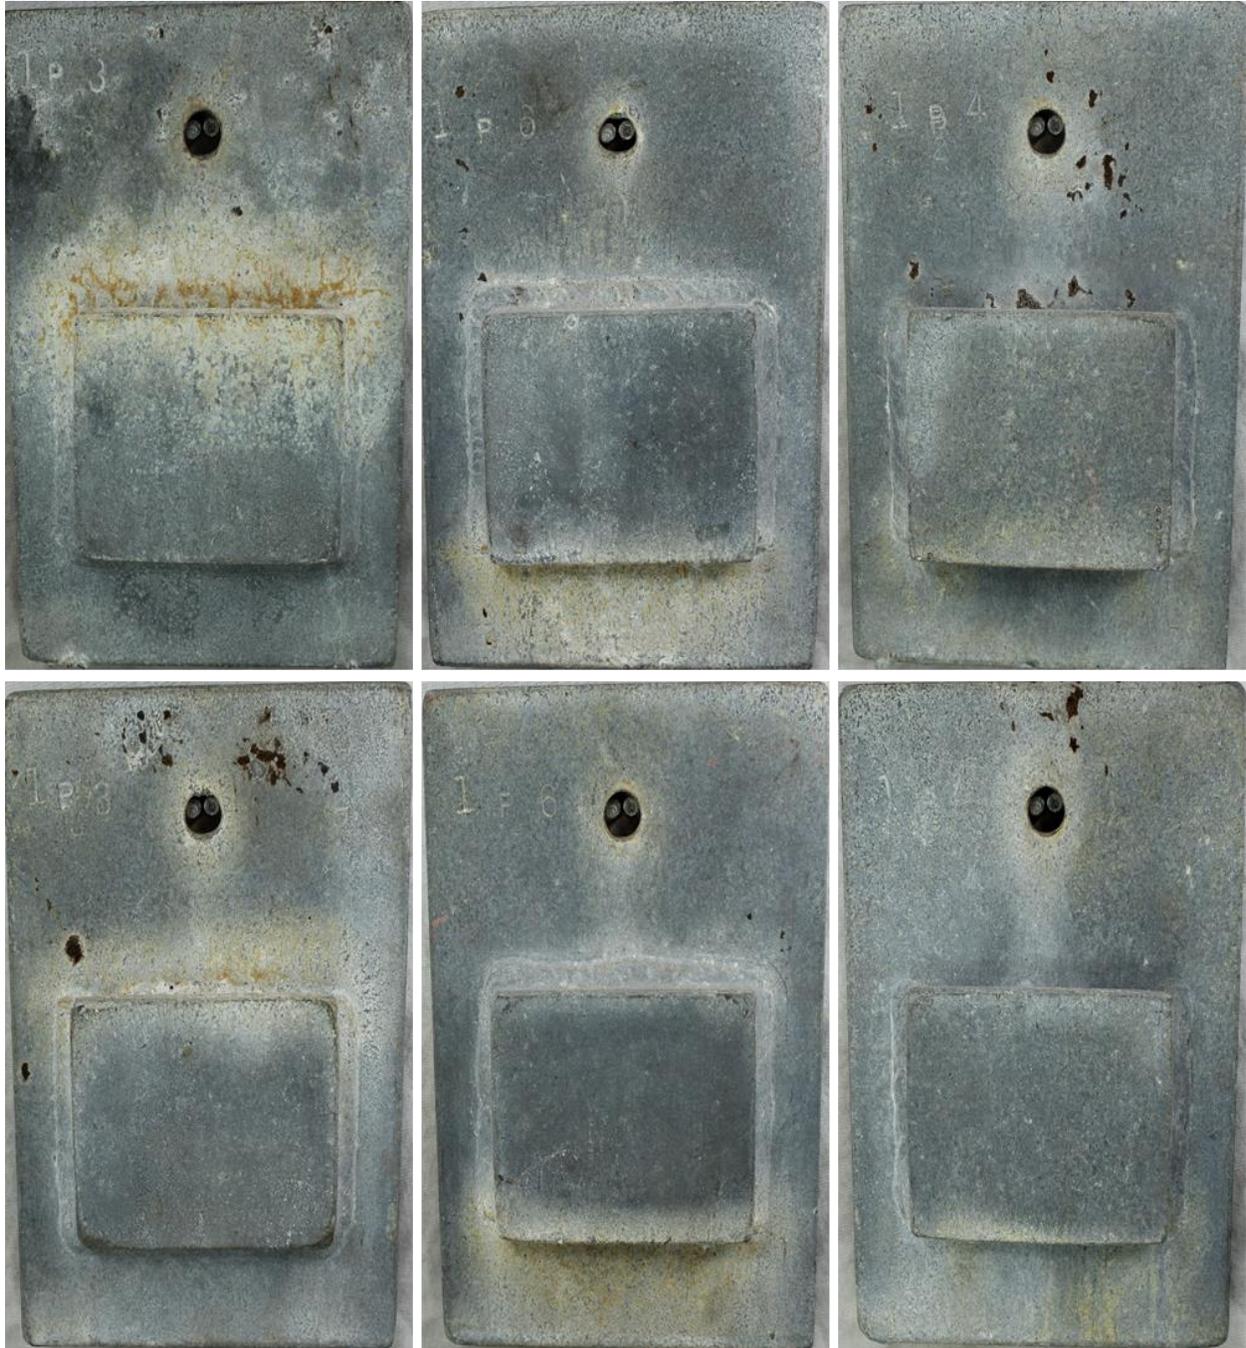
Figure 74: Configuration 3 (left column), Configuration 6 (middle column) and Configuration 4 (right column) After 40 Cycles

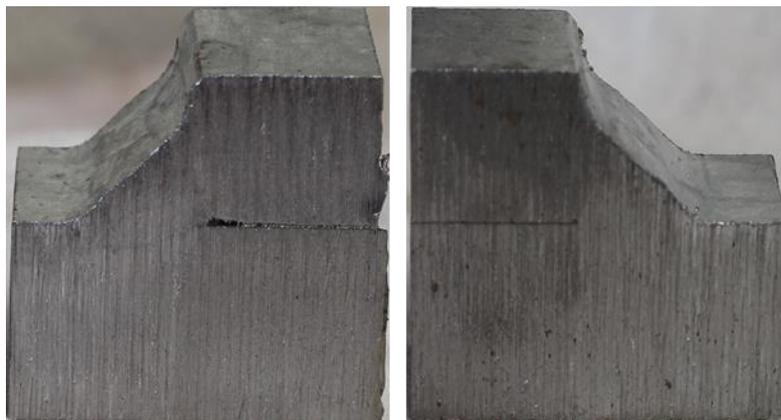
Figure 75: Weld Cross Section Configuration 1

For these configurations, the weld cross section was not affected by the galvanizing process as shown in Figure 75 and Figure 76. This was expected as the seal-weld prevented the fluids from the cleaning solution and zinc from penetrating for Configuration 1. Similarly, for Configurations 2 and 5, the weld sections were not affected by the galvanizing process, further investigations were done (1p2 unsealed) via microscope, as shown in Figure 77, which is a zoom-in from the upper left specimen of Figure 76, neither the galvanizing zinc nor the cleaning solutions penetrated inside the open edges. It should be noted that the red corrosion appearing in this piece specimen does not correlate with the configuration/type. The red corrosion started to appear after cutting the specimens for a period of time and was due to the atmosphere surrounding the specimen. In addition to the weld section, the open edge sections (for Configurations 2 and 5 only since Configuration 1 the top and the bottom were the same), whether with sealants or not, did not yield satisfactory results in the top interface, as shown in Figure 78 and Figure 79.

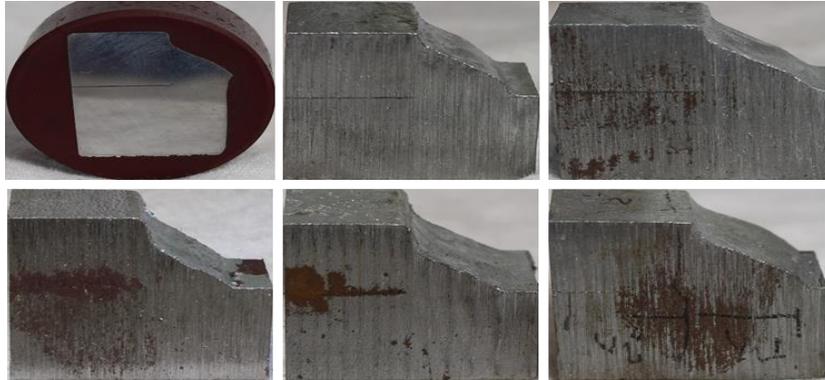
Figure 76: Weld Section for Configuration 2 (upper row) and Configuration 5 (bottom row)

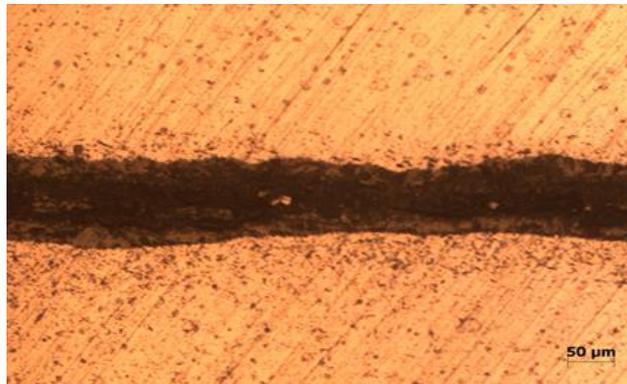
Figure 77: Corrosion of the Contacting Surface of Specimen 1p2

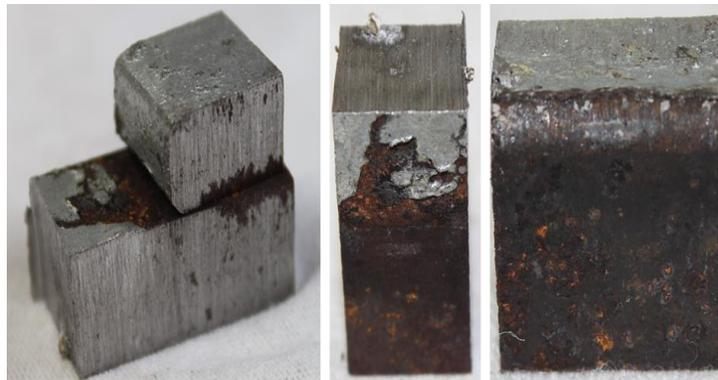
Figure 78: Top Interface of 2p2 (GE Silicone specimen)

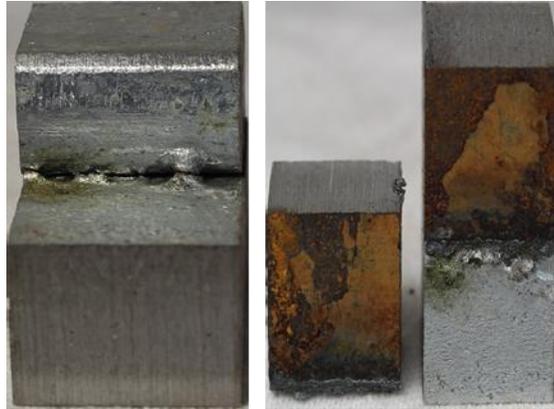
Figure 79: Top Interface of 5p1 (no sealant)

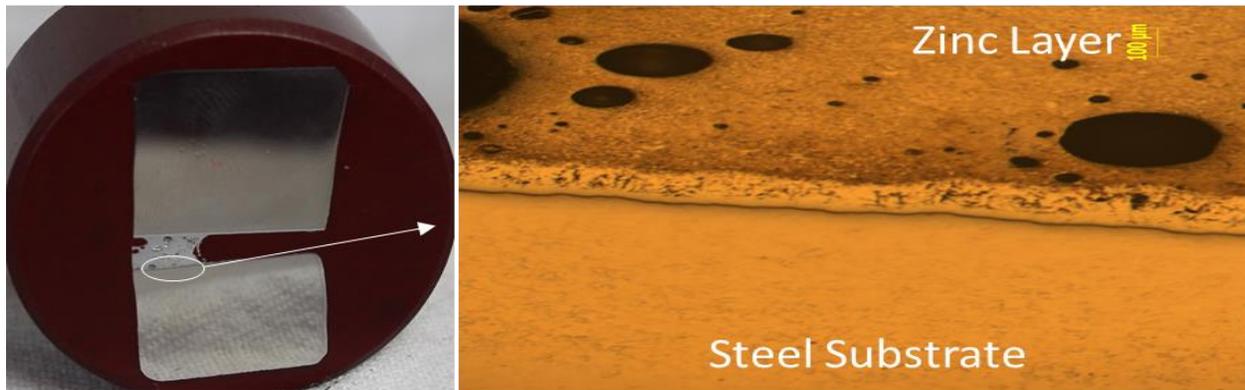
Figure 81: Interface Between the Zinc and the Steel Plates

Figure 80 shows the cross-section of configuration 3 when cutting in half. As can be seen, the gap was filled with zinc, which is the light gray layer between the two plates. Notice the blue and red circles, these were defects of the zinc thick layer. The blue circles show the existence of voids in the coating zinc. These voids could be problematic if located near the steel substrate as they could affect the metallurgical layer between the zinc and the steel. A cut was made in the right blue circle, as was indicated in section 3.3, to further investigate the coatings. Figure 81 shows the cut where the steel interfaces with the zinc in a microscope zoomed view. Clearly, there were plenty of voids in the zinc layer. A zoomed in picture is shown in Figure 82 (left), compared to a typical cracked coating section in the middle (right). Fortunately, the interface between the steel and zinc was uniform along the length of the interface and was not cracked. The second cut, which was located in the bottom of the specimen, is shown in Figure 83. As it can be seen, the zinc layer did not go all the way to the weld. The black material inside the red circle was believed to be a weld slag, and it was the cause of preventing the corner from being coated. It can be concluded that weld slags cannot be removed by the cleaning solutions from the HDG process, thus, it should be removed by alternative methods.

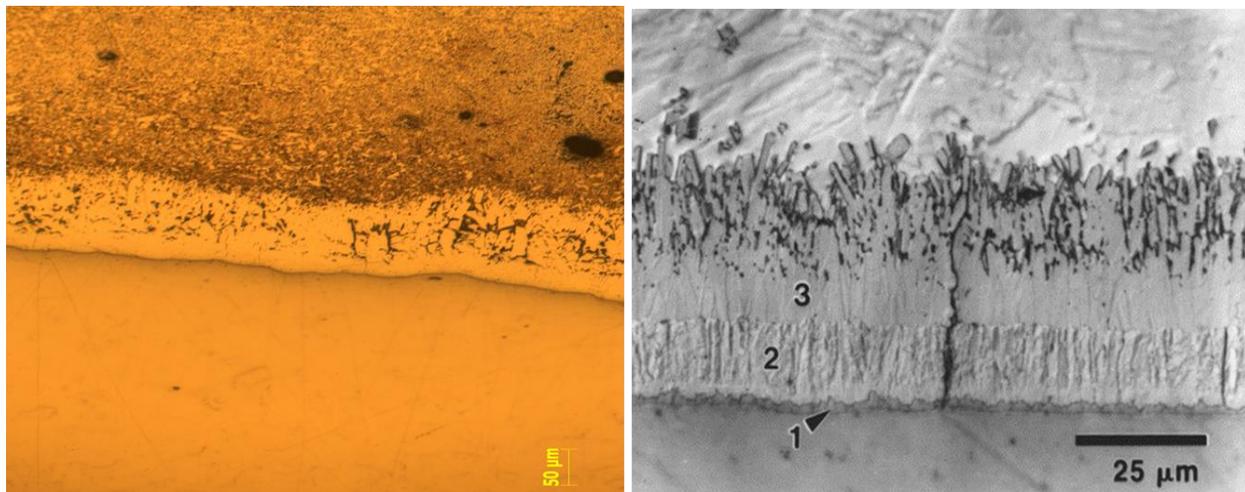
Figure 82: Coating Layer from Configuration 3 (left) and a Cracked Coating Layer (right) (Marder, 2000)

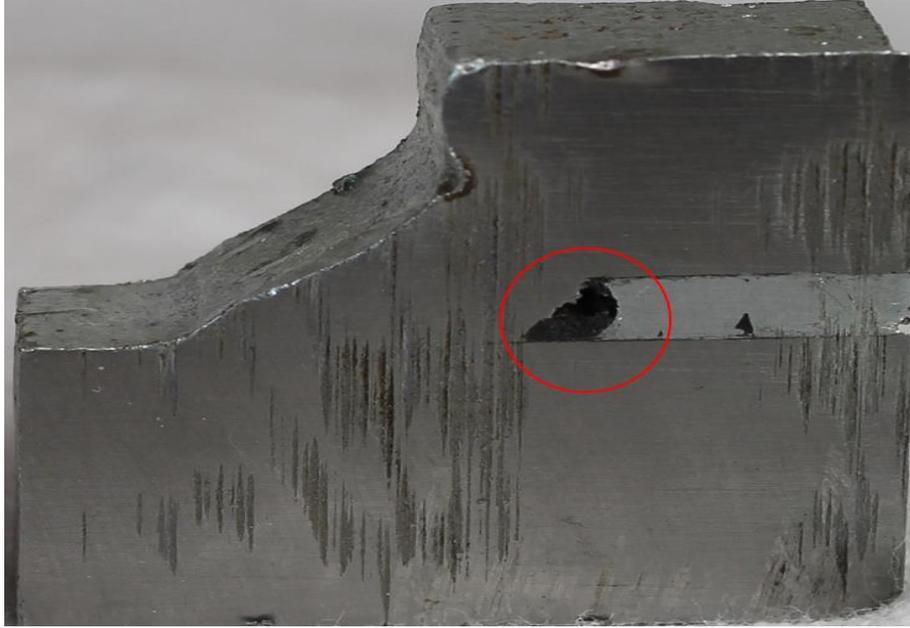
Figure 83: Zinc Coating in the Bottom Interface of the Specimen.

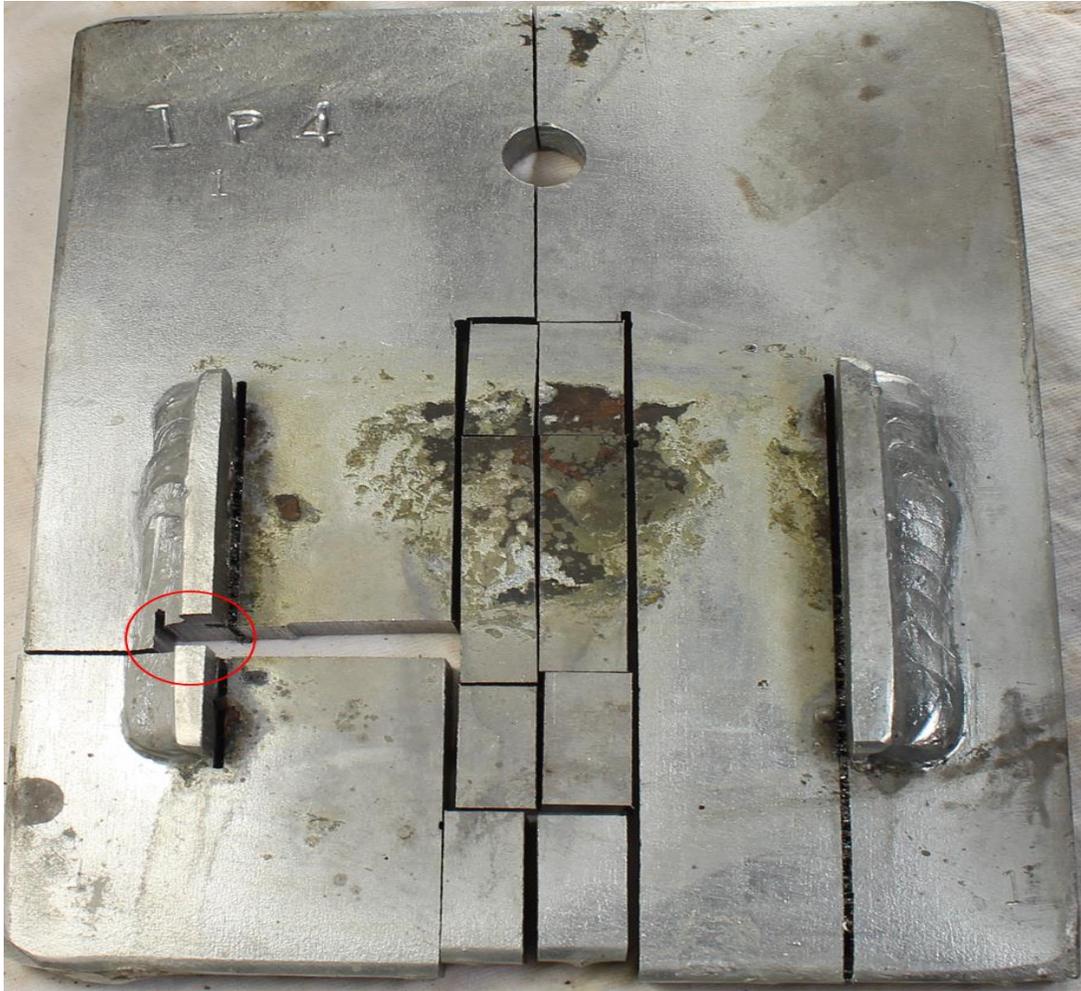
The cut of configuration 4 resulted in a relatively good coating in the bottom gap, while experienced unexpected poor galvanizing in the upper part, in spite of the fact that the top gap was wider than the bottom gap for this specimen in particular. Figure 84 shows the specimen after removing the overlapped plate. As can be seen, bare spots were concentrated near the top edge. They were probably an indication of insufficient cleaning of the specimen or poor drainage of the zinc. Also, note the green defect spots, these, as mentioned earlier, were probably flux deposits.

Figure 84: Configuration 4 After Cutting and Removing the Smaller Plate

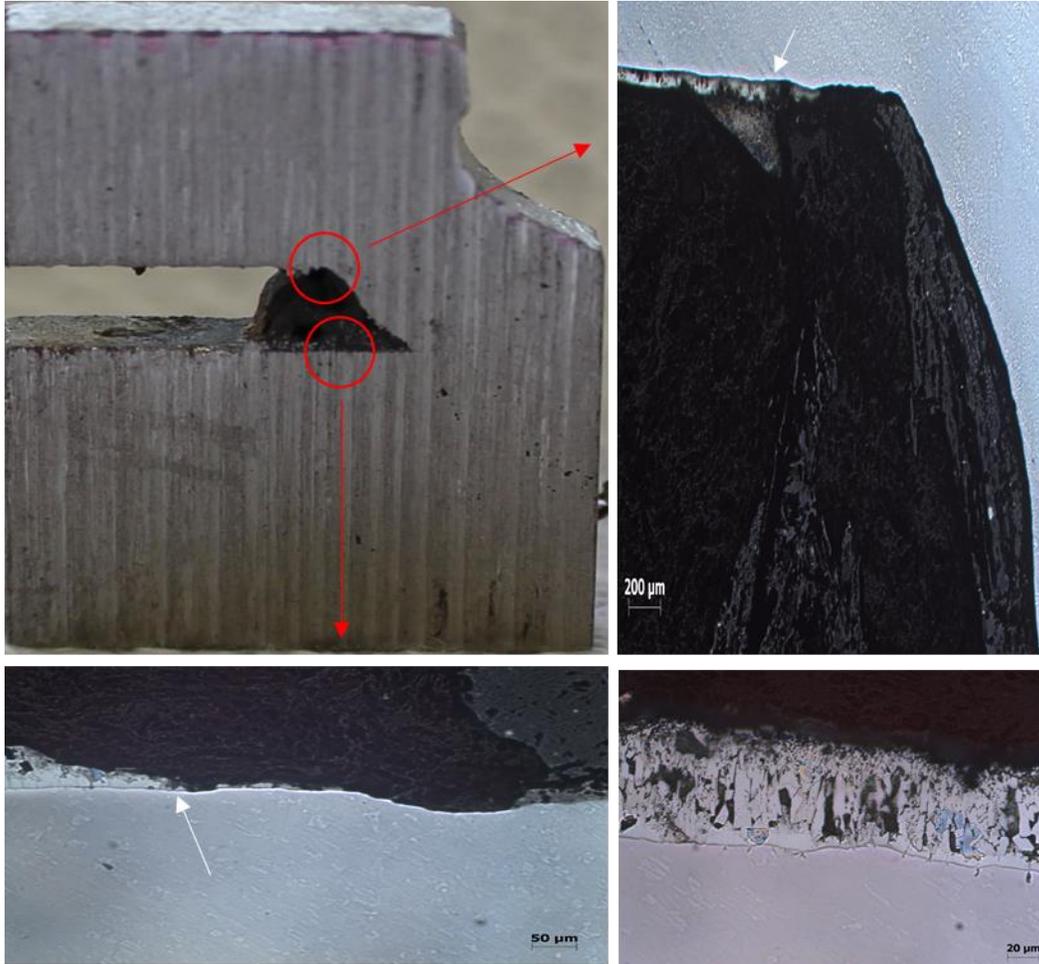
In addition to the bad quality in the upper part of the overlapping surface, the edges did not experience good coating as well. In an agreement with Configuration 3, weld slags were dominant in these spots. A further investigation was done via microscope in the weld section from this configuration to assess the weld/slag coating interfaces. The red circle from Figure 84 is the weld cut section shown in Figure 85. Two spots were observed where the coating stopped adhering to the steel surface as indicated by the white arrows. This means the upper and the bottom surfaces of the slag were galvanized to a certain extent, then stopped. This forms a new theory, in addition to the slags impeding the corners being galvanized, they did not get galvanized because of the narrow-angle of the weld detail that probably prevented the thick zinc from reaching the corners. The bottom right picture represents the coating layer when zoomed,

which seemed to be a good bond coating. In brief, even though Configuration 4 performed well from the corrosion behavior task, this task showed that the overlapping surface had inferior coating quality.

Figure 85: Microscope Analysis in the Weld Section of Configuration 4

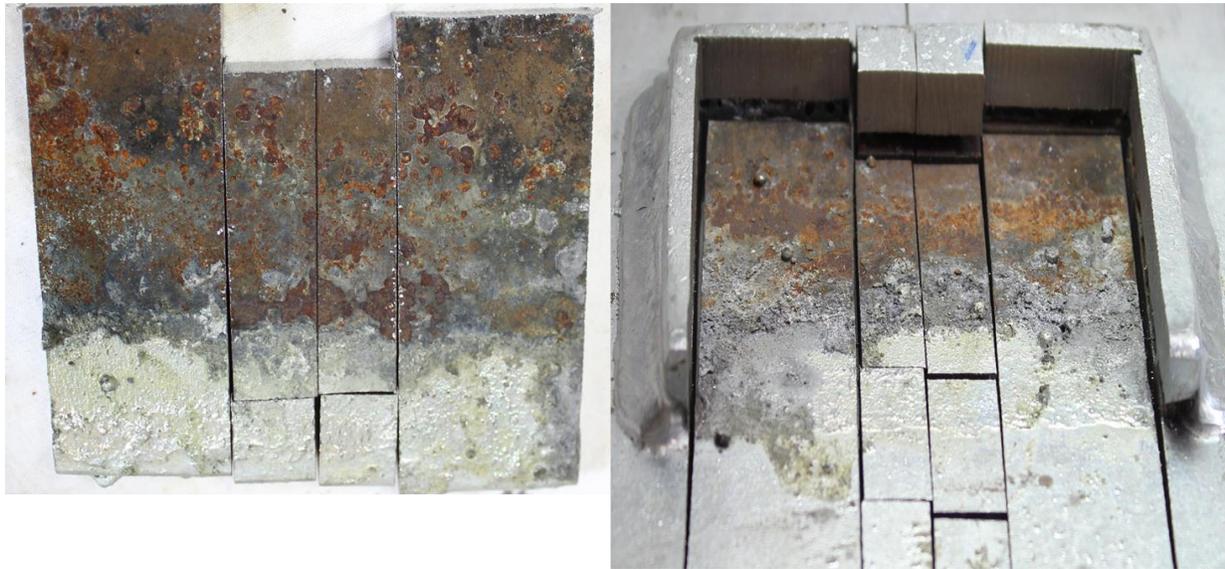
Configuration 6 did not yield satisfactory results in the overlapping surface. Figure 86 shows the removal of the overlapping surface. As seen, the profile of zinc coating over the overlapping surface was undesirable. Bare areas were dominant in the upper part, then reddish/brown rust, and then bad rough coating at the bottom edges. Clearly, the gap in the overlapping surface did not experience proper cleaning and galvanizing. Although it was concluded in task 2 for this

configuration that the gap contributed to preventing the rust bleeding occurrence due to the overlapping surface being galvanized, the results shown in this figure contradicts the findings from task 2. This could indicate that the zinc migrated to the bare spots and thus stopped rust leaching out from the overlapping surface for task 2. To prove which outcome is right, more cycles should be done for this configuration.

Figure 86: Removal of the Overlapping Small Plate (left) From the Bigger Plate (right) in Configuration 6

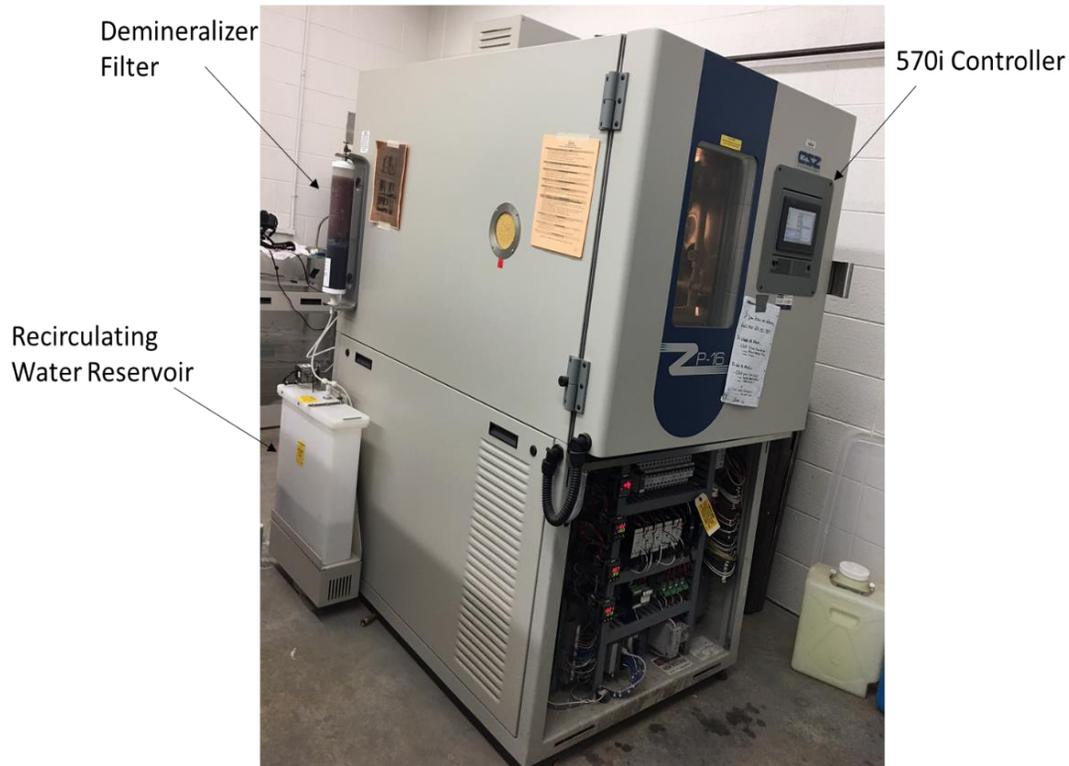
Air and water moisturize the chamber. This is done by a boiler heating water to generate steam. Water is pumped from a recirculating water reservoir, which is a filled water reservoir. After providing the necessary humidity, the condensed water from the steam is ultimately recirculated back to the reservoir. Through this journey, the water must be filtered first by a demineralizer filter as it removes impurities from the corrosion products of the specimens as they might corrode the components of the chamber if the water is not cleaned. It was found that cleaning the interior of the chamber daily, where moisture and corrosion products from the specimens are collected, increase the serviceability life of the filters since these are recirculated back to the reservoir (Groshek, 2017). In addition to cleaning the chamber, filling the reservoir with a de-ionized water maximize the life of the demineralization filters. Figure 87 shows the chamber and some components.

Figure 87: ZP-16 Chamber with Various Components

The screen controller, EZT-570i, indicated by the previous figure, controls the humidity and temperature. This can be done either manually or automatically. The automation was used to operate cycles. A cycle is 24 hours of operation, where 15 minutes of the 24 hours are external operation of immersing the specimens into the salt solutions and the rest are automated in the chamber.
