Alternative Methods for Sealing Overlapping Steel Members with Narrow Gaps During Galvanizing

Thesis submitted to the faculty of the Virginia Polytechnic Institute and State University in partial fulfillment of the requirements for the degree of

Civil Engineering

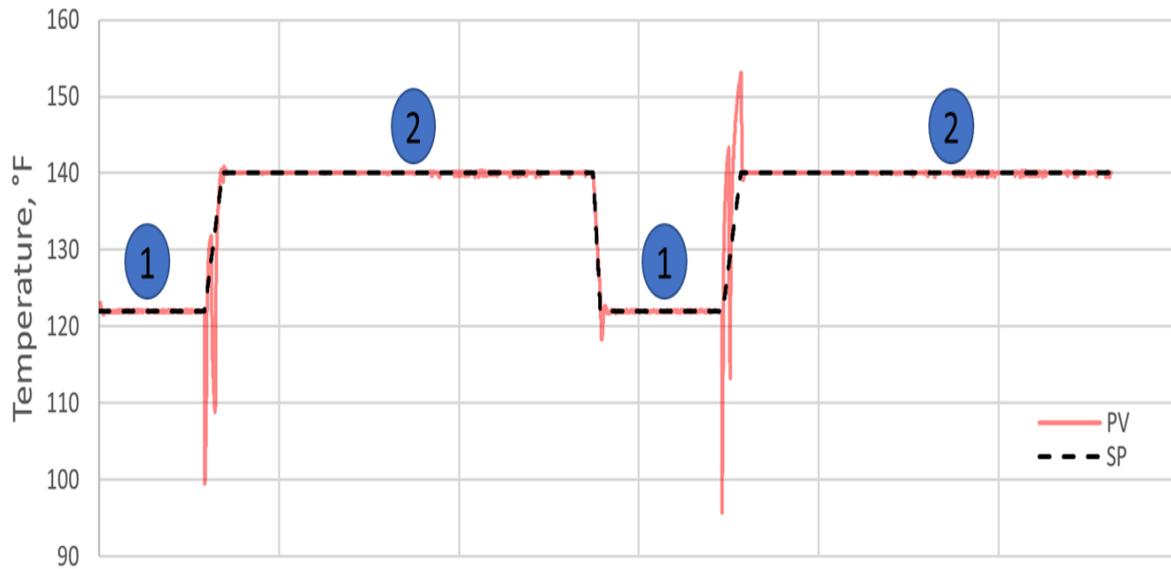
drying visually. Figure 88 and Figure 89 provide actual readings of temperature and relative humidity of two cycles during the testing, it should be noted that the graphs are not to scale. Before detailing them, some programming chamber concepts must be introduced. For this study, all the events were done automatically, using a term called “profile”. A profile consists of multiple steps that provide the events needed (temperature or humidity) to achieve a cycle. Each step is either called a ramp step or a soak step. A ramp step is used when the event is shifting from one stage to another. A soak step is when the event is constant. Also, the screen provides actual readings using sensors, which are called process variables “PV”, and provides the set values which the PV are projected to, which are called set-points or “SP”. In other words, SP is the value that the user inserts, whereas PV is the actual adjusting value to achieve the user’s input.

Back to the graphs, as can be seen, stage 1 represents the humidity stage (RH is 50% with a temperature of 50°C for 6 hours), which is a soak step since the temperature and RH are constant for the 6 hours. Then, a shift from stage 1 to stage 2, which is a shift from the humidity stage to the drying stage (60°C with 100% for 17 hours and 45 minutes), must occur. Since the chamber is incapable of shifting between two points at once, a ramp step is used to gradually transition between two events (Groshek, 2017). The arbitrary movement of the PV of the temperature and the humidity between the two stages as shown in both figures is due to the salt application. Since the specimens were taken manually from the chamber to apply the salt stage, opening the chamber’s interior to the atmosphere decreases the temperature and the humidity of the chamber significantly. Lastly to complete a cycle, after the drying stage, the chamber shifts back to the humidity stage. Because there is no salt application between the drying and the humidity shift, notice the gradual shift in both the PV and SP without abrupt changes.

Figure 88: Altering Events of Chamber Temperature

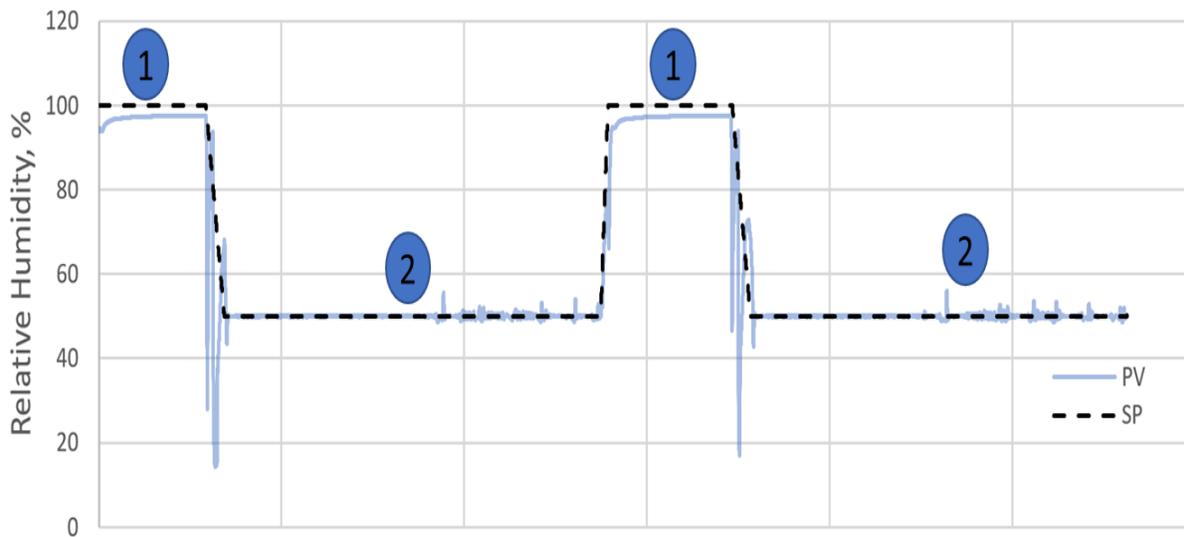
Figure 89: Altering Events of Chamber Humidity

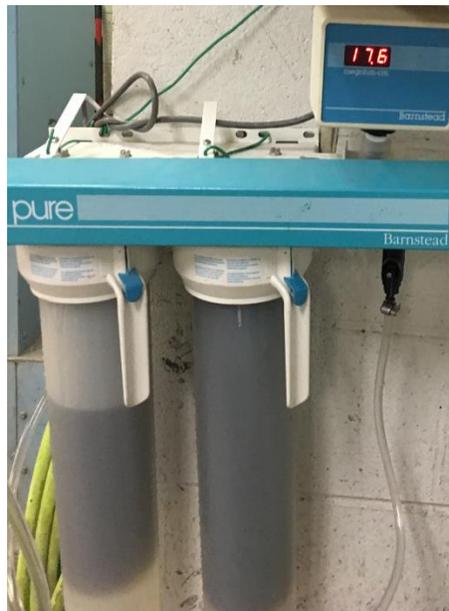
Figure 90: Barnstead Filters

The initial step of preparing the salt solution is to have a reagent purified water. The SAE J2334 requires using type IV of ASTM D1193 water. This entails having a resistivity of water at least $.2 \text{ M}\Omega \cdot \text{cm}$ with a maximum conductivity of $5 \mu\text{s}/\text{cm}$, and a pH level between 5.0 and 8.0. To meet this specification, water was obtained from Barnstead filters. The filters provide direct resistivity readings on the screen, as shown in Figure 90. To verify the readings from the filters, a conductivity meter was used as well. Likewise, a pH meter was used to record the measurements.

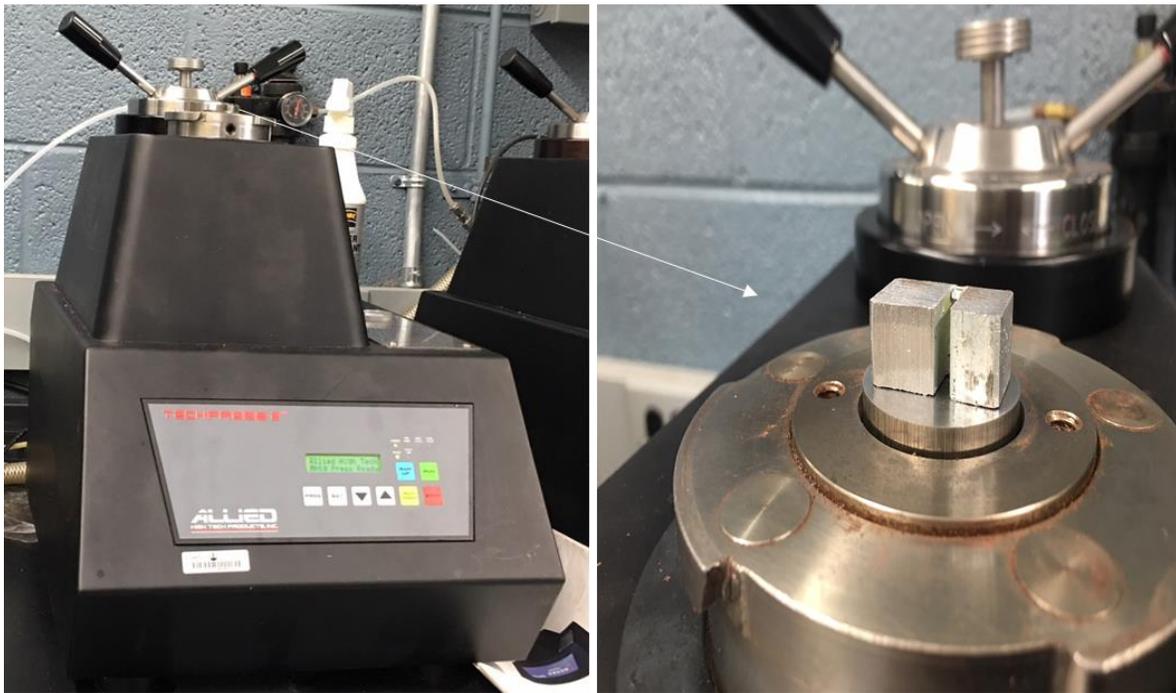
The first step involves mounting the sample with the aid of the hot press. The goal of this step is to facilitate the handling of the specimen for the following grinding and polishing steps by pressing a powder by applying heat and pressure to form a solid-state disc to carry the specimen. Figure 91 shows a picture of the machine and a zoomed picture showing the place where the specimen is placed. It is an automated machine and goes through three basic stages.

Figure 91: Mounting Press Machine

Before describing the stages, it should be noted the machine limits the size of the specimen. As seen in the same Figure 91, this specimen must fit the chamber's circular piston. Also, the face of the area that is investigated through the microscopic must face down toward the machine. Figure 92 shows the powder and how it is poured on top of the specimen, that is, after pressing the

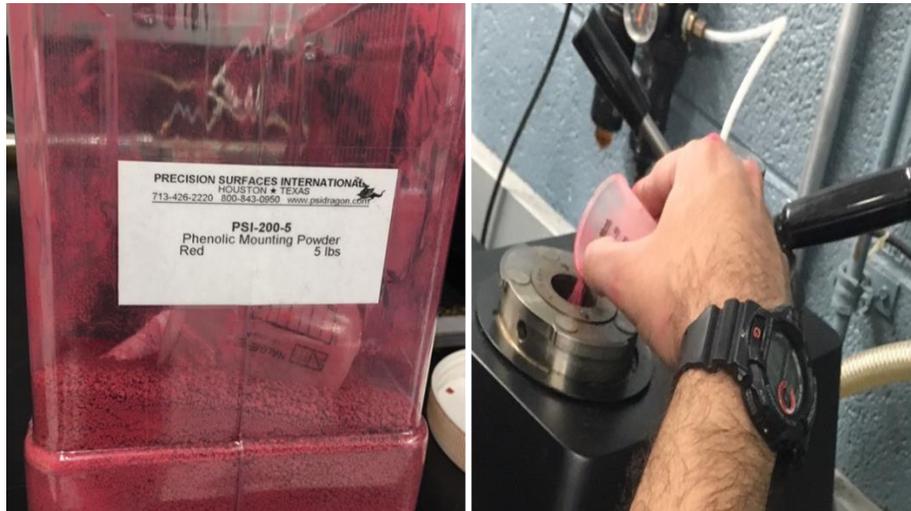
specimen inside the machine. The amount of powder poured is a function of the specimens' thickness.

Figure 92: Phenolic Mounting Powder (left) Poured Inside the Machine on Top of the Specimen (right)

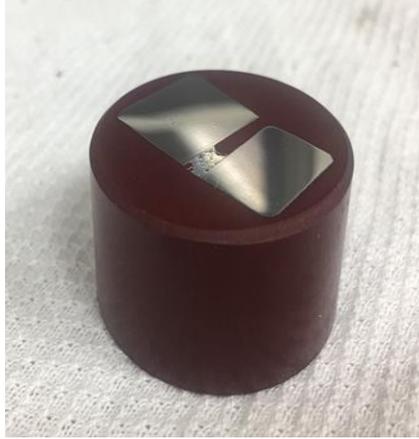
Back to the stages, the goal of this process is to press the powder to make it in a solid state. This is done by first preheating the chamber to around 100°C, which takes about 4 minutes. The purpose of this step is to make the powder softer and to facilitate the chemical reaction and sintering. Next, the temperature is increased to around 160°C and pressure is applied to around 3700 psi. This step takes between 5–7 minutes. Lastly, a cool down process is done for around 6 minutes. The result is shown in Figure 93.

Figure 93: Specimen in a Solid Disc After Heating the Powder

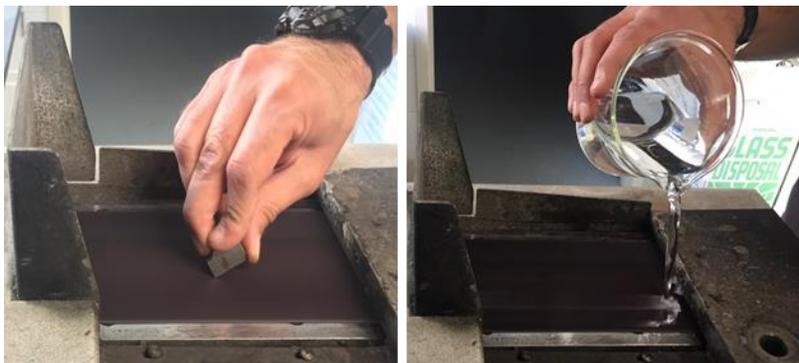
Because the mounting press enforces pressure and heat, specimens that contain sharp edges, where stress is concentrated, might cause cracks to the pressed powder polymer. Thus, a preventative measure is sometimes done before the mounting press is utilized, which involves rounding up the edges. This is done by holding the specimen against a fast-moving belt machine, as shown in Figure 94. This step takes about 2 minutes. Also, sometimes water rinsing is used to smoothen the contact between the moving belt and the specimen.

Figure 94: Grinding Belt

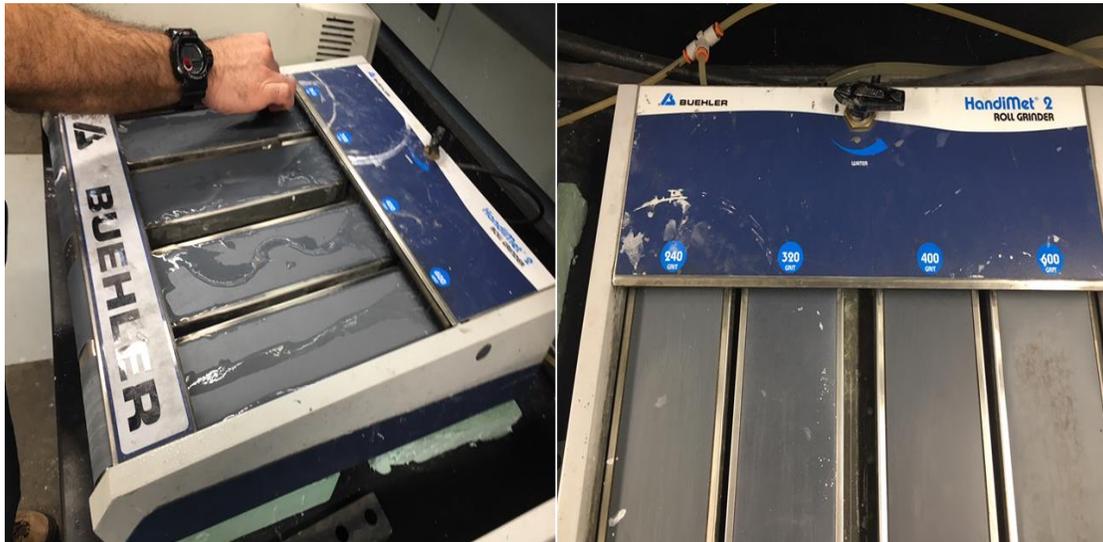
The second step is the grinding step. This is done by using a roll grinder as shown in Figure 95 . These grinders consist of different size of grits (sand paper). As the number of the grit size increases, the finer the abrasive grain used. The process of grinding is done manually by simply applying enough force to move the specimen by hand back and forth for around 50 rounds in each grit, starting from the lowest number grit to the highest. This is done to insure a smooth

removal of the material. The MSE lab has four grit sizes: 240, 320, 400, and 600. When moving the mounted specimen from one grit to another, it is rotated 90° degrees each time. This is to insure having a finished flat surface, which is an important characteristic to have when looking at the specimen through microscope. Also, during grinding, water is applied to the grits to insure a smooth contact between the specimen and the grit.

Figure 95: Roll Grinder Machine

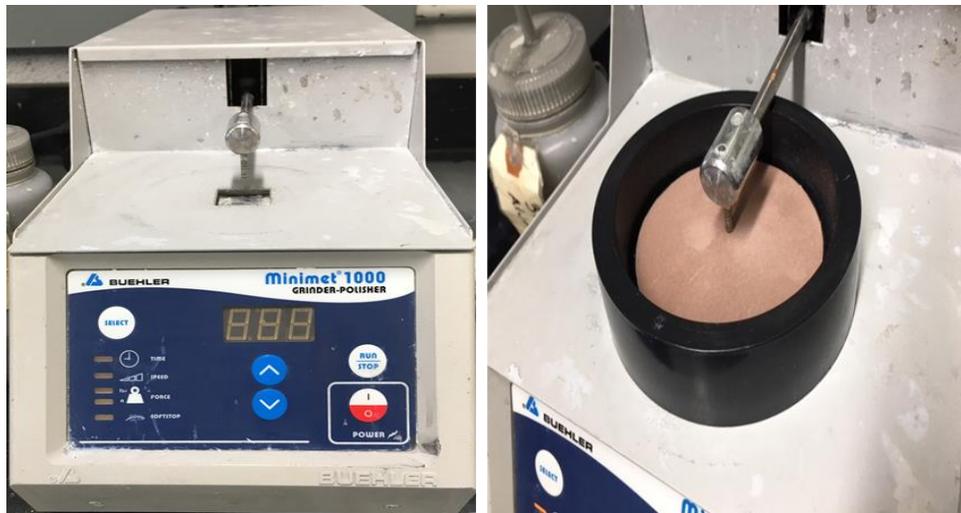
The last stage before looking through the microscope is the grinder polisher. The premise of this machine is applying force and rotation to the specimen to rub the face of it against a polishing cloth covered with a chemical suspension to remove scratches. The force and rotation is exerted by a rod attached to an unseen spring from in the machine. The polishing cloth to which the specimen is rubbed against is cut to a circular shape to fit in a circular plastic container. Figure 96 shows the rod on top of the paige color polishing cloth and there is a circular glass underneath the polishing cloth to resist the force exerted on it.

Figure 96: Grinder Roller (left) and Container with Polishing Cloth (right)

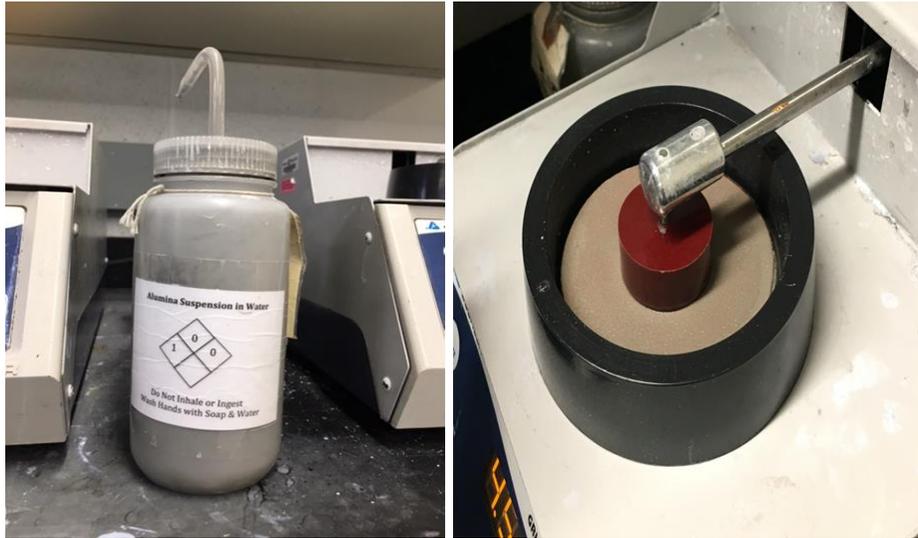
adding more polishing suspension is necessary. Note that each step requires a different polishing cloth. In other words, three polishing cloths were used for polishing a sample. Figure 97 shows one of the suspension liquids used along with a sample in the machine. Note that to attach the rod to the resin, a hole must be drilled in the center of it.

Figure 97: Aluminum Suspension (left) and a Sample in Process (right)

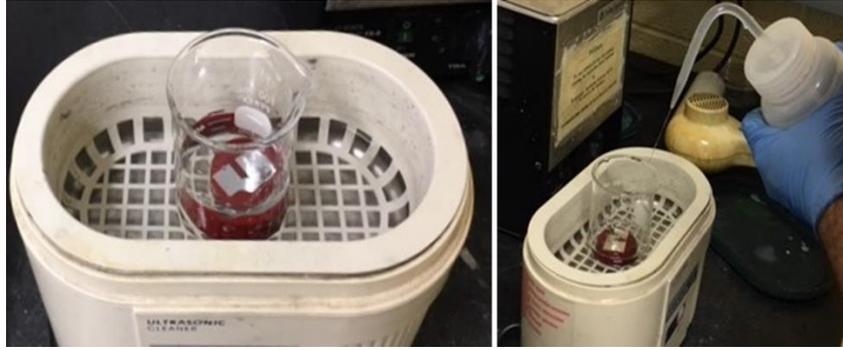
To remove any excessive polishing suspension between each step, as this may distribute the uniformity of the surface, ultrasonic cleaning is used between the steps. As shown in Figure 98, the device vibrates the water in a small container to clean the surface from the polishing suspension and prepare it for the next step. Also, for the last step, the .04-colloidal silica polisher, ethanol was added with water in the device to neutralize any chemical reaction from the surface.

Figure 98: Ultrasonic Cleaner
