THE USE OF THIN POLYMERIC COATINGS TO PREVENT FRETTING
CORROSION AND METALLIC CONTACT IN STEEL-ON-STEEL SYSTEMS

Thesis submitted to the Faculty of the
Virginia Polytechnic Institute and State University
in partial fulfillment of the requirements for the degree of

Mechanical Engineering

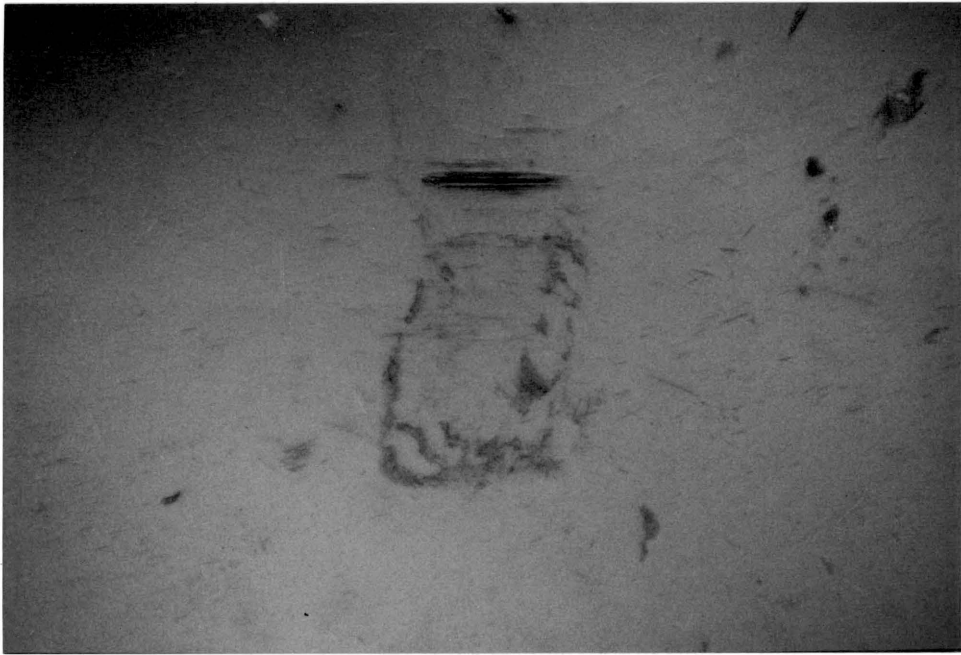
Figures 4-24 and 4-25 are the corresponding ball and disk scars for Test 3 (60 seconds run time); the film has failed. A large groove can be seen on the ball (Figure 4-24). A rectangle of transferred material can be seen below the groove. Loose debris, possibly polymer, can be seen scattered around the scar center.

FIGURE 4-24. Optical Macrograph of PMMA Test 3 Disk Scar (Magnification: 60X).

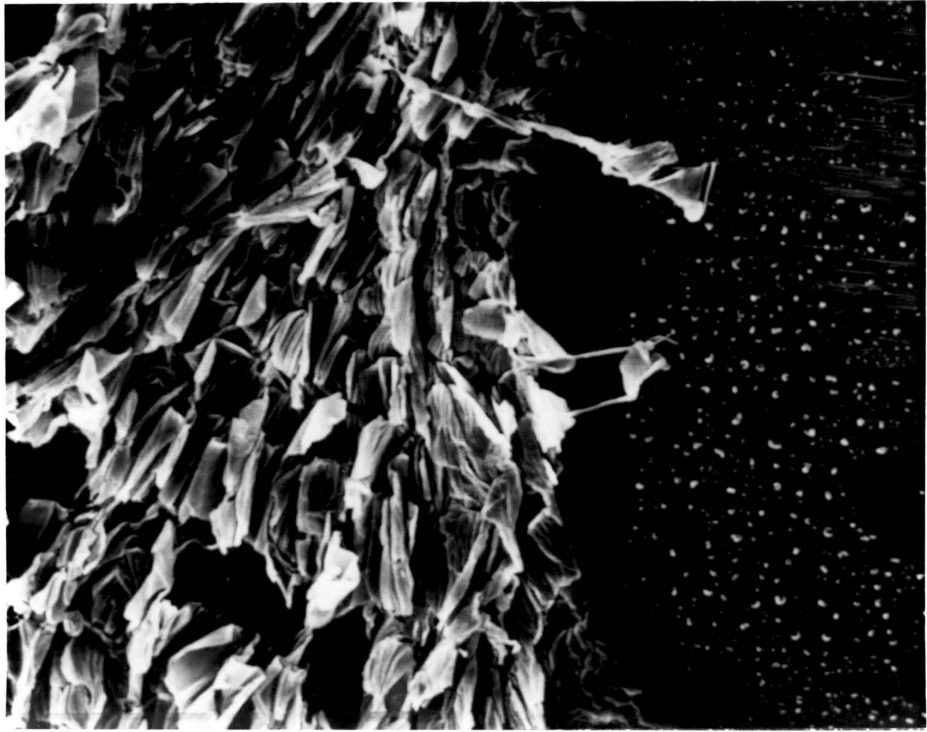
50 μm

Figures 4-30 and 4-31 are scanning electron micrographs of the disk scar. The debris at each end of the scar appears to be in the form of thin sheets of polymer. Figure 4-31 is a high magnification photograph of one end of the scar which shows the thin folds of polymer debris. Small debris particles can be seen within the scar.

FIGURE 4-31. Scanning Electron Micrograph of PTFE Test 3 Disk Scar End (Magnification: 200X).

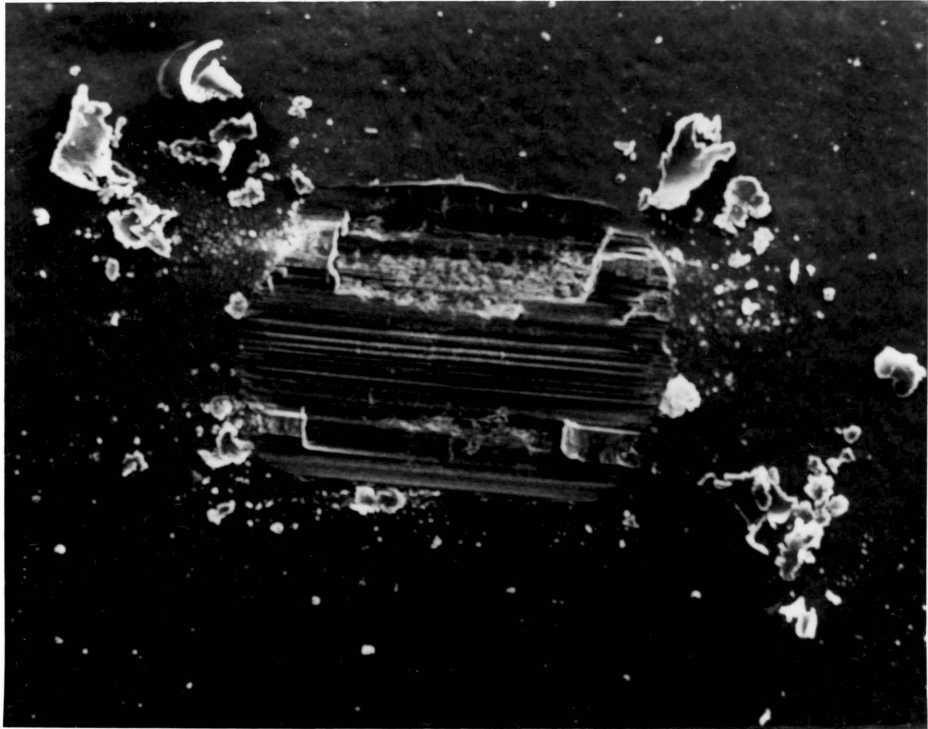
300 μm

Figures 4-34 and 4-35 are scanning electron micrographs of the disk scar which show the uneven nature of the polymer that has been removed from the disk. These photographs also permit identification of the small areas of reflective material seen in the optical macrographs. A match of SEM photographs of an uncoated disk surface to the light regions in Figure 4-35 shows that a sufficient layer of polymer has been removed to expose the disk substrate. Large grooves can also be seen along the length of the scar in the polymer.

FIGURE 4-34. Scanning Electron Micrograph of PI Test 1 Disk Scar (Magnification: 50X).

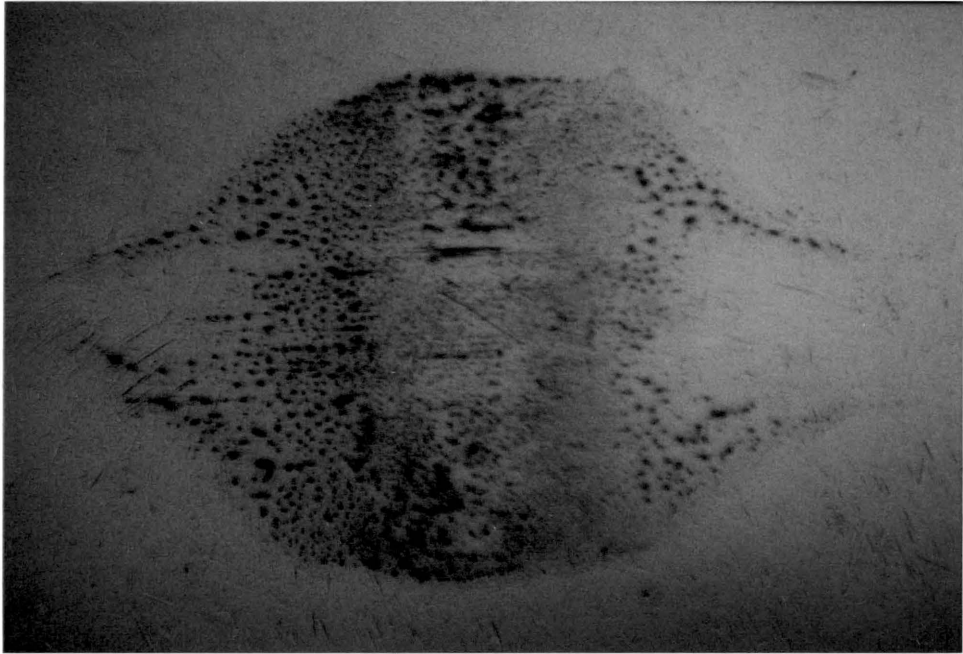
FIGURE 4-44. Optical Macrograph of PVDC Test 1 Ball Scar (Magnification: 60X).

Test 1 ball and disk scars (5.0 seconds run time, metallic contact) are presented in Figures 4-44 and 4-45. The ball scar is covered with small brown deposits and has a shape similar to the disk scar (note that the ball scar is presented at a higher magnification). A small groove can be seen in the ball just above the center of the scar. Scratches can be seen at the left end of the scar.

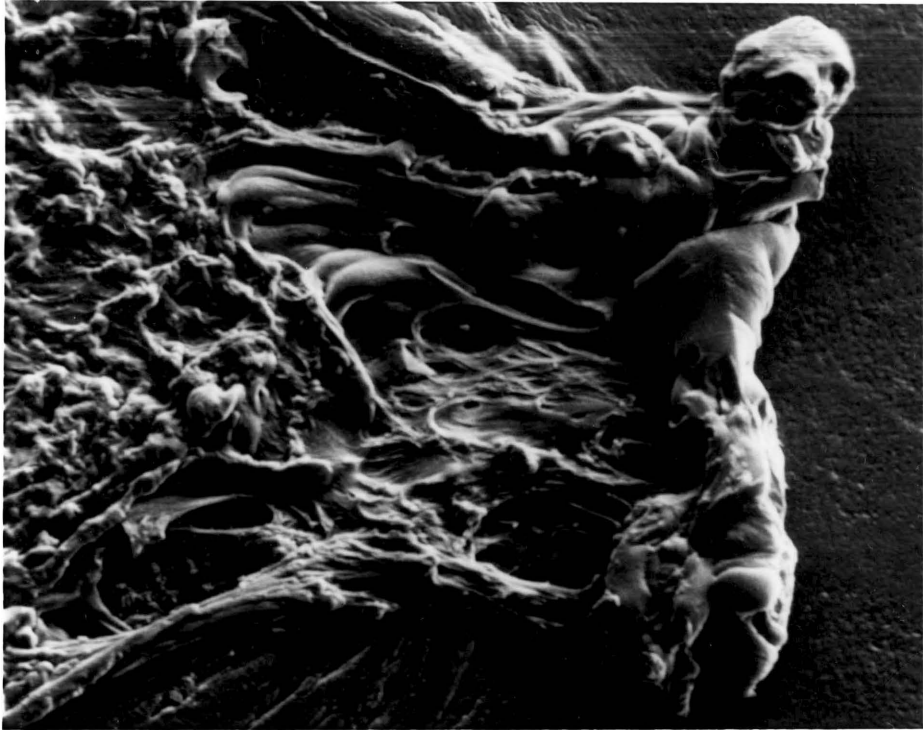
FIGURE 4-47. Scanning Electron Micrograph of PVDC Test 1 Disk Scar (Magnification: 200X).

The disk scar is fairly elliptical in shape and polymer that has been removed from the interface can be seen at each end of the scar. At the right of the scar a "roll" of polymer debris can be seen. Also note the peculiar structure of the polymer surface. Figure 4-46 is a SEM photograph of the disk scar which shows the detail of the scar surface. The scar interior has a rough texture, being slightly smoother at the center region. The indented region of the scar appears to be slightly larger than the roughened region. Stretch marks can be seen at the ends of the scar on the periphery. Figure 4-47 is a higher magnification photograph of one of the scar ends.

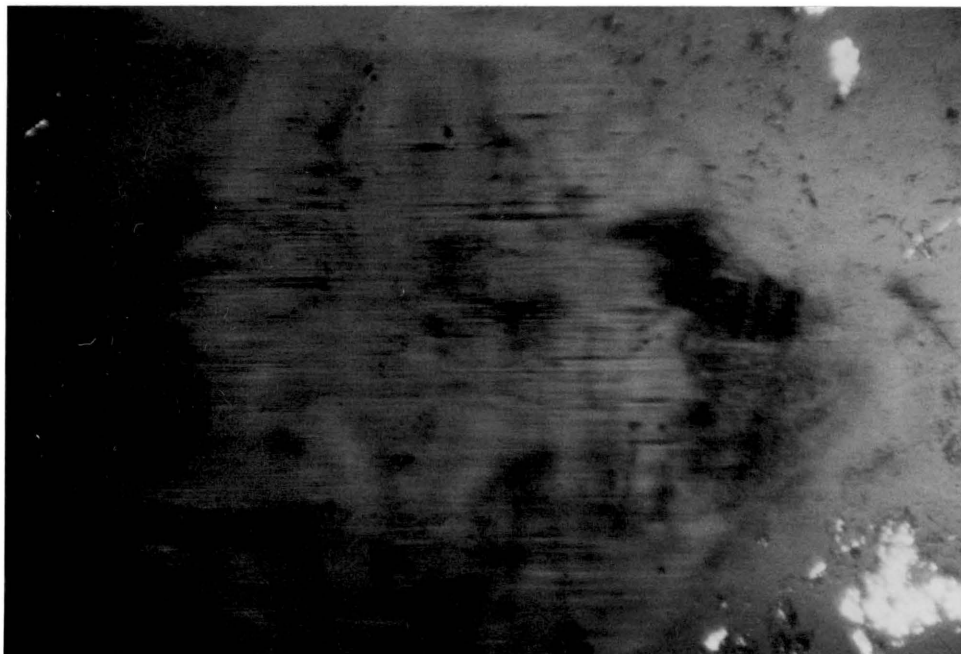
FIGURE 4-63. Optical Macrograph of PSO Test 1 Ball Scar (Magnification: 60X).

Test 1 ball and disk scars (15 minutes run time, no metallic contact) are presented in Figures 4-63 and 4-64. The ball scar is shown at a higher magnification than the disk scar. The ball scar has an unusual shape and shows evidence of grooving in the sliding direction. Fine particulate brown debris can be seen within the scarred region. Highly reflective polymer debris can be seen scattered around the periphery of the scar.

The disk scar is shown in Figure 4-64. Note the light hour-glass shaped region around the contact area. The contact region shows a peculiar brown ridge structure. The ridges are oriented perpendicular to the sliding direction. Referring back to the ball scar (Figure 4-63), the pattern of the scarred region on the disk can be recognized.

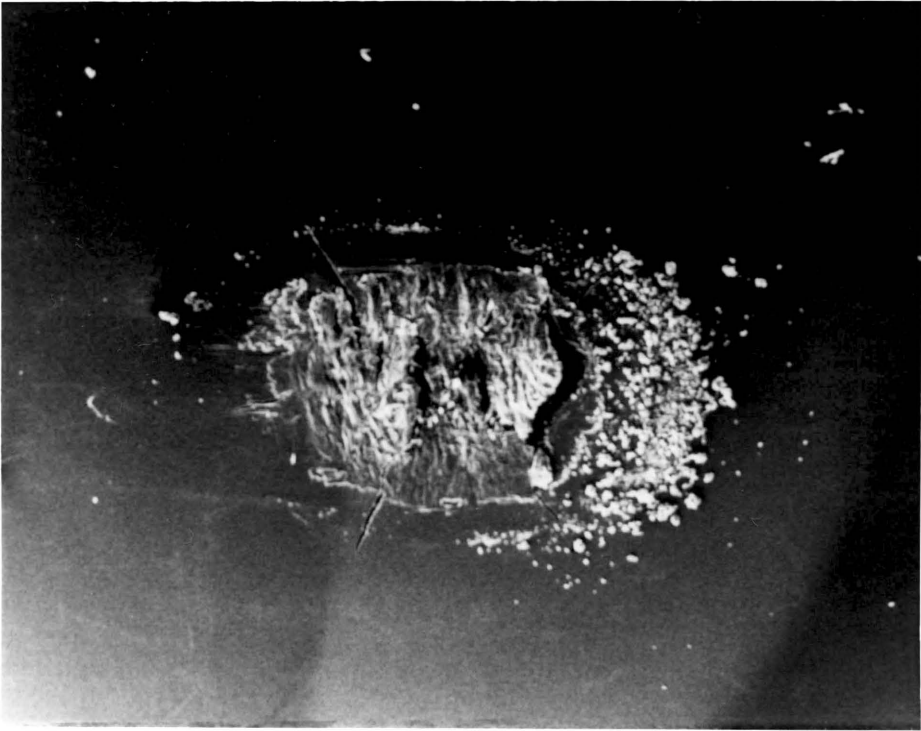
FIGURE 4-74. Scanning Electron Micrograph of PS Test 1 Disk Scar (Magnification: 20X).

than elliptical. A large portion of the scar interior is white in color, contrasting with the undamaged gray surface. This area seems to be composed of ridges which are oriented perpendicular to the sliding direction. Four cracks can be seen at the edges of the scar. Figure 4-74 is a SEM photograph of the disk scar which provides a more detailed view. The damaged region appears to be very rough and there is little evidence of penetration by the ball. A large crack can be seen at the right end of the scar. Large debris particles can also be seen at the right end of the scar. Figure 4-75 is a high magnification micrograph of the central region of the disk scar. As can be seen, the surface is indeed very rough and has a layered appearance.

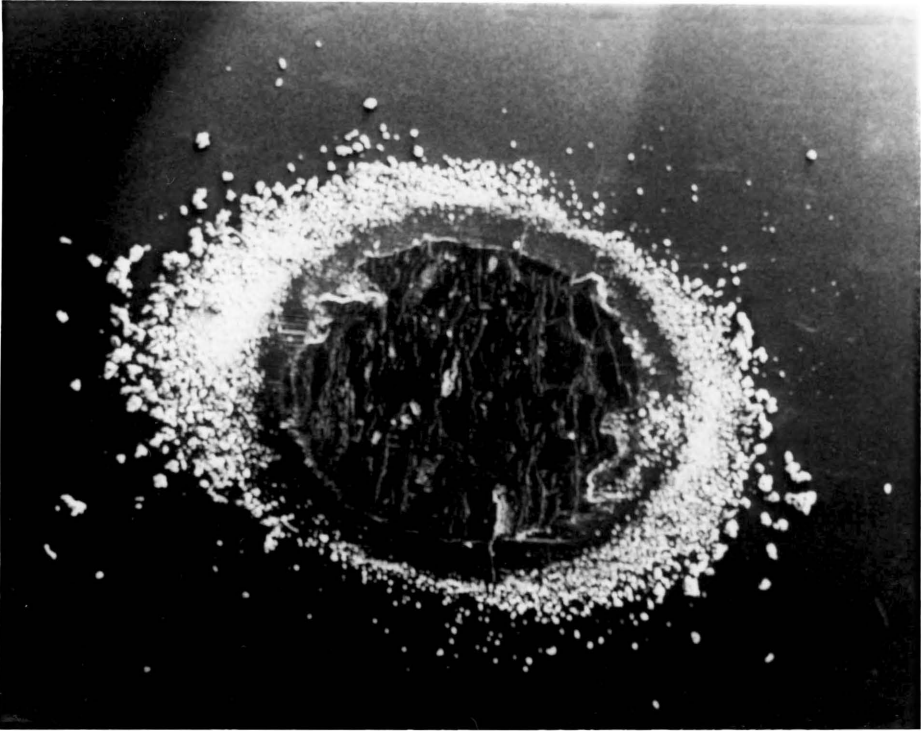
FIGURE 4-77. Optical Macrograph of PS Test 3 Disk Scar (Magnification: 37.5X).

Test 3 ball and disk scars are presented in Figures 4-76 and 4-77 (45 minute run time, no metallic contact). The ball appears to be undamaged. The scar is similar to the Test 1 scar with the exception that there is more polymer debris and it is more evenly distributed around the contact zone. Notice that most of the debris is piled at the scar ends. Large debris particles are only found at the ends on the outside of the debris pile.

The disk scar shows less of the white regions seen in Test 1. Reflective particles can be seen within the scar. Figure 4-78, a corresponding SEM photograph, illustrates the scar structure. The scar is almost perfectly elliptical in shape and the central region appears to be smoother than the Test 1 scar. Note that the debris is more heavily concentrated at the ends and is displaced from the damaged region by a small amount. Figure 4-79 is a higher magnification shot of the scar center showing that the surface is much smoother than the Test 1 scar.

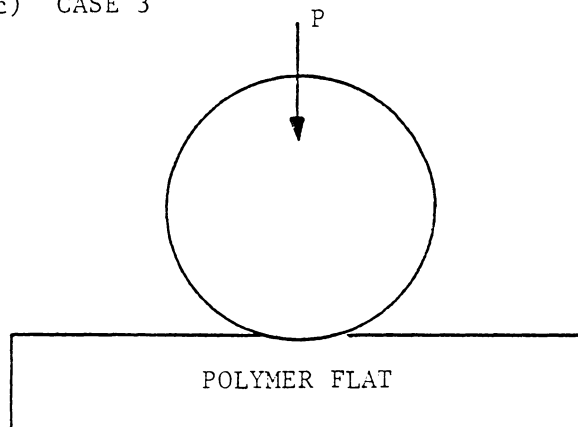
FIGURE 5-1. Possible Contact Geometries: (a) Steel Sphere-on-Steel Flat; (b) Steel Sphere-on-Polymer-Coated Flat; and (c) Steel Sphere-on-Polymer Flat.

In the first stage, static normal loading, the contact geometry can fall into one of the three categories which are illustrated in Figure 5-1. The first, Figure 5-1(a), is only valid if the thickness of the film is less than the surface roughness of the disk upon which it is coated. In this case, stresses at the interface are accurately predicted by classical Hertzian theory for a steel sphere on a steel half-space. The second case, Figure 5-1(b), considers the effect of a layered half-space which has been studied by Matthewson (33), considering only elastic deformation. In the third case, shown in Figure 5-1(c), the thickness of the film is sufficient to eliminate the effect of the rigid substrate on the stresses within the layer and Hertzian theory again applies, considering the steel sphere to act on a semi-infinite half-space of the polymer film material.

The first case is not applicable to this work because all of the film thicknesses were larger (by at least a factor of four) than the surface roughness of the disk. Since the system will obviously be described by either the second or third case, a method must be devised to distinguish between them. Matthewson (33) states that for values of $a/h < 1$ (where a is the Hertzian contact radius and h is the film thickness), stresses at the interface will be accurately predicted by considering the third case and Hertzian theory. For values of $a/h > 1$, stresses within the layer and at the interface can be predicted by the theory developed (however not completely published) by Matthewson.

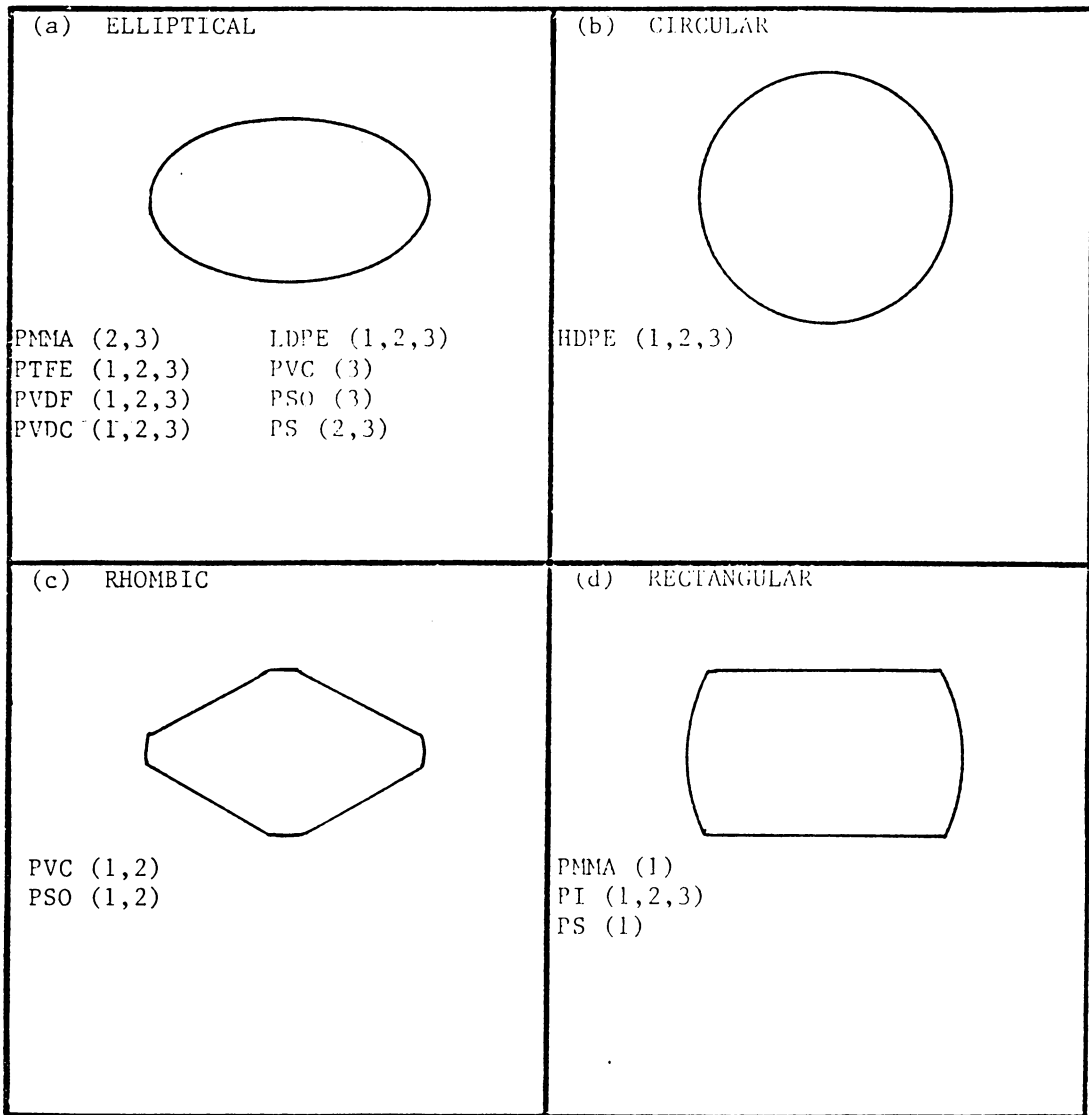
FIGURE 5-3. Various Scar Shapes Observed on Polymer-Coated Disks in Fretting Tests Run at 22.3 N Normal Load. (Test Numbers in Parentheses Refer to Fretting Behavior Test Run Times Presented in Table 4-2).

each polymer type. Four different types of shapes: elliptical, circular, rhombic and rectangular were noted and are summarized in Figure 5-3 along with the polymers that developed each shape. The difference in scar shapes suggest complex physical phenomena--a definite source for future study. It is also believed that these shapes could provide valuable insight as to the behavior of the films studied.

It is also important to note that the scar shape is a function of run time. Examination of Figure 5-3 shows that for several of the polymers, the shape of the scar changed with increasing run time. For example, PMMA Test 1 scars (5 seconds run time) were rectangular in shape while the Test 2 and Test 3 scars (33 and 60 seconds run time, respectively) were elliptical in shape. This effect may be explained by the fact that penetration of the ball into the polymer film is not constant throughout a test for these polymers. As penetration increases, leading to film failure, the pattern of the scar will change.
