The Feasibility of Recycling CCA Treated Wood From Spent Residential Decks

Masters Thesis submitted to the Faculty of Virginia Polytechnic Institute and State University at Blacksburg, Virginia in partial fulfillment of the requirements for the degree of:

Wood Science and Forest Products

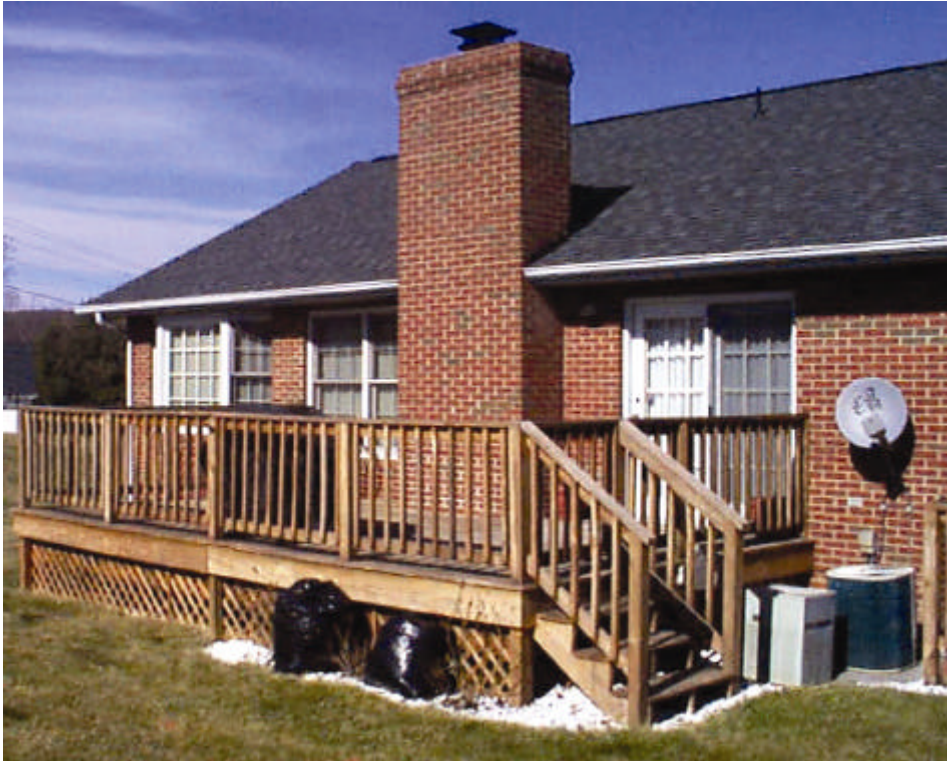
Figure 2- 1. Deck #1 while in-service.

The average size prior to removal of all decks obtained for this study were 220 square feet. Table 2.3 displays the sizes of each deck prior to removal. The deck sizes in this study are similar to other studies (Alderman, 2001), which found the average size of a deck removed in the North Carolina, Georgia, and South Carolina, in 1999, was 199 square feet. A picture of each deck obtained for this research is located in Figures 2-1 through 2-6.

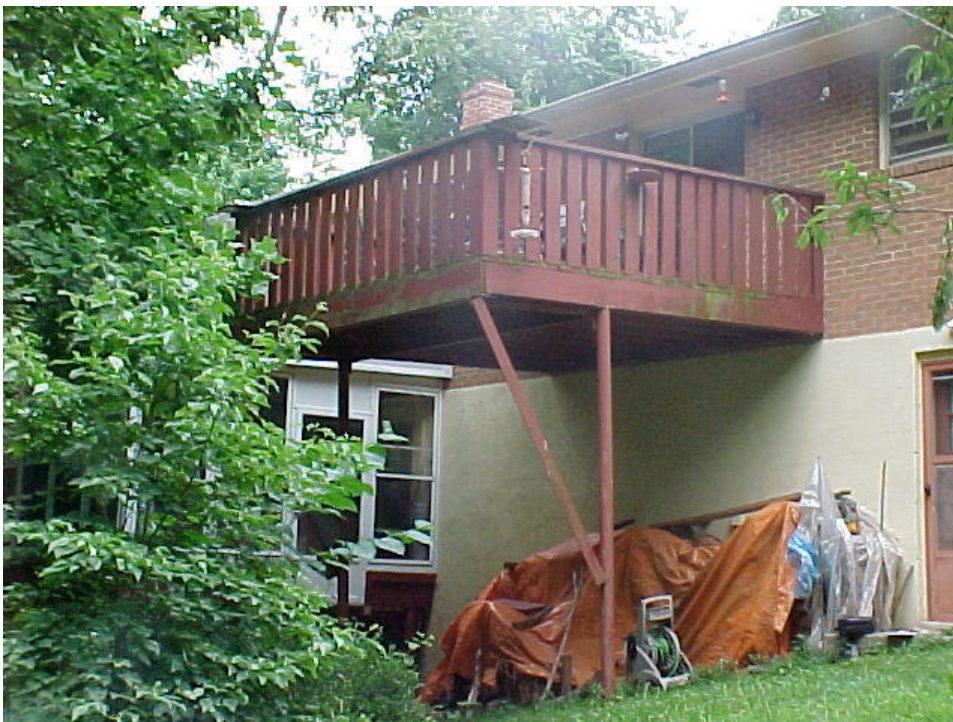
Figure 2- 2. Deck #2 while in-service.

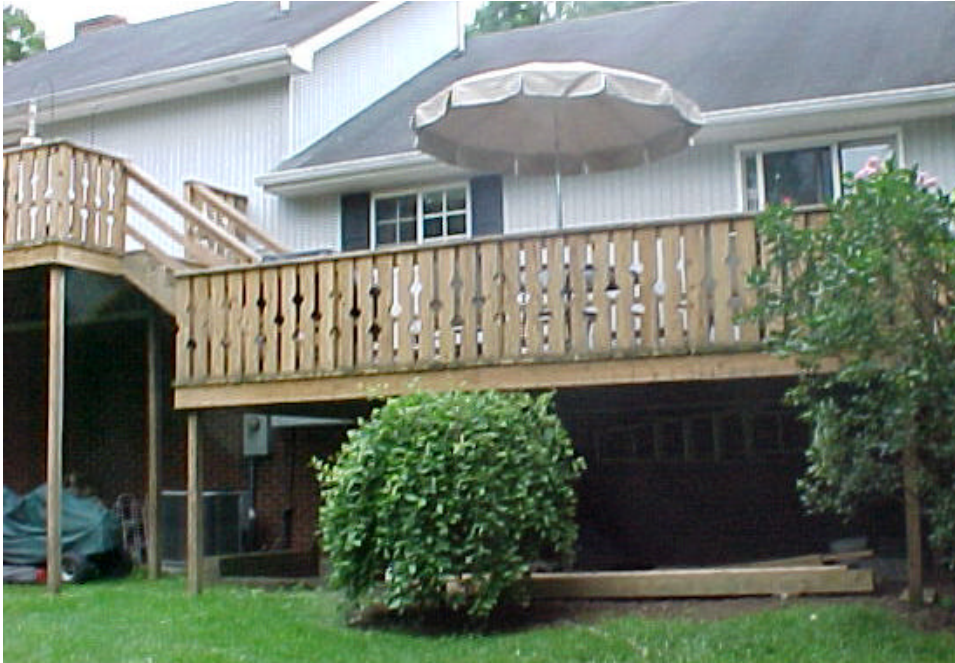
Figure 2- 3. Deck #3 while in-service.

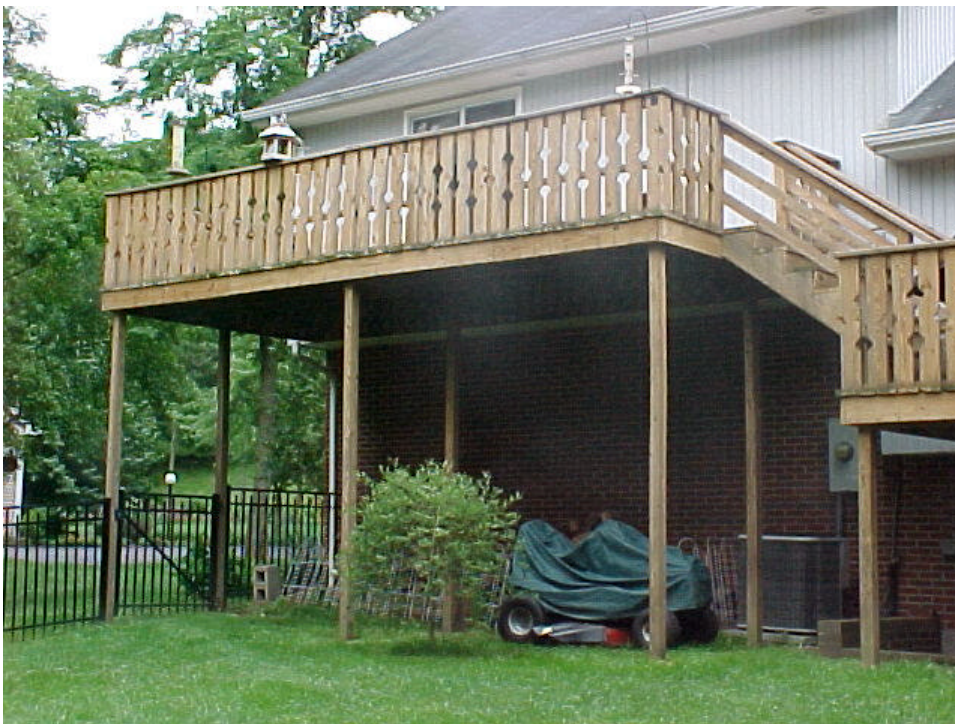
Figure 2- 4. Deck #4 while in-service.

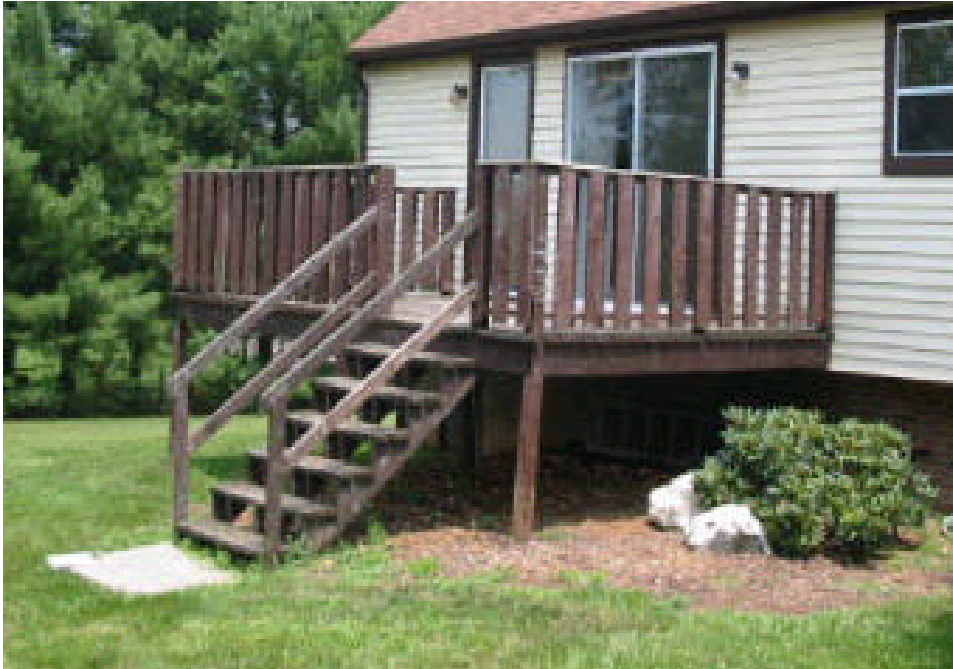
Figure 2- 5. Deck #5 while in-service.

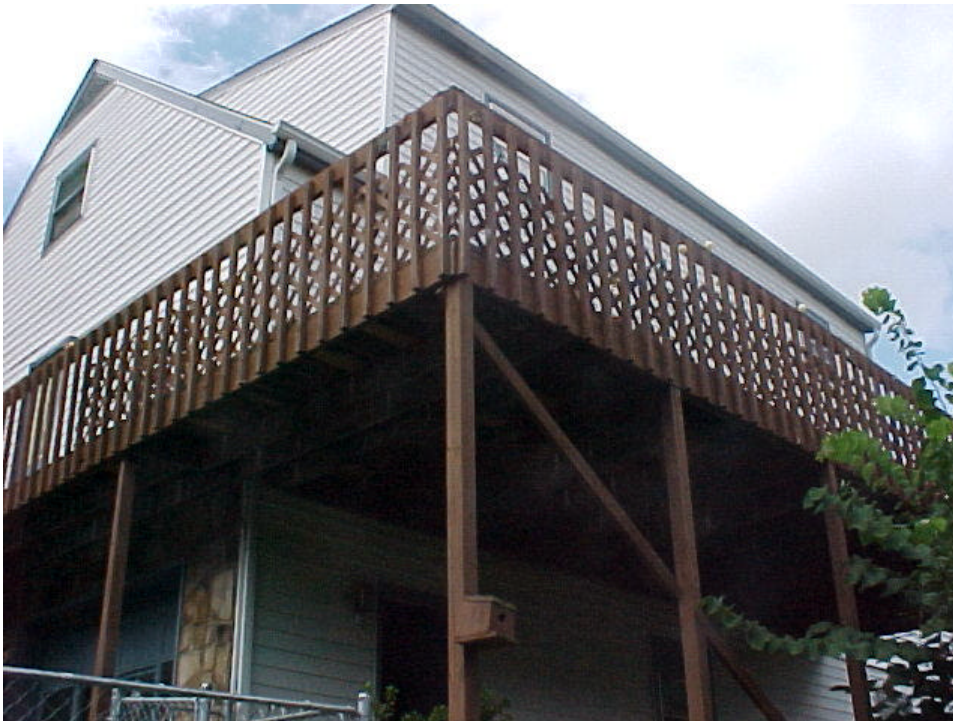
Figure 2- 6. Deck #6 while in-service.

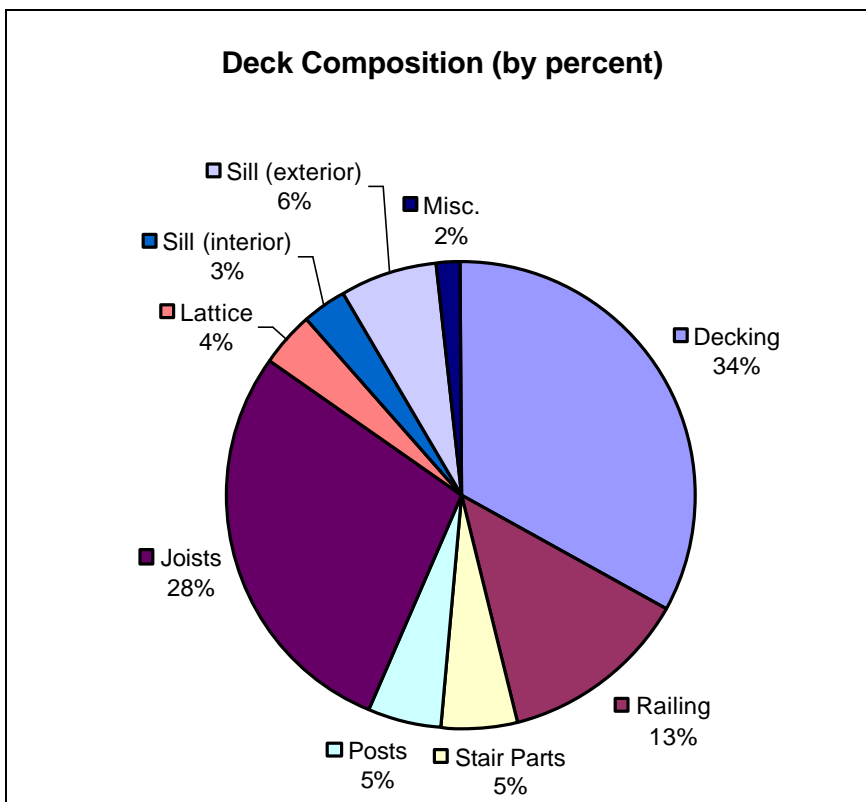
Figure 2- 9. Deck No. 1 composition by percent while in-service.

Deck No. 1 took approximately 9 worker-hours to demolish by the employees of the building contractor, and then an additional 13-3/4 worker-hours to remove the hardware and stack the material according to dimension. The hardware consisted of 3-1/2" and 2-1/2" spiral shank nails and joists hangers, and the total weight of the hardware remove from the deck was 24.4 lbs. It was assumed that this was not the total amount of hardware in the deck, because during demolition hardware could have been removed and not remained with the rest of the removed material. The removal of unusable parts of the lumber took 1-1/2 worker-hours. The total amount of time needed to recover the CCA treated wood from Deck No. 1 was 24.25 worker-hours. The composition of Deck No. 1, while in-service, is located in

Figure 2-9. As expected the decking (5/4" RED) and the joists (2"x8" and 2"x10") comprise the majority of the deck volume, over 60%. The volume of lumber after demolition and that is reusable was then obtained. A picture of the CCA treated wood recovered in Deck No. 1 after the hardware and unsuitable portions were removed is located in Appendix C. Table 2-4 displays the volume of material in-service, after demolition, and finally the volume of the deck that can be reused from each type of material and the percent of material usable after demolition.

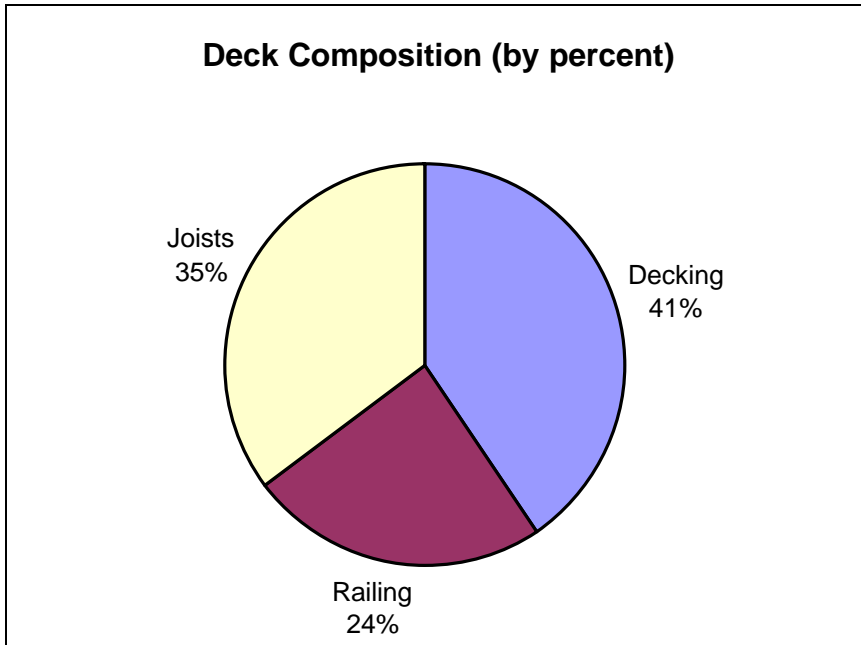
Figure 2- 10. Deck No. 2 Composition by percent while in-service.

The composition of Deck No. 2, while in-service, is located in Figure 2-10. As expected, the decking and joists were the majority of the deck, especially since the posts were not used. The volume of CCA treated wood composing the deck while in-service, after demolition, and recovered is located on Table 2-5. From a total of 531 board feet of CCA treated wood from Deck No. 2, 94%, or 501, board feet were recovered. The 2x4s and 1x6s increased in volume between being in-service and then recovered. This increase is due to the 1x6s and 2x6s that were ripped during the recovery process into narrower boards. Also, the percentages are misleading because this material represents a small percent of the total deck volume. The joists and the deck were recovered the best, resulting in 94% of the material retained from the deck while in-service. The 1x6s, used mainly in the railing, were the least recovered material, since only 77% of that material could be recovered. More unusable CCA

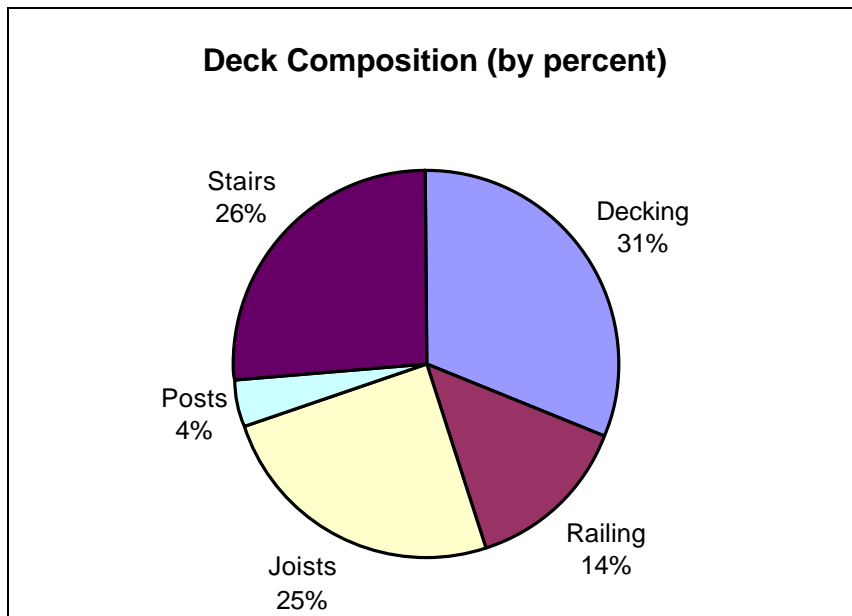
Figure 2- 11. Deck No. 3 composition by percent while in-service.

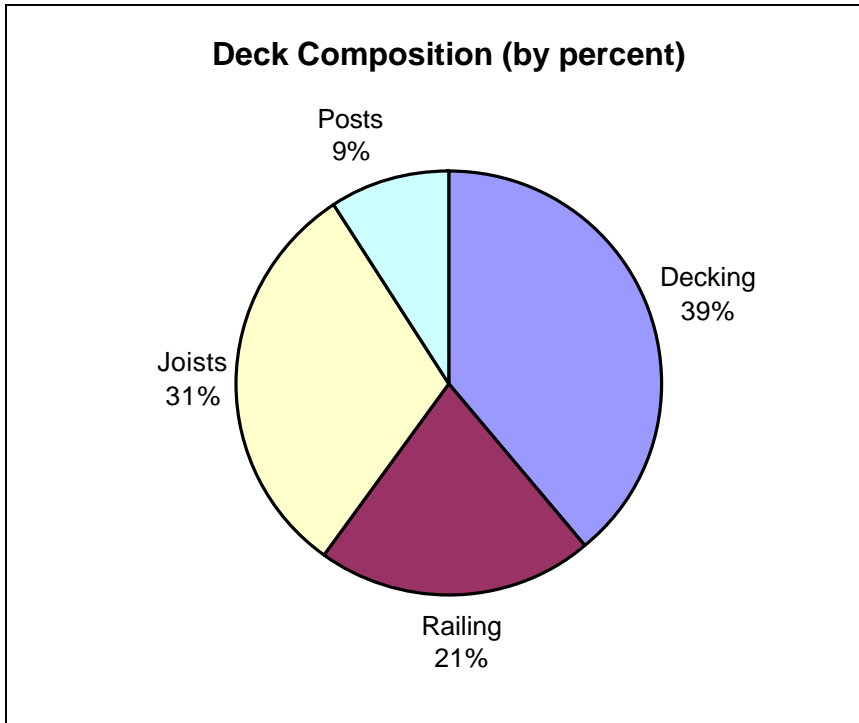
Figure 2- 12. Deck No. 4 composition by percent of component volume, while in-service.

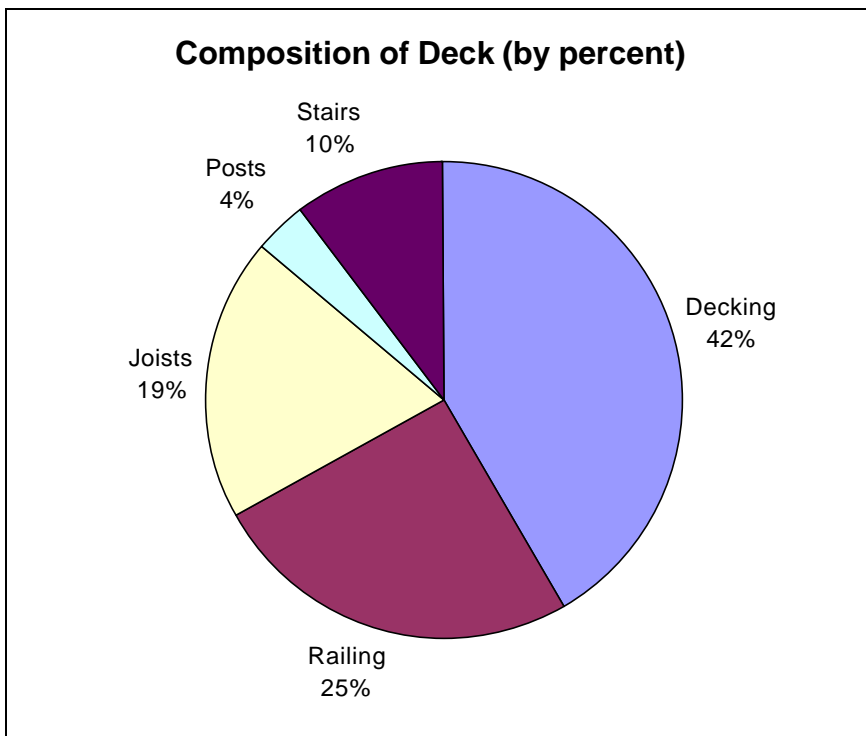
Figure 2- 13. Deck No. 5 composition by percent of component volume, while in-service.

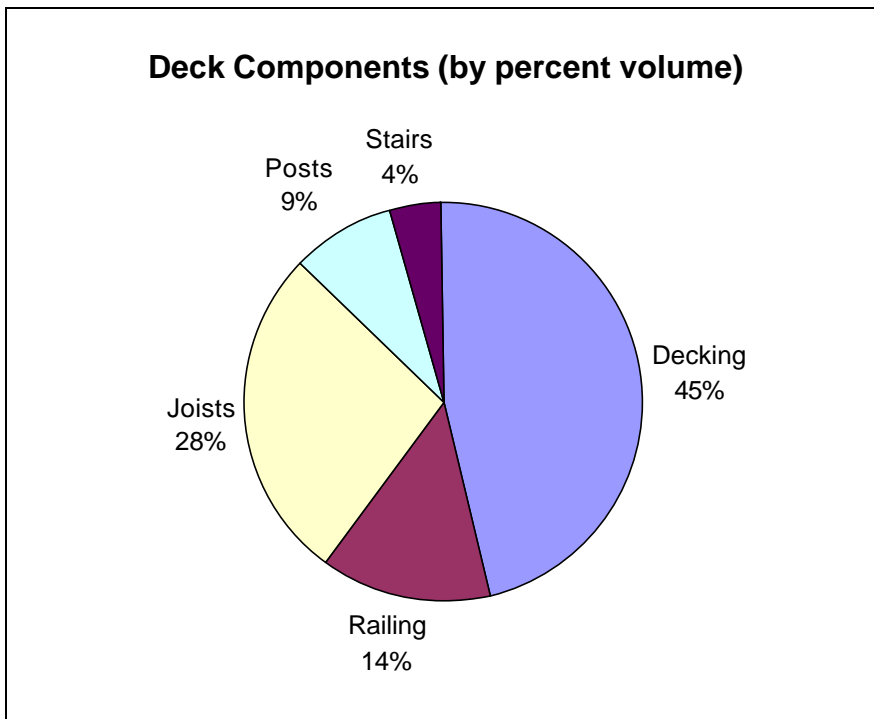
Figure 2- 14. Deck No. 6 composition by percent of component volume, while in-service.

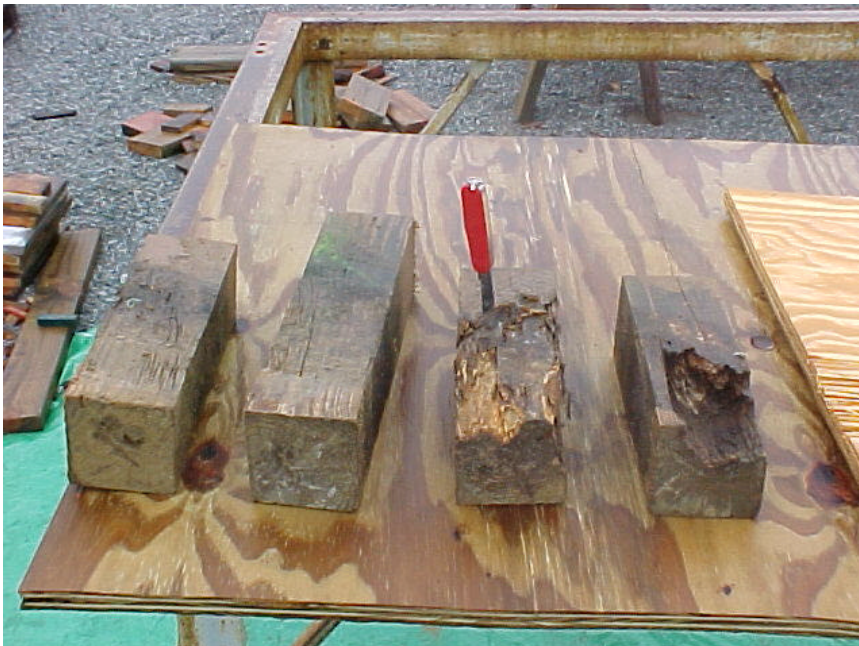
Figure 2- 15. Decayed portion of 4x4 posts of Deck No. 6 that were in ground contact while in-service.

The removal of unusable material had a larger affect than the demolition of the deck. After demolition 2.5% of the original material could not be recovered, and 5.6% of the CCA treated wood was unusable after unfeasible parts of the recovered wood was removed for future reuse. Decay of the wood was a large factor in the difference in loss of reusable CCA treated wood. As shown in Figure 2-15 the areas of the CCA treated wood that were in ground contact were decay severely, causing larger areas to be trimmed off of the CCA treated wood, in order for reuse.

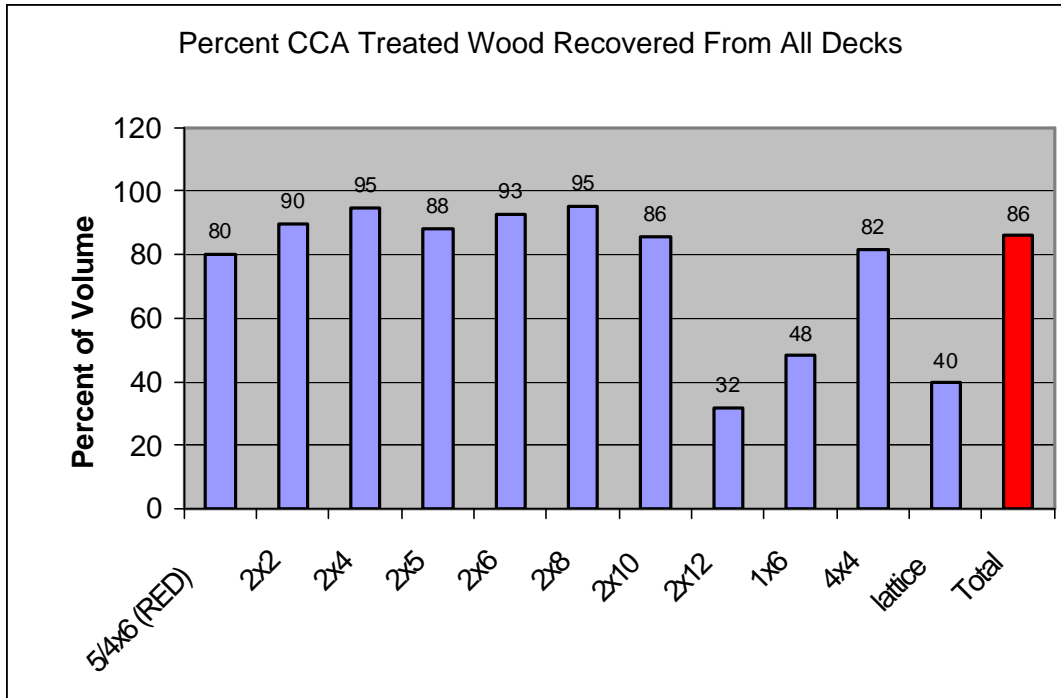
Figure 2- 16. Percent recovery of various CCA treated wood products from residential decks.

received from decks and recovered. This is expected since the decks in this study consisted of 40% decking. The most successful materials recovered were the 2x8s and the 2x4s. The success of recovering the 2x8s, which were predominantly joists, is due to the lack of exposure to weathering and physical wear. The fact that the 2x4s were recovered effectively is due to the ripping of wider material into 2x4s. It must be acknowledged that the volume of 2x4s was low and this might not be an accurate representation of the recovery success of this material. Only after obtaining a higher volume of 2x4s from a deck can that conclusion be stated. The information from Table 2-13 and Figure 2-16 indicate that the 2x6s, and 2x8s were highest volume of material received from the spent CCA treated residential deck and they also were the best material to recover.

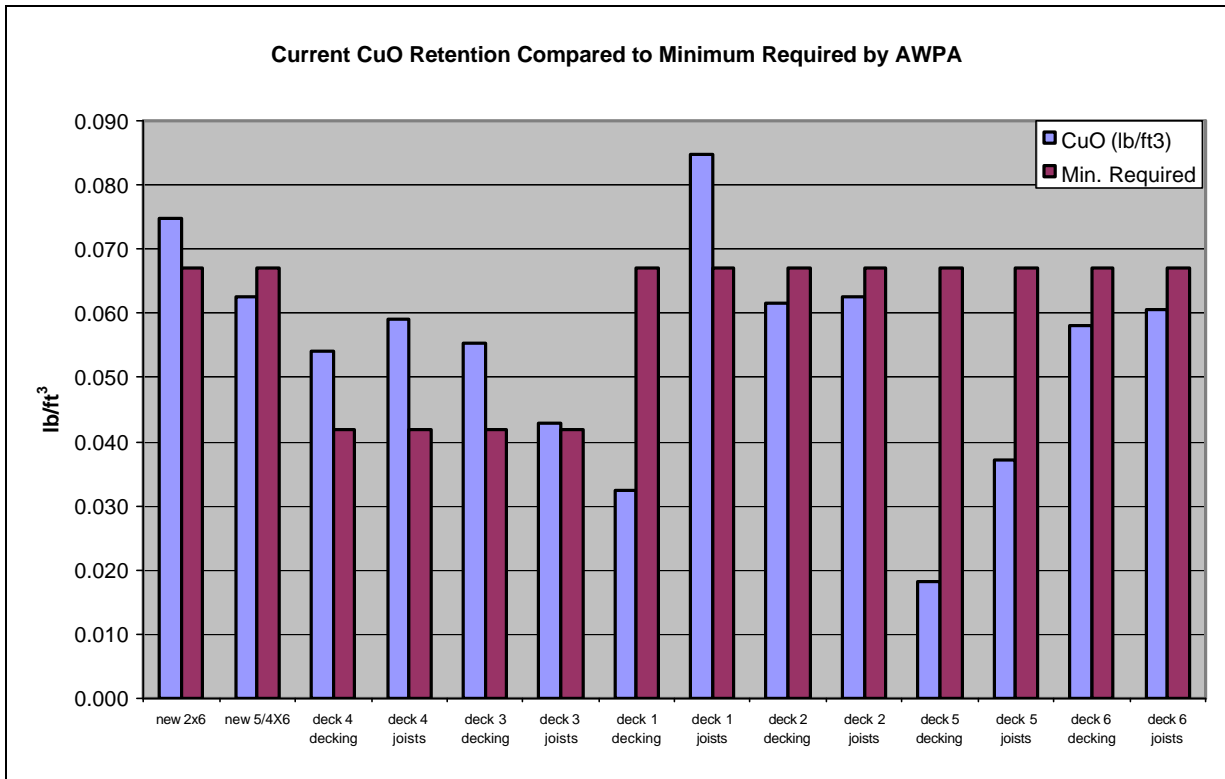
Figure 3- 1. Copper retention in all samples from chemical assay.

The copper retention levels of the decking and joists of the six decks removed and the recently treated 5/4x6 and 2x6 lumber is located in Figure 3-1. As shown, the recently treated 2x6 was above the minimum requirements, but the 5/4x6 was slightly below. The joists and decking of Deck No. 3 and No. 4 along with the joists of Deck No. 1 were above

the required minimum levels set by the AWWA. Both the joists and decking for Deck No. 5 were well below the minimum standards for recently treated wood, but Deck No. 5 was grade stamped mixed pine. Therefore, other species, such as Virginia or pond pine, could have an affect on the treatability and thus the retention levels. The decking of Deck No. 1 was extremely lower than the joists of the same deck, as shown in Figure 3-1. No explanation is known why this occurred, and further analysis will determine if this trend is true for all CCA chemicals. Overall, the joists and decking for just two of the decks retained or originally contained the required minimum level of copper. There seems to be no relationship of the age of the deck, shown in Table 3-2, to the retention of copper in the decks. Deck No. 2 was the deck that was in-service the longest and had similar or better copper retention compared to the other decks.

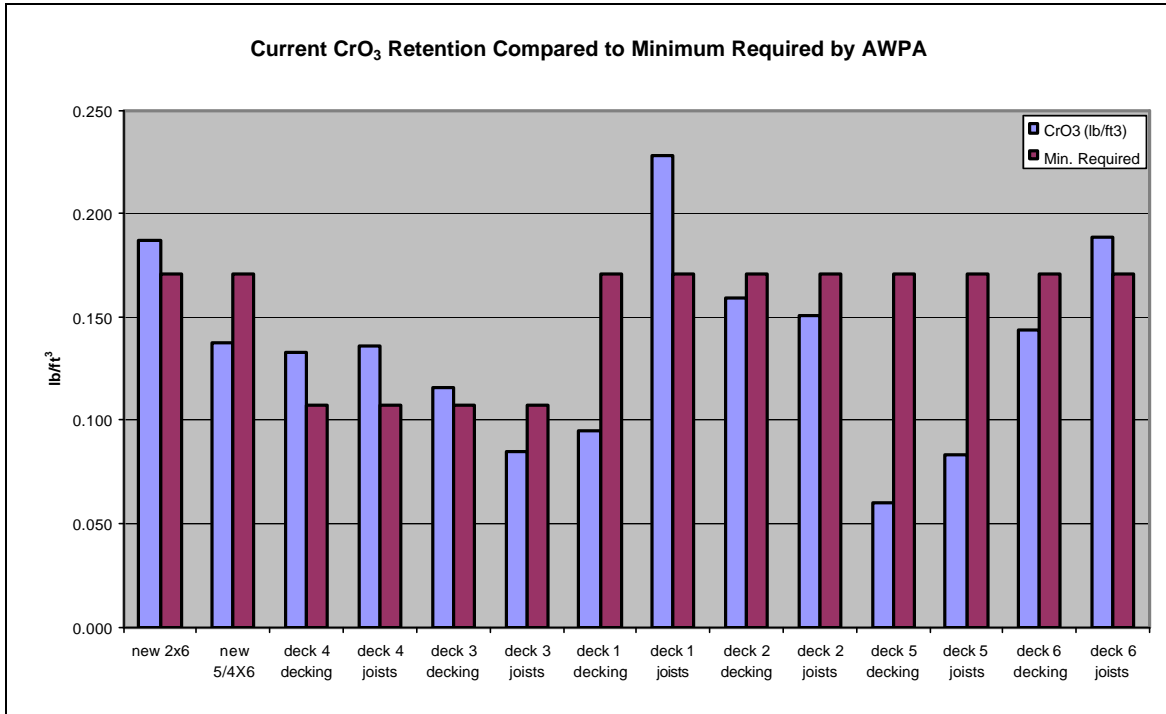
Figure 3- 2. Chromium retention in all samples from chemical assay.

The results of chromium retention follow a similar trend to that of the copper retention of the same samples. As shown in Figure 3-2, the recently treated 2x6 samples had a higher than required chromium content, in lb/ft^3 , and the 5/4x6 samples had lower than required retention level. As with the copper retention, the chromium retention for the decking and joists of Deck No. 4 were above the minimum requirements. The decking for Deck No. 3 was above the minimum required but the joists were below required retention levels. As with the copper retention the joists of Deck No. 1 were well above the minimum standards for chromium. The samples from Deck No. 5 have extremely low levels of chromium, as with copper, and may be due to the potential amount of mixed pine that was in the sample that influenced the retention when the wood was treated years ago. The retention of chromium in the samples from the deck material does not appear to be influenced by the age of the deck. Deck No. 2 had the longest service time and the retention of the samples from the deck performed similar or better than most of the other chemical assay samples from the other decks.

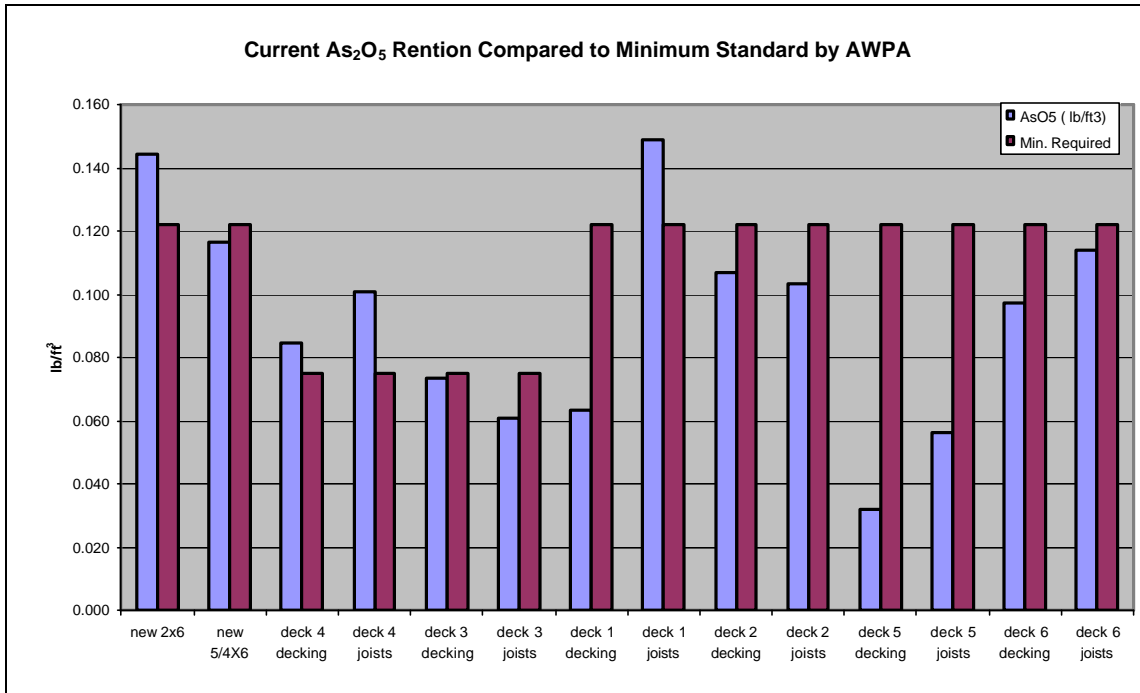
Figure 3- 3. Arsenic retention in all samples from chemical assay.

As with the retention of the copper and chromium, the arsenic retention of the samples from recently treated wood and CCA treated wood from residential decks followed a similar trend. The recently treated 2x6 samples were well above the minimum requirements, but like the copper and chromium levels, the retention for the 5/4x6 were slightly below required standards as shown in Figure 3-3. Deck No. 4 samples from both the decking and joists were above minimum requirements. The samples tested from the joists of Deck No. 1 were well above the required lb/ft³ of arsenic, similar to the data obtained on the copper and chromium levels. Again, Deck No. 5 was well below the minimum standard obtained by chemical assay. A majority of the arsenic retention levels are below the requirements by AWPA for all the six decks samples tested, but the recently treated 5/4x6 samples were also below the minimum required. Therefore, the low retention of arsenic in the deck samples

might not be an indication of chemicals leaching, but rather low initial retention from the original pressure treating process.

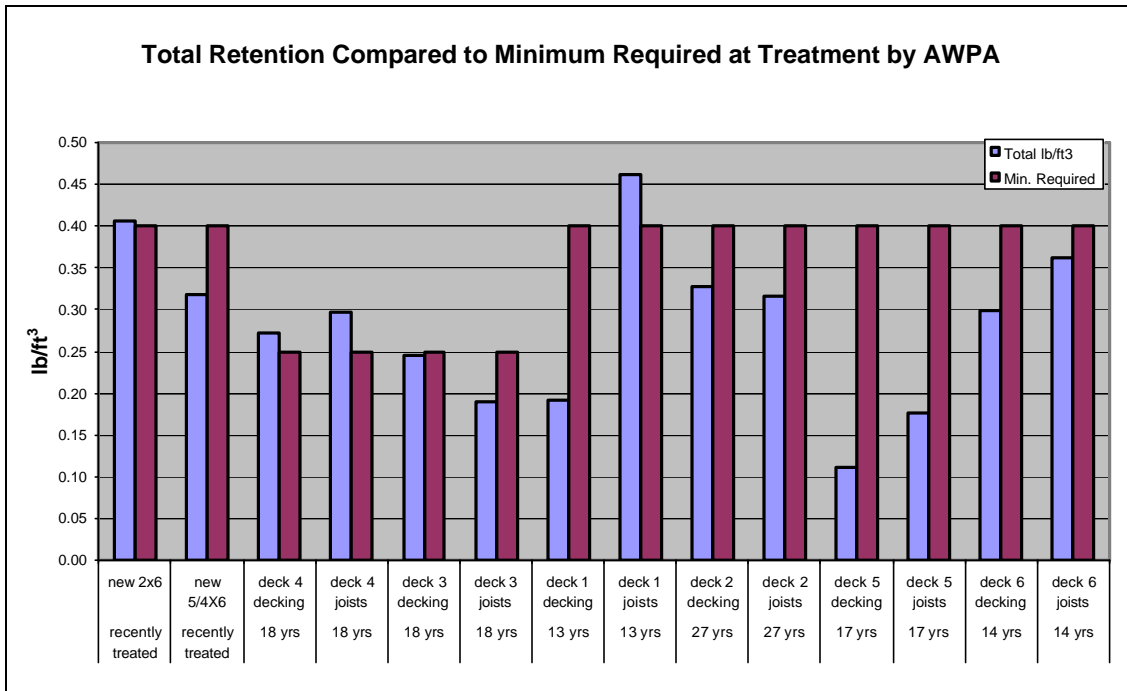
Figure 3- 4. Chemical assay of chemicals in the CCA treated wood samples taken from removed decks.

The service time of the decks in this sample did not have an effect on the retention level. As seen in Figure 3-4 there appears to be no correlation between amount of time in service and retention levels lower than the minimum required. Other factors, such as lower than required retentions during the pressure treatment process and environmental conditions while the decks were in-service, could have been larger influences on the retention of preservative treating chemicals.

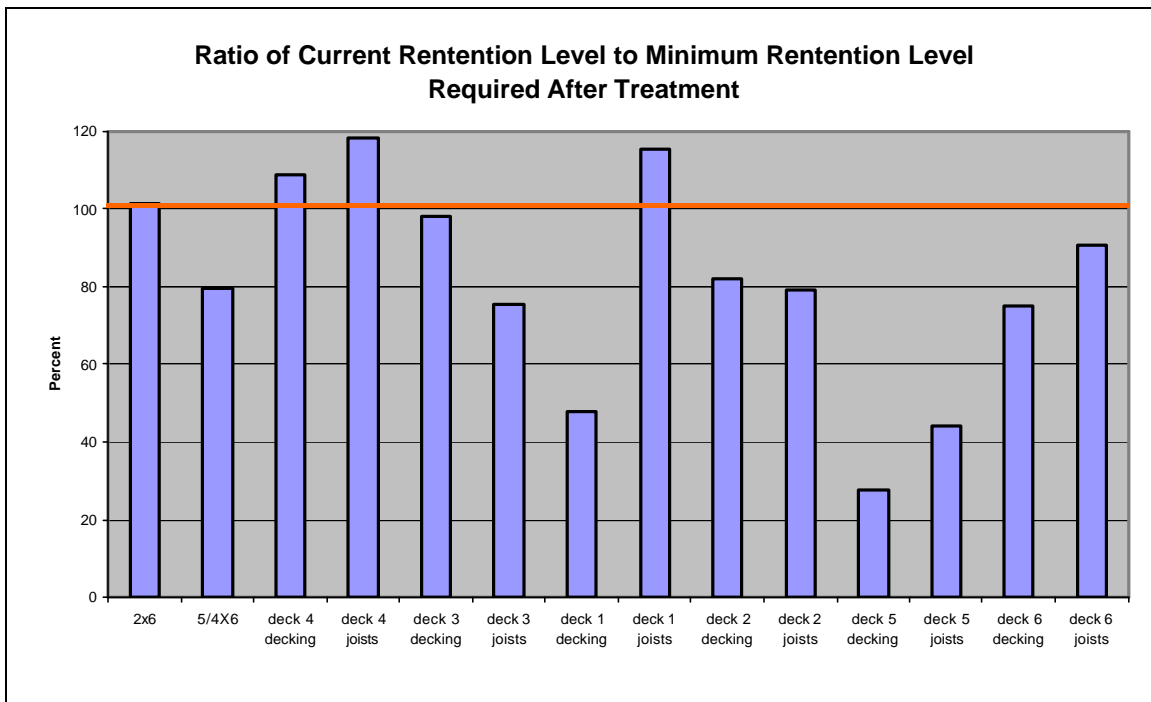
Figure 3- 5. Ratio of actual chemical retention to required chemical retention of chemical assay samples.

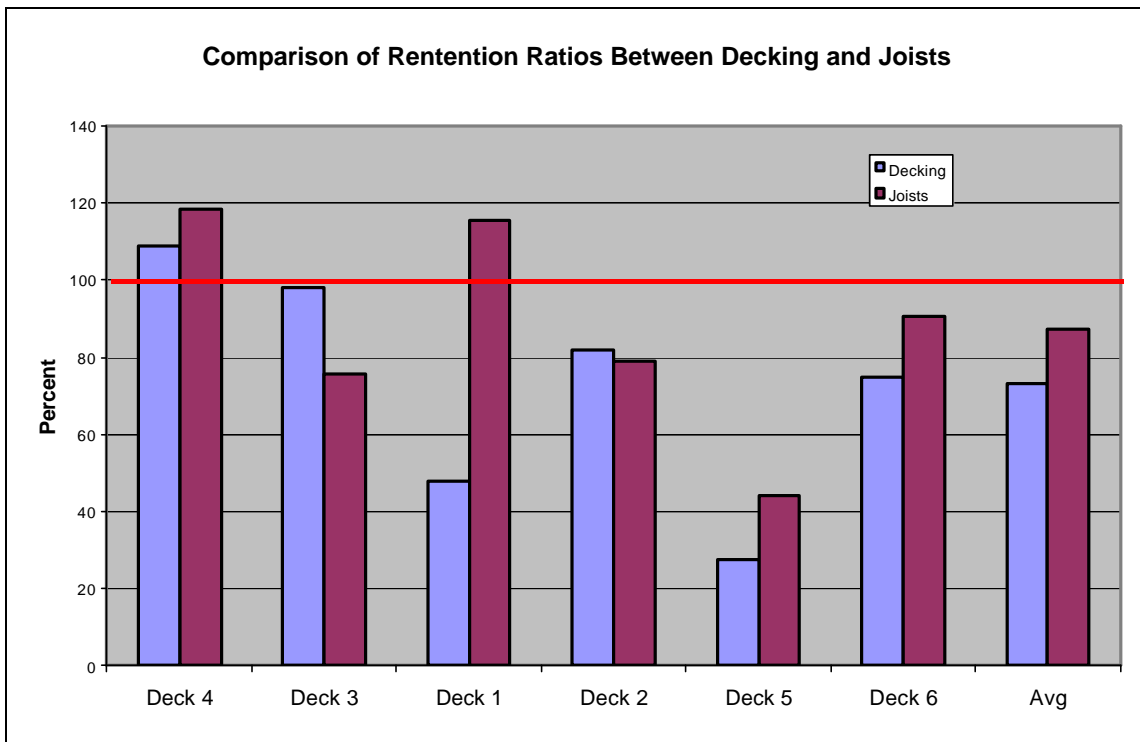
Figure 3- 6. Comparison of chemical assay samples from decking and joists of the removed decks.

From chemical analysis, the samples from the joists had, on average, a higher chemical retention compared to the samples from the decking of the six removed residential decks. The average retention of the chemical assay samples from the decking was .26 lb/ft³, and was .301 lb/ft³ from the joist samples. As seen in Figure 3-6, the joists chemical assay samples, on average, were approximately 15% below the minimum required chemical retention after preservative treatment. The decking samples, on average, were approximately 30% below the minimum required chemical retention after preservative treatment. Lack of physical and environmental exposure of the joists compared to the decking could be factors affecting the difference in preservative chemical retention, or there could have been a large amount of random variation due to a small sample size.

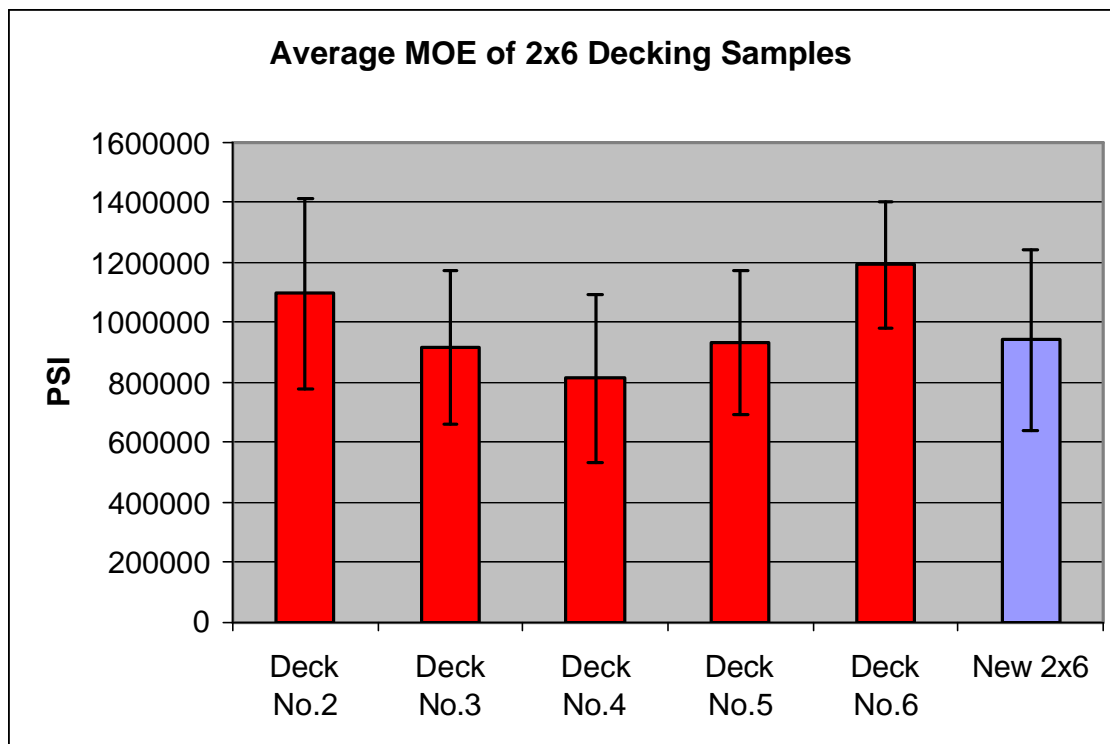
Figure 3- 7. Average and range of the MOE data from the 2x6 decking and recently treated sets.

* Darker bars represent samples that are statistically equal or greater than the new 2x6 data.

The Shapiro-Wilk normality test was performed and concluded all the MOE data from the 2x6 decking samples sets were normally distributed at an alpha level of 0.10. Figure 3.7 represents the average MOE of each 2x6 sample set, with error bars representing a range of twice the standard deviation. This type of error bar was used because it represents 95% of the cases from the mean of a normal distribution (SPSS, 2001). Analysis of Variance indicated that there are significant differences between the sample sets. Therefore, Tukey's HSD multiple comparison was performed and found that the MOE data from Deck No. 2, 3, 4, and 5 were statistically equal to the recently treated 2x6 samples. The MOE data from Deck No. 6 was found to be statistically greater than the recently treated material.

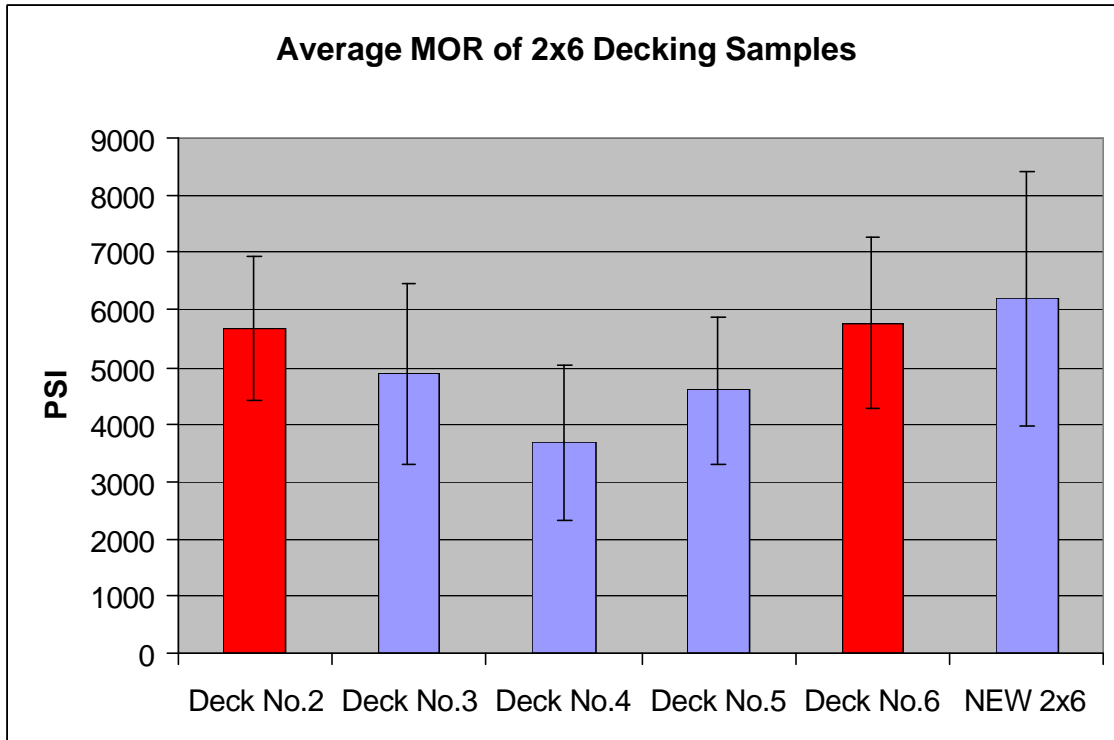
Figure 3- 8. Average and range of the MOR data from the 2x6 decking and recently treated sets.

* Darker bars represent samples that are statistically equal to the new 2x6 data.

Figure 3-8 displays the average MOR from each set and the range of the values from the mean. Analysis of Variance was conducted on the six sets and concluded that statistical differences exist between the MOR values at an alpha level of 0.05. Tukey's HSD multiple comparison was performed and the MOR values from Deck No. 6 and 2 were statically equal to the recently treated deck material. The multiple comparison test also found that the samples from Deck No. 3, 4 and 5 had statistically lower MOR values than the recently treated 2x6 decking.

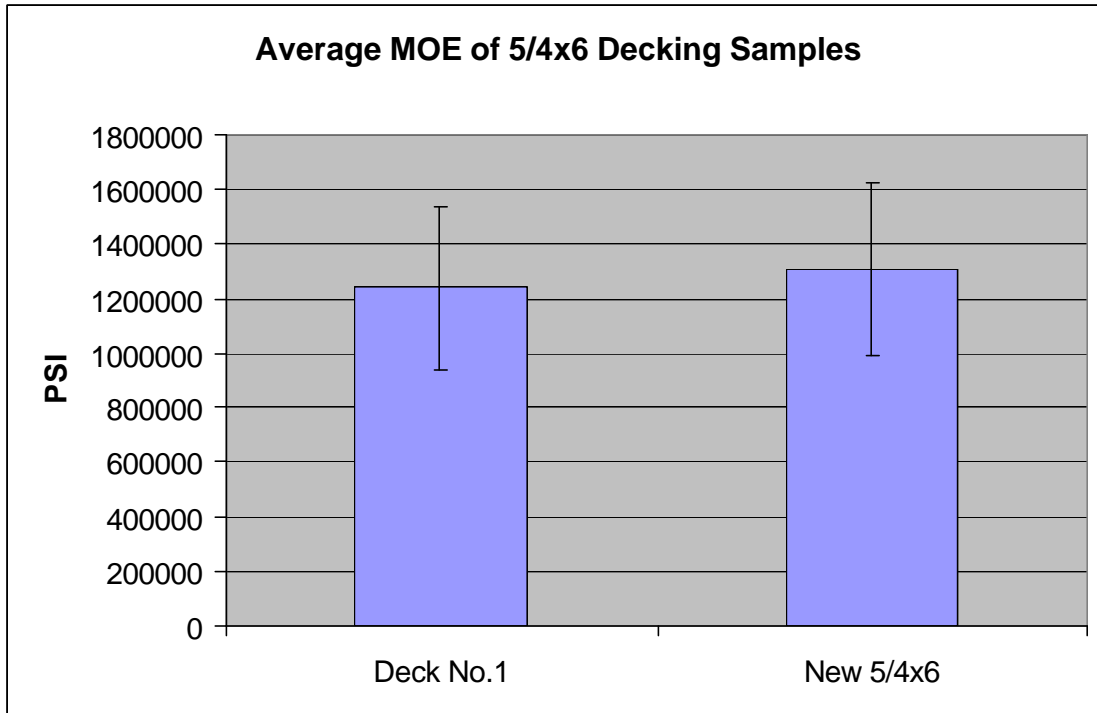
Figure 3- 9. Average and range of the MOE data from the 5/4x6 decking and recently treated sets.

A Shapiro-Wilk test of normality was performed on the two samples sets and both were normally distributed at an alpha of 0.10. Figure 3-9 displays the average and a range of both sample sets. After an independent t-test was performed, the samples were found to be statistically equal at an alpha level of .05.

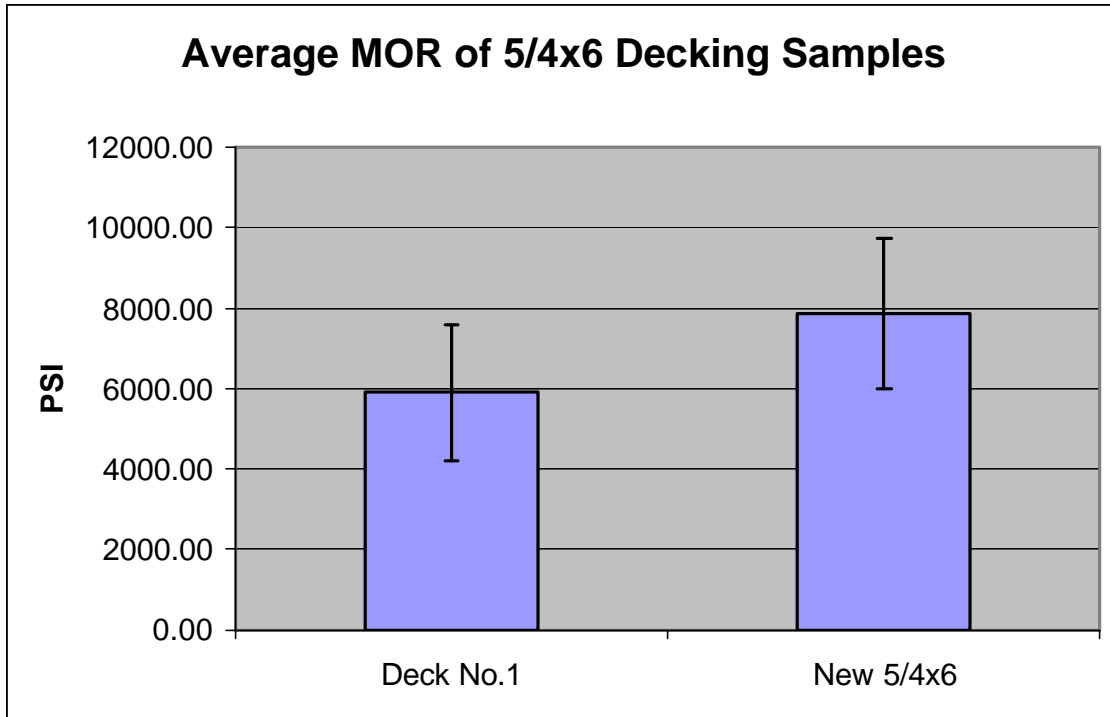
Figure 3- 10. Average and range of the MOR data from the 5/4x6 decking and recently treated sets.

The Shapiro-Wilk test for normality concluded that both sample sets were normally distributed at an alpha level of 0.10. The average and range of both sample sets are located in Figure 3-10. The independent t-test concluded that the MOR values from both sets were not statistically equal at an alpha level of 0.05.

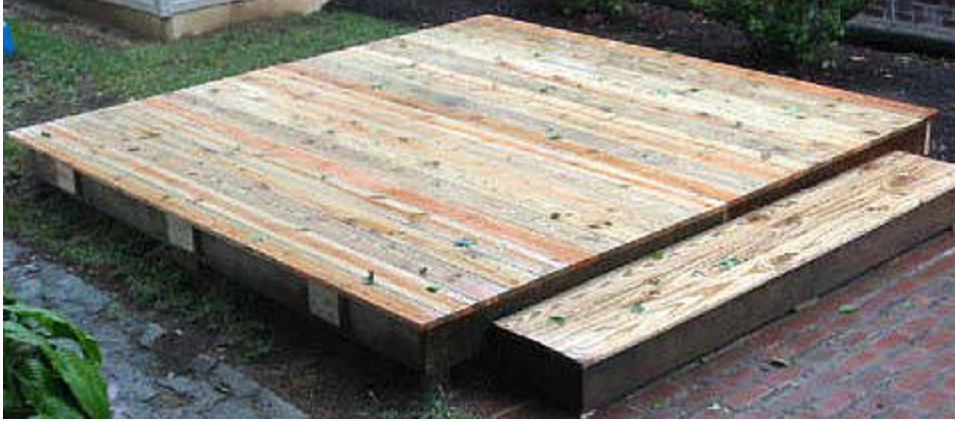
Figure 4- 9. Residential deck.

Pictures of the products made are located in Figures 4-1 through Figure 4-12. It should be noted that the worker-hours needed to complete each product will be much lower

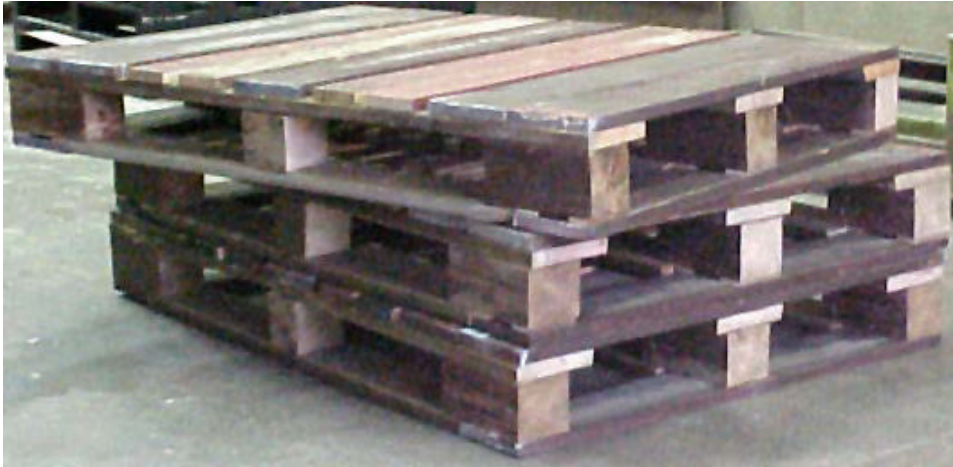
Figure 4- 11. Block pallets

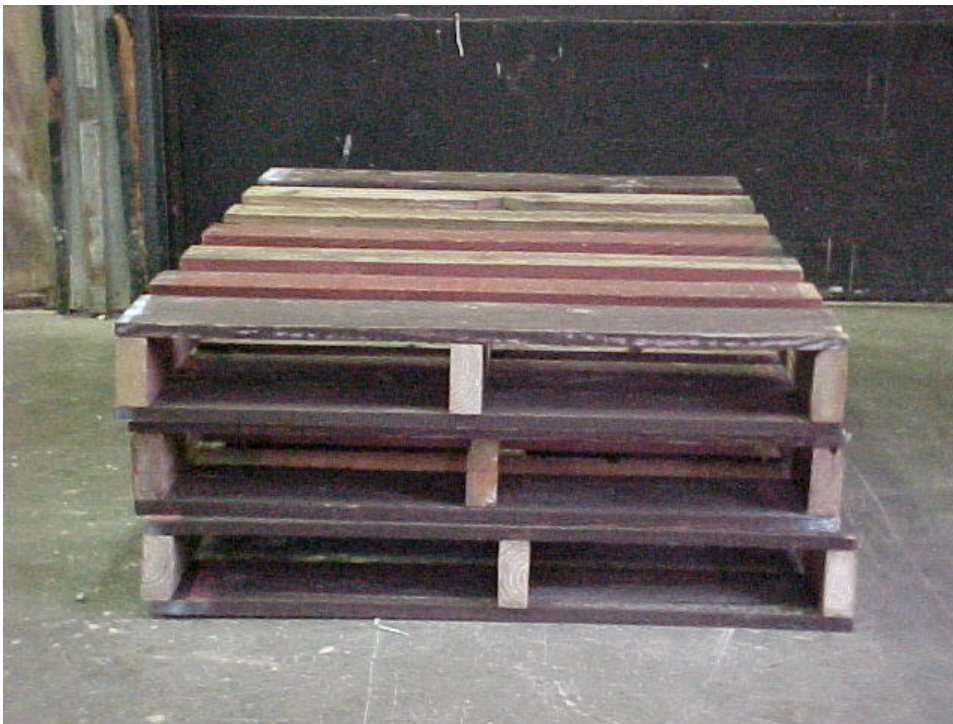
Figure 4- 12. Stringer pallet.
