The Feasibility of Recycling CCA Treated Wood From Spent Residential Decks

Masters Thesis submitted to the Faculty of Virginia Polytechnic Institute and State University at Blacksburg, Virginia in partial fulfillment of the requirements for the degree of:

Wood Science and Forest Products

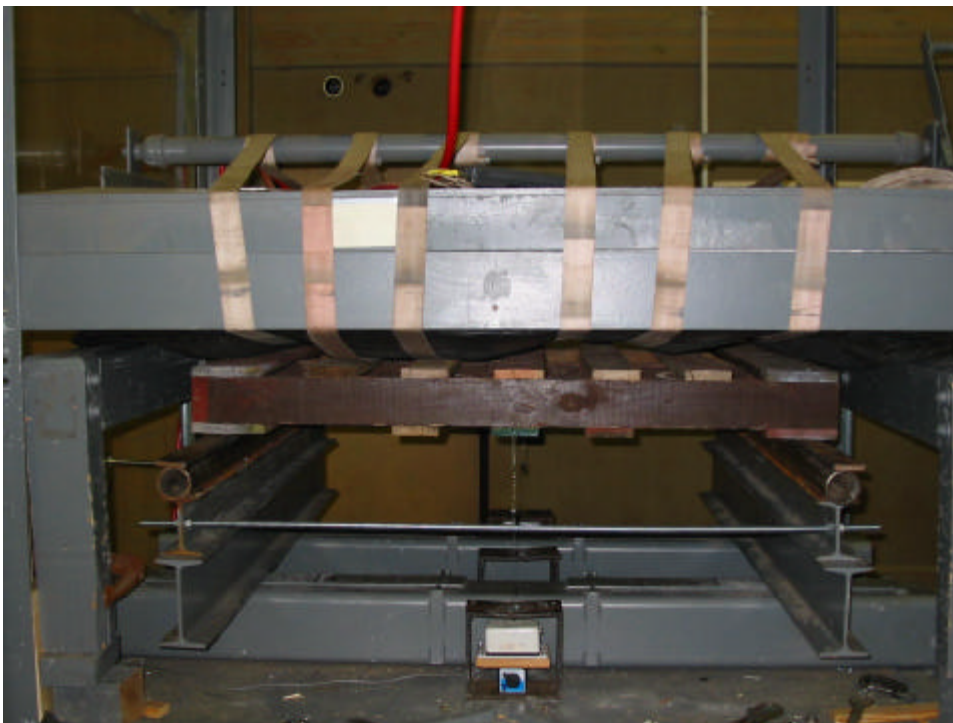
Figure 4- 13. Stringer pallet racked across the length, before load was applied.

The pallets were tested to determine how they would perform compared to pallets made with untreated virgin wood of the same specifications. The William H. Sardo Jr. Pallet and Container Research Laboratory at Virginia Tech tested the six pallets. Table 4-3 displays the pallets and how they were tested. Two of the three stringer pallets were tested to failure in rack across the width (stringer pallets No. 2 and 3), and the other pallet was tested to failure at rack across the length (stringer pallet No 1). Figure 4-13 displays a stringer pallet racked across the length, and Figure 4-14 shows a stringer pallet racked across the width. Two of the three block pallets were tested to failure in rack across the width (block pallets No. 1 and 2), and the other block pallet was tested to failure in rack across the width (block pallet No. 3). Figure 4-15 displays a block pallet racked across the length, and Figure 4-16 shows a block pallet racked across the width. The load was ramped at 500 lbs./min to a maximum of 10,500 lbs. for all pallets tested.

After testing, the maximum load to failure was recorded as shown on Table 4-3. The Pallet Design System (PDS) software, version 3.2, was used to compare the strength values obtained from testing to predicted strength values of pallets with the same material, components and specie (Southern Yellow Pine), but with untreated virgin wood. As shown in Table 4-3 the PDS software uses a safe maximum load, which is calculated by reducing the maximum load by a factor of 2.85. For comparison reasons the maximum rack across the length or width was reduced by a factor of 2.85. As seen in Table 4-3, the safe maximum loads of the six pallets compared favorably to the load specified by the PDS software. For the stringer pallets the safe maximum load across the width was 22% and 36% greater than the PDS analysis. Although the PDS software safe maximum load across the width was 11% greater than the safe maximum load across the length. For stringer pallets the critical member in the rack across the length is the center stringer, and it is the bottom deck board for rack across the width. Therefore the center stringer, which was a 2x4, could have had lower than anticipated bending strength and caused the pallet to perform worse than a simulated pallet using untreated unused wood. The opposite could be assumed for the pallets racked across the width were the bottom deck board is the critical member.

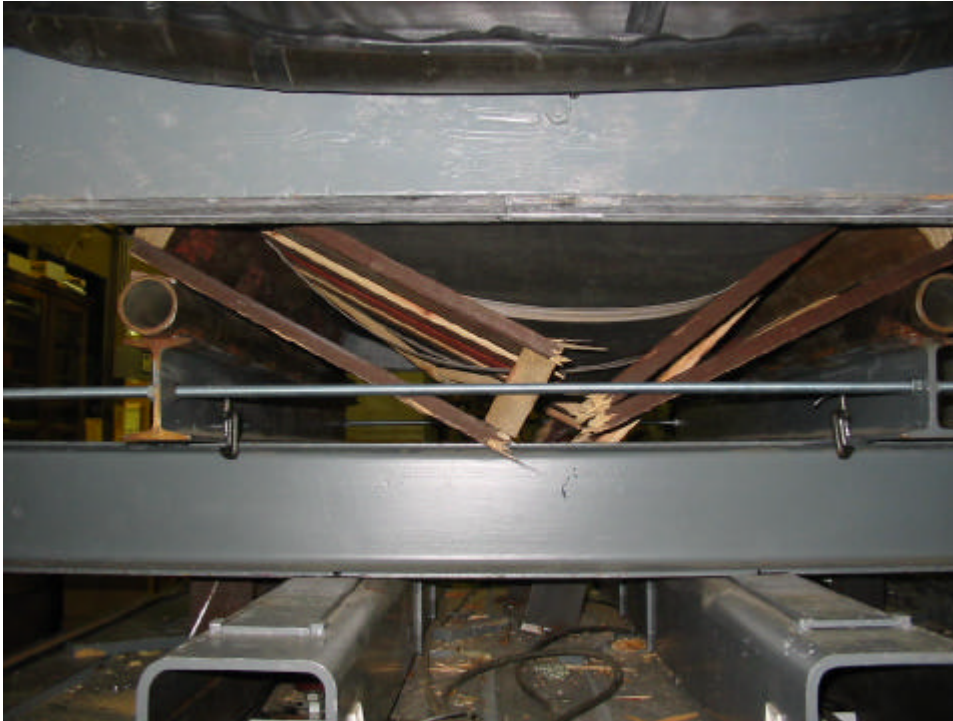
Figure 4- 14. Stringer pallet racked across the width, after failure.

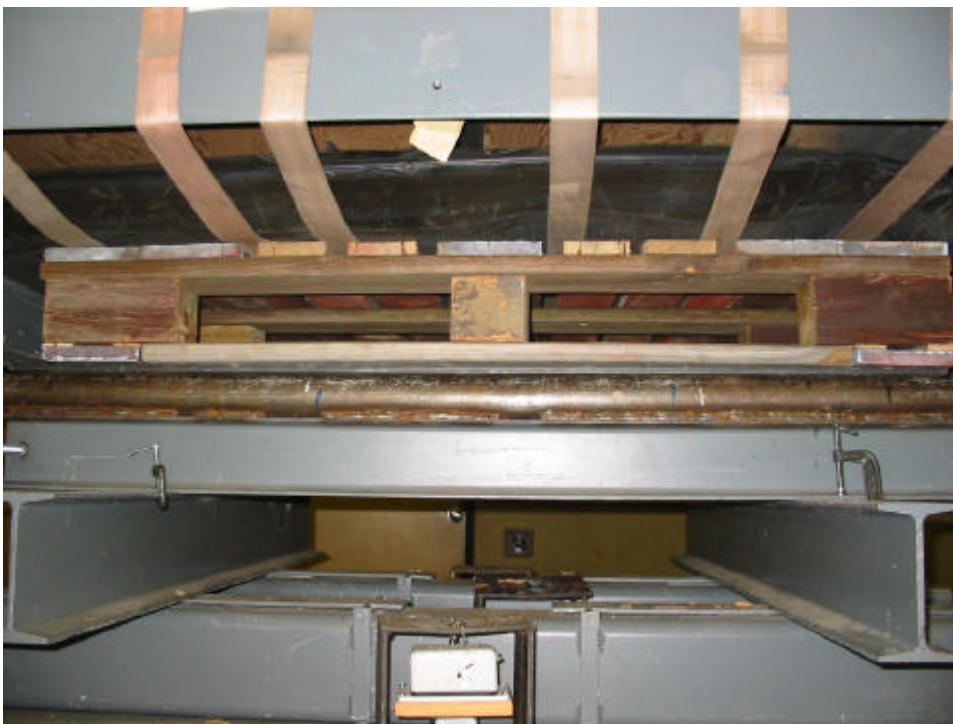
Figure 4- 15. Block pallet racked across the length, before load was applied.

The block pallets performed better than the PDS software analysis in rack across the length, but worse in rack across the width, as shown in Table 4-3. The critical member, which was the top stringer board in the rack across the length, performed worse than what would be anticipated for untreated and unused Southern Yellow Pine boards. The outer board is the critical member in rack across the width, and this board performed up to the level of the PDS pallet design. It should be noted that concrete conclusions cannot be drawn until several more tests are run, but the recycled CCA treated wooden pallets tested had similar structural values as designed pallets using virgin untreated Southern Yellow Pine.

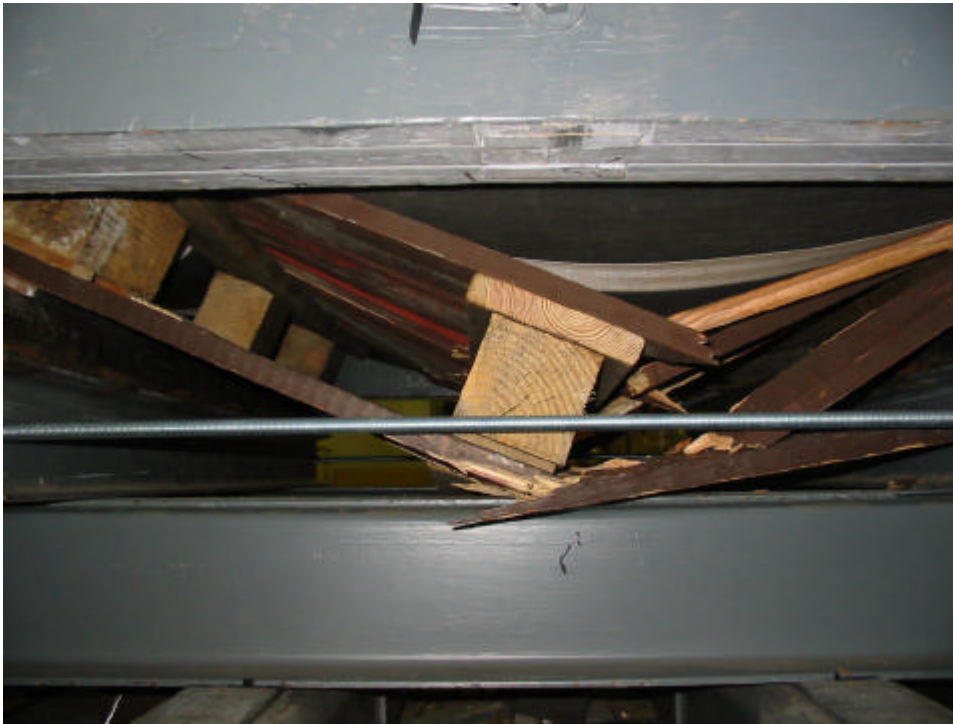
Figure 4- 16. Block pallet racked across the width after failure.

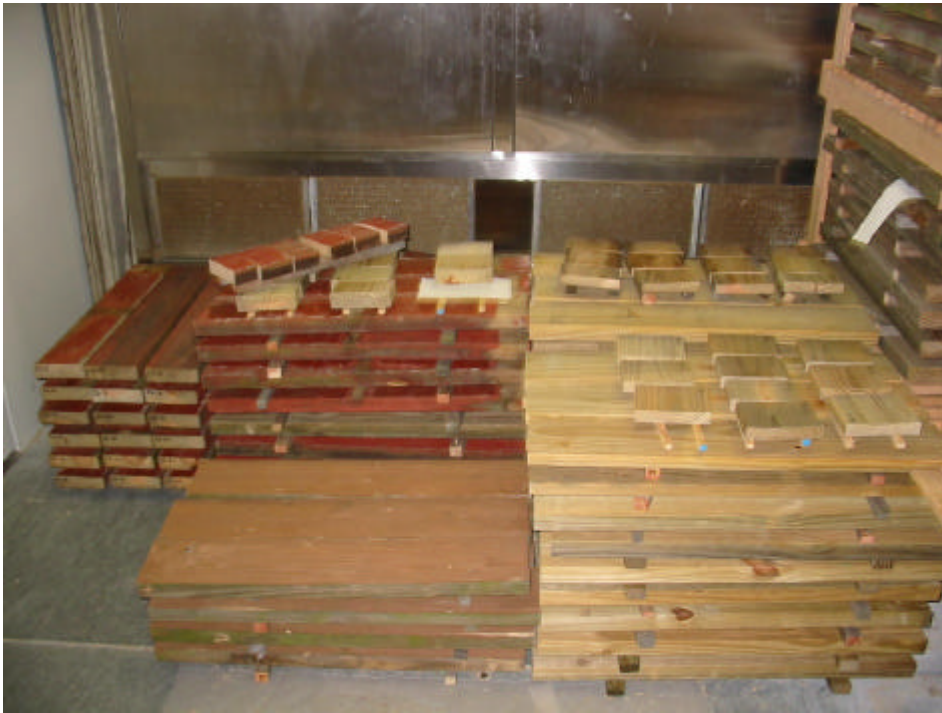
Figure A- 7. Mechanical test samples in conditioning chamber.

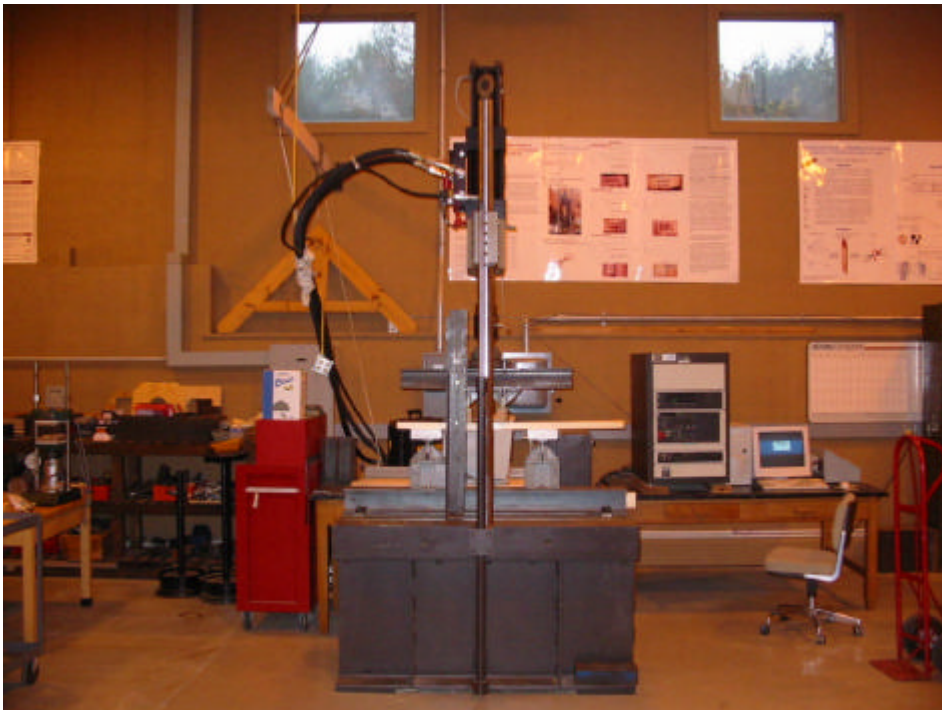
Figure A- 8. MTS used to test mechanical properties.

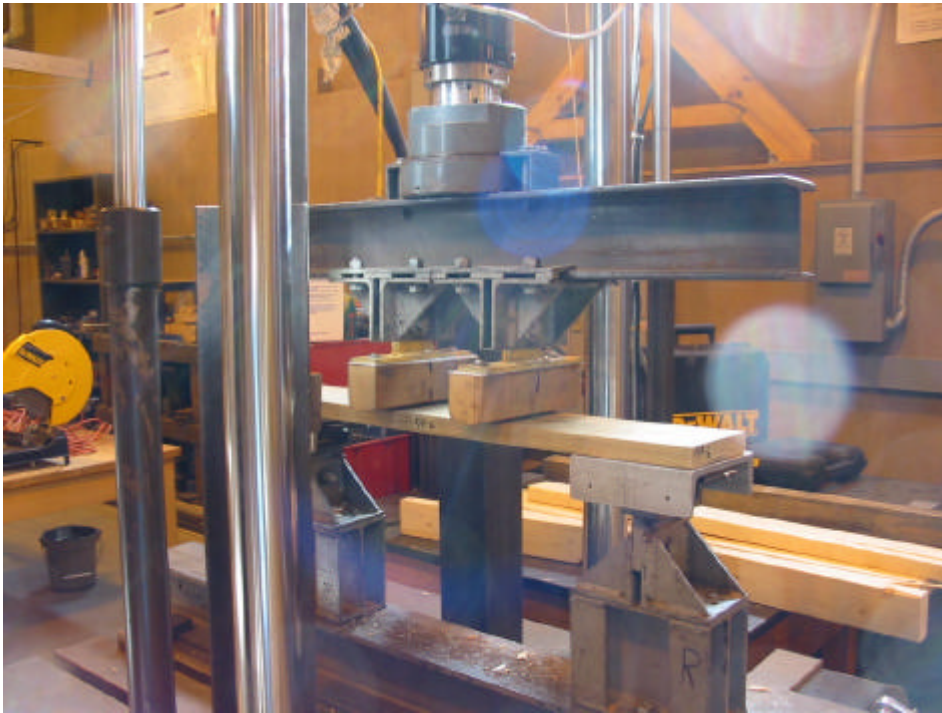
Figure A- 9. Loading of samples in MTS machine.

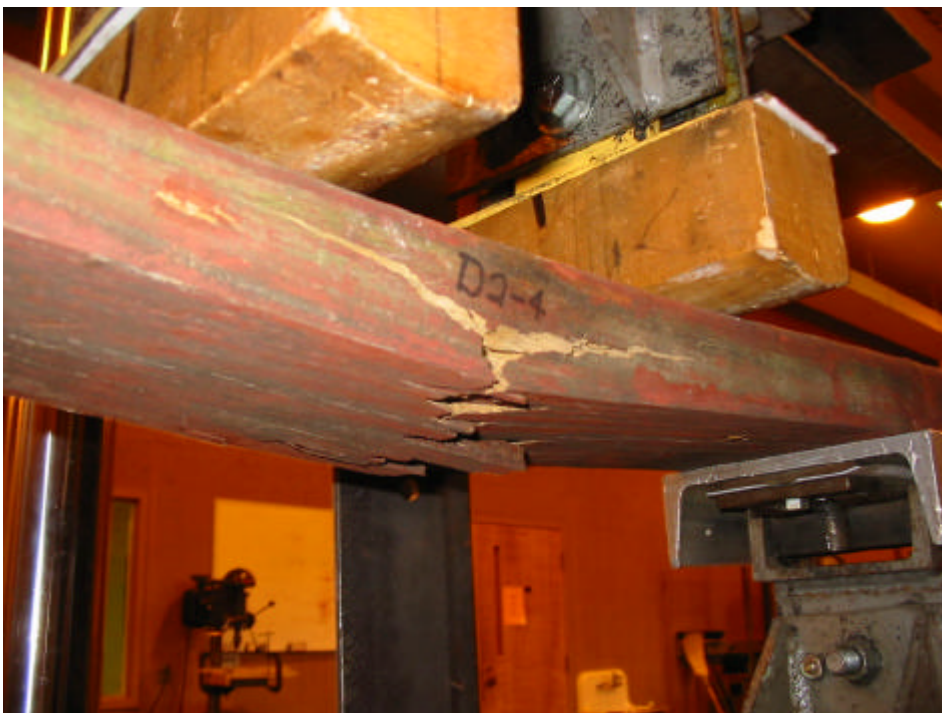
Figure A- 10. Typical failure of test samples under load.

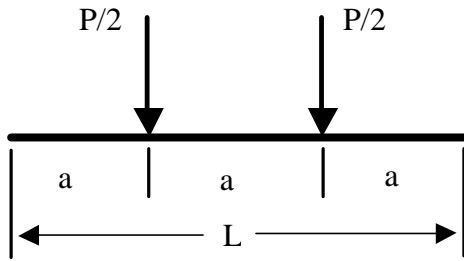
APPENDIX G. FREE BODY DIAGRAM OF MECHANICAL TESTS.

$$L = 3a$$
$$a = L/3$$
