## EXTERNALLY BONDED FBG STRAIN SENSORS FOR STRUCTURAL HEALTH MONITORING OF MARINE HYDROKINETIC STRUCTURES

### ABSTRACT

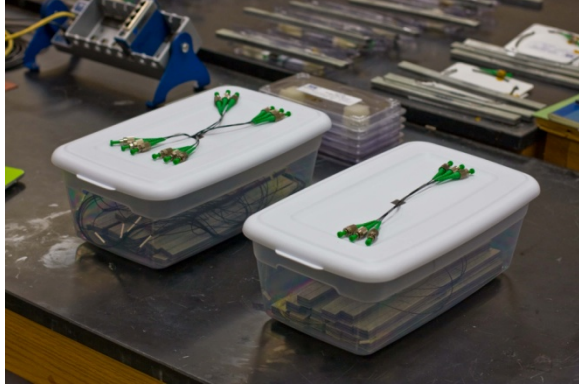
**FIGURE 2: COUPONS IN SOAK TUBS**

A set of coupons were soaked in salt water in tubs with the FBG connects passed through a hole in the lid and out of the water, as shown in Figure 2. ASTM standard D570 was used to simulate a marine environment and the tubs were placed in a furnace for five months at 50° C to assist salt-water diffusion. This is within the operating range of both sensors [22, 23]. Mass and wavelength measurements were taken for every coupon before and after the soaking process. These measurements were also tracked for a set of representative coupons during the first month to determine the amount of water absorbed by the composite matrix and its effect on material strain.

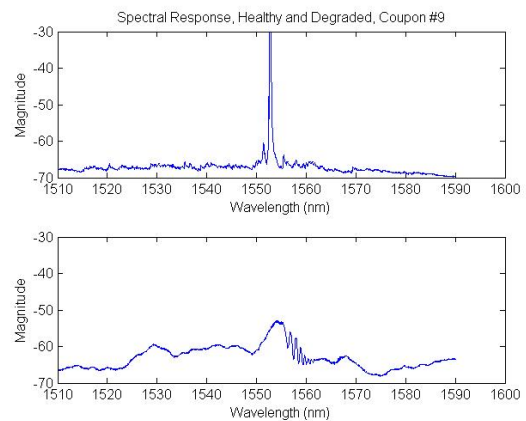
**FIGURE 5: COMPARISON OF HEALTHY AND FAILED SENSOR SPECTRAL RESPONSE**

manufacturer recommended strain limit, which is a common limit for fiber optic cables. As the peak wavelength response moved further from its original tuned wavelength, the peak degraded, evident by a widening in wavelength and flattening in the power spectrum. However, this did not limit the default software settings from adequately capturing the principal wavelength. Sensor failure was characterized by a sudden loss of the tuned wavelength peak. The software often identified a new peak to return a strain value after failure, but by analyzing the spectral response it was clear that the returned value was erroneous. The spectral response of coupon 9 is shown in Figure 5, where the upper plot shows a healthy and well-defined peak while the lower plot is representative of a failed sensor.

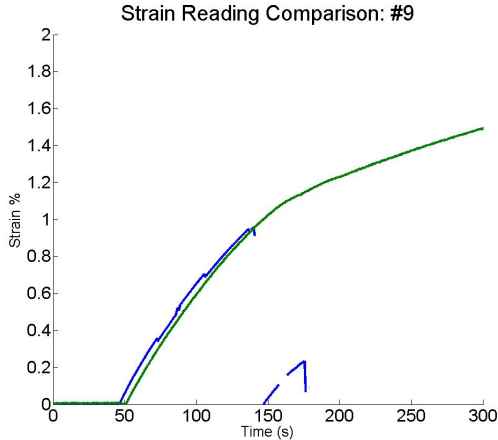
**FIGURE 7: COMPARISON OF EXTENSOMETER AND FBG STRAIN USING EXTENSOMETER (GREEN) AND UNCOATED OS100 (BLUE)**

Also of interest was the accuracy of the FBG strain measurements throughout the mechanical testing. Figure 7 shows the strain readings from the extensometer and an uncoated os1100 FBG, sample 9, plotted against time. As seen, the strain readings correlate very well up until sensor

failure; however, the FBG jumps slightly in its reading over the course of time. This occurs as the sensor response begins to degrade and the software detects multiple, small wavelength peaks that each fit the peak definition criteria. Each could be selected as the true peak and the software determines the peak that best fits the given criteria, however incorrect it may be. It needs to be noted that the software does allow parameter calibration that could reduce the error in peak selection and that the peaks selected are very near the true strain. Also seen in Figure 7 is that the software does return a value after sensor failure though it is very much in error.
