APPENDIX C: CYCLIC TESTS WITHOUT HOLD-DOWNS

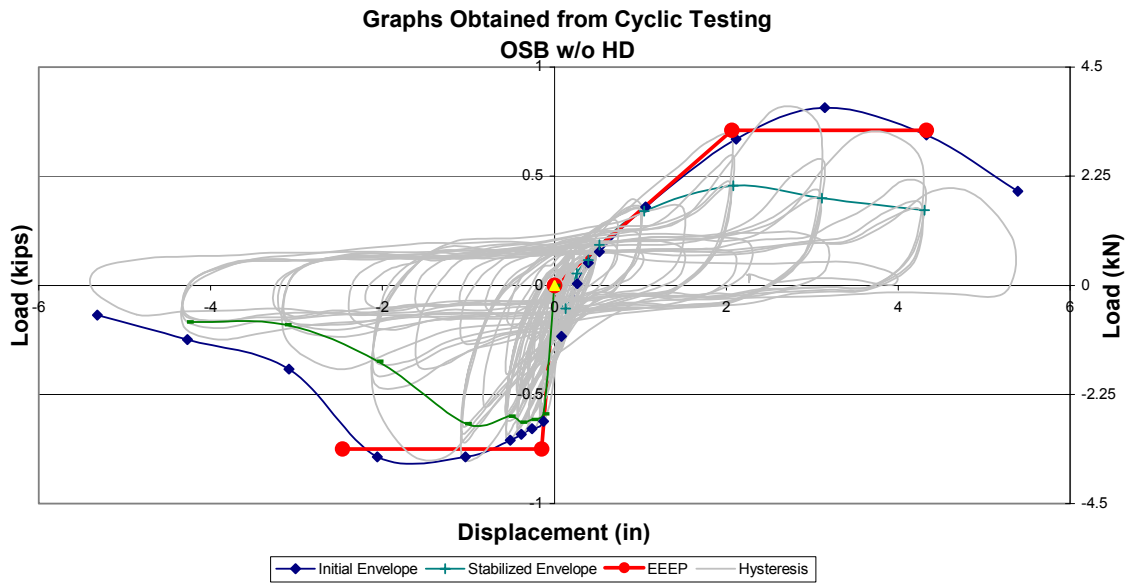
Figure C.1: Load-Displacement graph for OSB cyclic tests (Test 17)

-Mode of failure: The nails pulled through the sheathing on the bottom plate. Because of this separation, the studs separated from the bottom plate.

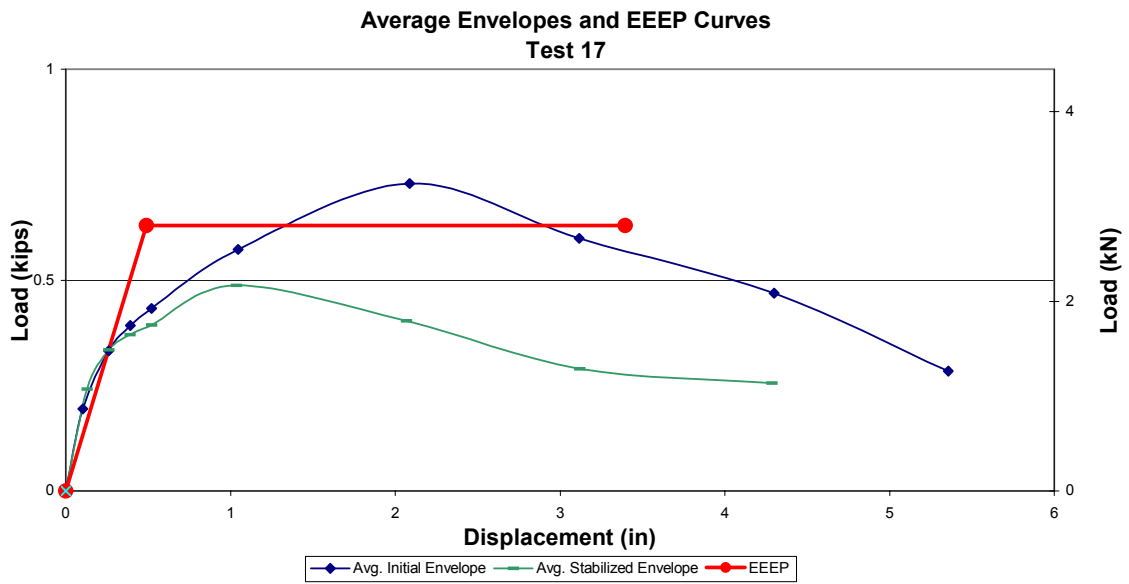
Figure C.2: Average envelope curves and EEEP curve (Test 17)

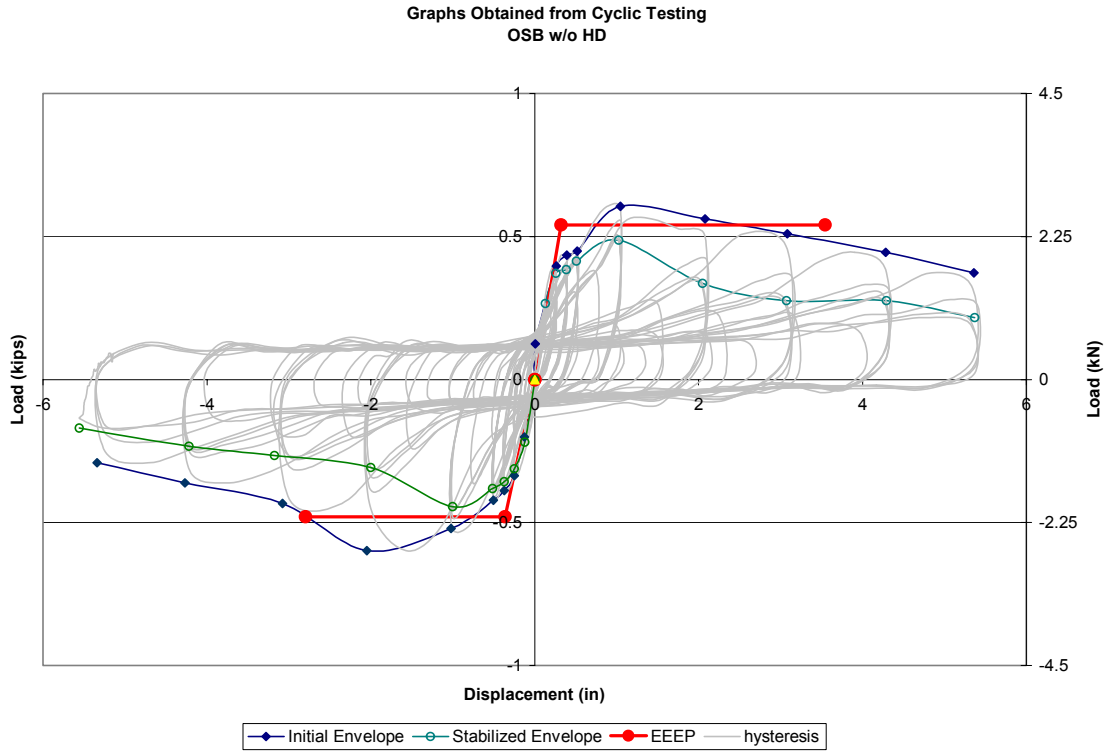
Figure C.3: Load-Displacement graph for OSB cyclic tests (Test 18)

-Mode of failure: The nails pulled through the sheathing on the bottom plate. Because of this separation, the studs separated from the bottom plate.

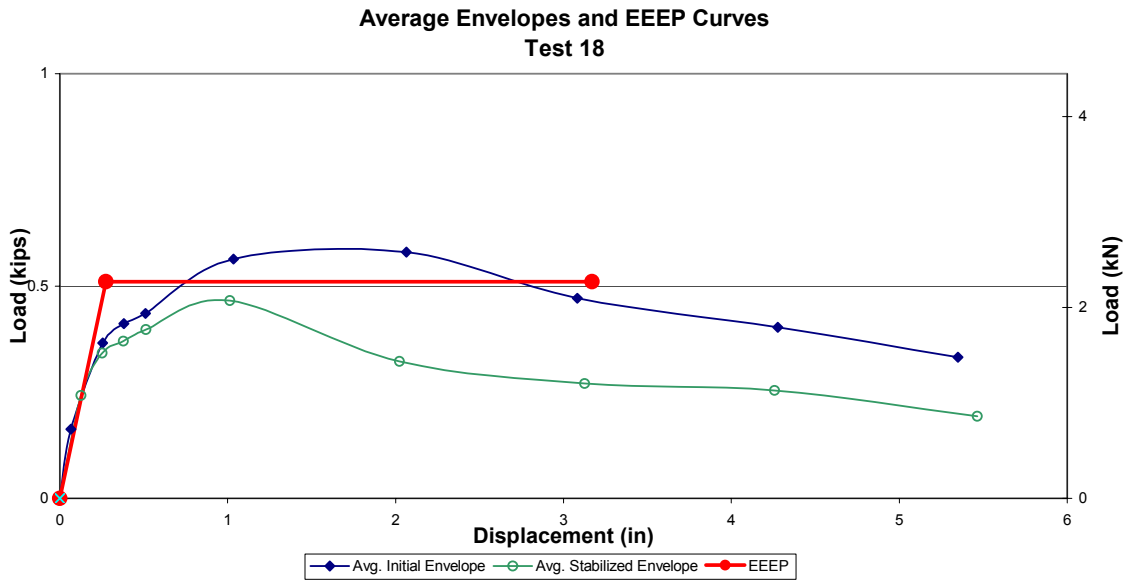
Figure C.4: Average envelope curve and EEEP curve (Test 18)

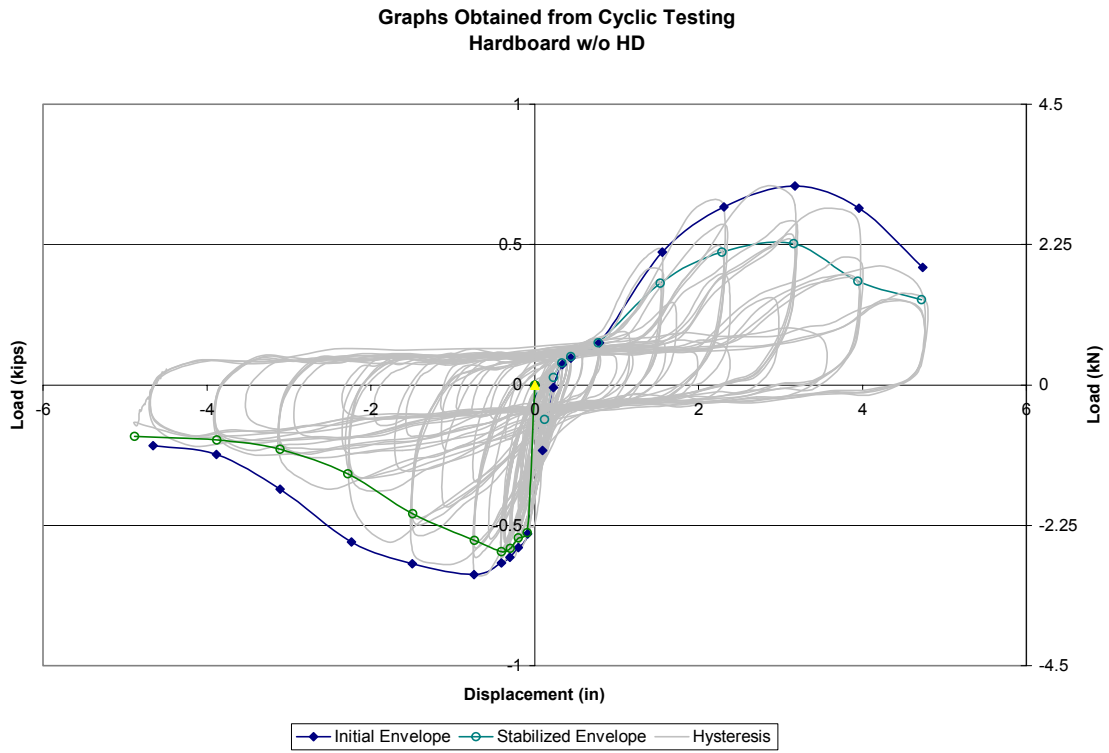
Figure C.5: Load-Displacement graph for Hardboard cyclic tests (Test 19)

- Nails on the bottom plate pulled out of the framing.
- There was no damage to the sheathing panel as the nails pulled out of the framing.
- No damage was apparent to the other nails.
- Mode of failure:** Sheathing nails along bottom plate pulled out of the framing allowing the wall to separate from the bottom plate.

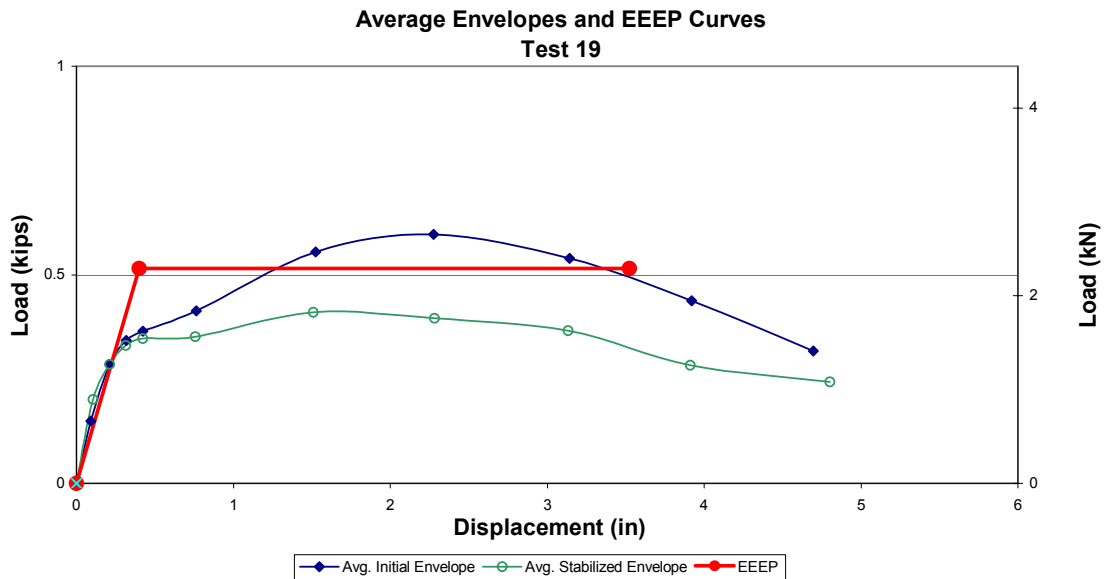
Figure C.6: Average envelope curve and EEEP curve (Test 19)

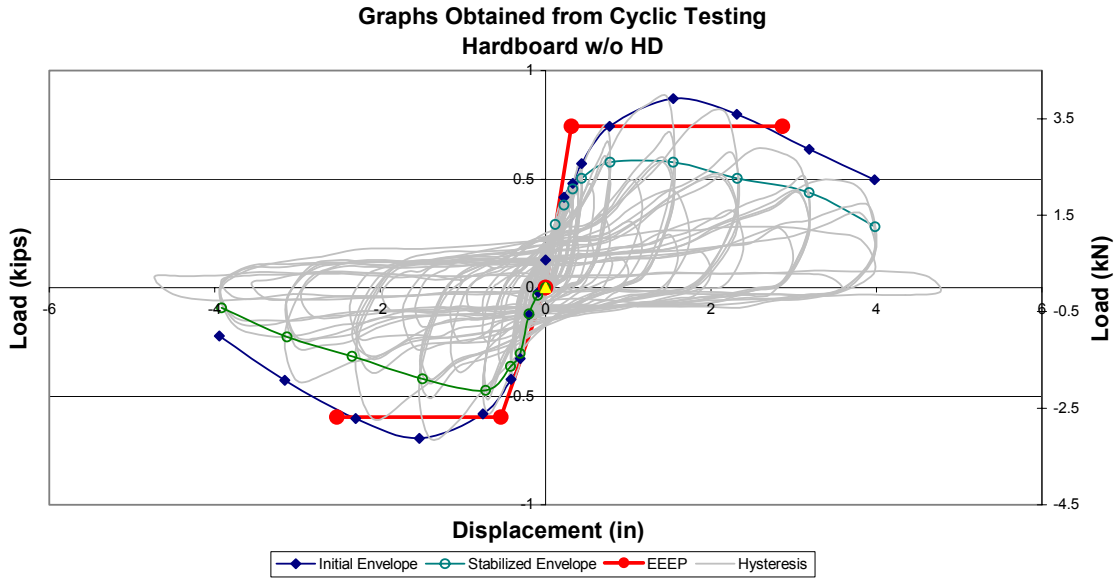
Figure C.7: Load-Displacement graph for Hardboard cyclic tests (Test 20)

- Nails on the bottom plate pulled out of the framing.
- There was no damage to the sheathing panel as the nails pulled out of the framing.
- No damage was apparent to the other nails.
- The bottom plate split at the right anchor bolt. There was a large knot at the site, which may have produced a weakness at that point.
- Mode of failure:** Sheathing nails along bottom plate pulled out of the framing allowing the wall to separate from the bottom plate.

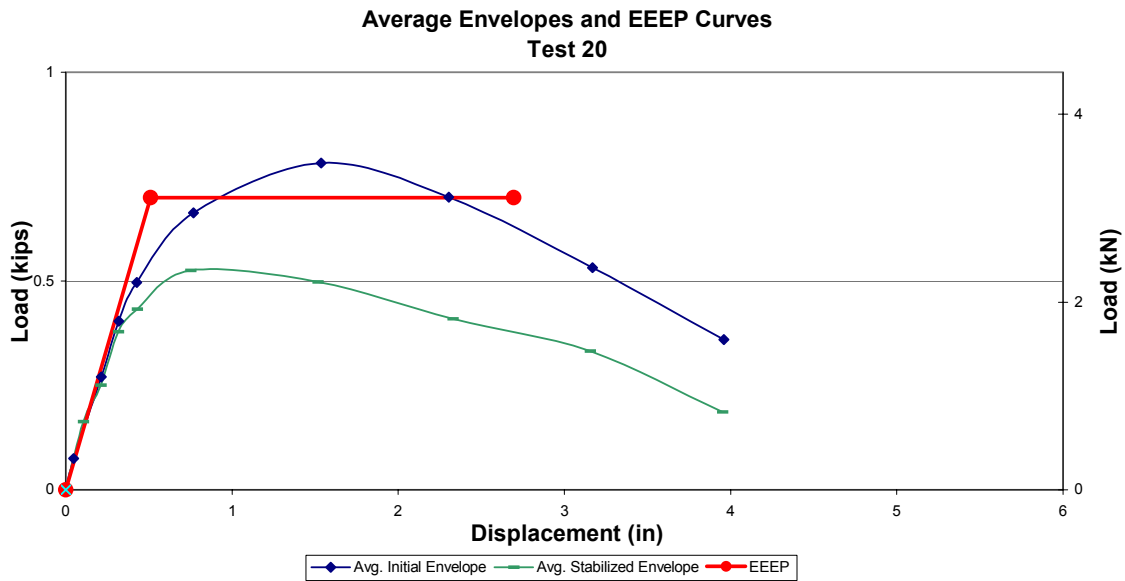
Figure C.8: Average envelope curve and EEEP curve (Test 20)

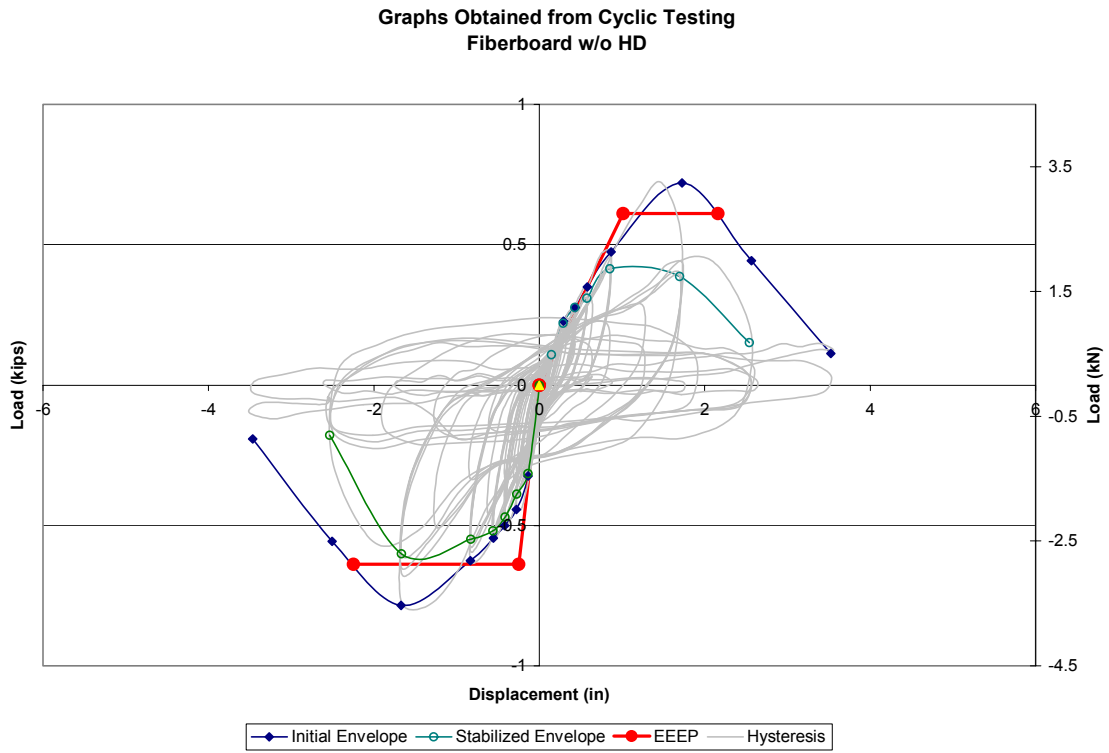
Figure C.9: Load-Displacement graph for Fiberboard cyclic tests (Test 21)

- The nails on the bottom plate ripped through the edge of the sheathing and totally separated from the framing.
- After the nails unzipped, the studs completely separated from the bottom plate.
- The failure occurred early in the cyclic program. Perhaps the FME was too large for this wall
- Mode of failure:** Sheathing on bottom plate unzipped and studs separated from bottom plate.

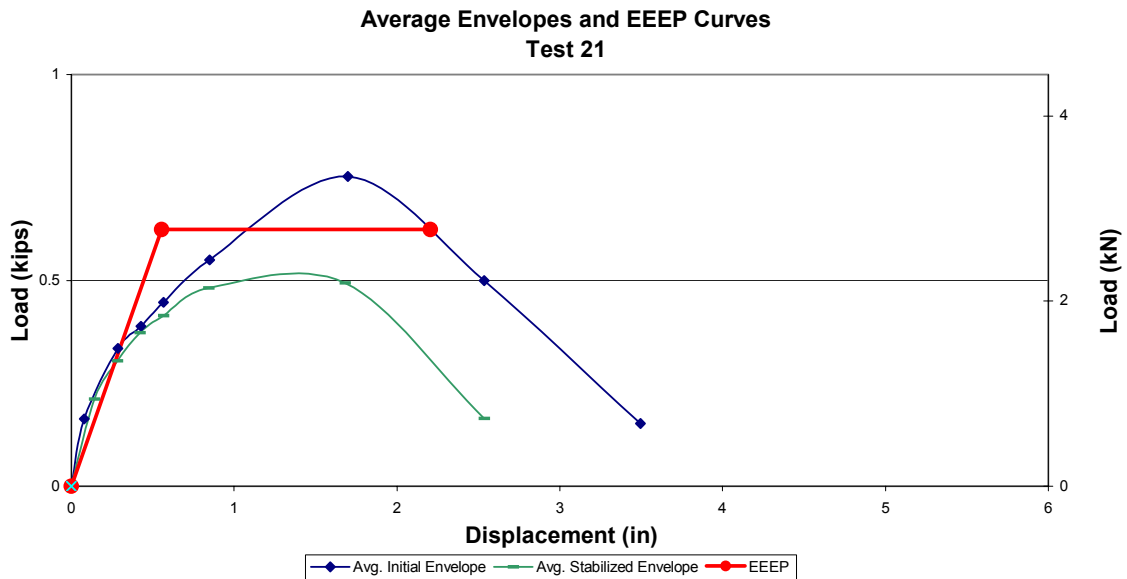
Figure C.10: Average envelope curve and EEEP curve (Test 21)

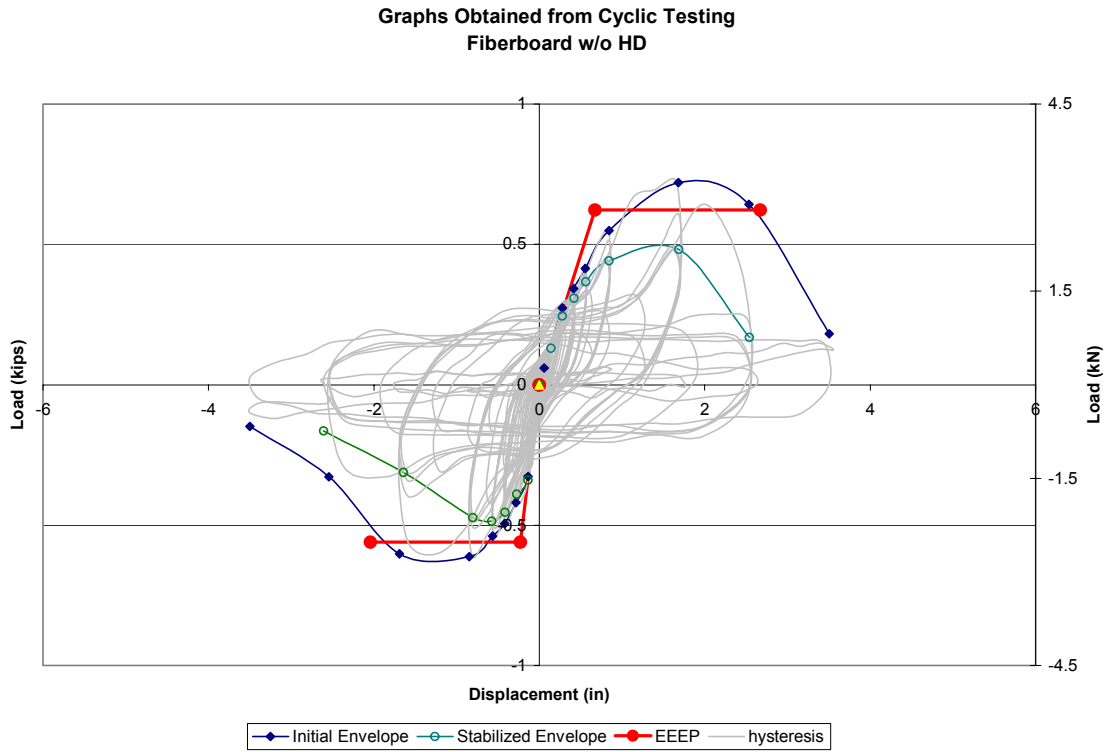
Figure C.11: Load-Displacement graph for Fiberboard cyclic tests (Test 22)

- The nails on the bottom plate ripped through the edge of the sheathing and totally separated from the framing.
- After the nails unzipped, the studs completely separated from the bottom plate.
- The failure occurred early in the cyclic program. Perhaps the FME was too large for this wall
- Mode of failure:** Sheathing on bottom plate unzipped and studs separated from bottom plate.

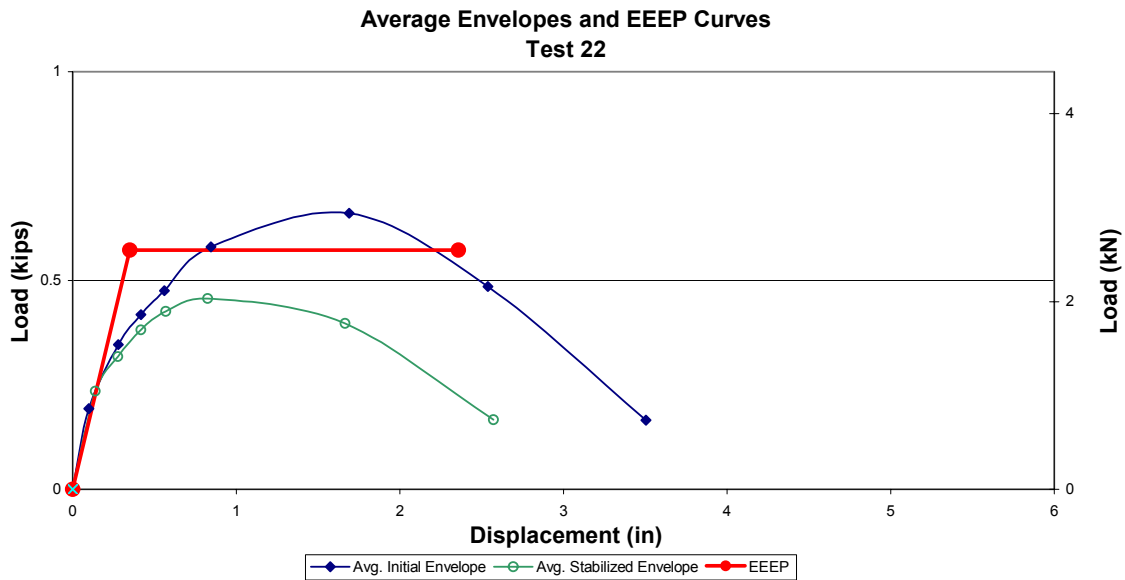
Figure C.12: Average envelope curve and EEEP curve (Test 22)

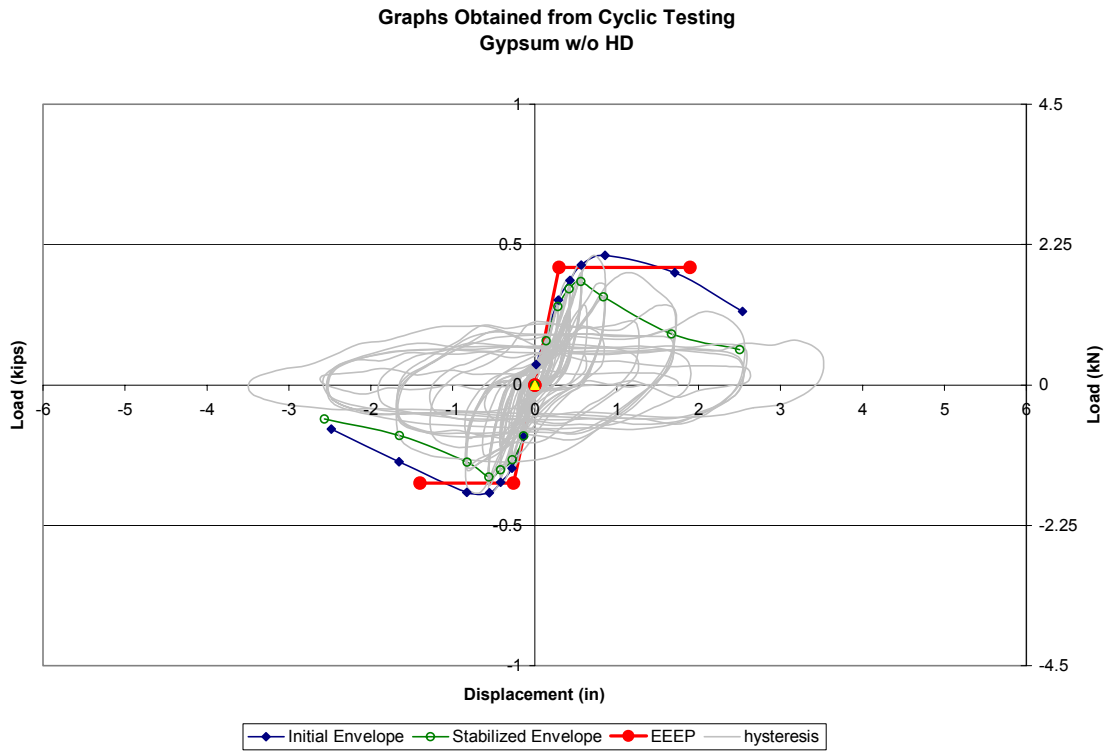
Figure C.13: Load-Displacement graph for Gypsum cyclic tests (Test 23)

-Mode of Failure: Sheathing nails along the bottom plate could easily sink through the gypsum or tear through the gypsum, which disallowed the wall to resist shear.

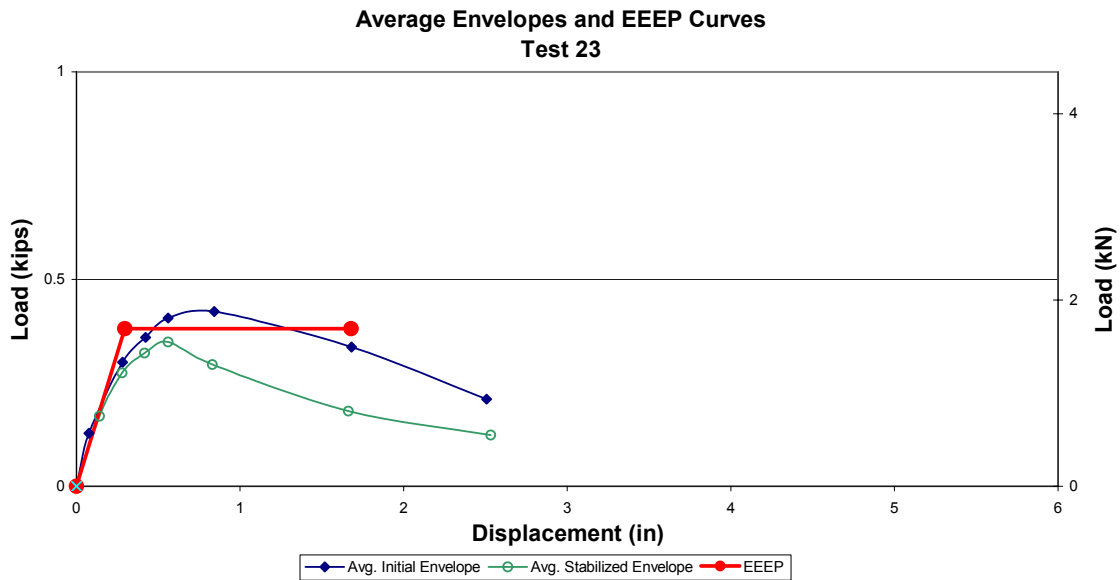
Figure C.14: Average envelope curve and EEEP curve (Test 23)

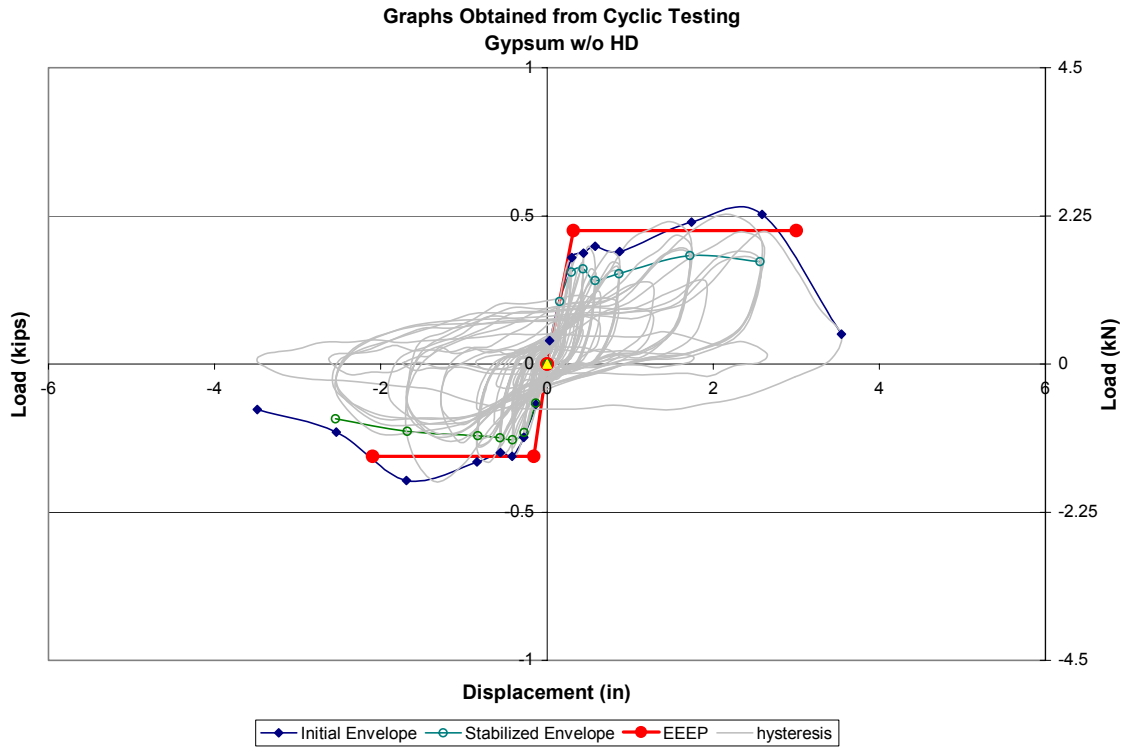
Figure C.15: Load-Displacement graph for Gypsum cyclic tests (Test 24)

-Mode of Failure: Sheathing nails along the bottom plate could easily sink through the gypsum or tear through the gypsum, which disallowed the wall to resist shear.

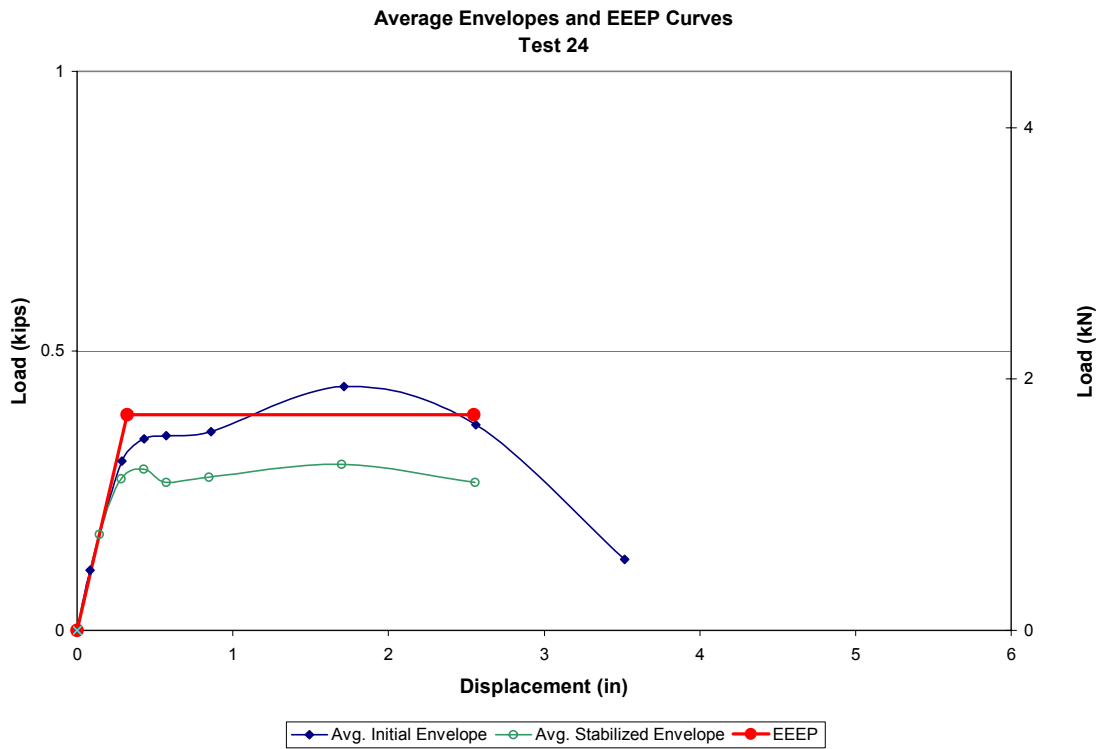
Figure C.16: Average envelope curve and EEEP curve (Test 24)

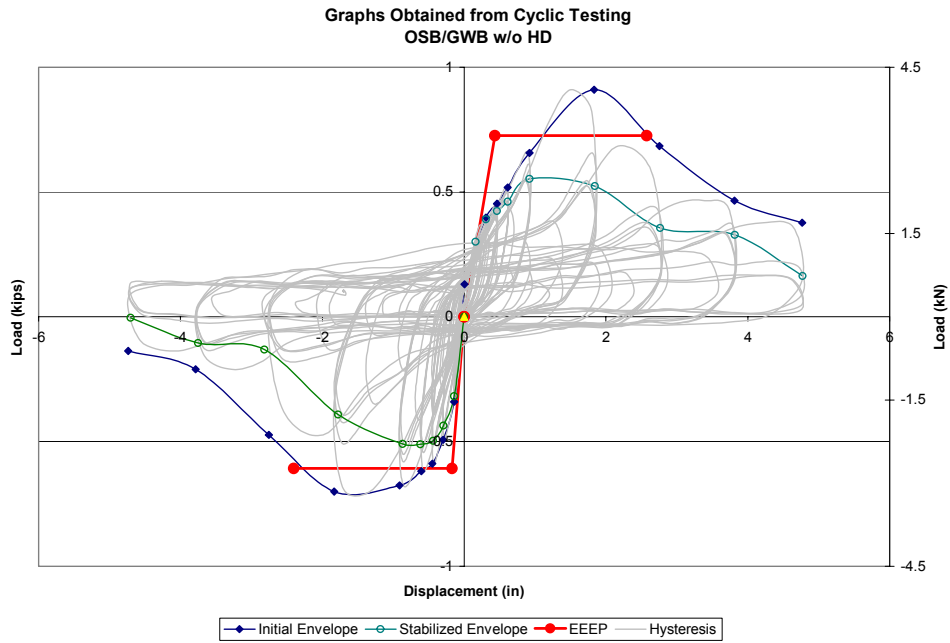
Figure C.17: Load-Displacement graph for OSB/GWB cyclic tests (Test 37)

-Mode of failure: OSB sheathing nails along bottom plate either pulled out or tore through the sheathing, allowing the wall to separate from the bottom plate. Gypsum nails performed as in Tests 23 and 24.

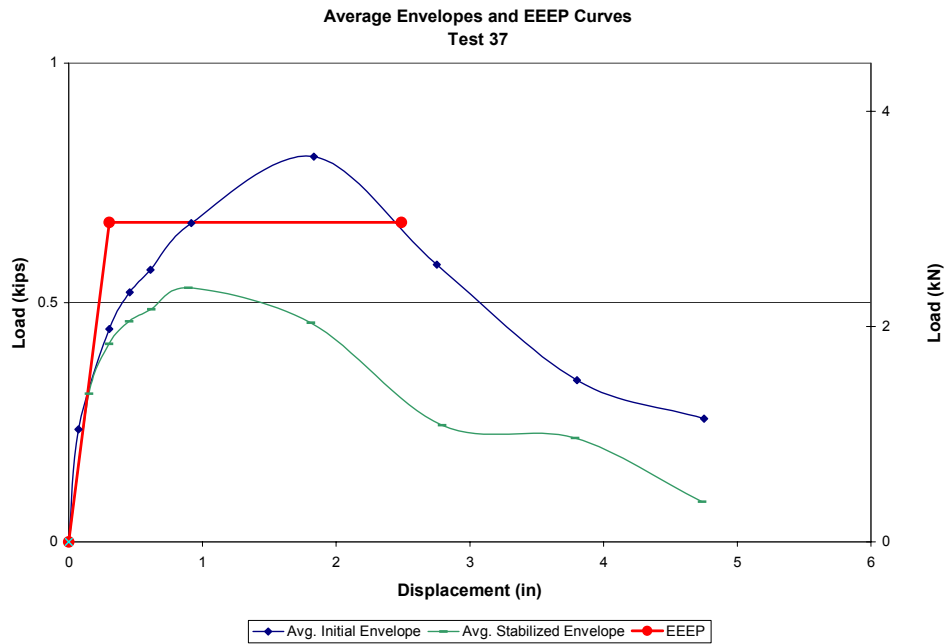
Figure C.18: Average envelope curve and EEEP curve (Test 37)

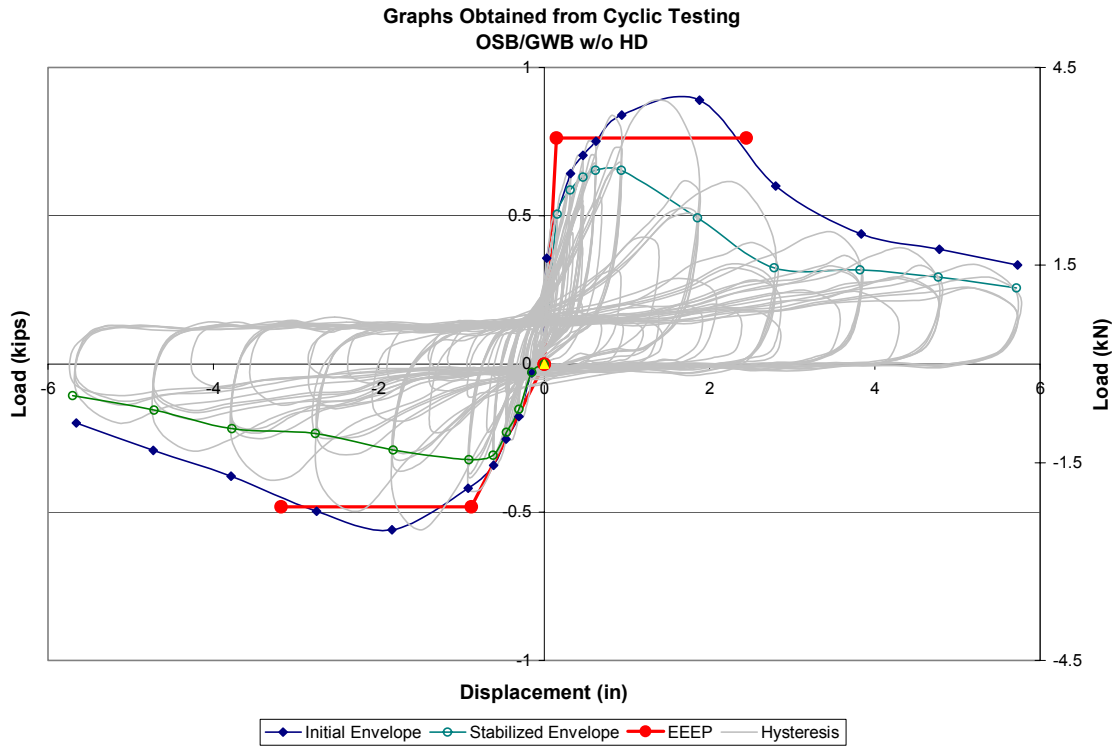
Figure C.19: Load-Displacement graph for OSB/GWB cyclic tests (Test 38)

-Mode of failure: OSB sheathing nails along bottom plate either pulled out or tore through the sheathing, allowing the wall to separate from the bottom plate. Gypsum nails performed as in Tests 23 and 24.

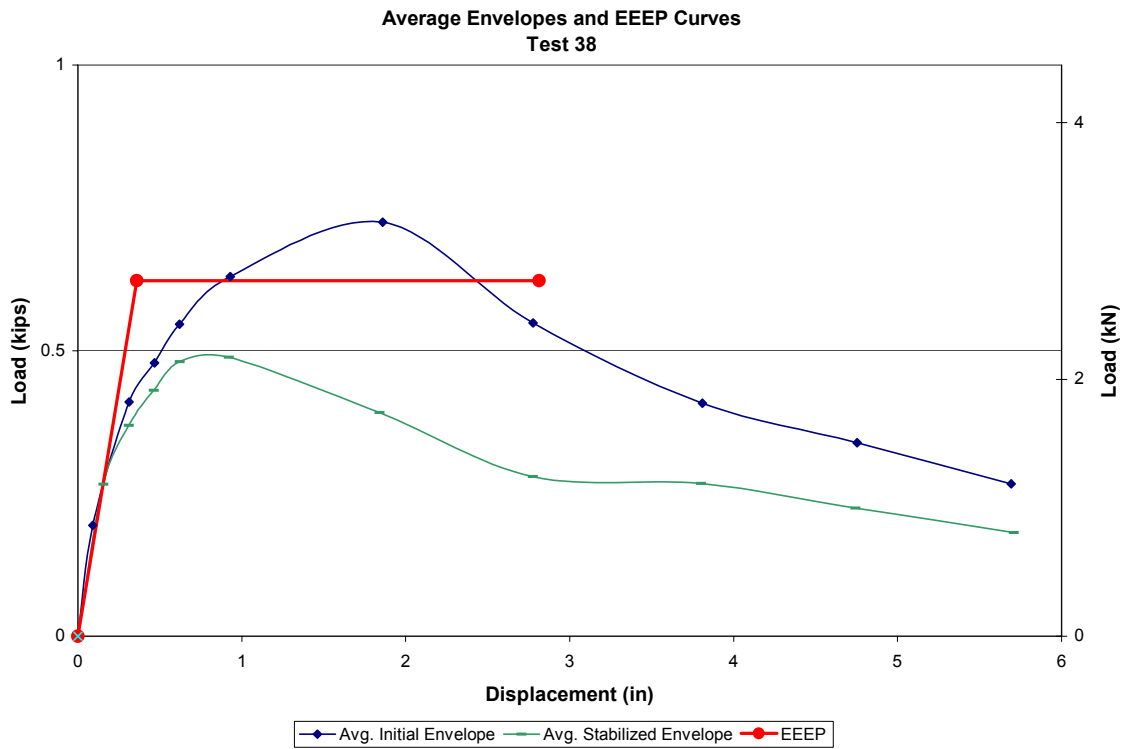
Figure C.20: Average envelope curve and EEEP curve (Test 38)

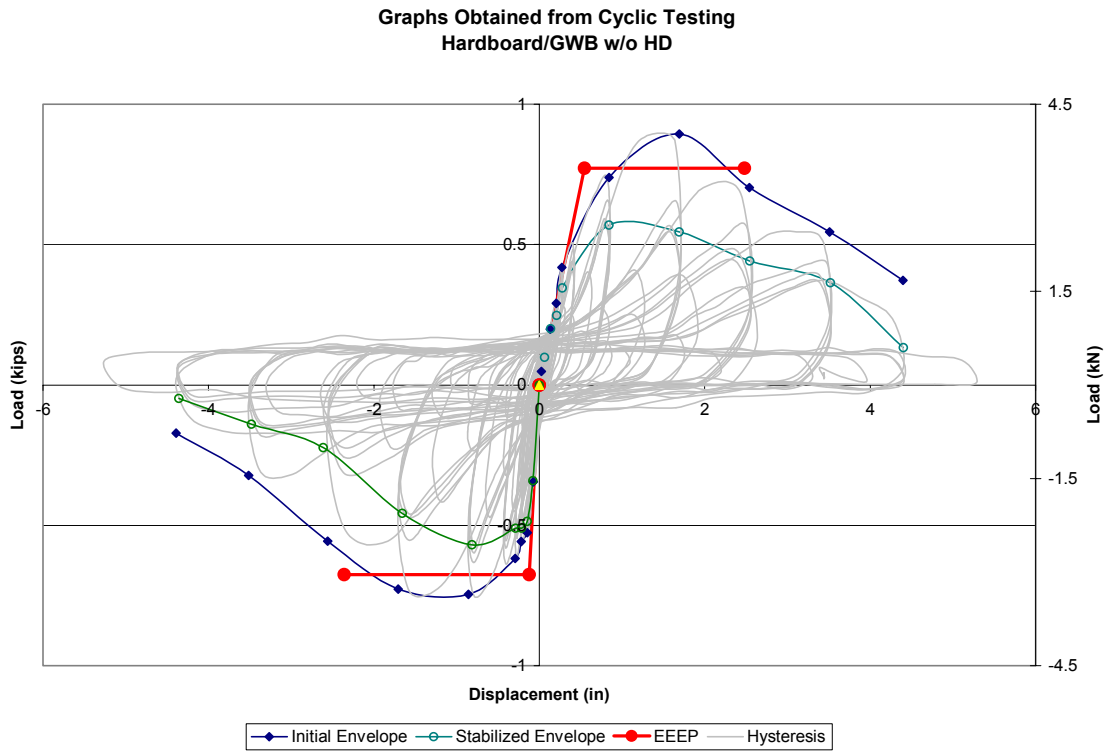
Figure C.21: Load-Displacement graph for Hardboard/GWB cyclic tests (Test 39)

-Mode of failure: Hardboard sheathing nails along bottom plate pulled out of the framing allowing the wall to separate from the bottom plate. The gypsum nails behaved similar to Tests 23 and 24.

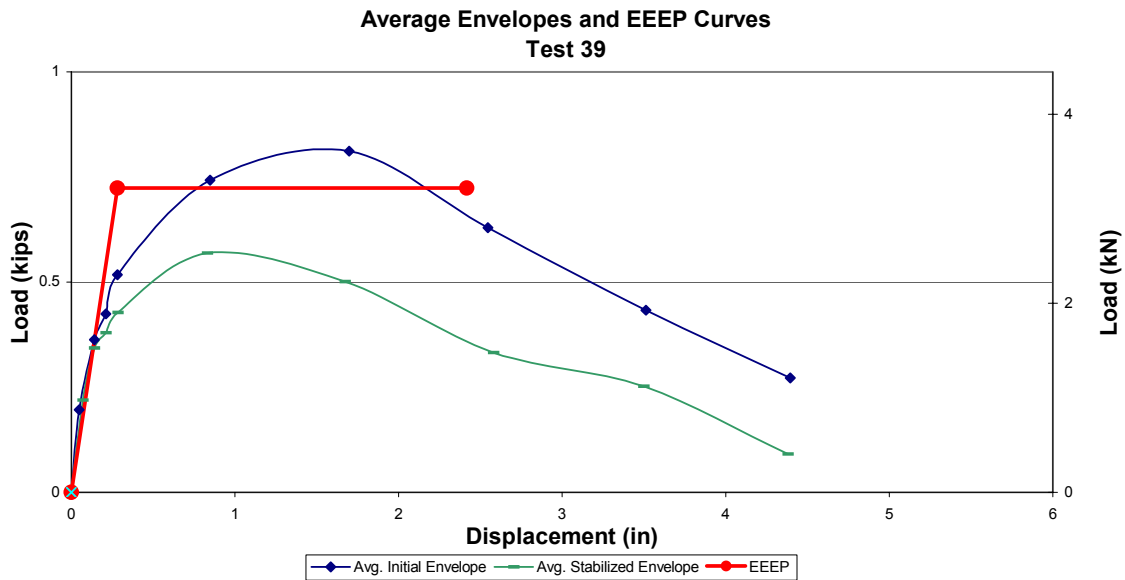
Figure C.22: Average envelope curve and EEEP curve (Test 39)

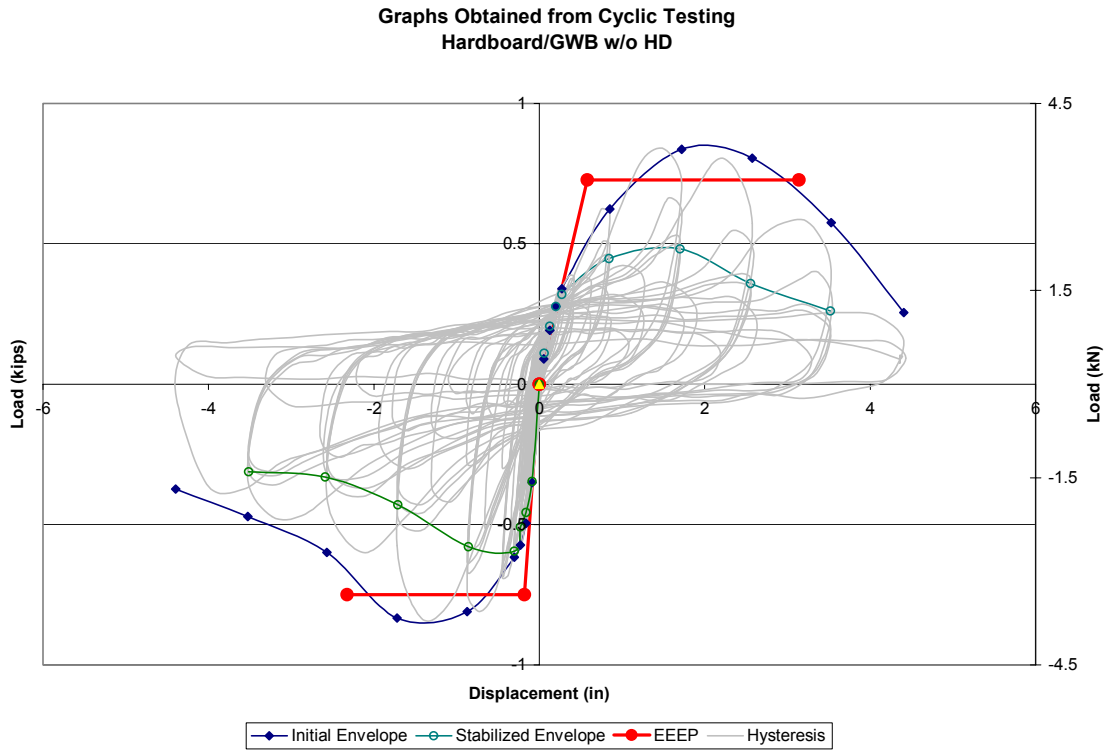
Figure C.23: Load-Displacement graph for Hardboard/GWB cyclic tests (Test 40)

-Mode of failure: Hardboard sheathing nails along bottom plate pulled out of the framing allowing the wall to separate from the bottom plate. The gypsum nails behaved similar to Tests 23 and 24.

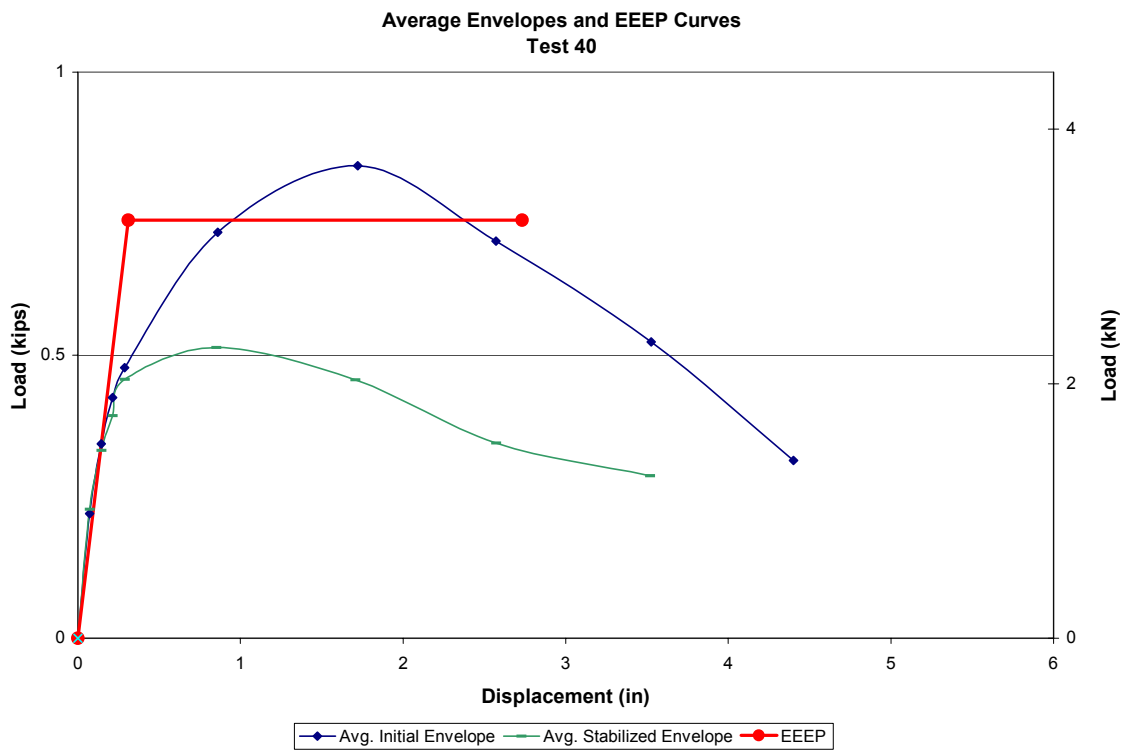
Figure C.24: Average envelope curve and EEEP curve (Test 40)

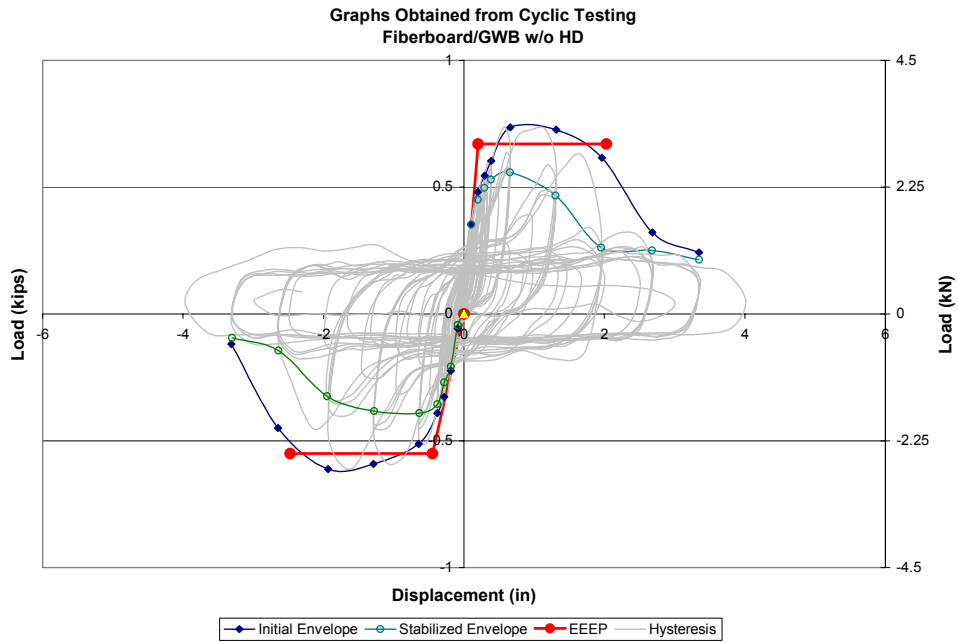
Figure C.25: Load-Displacement graph for Fiberboard/GWB cyclic tests (Test 41)

-Mode of failure: Nails on bottom plate unzipped and studs separated from the bottom plate. Gypsum sheathing nails behaved in similar manner to Tests 23 and 24.

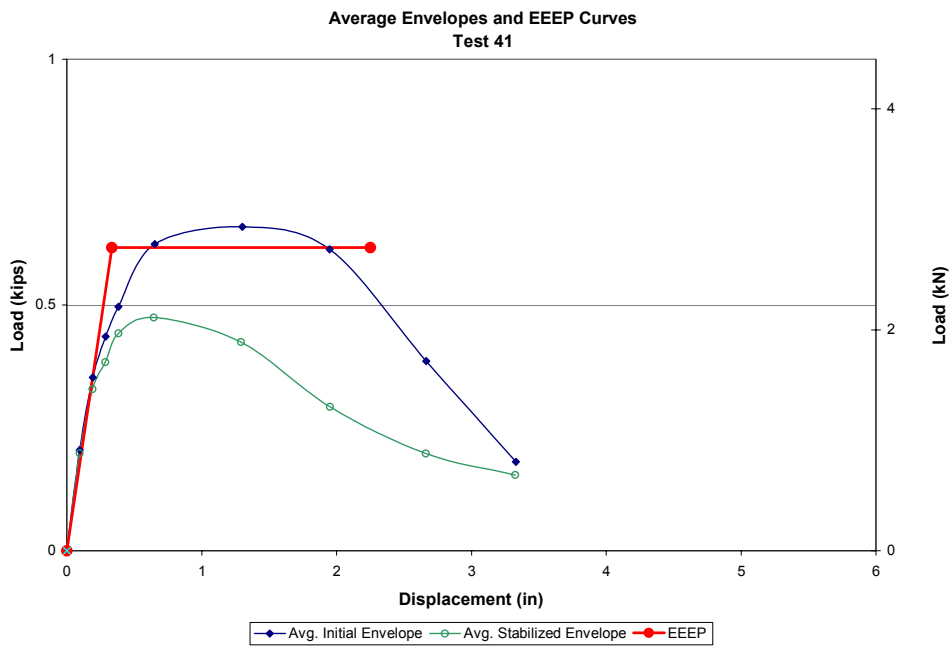
Figure C.26: Average envelope curve and EEEP curve (Test 41)

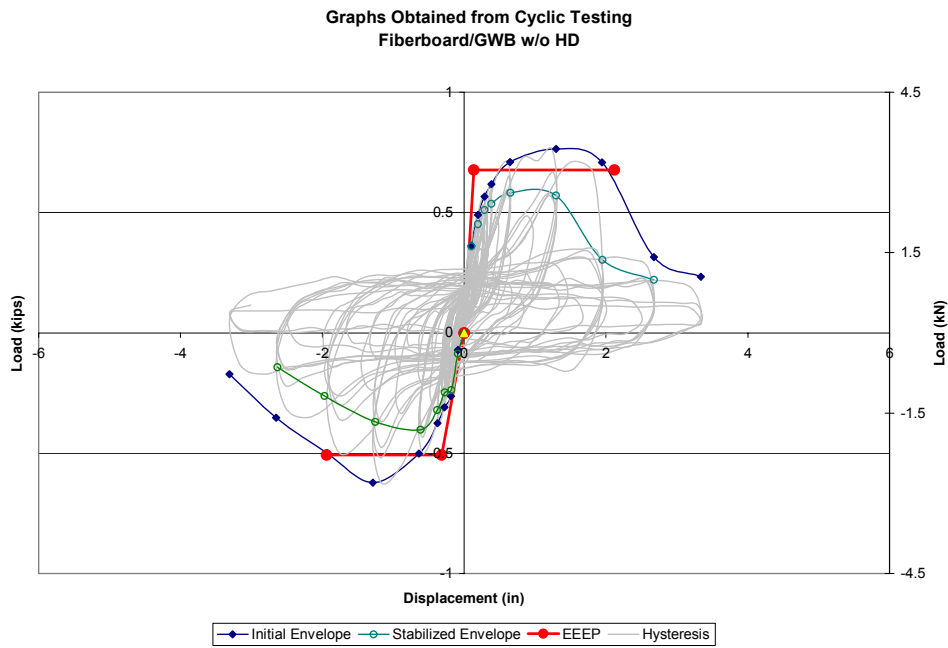
Figure C.27: Load-Displacement graph for Fiberboard/GWB cyclic tests (Test 42)

-Mode of failure: Nails on bottom plate unzipped and studs separated from the bottom plate. Gypsum sheathing nails behaved in similar manner to Tests 23 and 24.

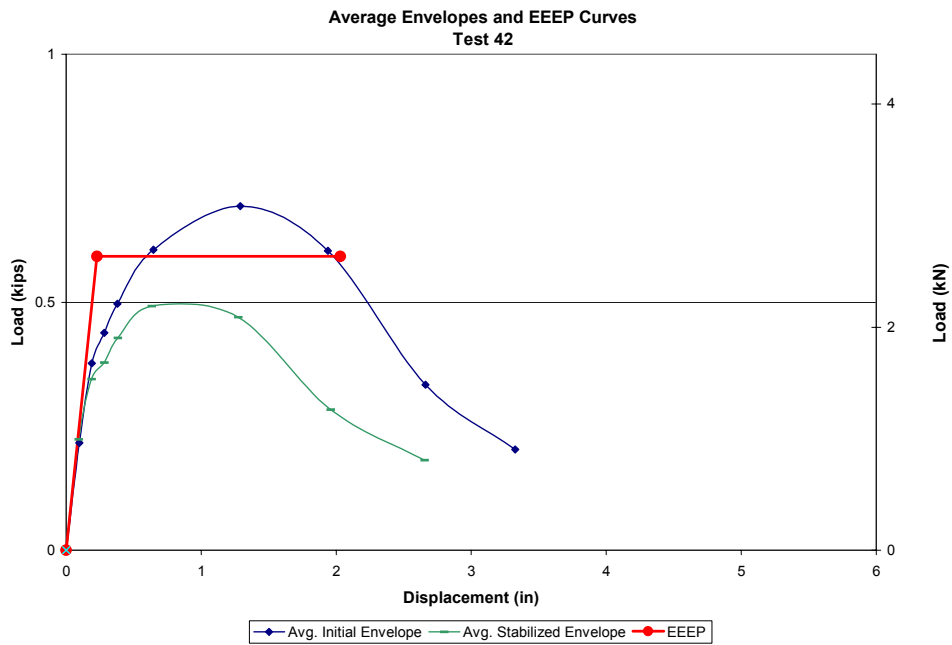
Figure C.28: Average envelope curve and EEEP curve (Test 42)
