FINAL CONTRACT REPORT

EVALUATION OF THE IN-SERVICE PERFORMANCE OF THE TOM'S CREEK BRIDGE FIBER-REINFORCED POLYMER SUPERSTRUCTURE

September 2003
VTRC 04-CR5

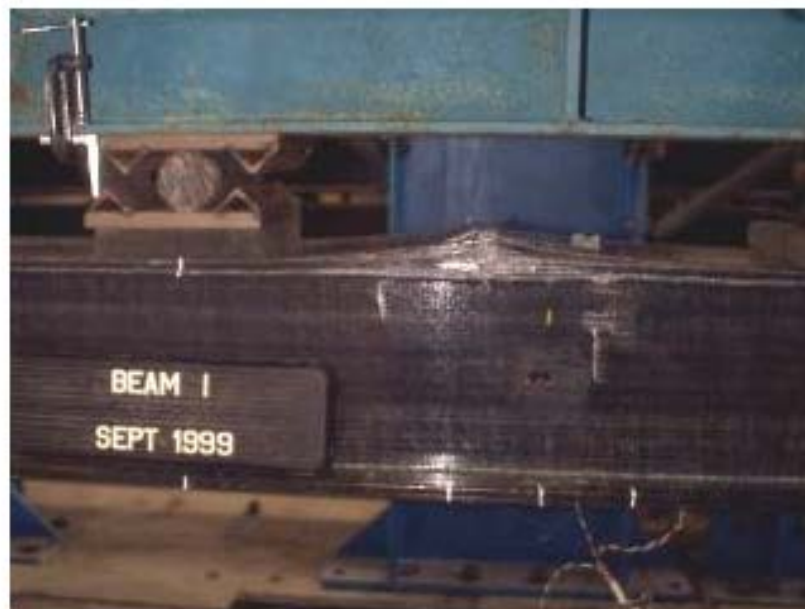
Figure 8. Failure of the compression flange for removed Tom's Creek Bridge FRP composite Girder 1. Note failure occurs at mid-span.

The FRP composite girders suffered a sudden, explosive failure that was the result of delamination of the compression (top) flange, while the tensile flange remained intact. Figure 8 shows one of the FRP composite girders after experiencing such a failure. This failure is best
