FINAL  
CONTRACT REPORT  
VTRC 07-CR14

**DEVELOPMENT AND EVALUATION  
OF AN ADHESIVELY BONDED PANEL-TO-PANEL  
JOINT FOR A FIBER-REINFORCED POLYMER  
BRIDGE DECK SYSTEM**

April 2007  
VTRC 07-CR14

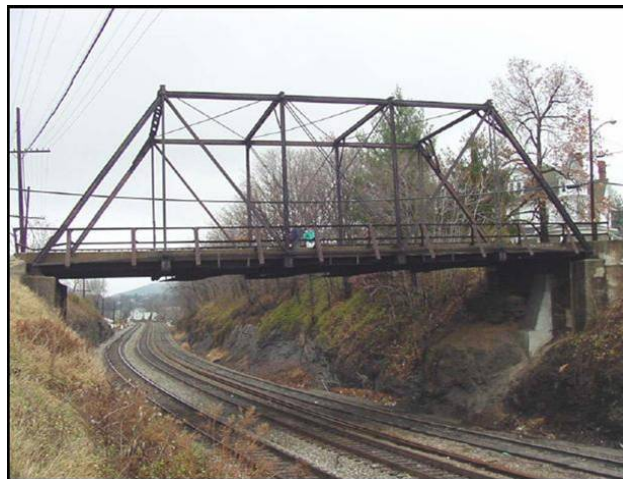
The Hawthorne St. Bridge in Covington, Virginia (Figure 1) is one of many candidates for rehabilitation or replacement in Virginia. The thru-truss bridge has a 75 ft. clear span 5-bay Pratt-truss structure, with a roadway width of 22 ft., running over three rail-lines. It also serves as the only lifeline to parts of downtown Covington during periods of high water, and thus must support emergency vehicles. The historical significance of its cast iron thru-truss has ruled out bridge replacement. Virginia Department of Transportation (VDOT) plans to rehabilitate the bridge superstructure with a new deck/stringer/floor-beam system and keep the historical thru-truss. VDOT plans to replace the existing, deteriorating reinforced concrete deck with an FRP composite bridge deck system. The most important characteristic of the deck/beam/girder replacement is the reduction in self-weight of the bridge, which will increase the posting (current posted at a maximum load of 7 tons) to 20 tons and allow for use by emergency vehicles.

**Figure 1. The Hawthorne St. Bridge in Covington, VA**

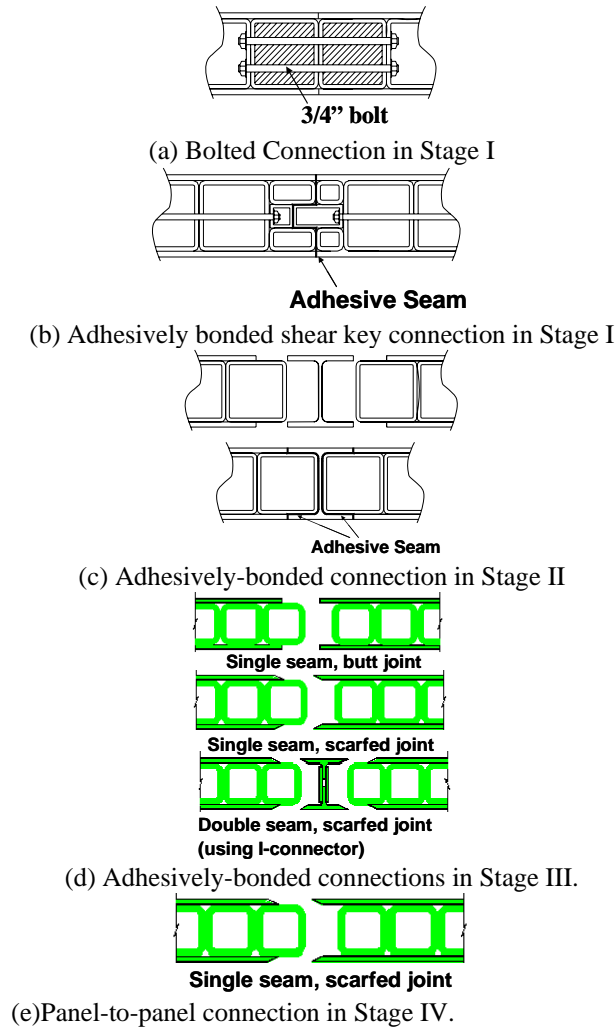
**Figure 2. Evolution of panel-to-panel connections at Virginia Tech**

The research began with a project conducted by Christopher T. Link (Link 2003) and is referred to as Stage I. Two panel-to-panel connections were developed and tested, as shown in Figure 2(a) and (b). One was a bolted connection and the other was an adhesive shear-key joint. Results showed that the bolted joint could carry the design load, but was susceptible to fatigue damage. Although the adhesive shear-key connection showed less capacity than bolted connection, it showed more promise than a bolted connection because of better fatigue performance and a linear behavior up to failure, with a progressive, nearly “ductile” failure mode.

In Stage II, a full-length, simplified adhesively-bonded tongue and groove panel-to-panel connection [Figure 2(c)] was tested in a weak-direction (beam) bending configuration. The testing showed some promising aspects: linear behavior up to failure stage; crack initiation after design service load strain was reached; and a factor of safety of 2.4 with respect to the anticipated service strain. Testing results indicated the adhesive bonding was a viable technique in using with panel-to-panel joint for FRP decks. Stage III research was aimed to further optimize this design.

Two types of adhesively-bonded panel-to-panel connections with scarfed joints were tested in Stage III: one single seam connection and one double seam connection, as shown in

Figure 2(d). A plate bending setup with three sides simply supported and one side free (which approximates the support condition near an abutment) was used to better represent the on-site situation instead of one-way bending setup in Stage II.

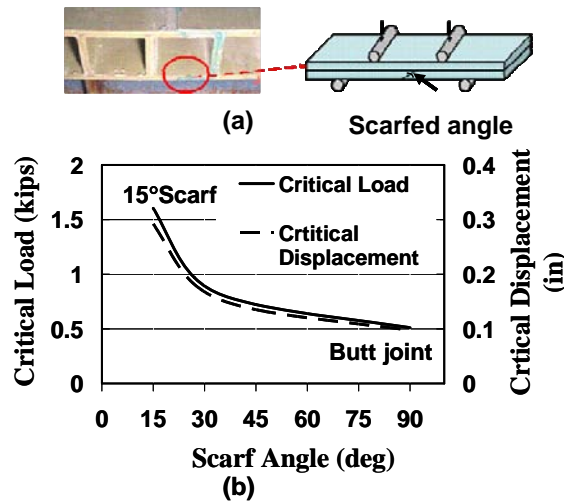
Figure 3. Critical load and displacement increased as scarf angle decreased, under 4-point bend test.

In Stage III, different connection geometries (scarfed vs. butt joint behavior) were investigated. The joining effectiveness of simple butt joint geometry was tested as shown in Figure 2(d). Premature cracking was observed in the butt joint area. To eliminate this tendency the joints in Stage III panels were sloped or scarfed, as shown in Figure 2(d). The testing setup and the mimic part of the FRP deck system are shown in Figure 3(a). Test results (Soto J et al. 2004) indicate that FRP samples with a scarfed edge have better performance than those having a butt joint (90°) under a four-point bending configuration, as shown in Figure 3(b). The critical load and displacement (at crack initiation) increased as scarf angle decreased. But for FRP deck panels, sharper scarf angles (smaller than 1/2 slope) are difficult to manufacture and can be easily damaged during transportation and installation. Therefore, scarf joints with an angle of 27° (1/2 slope) were used on the test specimens and recommended for future field application.

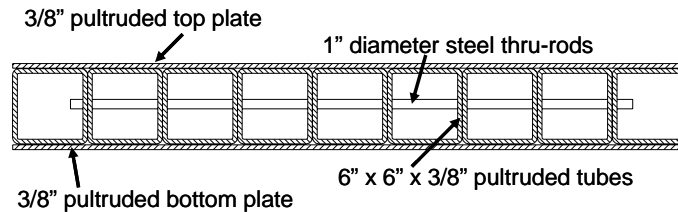
**Figure 4. Cross section of the Strongwell FRP Deck System**

are made of E-glass roving and continuous strand mat embedded in polyester resin. The typical cross section of a deck panel is shown in Figure 4. The off-the-shelf components include: 6 in. x 6 in. x 3/8 in. pultruded EXTREN<sup>®</sup> tubes, 3/8 in. pultruded EXTREN<sup>®</sup> top and bottom plates as well as 1 in. diameter steel thru-rods. The tubes, top and bottom plate are adhesively bonded to form FRP bridge deck panels. The steel thru-rods are used to provide necessary binding forces when the deck panels are in curing. Bonding is accomplished in a vacuum bag to produce uniform pressure and continuous bonding.

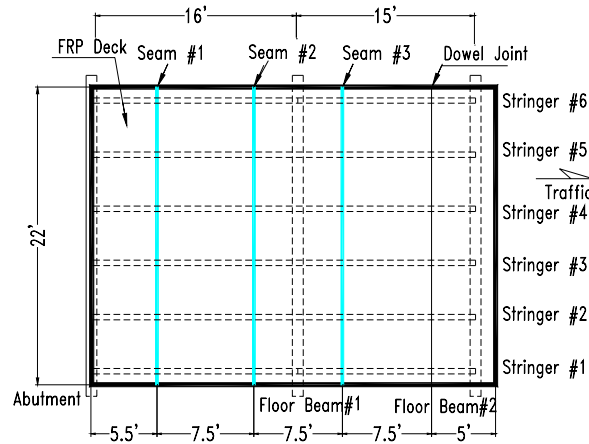
**Figure 5. FRP deck panels and joints of the Hawthorne St. Bridge mock-up.**

Figure 5 shows a plan view of deck panels, panel-to-panel connections, and supporting steel superstructure. The FRP deck specimen consisted of five individual modular deck panels that were jointed together using three adhesive panel-to-panel connections (Seam #1 through #3) and one dowel joint. The dowel joint was developed as an expansion joint for future applications, and will not be discussed here. Each individual panel was 22 by 7.5 ft., with the exception of the two end panels which measured 22 by 5.5 ft., and 22 by 5 ft. These individual panels were connected to form a full width 22 ft. panel that was about 33 ft. long in the direction of traffic.

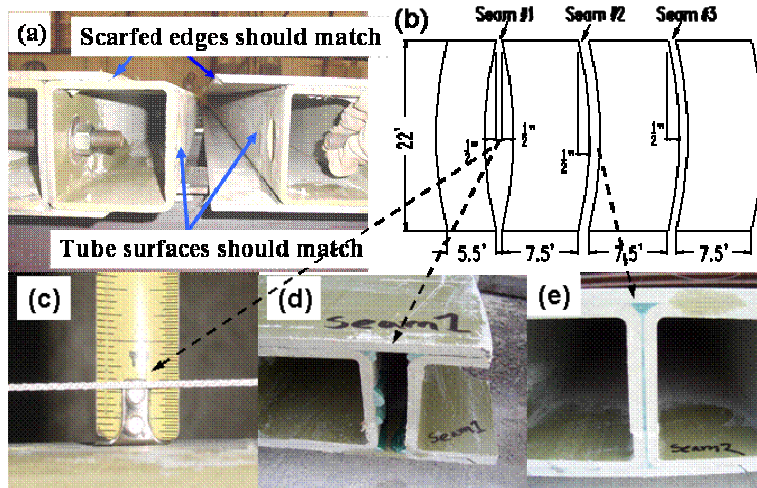
**Figure 6. Fitting of the adhesively-bonded panel-to-panel connection.**

During dry-fitting of three panel-to-panel connections, it was found that the sweep of the tubes was not well controlled during pultrusion. Figure 6(b) shows the curved panels resulting from the use of curved tubes. Each panel had a pre-existent sweep with a midway deflection about 0.5 in. (Figure 6(c)). The worst case was Seam #1 with two opposite curvatures at the side walls of the tube bonding surface. Although Seam #2 and #3 also had similar curvatures, mating tubes were bent in the same direction. The deck panels were autopsied after testing was completed to further investigate the bonding quality. Figure 6(d) shows that the gap distance between two bonding tube surfaces of Seam #1 was about 1 in. The gap distances of Seam #2 and #3 were less than 0.1 in. and all scarfed edges matched well. Figure 6(e) shows the bonding quality of Seam #2.

6. Aligning the tongue-end panel (the left side of the connection in Figure 6(a)) so that the tongue fits in the groove.

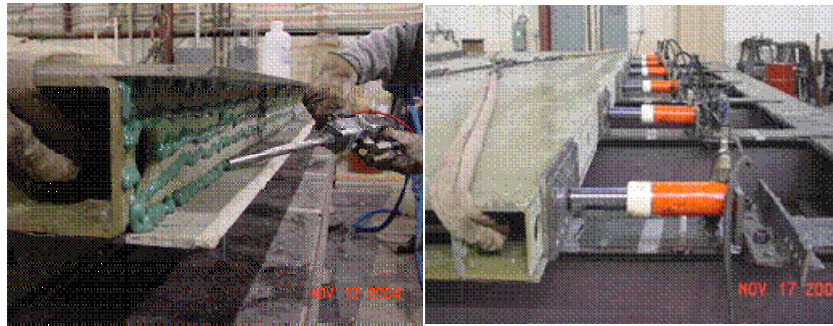
(a) Adhesive application

(b) Jacking system

**Figure 7. Adhesive construction for panel-to-panel connection.**

7. Joining deck panels by equal jacking pressure from six hydraulic jacks with a manifold system, shown in Figure 7(b). Enough pressure must be applied to close the joint and ensure that adequate adhesive squeezes out.
8. Maintaining the jack pressure for about 12 hours, until the adhesive cured.
9. Bolting down the deck panel to the stringers with deck-to-stringer connectors.
10. Going through steps (3) through (9) for another adhesive connection.

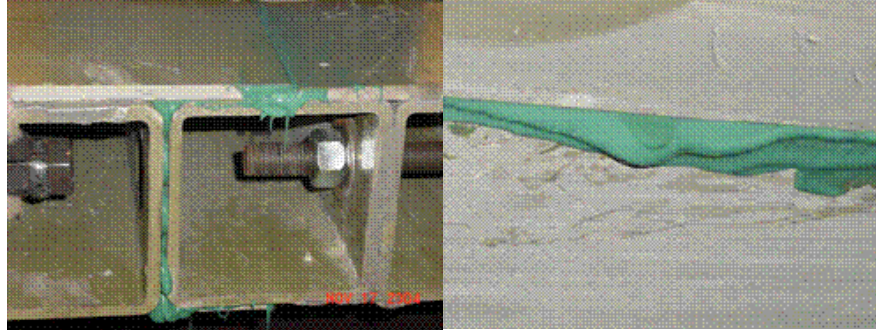
(a) Side view

(b) Bottom view

**Figure 8. Adhesive squeezing out from joints during adhesive construction.**

The performance of adhesive bonding is not only dependent on the matching condition of mating parts, surface preparation, and joint geometry as discussed above, but also the amount of adhesive applied. Adequate adhesive squeeze out is a sign that adequate adhesive was applied and is recommended as the quality control check-point in field construction. Increasing amounts of adhesive was applied to the three seams in order to compare performances of seams with different amounts of adhesive (Seam #3 had the most and Seam #1 had the least). Seam #3 was thought to be the best joint with the best fit and sufficient adhesive squeeze out. Figure 8 shows Seam #3 after adhesive was applied and adequate adhesive squeezed out from the top, side and bottom of the joint. Although Seams #1 and #2 performed well during static tests (discussed in a later section), the amount of adhesive used for Seam #3 was selected as enough to ensure adequate strength and life of the panel-to-panel connection.

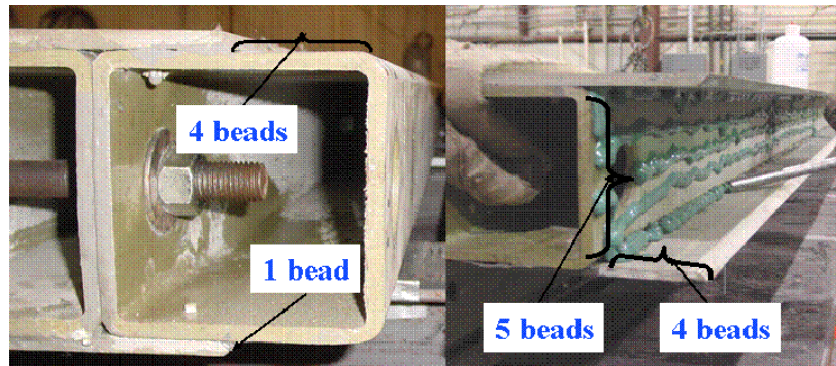
(a) Adhesive on tongue part

(b) Adhesive on groove part

The Pliogrip 8000/6660 two-component, structural urethane adhesive system from Ashland Chemicals Inc. was used in this application for its superior adhesion property, UV resistance and proper glass transition temperature. Figure 9 shows how the adhesive beads were applied on the tongue and groove parts. Each bead had a width of about 0.4-0.6 in. and a thickness of about  $\frac{1}{4}$ - $\frac{1}{2}$  in. One bead of adhesive was applied on each scarfed edges. The amount of adhesive applied per connection was about 14.2 Liters of Pliogrip 8000 and 6.3 Liters of Pliogrip 6660.

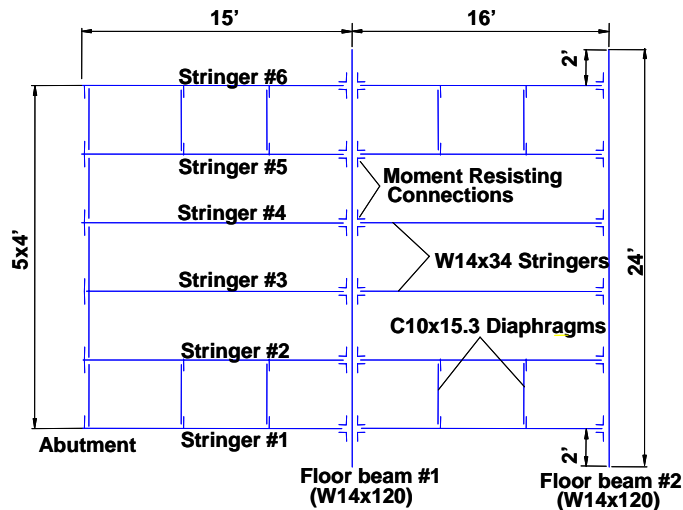
Figure 10. Framing plan of the steel superstructure of the Hawthorne St. Bridge mock-up.

The steel frame mock-up of the Hawthorne St. Bridge superstructure consisted of two bays, which were 16 ft. and 15 ft. in length in the direction of traffic. Figure 10 shows a framing plan of the steel superstructure. Each bay had six wide-flange W14x34 stringers, having a transverse spacing of 4 ft. on-center. Diaphragm members, consisting of C10x15.3 steel sections, were bolted to connector plates, which were in turn welded to the stringers. Two W14x120 floor beams were supported by four pedestals that simulated the hangers in the through-truss bridge. All steel member sizes and dimensions mimic the actual ones in the Hawthorne St. Bridge superstructure. Neoprene pads were used between floor beams and pedestals to avoid direct contact of steel and to allow some movement at floor beam ends. Stringers and floor beams were jointed together using moment resisting connections. A W21x132 beam was used to simulate the concrete abutment in situ, and five end diaphragms (C10x30) were flush with the top stringer to avoid free edge effect of the FRP deck. All stringers at the abutment rested on the bearings anchored on the abutment.

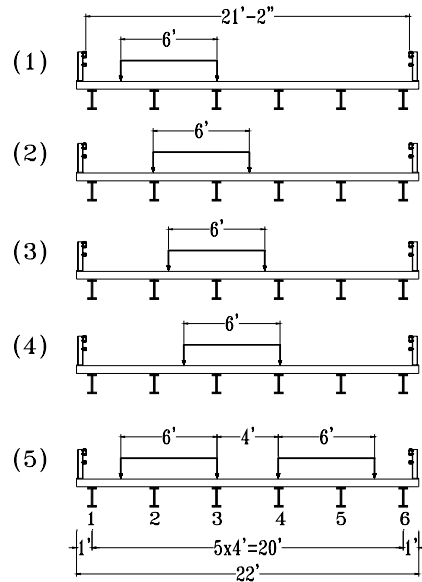
**Figure 11. Load Cases for service load test.**

Five Load Cases used for service load tests are shown in Figure 11. All Load Cases followed HL-93 truck weights and dimensions to apply the worst-case load scenario to the FRP deck and superstructure. Load Cases 1–4 were single truck cases. Load Cases 1, 2 and 4 were the

critical cases for flexure of an FRP deck transverse to the traffic, with a wheel located at mid-span between two stringers. Load Case 3 represented a truck straddling on Stringer 3. Load Case 5 is the symmetric case, with double trucks representing the full lane Load Case.

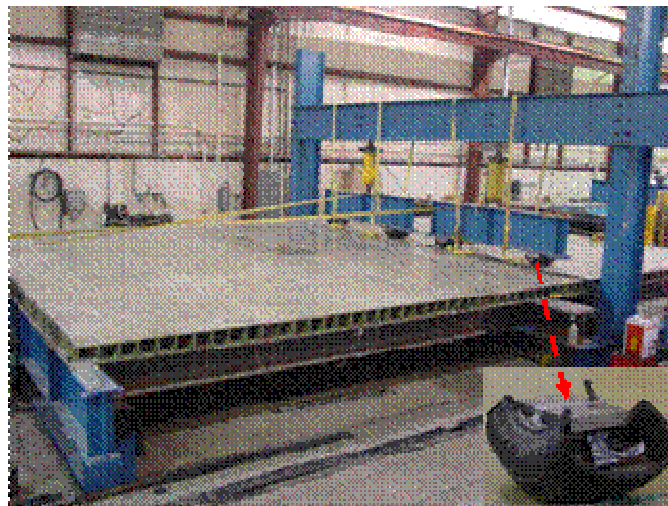
**Figure 12. Experimental Setup for service load test (Load Case 5) on Seam #3.**

The double truck service load test (case 5) was simulated by two single-truck setups, as shown in Figure 12. A special loading patch (Figure 12) which consisted of a quarter tire internally reinforced with silicone rubber was used to mimic the cushioning effect of a pneumatic tire. This was done to minimize the local stress concentrations of a standard rectangular steel patch because of the relative local flexibility of the FRP composite cellular decks, as compared to the steel plate (Zhou et al. 2005).

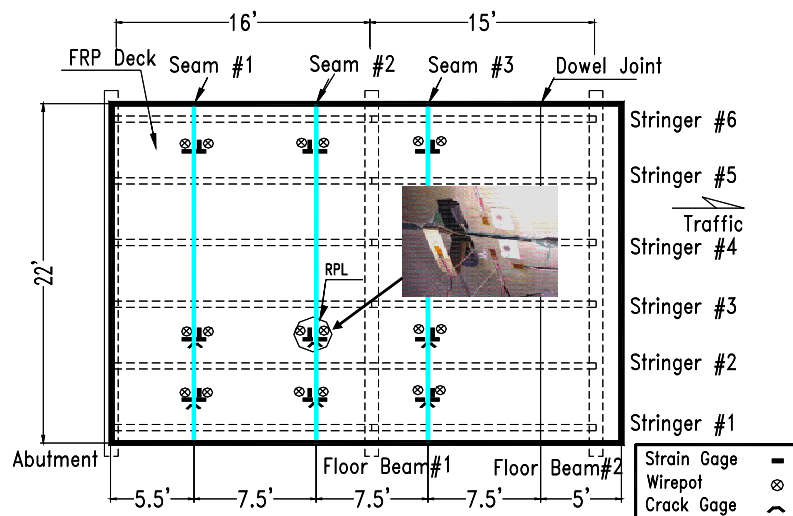
Figure 13. Instrumentations for three adhesively-bonded panel-to-panel connections (underneath the deck).

The schematic of the instrumentation plan used to investigate the performance of adhesively-bonded joints is shown in Figure 13. The stringers and floor-beams are referred to as “Stringer #1” through “Stringer #6” and “Floor Beam #1” and “Floor Beam #2.” For consistency throughout the discussion, all references to “longitudinal” and “transverse” are given with respect to the bridge deck orientation; thus, “longitudinal” implies parallel to the pultruded tube direction of the FRP deck system, and the “transverse” direction refers to the traffic flow direction (perpendicular to the tube axis).

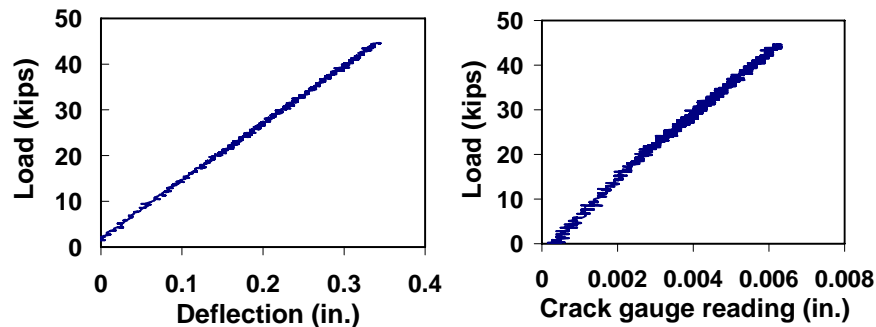
(a) Load vs. deck overall deflection (b) Load vs. crack gauge reading

**Figure 14. Representative plots in service load tests**

The representative span deflection and crack gauge responses at one location, location RPL (shown in Figure 13) under Load Case 4 are shown in Figure 14. The load vs. strain and load vs. deflection behaviors were observed to be fairly linear elastic up to the design service load. The absolute deflection at the mid-span of the deck was 0.335 in., as shown in Figure 14(a), and the relative deflection at this point with respect to supporting stringers was 0.074 in. at the design service load, which indicated an L/649 response.

At location RPL under Load Case 4, the longitudinal strain on the bottom plate right under the load patch was  $1090 \mu\epsilon$ , which is only 6% of the estimated ultimate strain of the bottom plate. Transverse strain at one side of the seam close to the loading patch was  $490 \mu\epsilon$  at the design service load, which was about 45% of the longitudinal strain at this load. However, transverse strain at the other side of the seam was  $-290 \mu\epsilon$  at the design service load, which was in compression; this indicated that this region experienced double curvature due to an applied load at one side of the seam. The linear response of crack gauge indicates that no crack was initiated up to design service load, as shown in Figure 14(b).

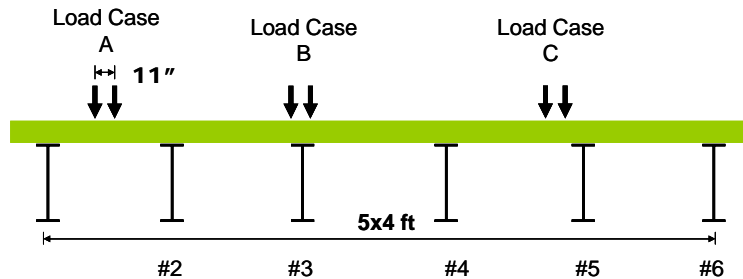
**Figure 15. Load Cases for strength tests on as-received deck.**

adhesively-bonded panel-to-panel connections. Figure 15 shows three different Load Cases. These cases were designed to study which one is the worst case and what is the corresponding failure mode. Load Case A was the critical case for flexure of the FRP deck transverse to traffic, with a pair of tire patches located at mid-span between Stringers #1 and #2. Load Case B is a pair of tire patches straddling Stringer #3, which is the critical case for compression. Load Case C is a pair of tire patches sitting just at the edge of Stringer #5, which is the critical case for punching shear. The same setup and procedure were used and will not be discussed in detail here. All testing data from strength tests are included in Table 3 for comparison. Test results show that Case A (flexure of the FRP deck transverse to traffic) is the critical case, Other Load Cases had larger safety factors, calculated as failure load at crack initiation divided by the design service load.

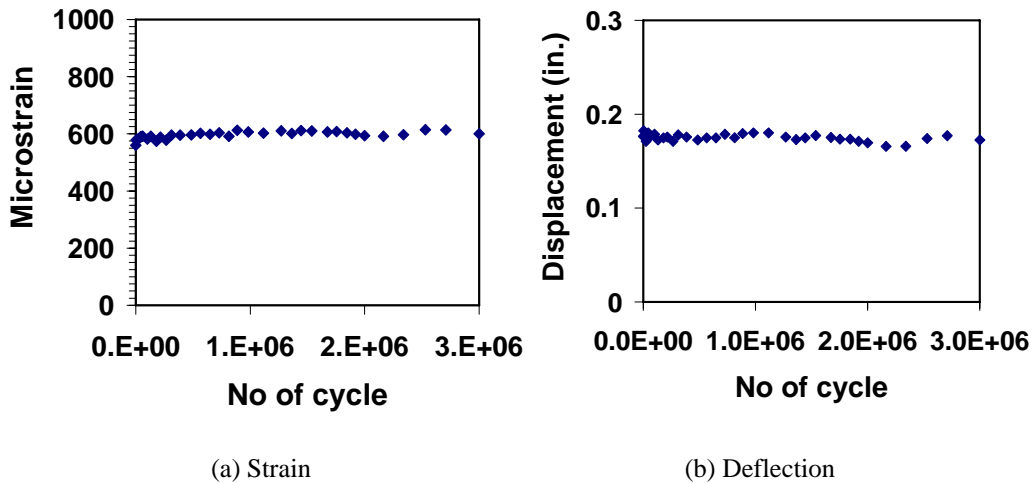
**Figure 16. Maximum strain and deflection at service load after interrupted fatigue loading.**

The maximum deflection and strain measurements at the service load (22 kips) taken during each static test can be seen in Figure 16(a) and (b), respectively. The deflection and strain responses remained fairly constant for all of the static service load tests, and the deck demonstrated no apparent loss in stiffness near the adhesive joint. The crack gauge measurements taken during the static test after 3,000,000 cycles show linearly response indicating no crack was initiated after 3,000,000 cycles. Similar deflection measurements at two sides of the adhesive joints during the static test after 3,000,000 cycles also demonstrated that no crack was initiated inside the joint.

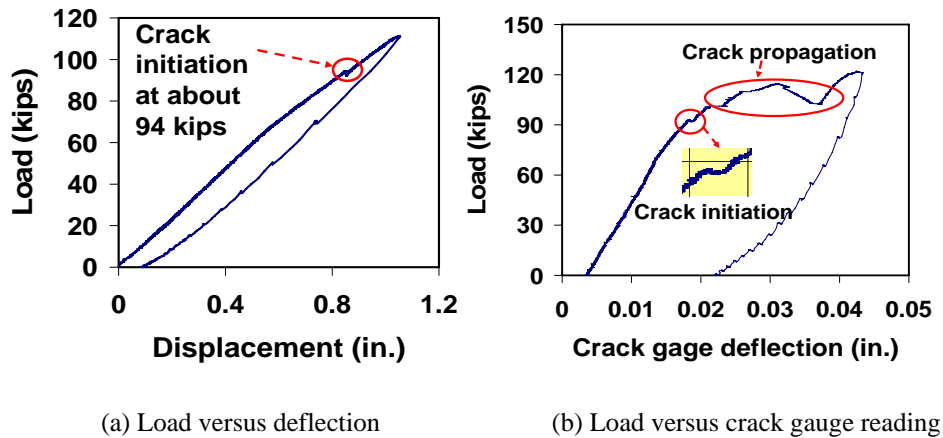
**Figure 17. Crack gauge and deck deflection results from residual strength test after 3,000,000 cycles**

The fatigue test was followed by a residual strength test at the same location. Figure 17(a) shows the load versus deflection plot and Figure 17 (b) shows the load versus crack gauge plot. Both responses showed fairly linear-elastic behavior up to the crack initiation of the adhesive joint after 3,000,000 fatigue cycles. The first failure (crack initiation in the joint) occurred at 94 kips. At the crack initiation point, both plots showed a significant drop due to stiffness loss caused by cracking in the adhesive joint. Figure 17(b) also shows a clear crack propagation stage after crack initiation. The critical loads at initiation of crack after fatigue and without fatigue shown in Table 3 indicate no significant loss in strength after fatigue.

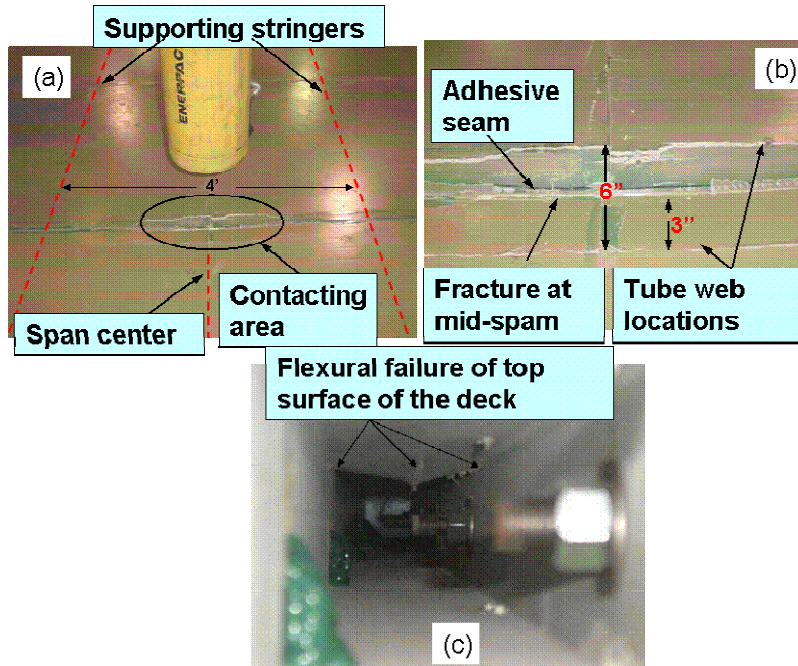
Figure 18. Failure mode in strength test (a) Highly localized surface failure (b) Failure detail on top surface of the deck (c) Side view of the flexural failure of top surface.

The failure mode observed on the seam that was fatigued to 3,000,000 cycles and then tested to failure is very consistent with that observed on two adhesive seams tested to failure without being fatigued. For all seams in the ultimate test, the failure areas were highly localized and right under the tire patches, as seen in Figure 18(a). Failure mode was flexural failure of the top plate and top flange of the tube. Three cracks could be seen (Figure 18(b)). Two cracks developed along two webs of the tube under the loading tire patch, and one crack was at about the center of the 6 in. span between two webs of the tube. Figure 18(c) shows a side view of the top surface flexural failure; no crack was observed on the tube webs. Also, no visible crack was observed at the bottom side of the deck near the adhesive joint after the top surface failed. From these results, it was concluded that the top plate and the top flange of the tube failed in weak-axis bending, with cracking parallel to the tube webs.

Another important observation from Figure 18(b) is that although the fracture at mid-span of two webs of the tube was near the adhesively-bonded line, no failure was observed in the adhesive layer or in the joint interface. This suggests the adhesive layer and adhesive-substrate interface are stronger than the FRP components and that adhesive bonding is a viable technique for the panel-to-panel connections in FRP bridge deck system. In addition, the tests demonstrated ductile failure rather than a total collapse, which would provide plenty of time for evacuation and maybe considered as another advantage of this FRP deck system.

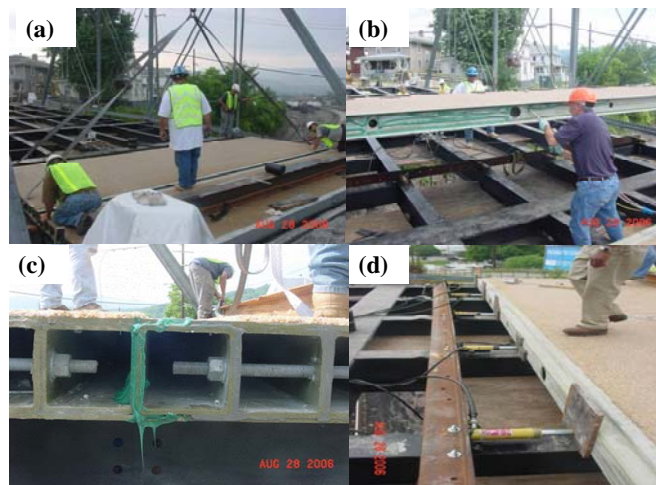
Figure 19. Field installation of the FRP bridge deck (a) Dry fit (b) Adhesive application (c) Seam curing (d) Jacking system

The FRP bridge deck installation was started at the Hawthorne St. Bridge on August 29<sup>th</sup>, 2006. Figure 19 shows the adhesive bonding process of the panel-to-panel connections during deck installation. The accuracy of panel dimensions of the mating parts was well controlled and installation protocols were strictly followed during the field installation. The bridge is scheduled for a controlled live load test and the response of the adhesively bonded panel-to-panel connection will be monitored.
