Evaluation of Household Water Quality in Spotsylvania and Stafford Counties, Virginia

AUGUST 2012

VIRGINIA HOUSEHOLD WATER QUALITY PROGRAM

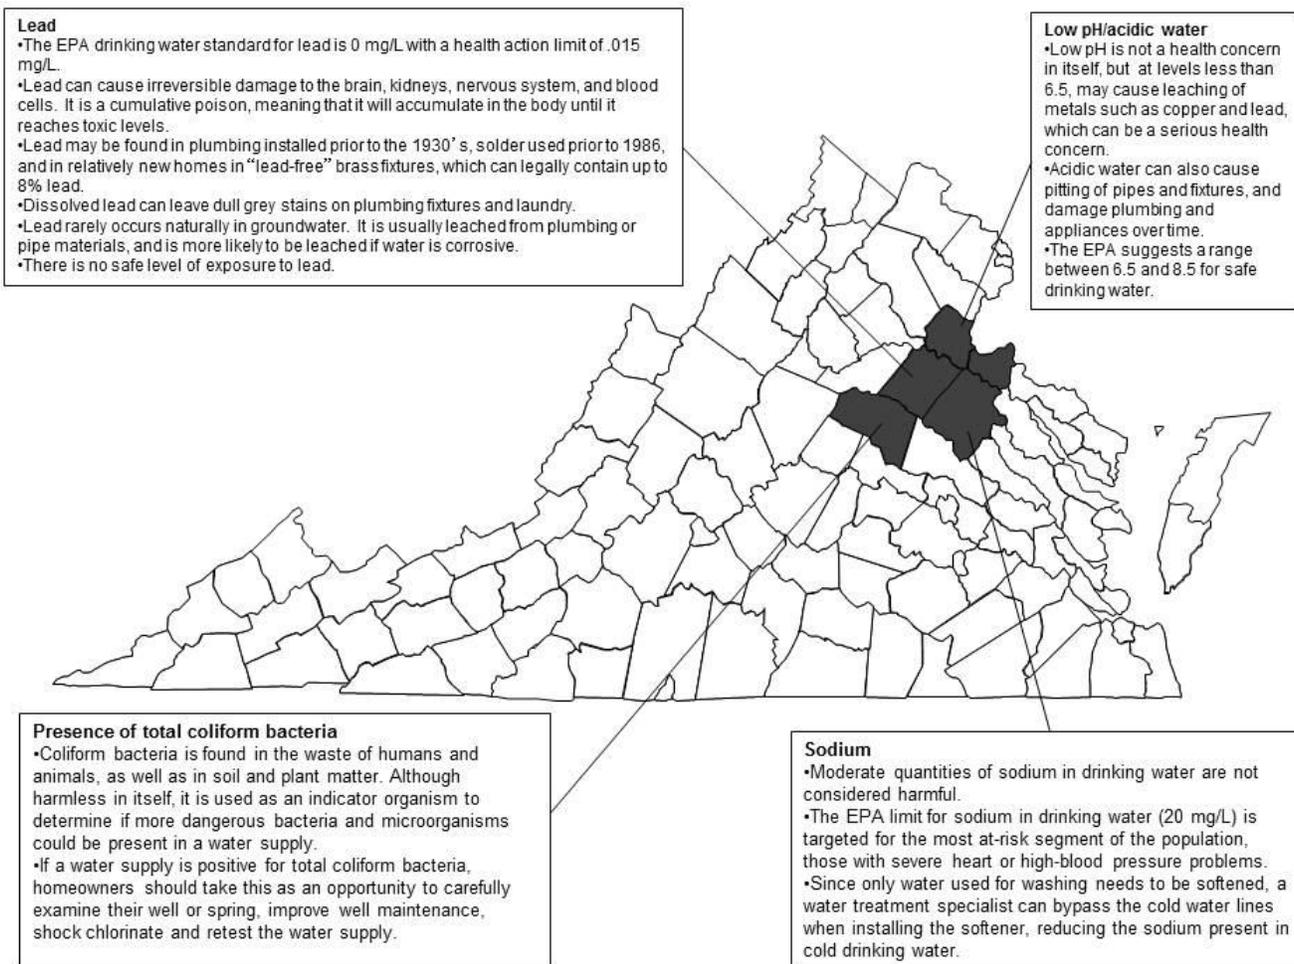
Figure 1. The most common household water quality issues found in the 95 Spotsylvania/Stafford clinic participant samples were high levels of sodium, lead, low pH, and the presence of total coliform bacteria.

In August 2012, 95 residents from Spotsylvania, Stafford and a few surrounding counties participated in a drinking water clinic sponsored by local Virginia Cooperative Extension (VCE) offices and the Virginia Household Water Quality Program. Table 1, found at the end of the report, shows the counties participating in the clinic as well as the number of respondents per county. The Spotsylvania/Stafford clinic participants received a confidential water sample analysis and attended educational meetings where they learned how to interpret their water test results and address potential issues. The most common household water quality issues identified as a result of the analyses for the participants in the Spotsylvania/Stafford clinic were sodium, manganese, low pH, and the presence of total coliform bacteria. In addition, levels of lead and copper exceeding recommendations for household water were detected in some first draw samples. Figure 1, found at the end of this report, shows these common water quality issues along with basic information on standards, causes, and treatment options.
