Evaluation of Household Water Quality in Floyd County, Virginia

APRIL 2010

VIRGINIA HOUSEHOLD WATER QUALITY PROGRAM

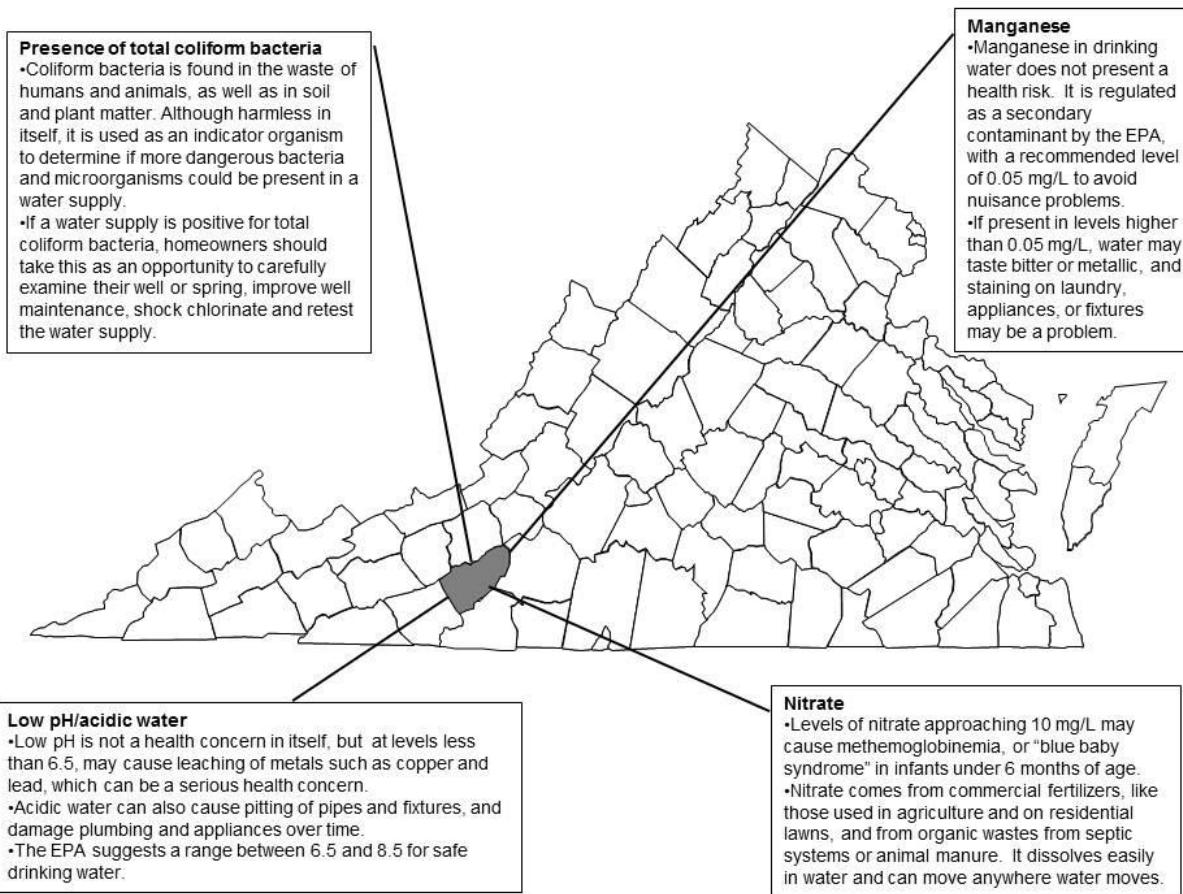
Figure 1. The most common household water quality issues found in the 32 Floyd clinic participant samples were high levels of manganese, nitrate, low pH, and the presence of total coliform bacteria.
