Evaluation of Household Water Quality in Madison and Orange Counties, Virginia NOVEMBER 2010 VIRGINIA HOUSEHOLD WATER QUALITY PROGRAM

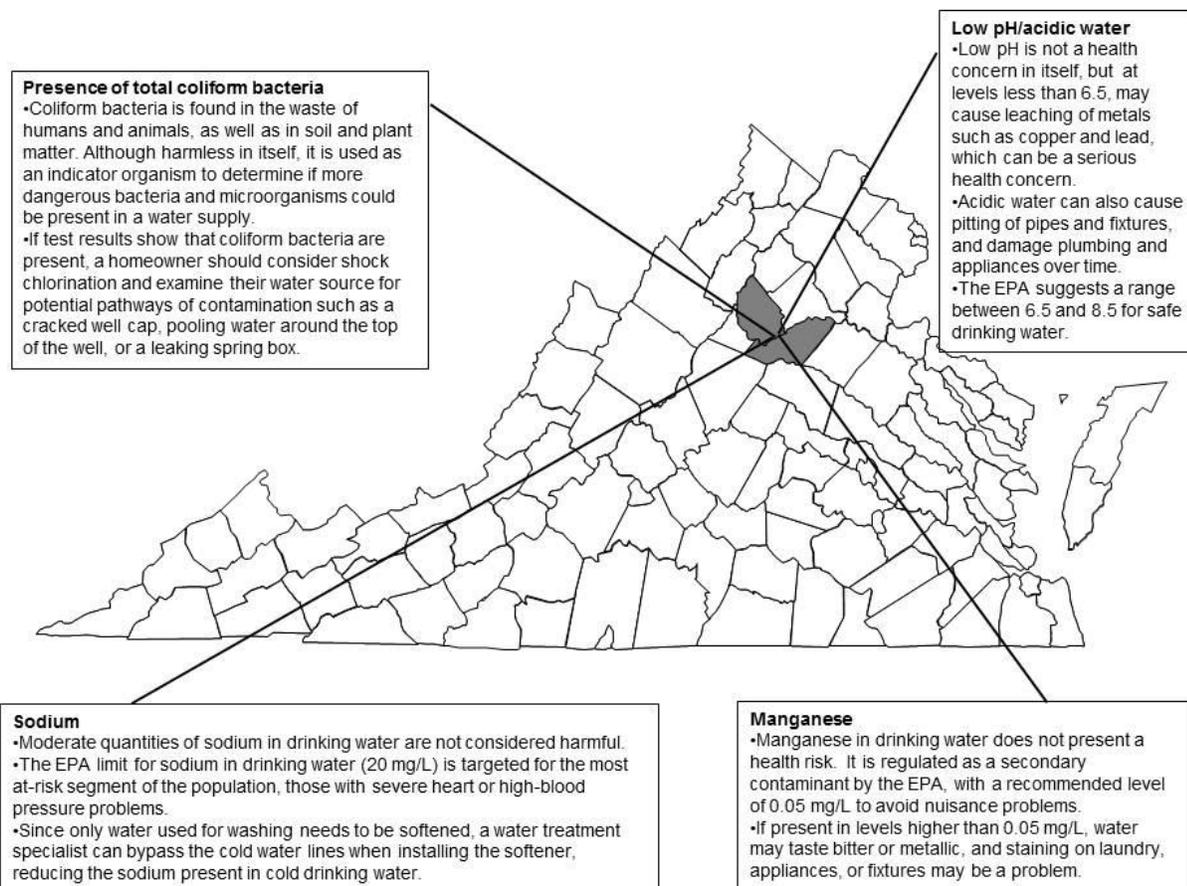
Figure 1. The most common household water-quality issues found in the 64 Madison/Orange clinic participant samples were high levels of sodium and manganese, low pH, and the presence of total coliform bacteria.
