The Influence of Roof Reflectivity on Adjacent Air and Surface Temperatures

An experimental study was conducted to answer questions about the thermal effects of roof reflectivity on the neighbouring built environment. Temperatures were recorded at the surface of black ethylene propylene diene monomer (EPDM) and white thermoplastic polyolefin (TPO) membrane overlay areas; in the air and at electrical metallic tubing (EMT) above them; and at opaque and glazed wall surfaces adjacent to them. The surface of the EPDM roof was significantly hotter than the TPO roof by 36°C and 26°C on two test dates. Air temperatures were 2°C higher above EPDM versus TPO up to 14 cm, with no significant differences above this height. Temperatures were 2°C higher at EMT above the TPO surface than above the EPDM. A precast concrete panel wall was 3°C to 5°C warmer adjacent to TPO versus EPDM. Exterior glazing surface temperatures were 2°C warmer adjacent to TPO versus EPDM.

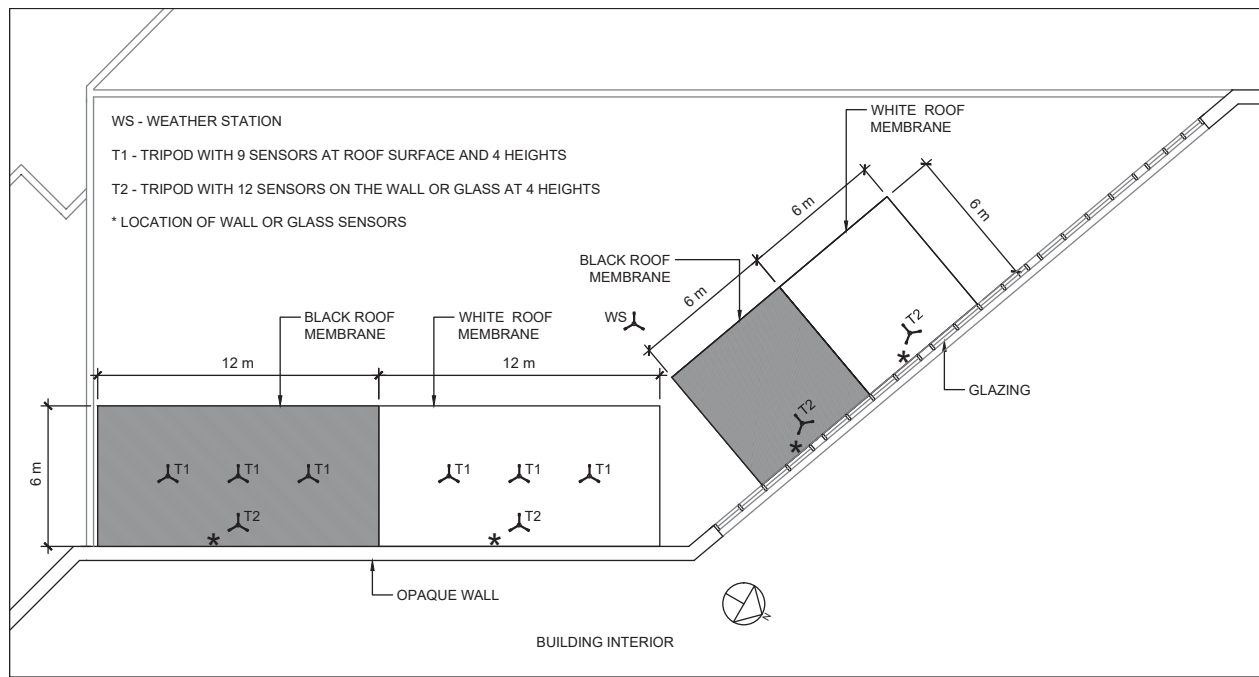
Figure 1

Figure 1. Diagram of Experimental Setup

During the week of August 10, 2015, 1.5 mm reinforced white TPO and 1.5 mm non-reinforced black EPDM from the same manufacturer were positioned at the roof site. A 12-by-6-meter overlay of each membrane was installed adjacent to the opaque wall, and a 6-by-6-meter overlay of each was installed next to the glazed wall (Figure 1). The membranes were installed over the existing EPDM membrane, using pressure-sensitive seam tape. On October 21, 2015, an albedometer was used to measure the reflectivity of the TPO and EPDM membranes. Readings on the TPO membrane began at 13:22 and ended at 13:35 Eastern Daylight Time (EDT). The readings for the EPDM membrane began at 13:42 and ended at 13:55 EDT. Reflectivity measurements were taken at 10-second intervals during the monitoring periods. The TPO had an average reflectivity of 65.7%, and the EPDM had an average reflectivity of 6.5%. With this information, and using the Lawrence Berkeley National Laboratory calculation for Solar Reflectance Index (SRI), the TPO had an SRI of 80, and the EPDM had an SRI of 0.2.

At each location of interest, three temperature sensors were installed. This provided three replications to allow for averaging of data and determination of the statistical significance of any temperature differences recorded. The accuracy of the temperature sensors was $< \pm 0.2^{\circ}\text{C}$ from 0° to 50°C , with a resolution of $< 0.03^{\circ}\text{C}$ from 0° to 50°C .

Temperature sensors were embedded in a bead of thermal compound and affixed to the precast concrete panel walls with small strips of super strength moulding tape to prevent pull-off. At the exterior surface of the glazed walls, clear, two-part, instant-mix epoxy was used to provide a direct connection to the glass. Opaque wall and glazing sensors were placed at heights of 56, 86, 132, and 162 cm as dictated by the geometry of the sun shield bisecting the glazed wall. Table 1 lists the experimental equipment used, and Figures 1 and 2 show the experimental setup.

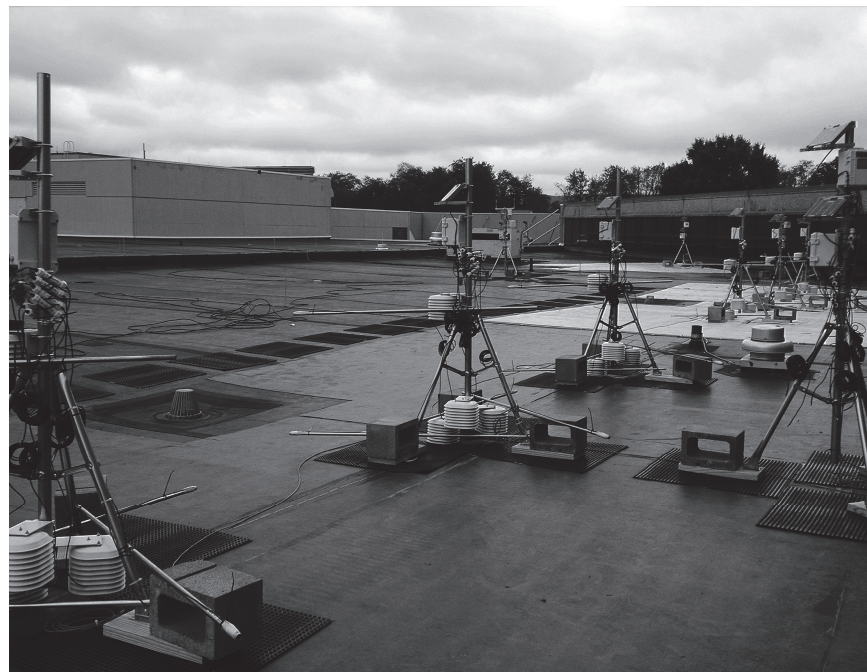
Figure 2

Figure 2. Photograph of Experimental Setup

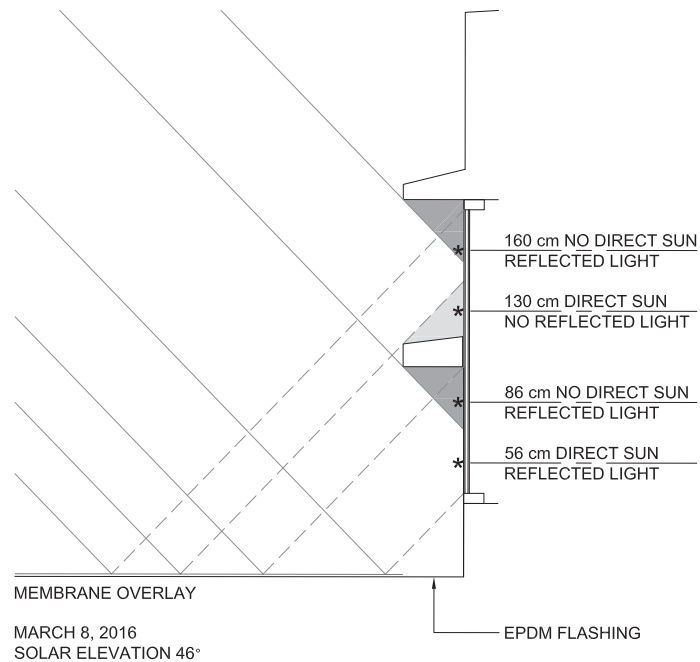
Figure 3

Figure 3. Geometry of Direct and Reflected Sunlight at Glazed Wall Sensors

The temperatures of the glazed surfaces were tested on a different day from the rest of the building elements because, for roughly half of the year, the glass is blocked from reflections off of the overlay roofs by exterior shading elements. Additionally, the solar elevation angle is low enough to bounce exclusively off the treatment area, and not the existing black EPDM flashing adjacent to the glazed wall, only between the autumnal and vernal equinoxes (Figure 3). Data from March 8, 2016 were therefore used to evaluate temperatures on the exterior of the glazing when the solar azimuth was perpendicular to the glass. Readings from sensors at a height of 132 cm were not reported, as they were obstructed from light reflected from the overlay surfaces on that day by a shading element. This area of the roof is unaffected by the exhaust louver at the opaque wall.

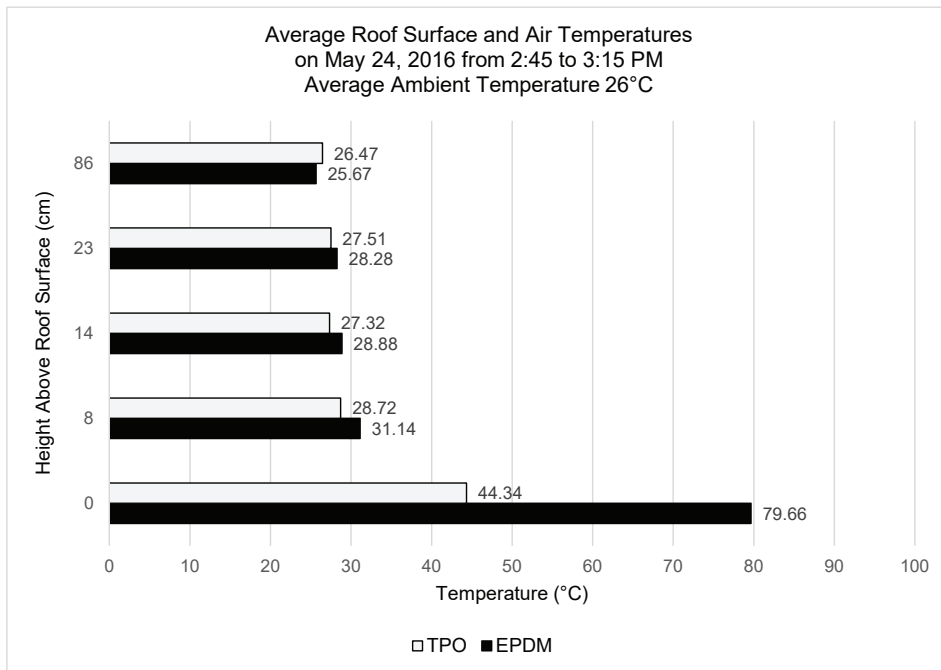
Figure 4

Figure 4. Average Roof Surface and Air Temperatures on May 24, 2016

The difference in roof surface temperatures, indicated by a height of 0 cm, was estimated at 35.34°C, with the EPDM much hotter than the TPO (Figure 4, Table 3). The average shielded air temperature above the EPDM overlay membrane was approximately 2°C hotter than the air temperature above the TPO at 8 cm and 14 cm above the roof surface. The air temperature differences at the higher elevations of 23 cm and 86 cm were not found to be statistically significant.

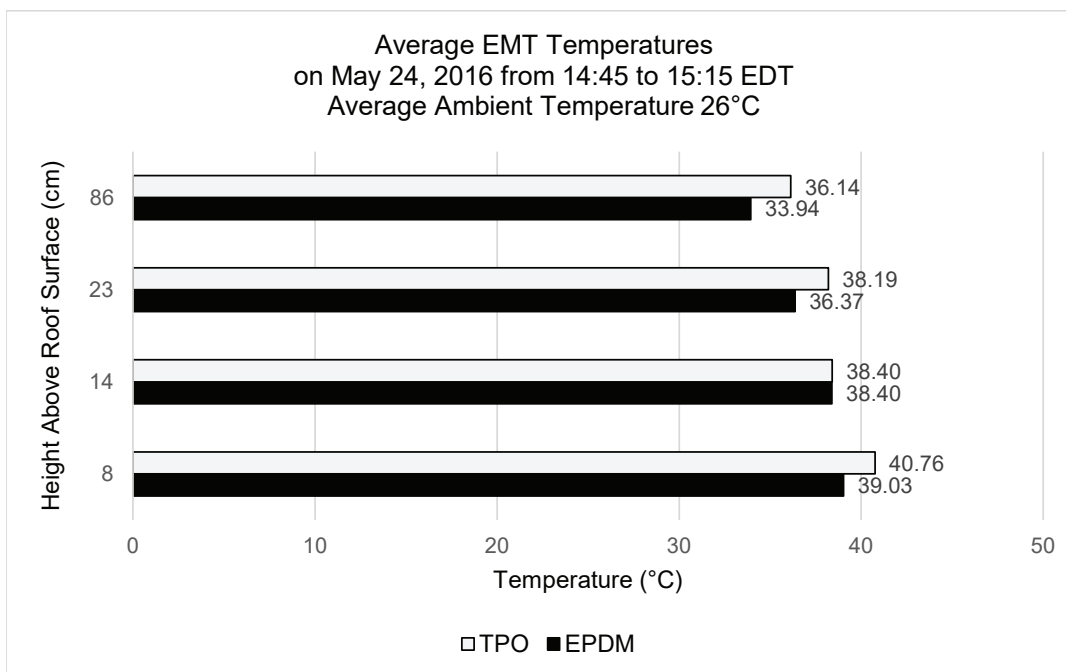
Figure 5

Figure 5. Average EMT Temperatures on May 24, 2016

At the EMT, all averaged temperature differences between the EPDM and TPO overlays were statistically significant except at 14 cm above the roof surface, where temperatures were nearly equal (Figure 5, Table 4). At the remaining heights, the EMT above the TPO roof was 2°C hotter than it was above the EPDM roof.

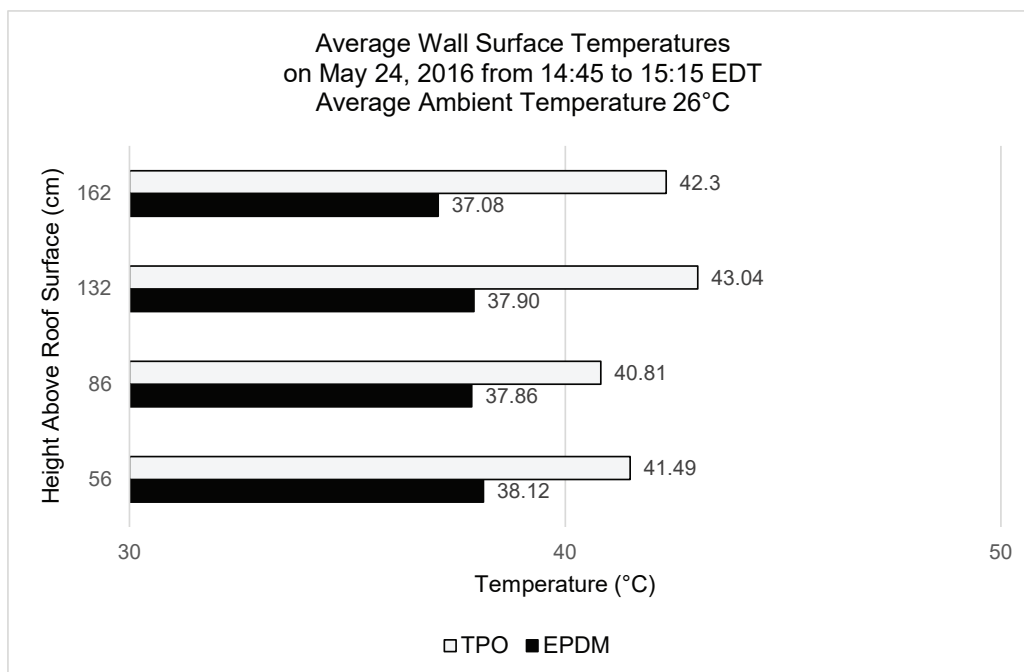
Figure 6

Figure 6. Average Wall Surface Temperatures on May 24, 2016

At heights of 56, 132, and 162 cm significant differences ranging from 3°C to 5°C were found at the precast concrete wall panels, with the wall next to the TPO roof hotter than the wall next to the EPDM roof (Figure 6, Table 5). No significant difference was found at 86 cm above the roof.

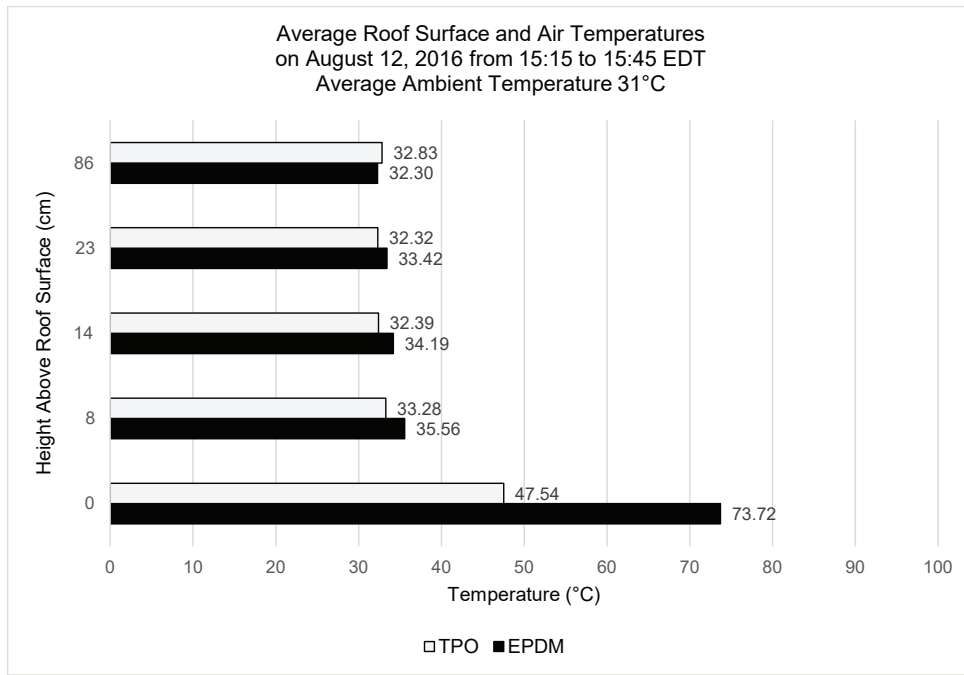
Figure 7

Figure 7. Average Roof Surface and Air Temperatures on August 12, 2016

The difference in temperature between EPDM and TPO overlay areas was significant at the roof surface and at the shielded air temperature sensors at 8 and 14 cm above the roof (Figure 7, Table 6). The sensors at 23 and 86 cm did not record a significant difference in temperature between the two treatments. The EPDM roof surface was a mean of 26.20°C hotter than the TPO roof. Where the differences were significant, air temperatures were again 2°C hotter above the EPDM than above the TPO.

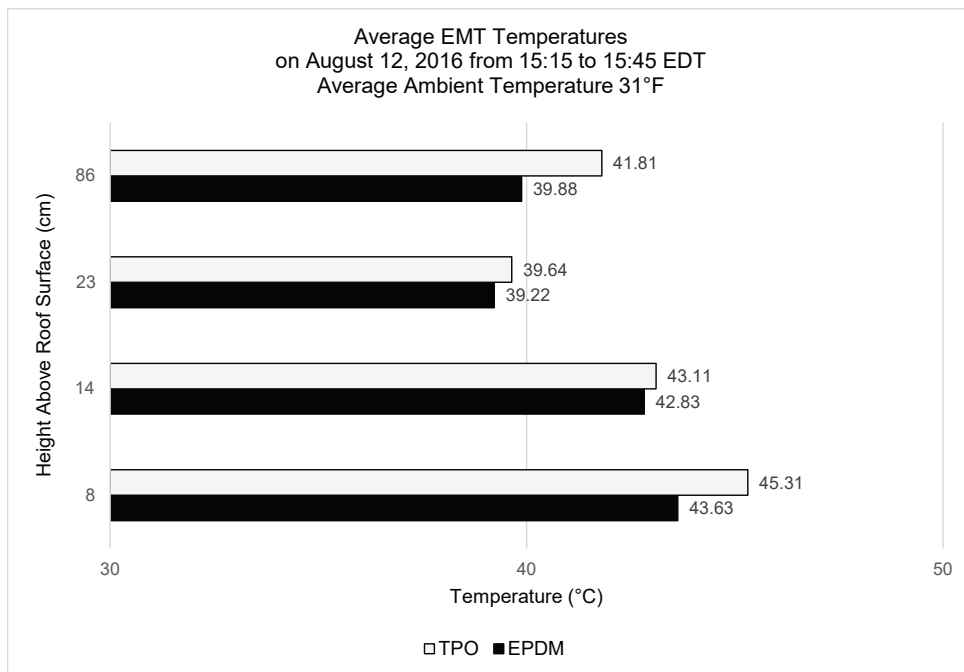
Figure 8

Figure 8. Average EMT Temperatures on August 12, 2016

The difference in EMT temperatures above EPDM and TPO overlays was significant at heights of 8 and 86 cm, with the EMT above the TPO roof about 2°C hotter than the EMT above the EPDM roof (Figure 8, Table 7). The differences in EMT temperatures at 14 and 23 cm were not significant.

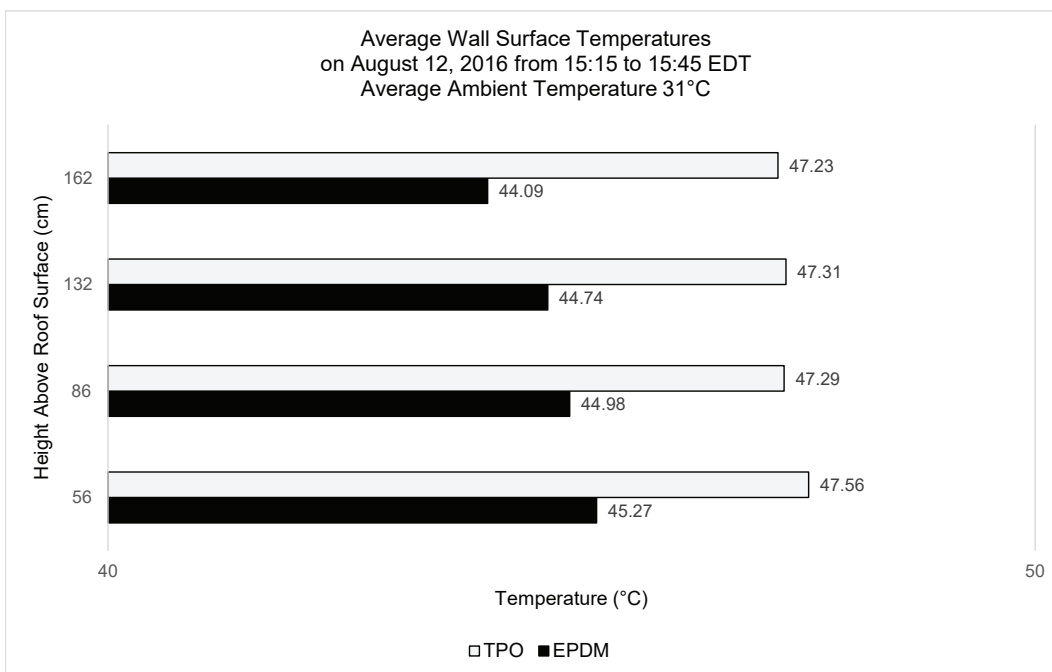
Figure 9

Figure 9. Average Wall Surface Temperatures on August 12, 2016

The only significant finding at the wall surfaces occurred at a height of 162 cm above the roof surface (Figure 9, Table 8). There, the wall next to the TPO roof was estimated to be about 3°C warmer than the wall next to the EPDM roof.

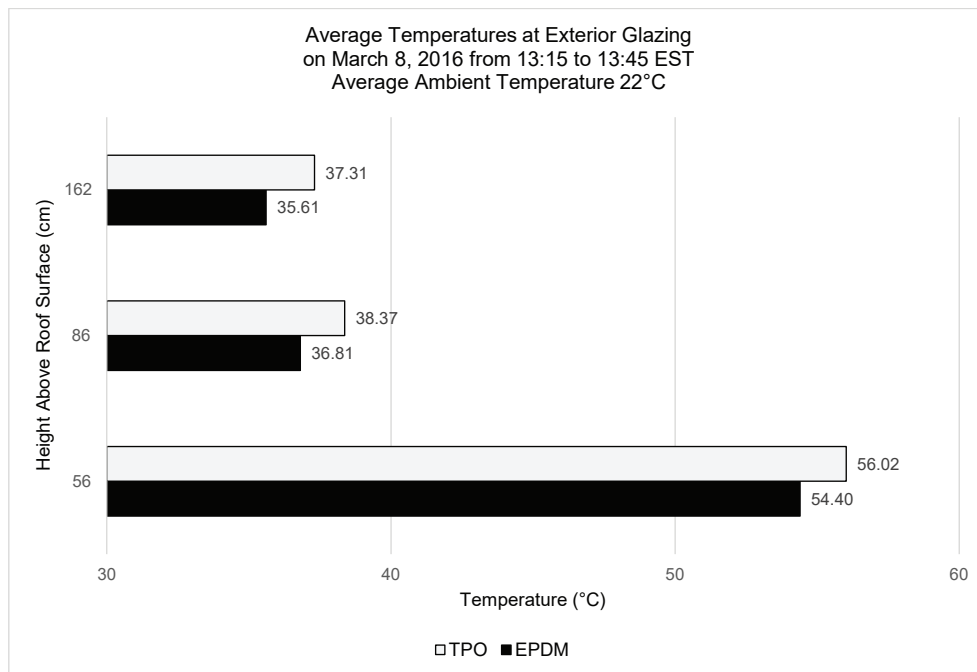
Figure 10

Figure 10. Average Exterior Glazing Surface Temperatures on March 8, 2016

On March 8, 2016, the difference in temperature for glazed walls adjacent to the EPDM and TPO surfaces was significant for all three heights evaluated, with the glazing adjacent to the TPO roof approximately 2°C hotter than the glazing adjacent to the EPDM roof (Figure 10, Table 9).

- (5) Exterior glazing surface temperatures measured on March 8, 2016 were found to be approximately 2°C hotter adjacent to the TPO overlay as compared to the EPDM overlay area at all heights. Statistically, the difference in temperature by height for each condition was significant for all pairs of sensor heights except at the TPO roof where there was no significant difference between the temperatures at 86 and 162 cm. Qualitatively, it is clear that the effect of direct sunlight falling only on the sensors at 56 cm above both roof treatments created much higher temperatures there than elsewhere. Despite this, the relative difference in temperature from EPDM to TPO was similar whether sensors were shaded from direct sun or not, most likely due to the greater reflectivity of the TPO.
